# **Preliminary Roost Assessment and Bat Survey Report**

Unit 32,  
Stakehill Industrial Estate,  
Manchester

**PEG681-02B**

Stakehill Industrial Estate,  
Middleton, Manchester, M24 2RW

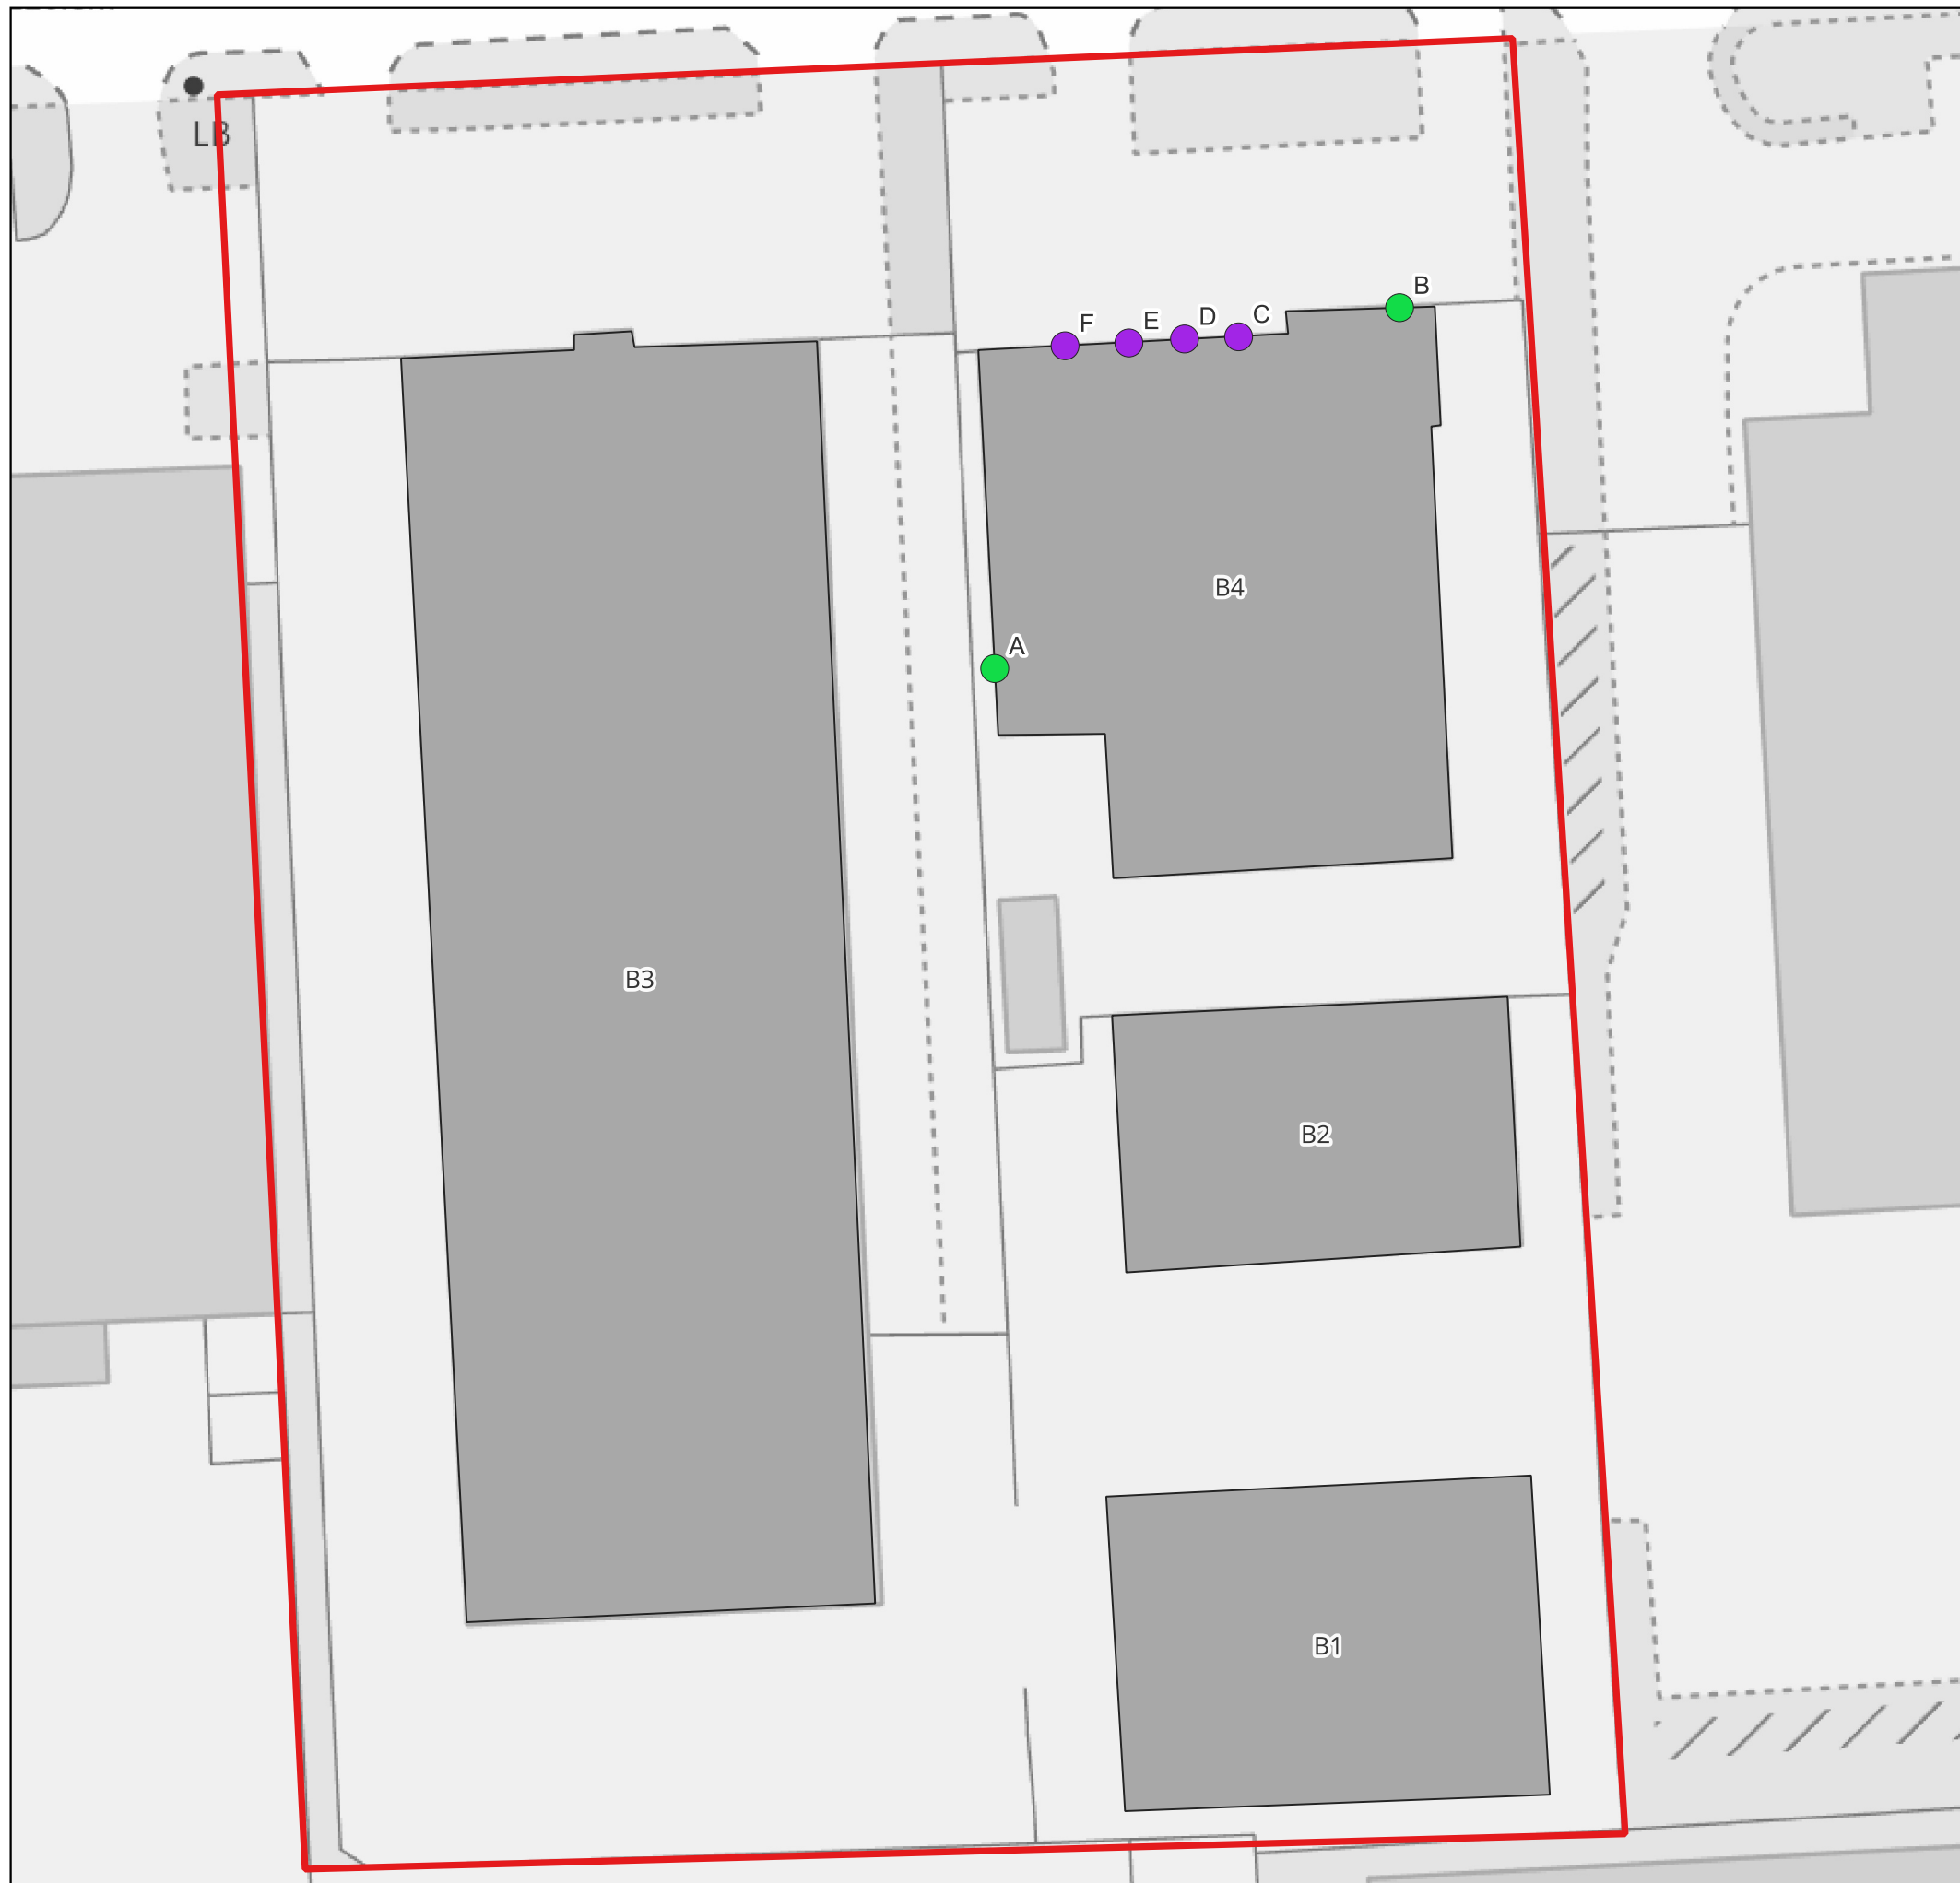
Site Layout and PRF  
Location Plan

- 5.4 The site structure and PRF locations can be seen on Figure 2. Full PRA survey notes including building descriptions, exact locations, and photographs can be found in Appendix A. A short summary for the site has been given below.

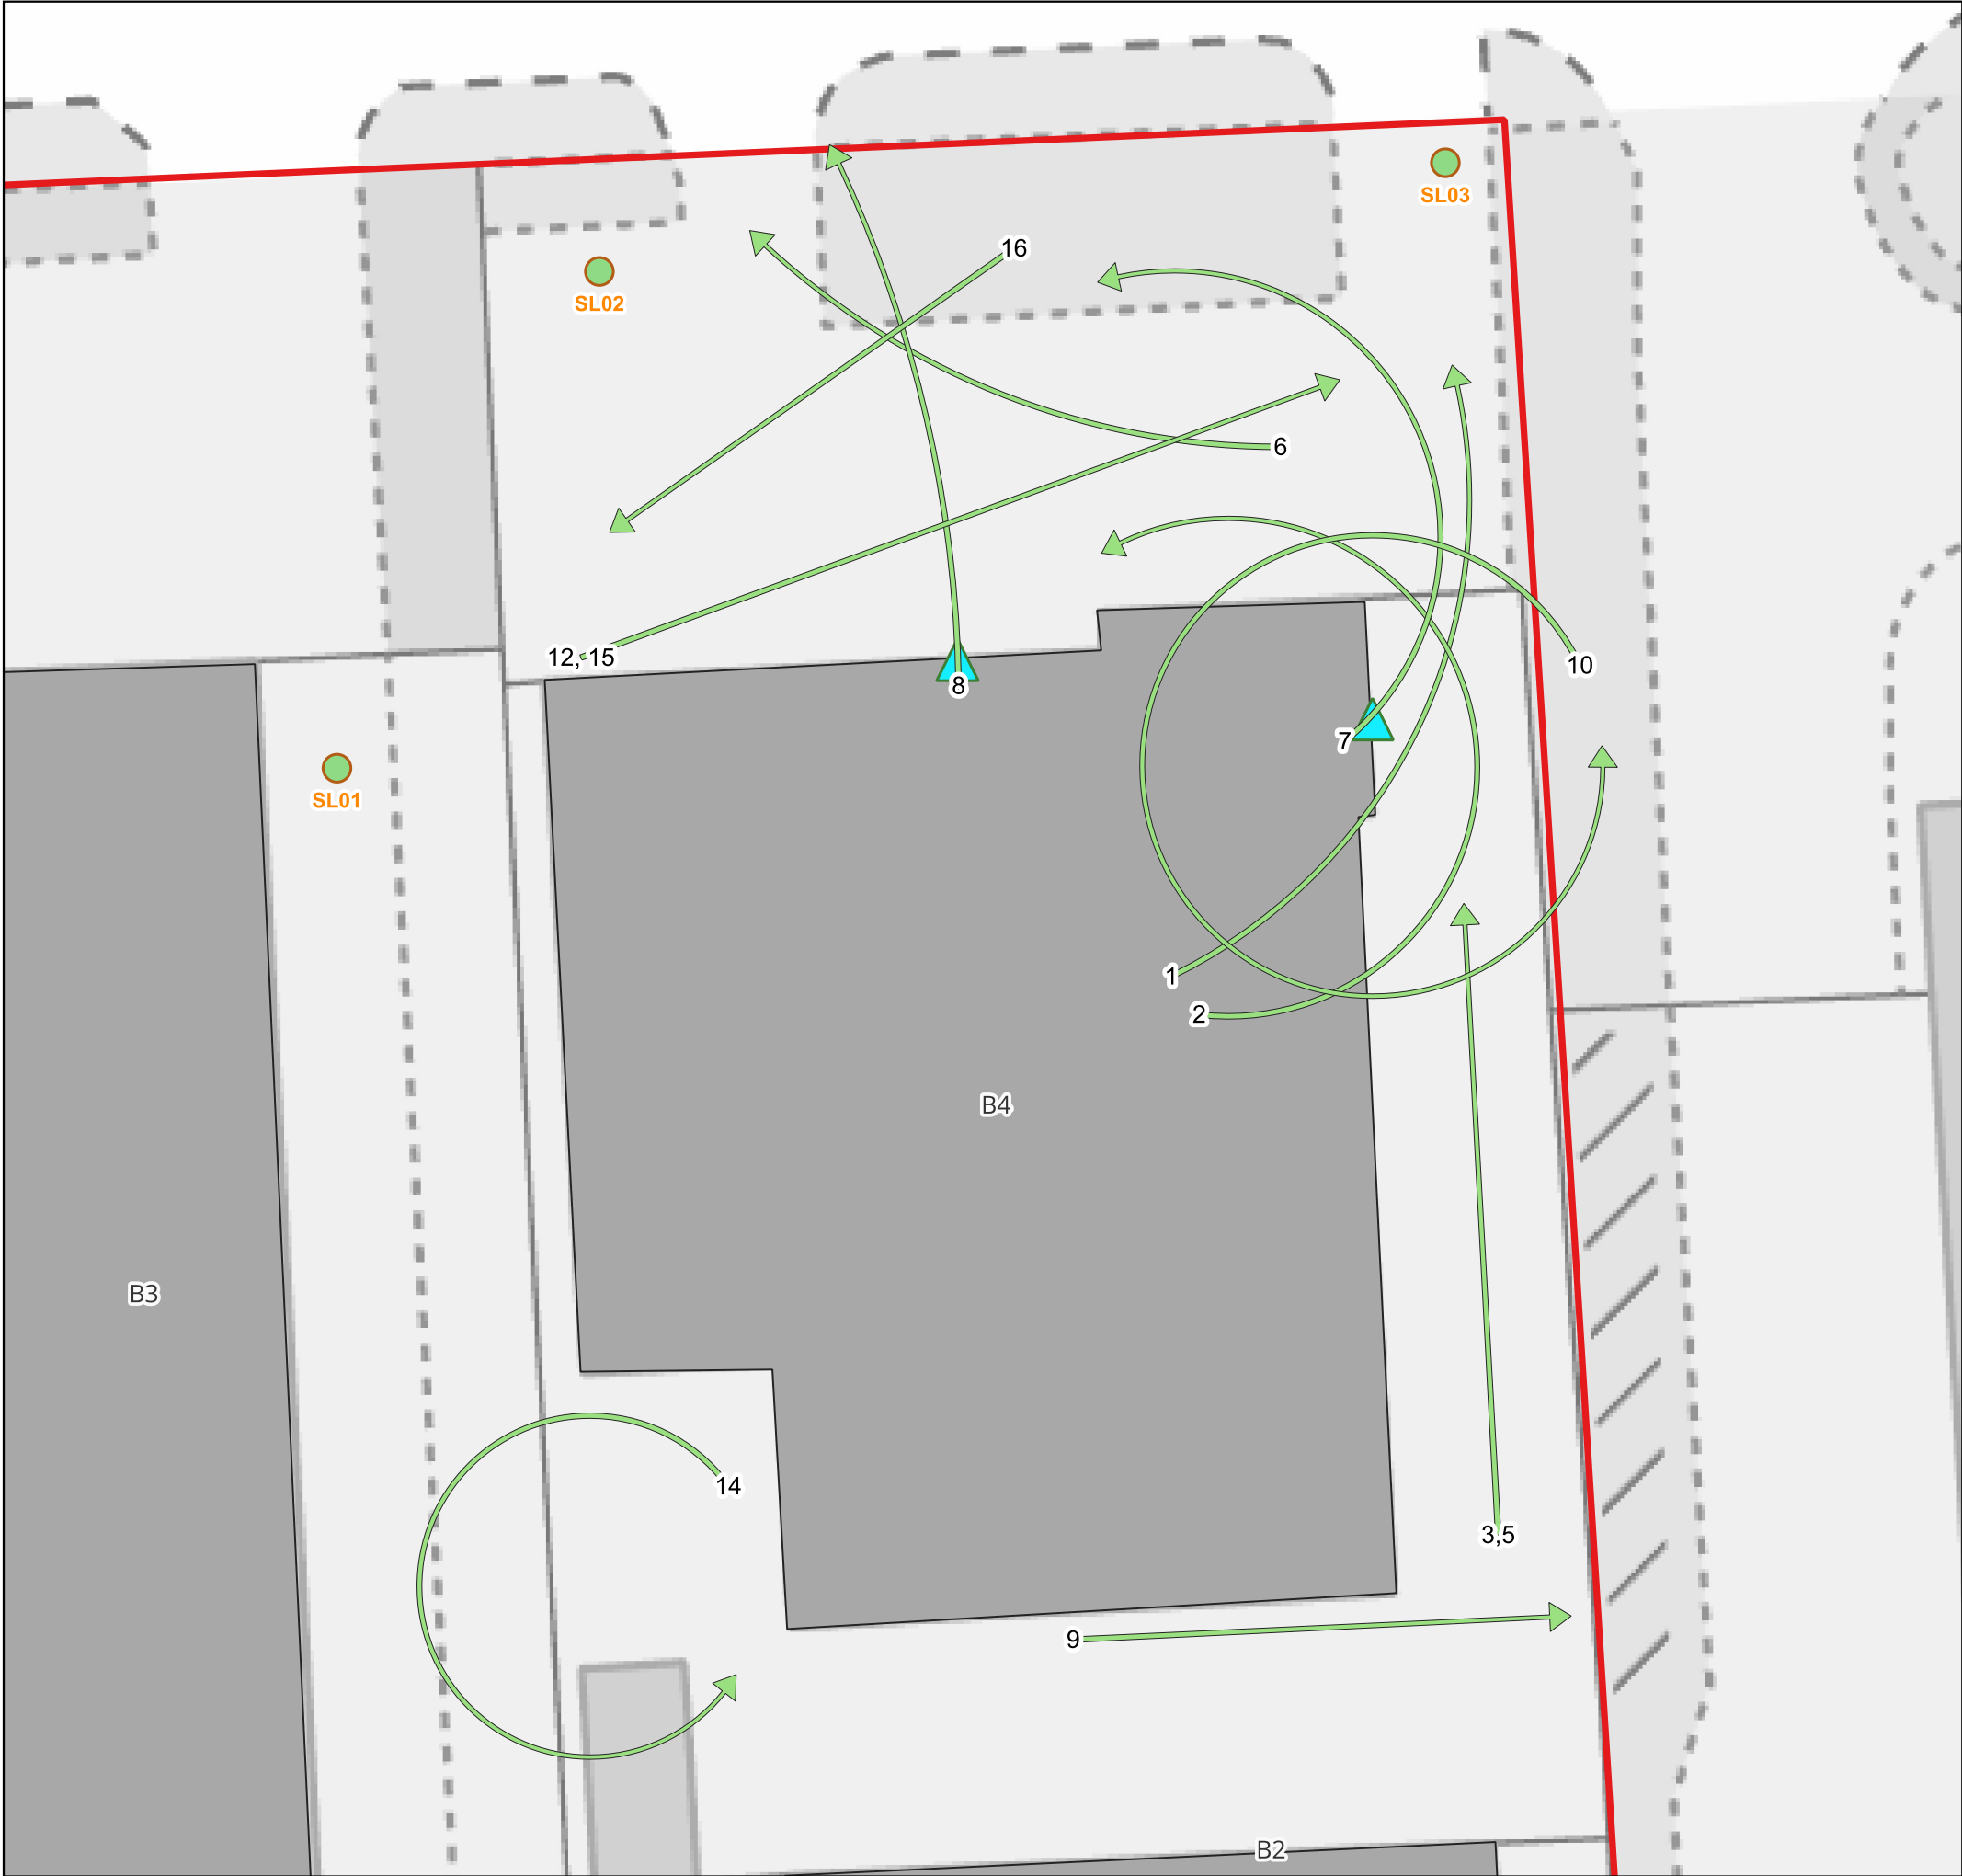
- Site Boundary
- Buildings (With Reference)
- Surveyor Locations
- Bat Roost Location
- Common pipistrelle
- Bat Observations (Appendix B)
- Common Pipistrelle

- 5.25 Two emergences of individual common pipistrelle bats were observed from separate locations behind the facias on the Northern aspect of B4.
- 5.26 Two bat species were recorded commuting and foraging in close proximity to the site. One noctule *Nyctalus noctula* was detected acoustically commuting past the site, and 13 common pipistrelles *Pipistrellus pipistrellus* were observed commuting and foraging within the site, two more common pipistrelles were detected acoustically but not visually observed. Social calls were detected from common pipistrelle bats at around 19:50-19:52.

- 6.2 During the initial emergence survey, two bat roosts were identified within B4. Two Common pipistrelles were observed emerging from behind lifted flashing on the office section of B4 (Appendix B, Figure 3). These roosts have been identified as day roosts for single common pipistrelle bats.

Following the completion of these surveys, it was deemed that roosting bats were present with B4 (Figure3). Two further bat surveys are recommended between May and September 2026 to ascertain an accurate and thorough understanding of the use of B4 by roosting bats.

As two bat roosts were identified within the Brick section of B4, no structural, external, or demolition works should be undertaken on B4 until further surveys have been completed. In order to demolish B4, a bat mitigation license suitable to the species and roost type present will be required if significant works are required.

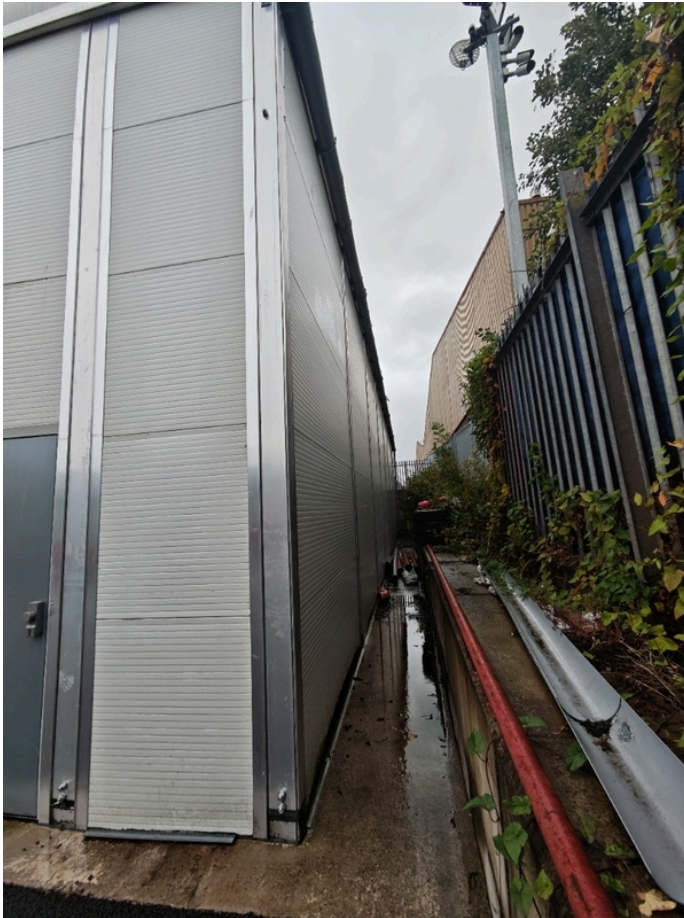
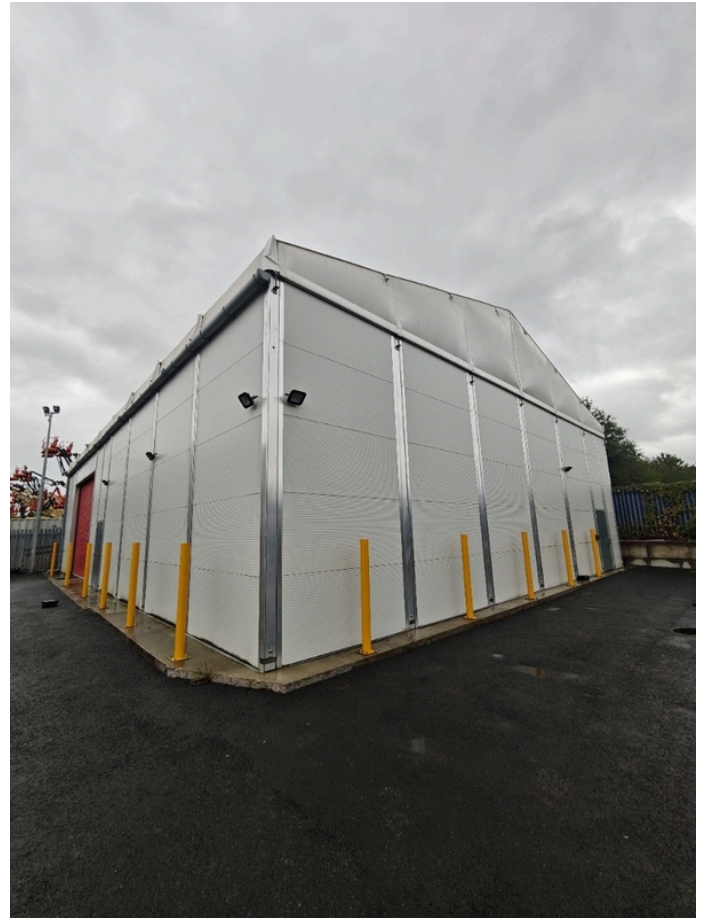
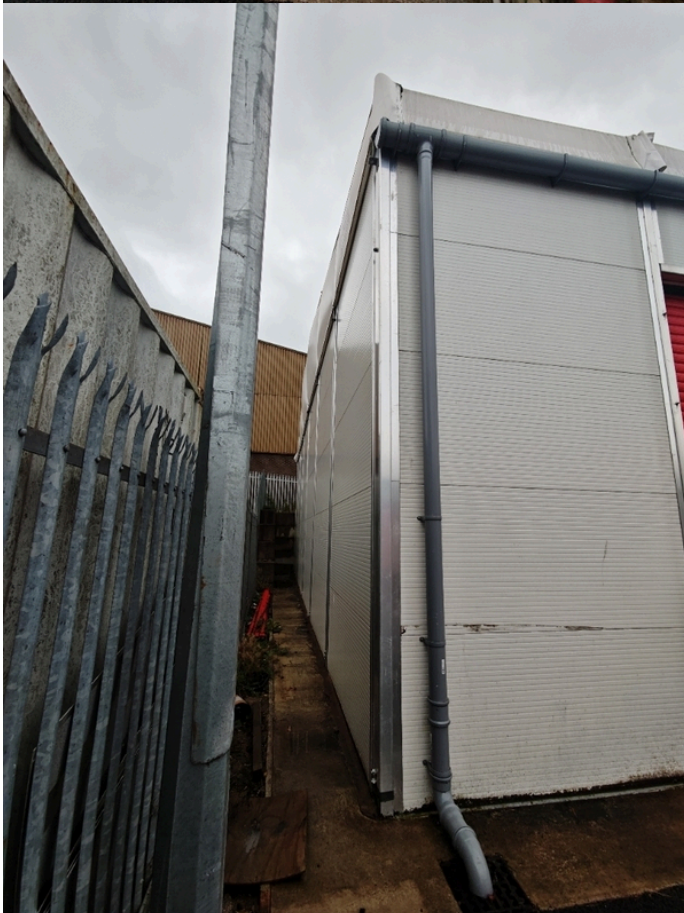
#### External Photos

| <b>Further Notes</b> | No suitable features for roosting bats or birds and no evidence of either observed. |

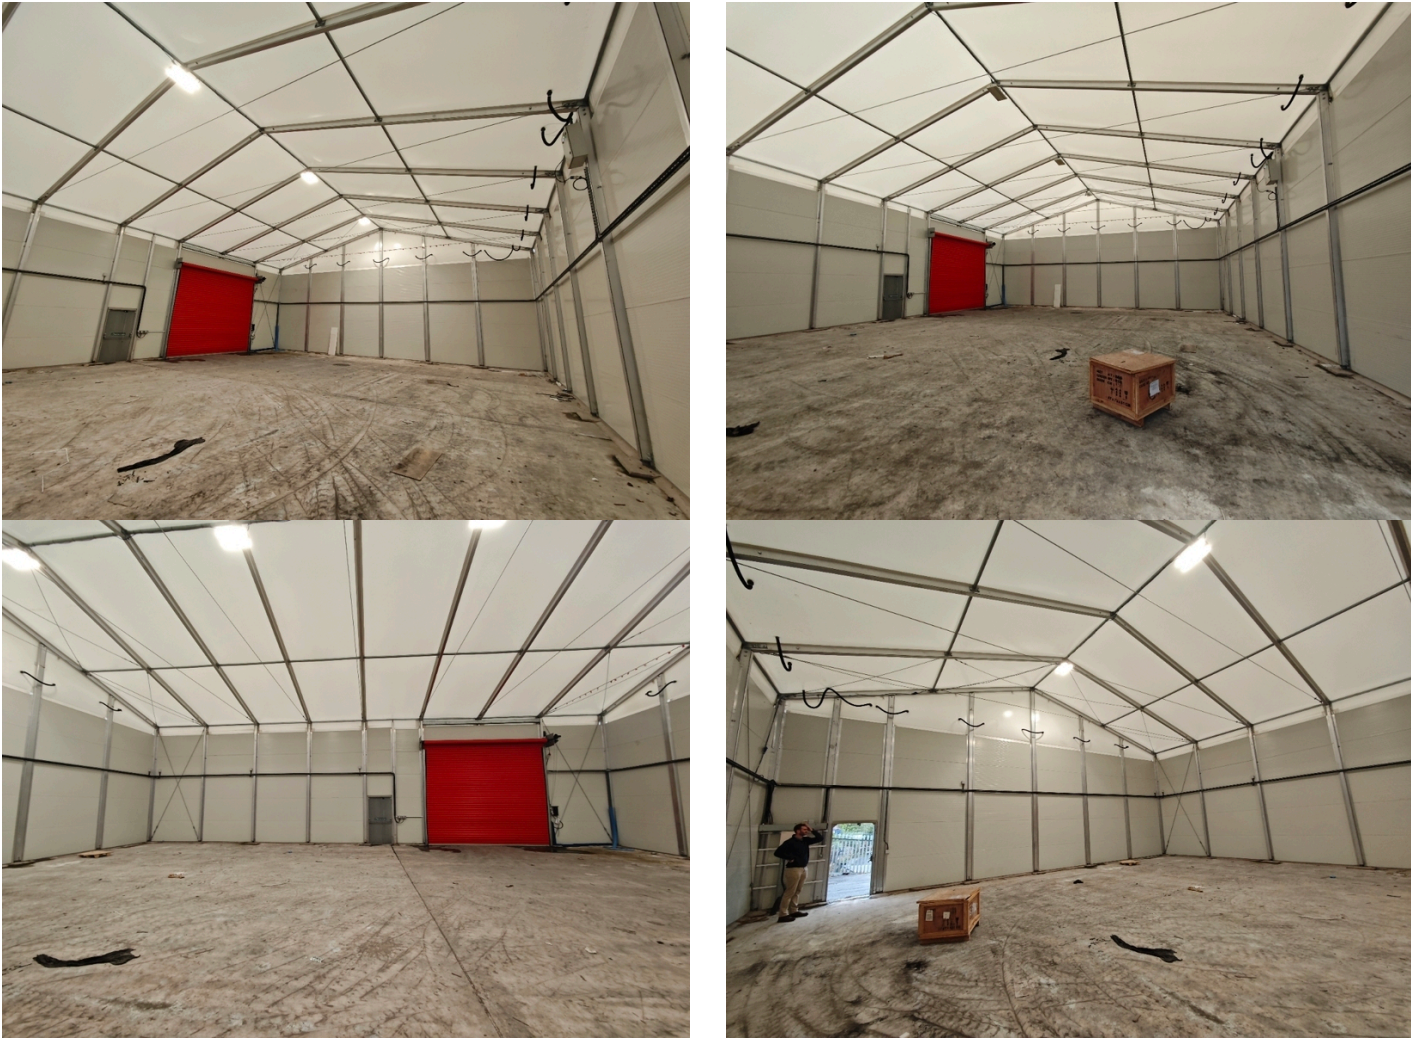
| <b>Internal Photos</b> | |

| <b>Further Notes</b> | No evidence of bats observed and no suitable roost features identified. |

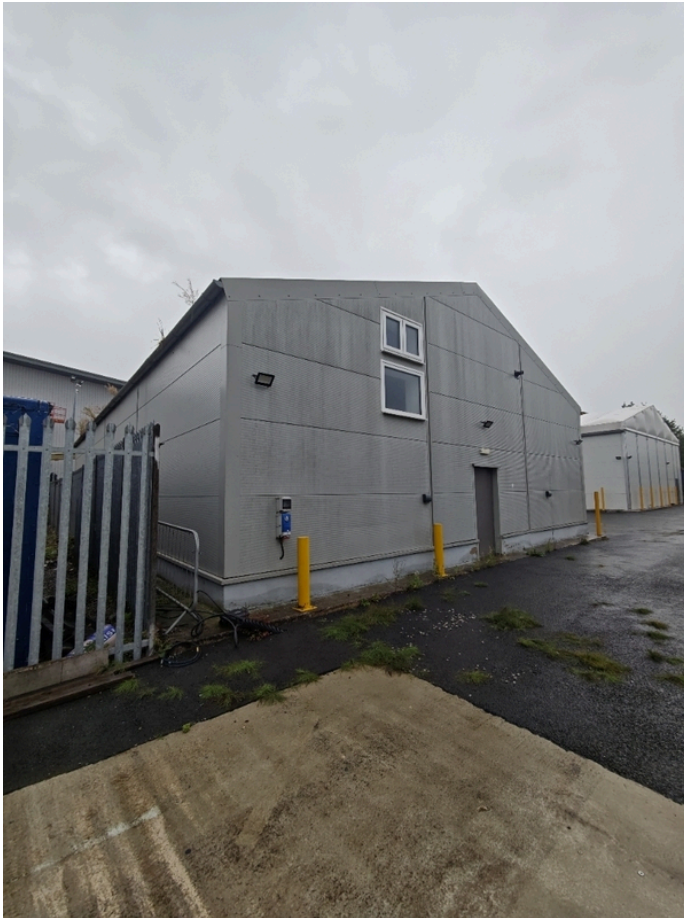
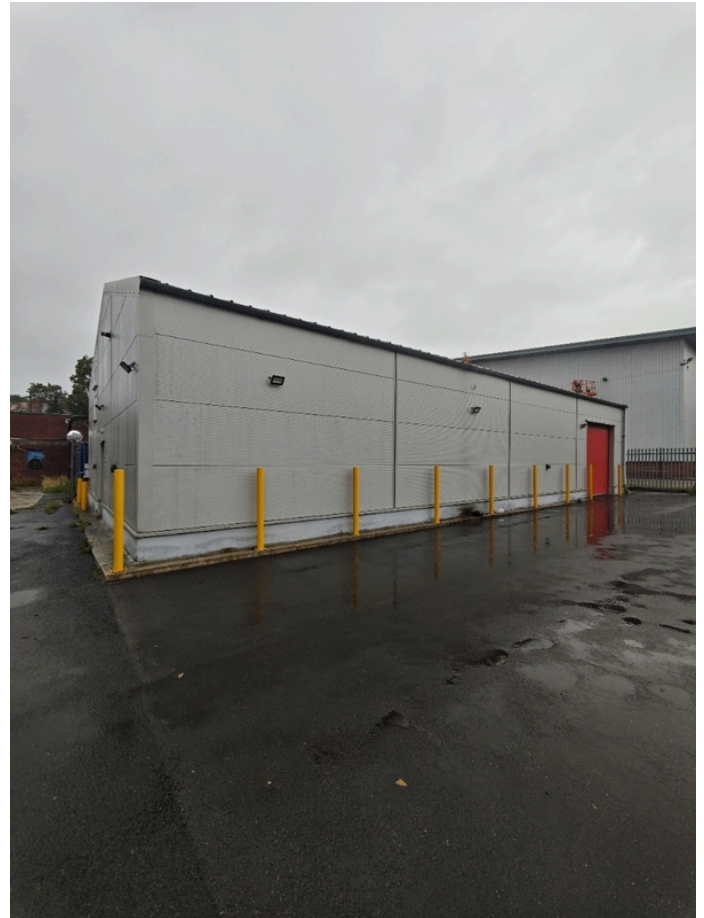
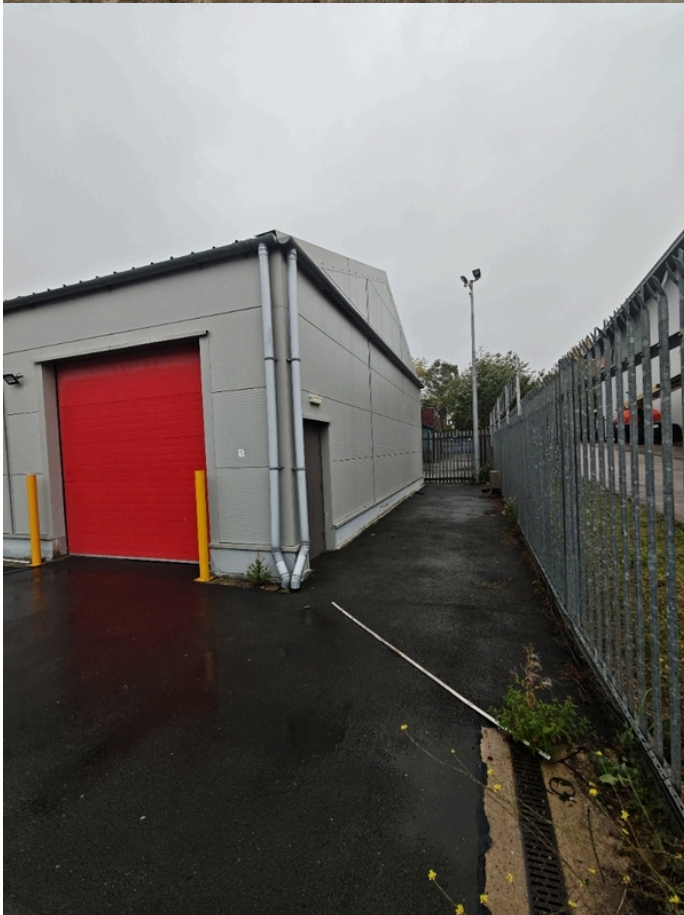
### External Photos

**Further Notes** | No evidence of bird or bats roosting and no suitable habitat identified.

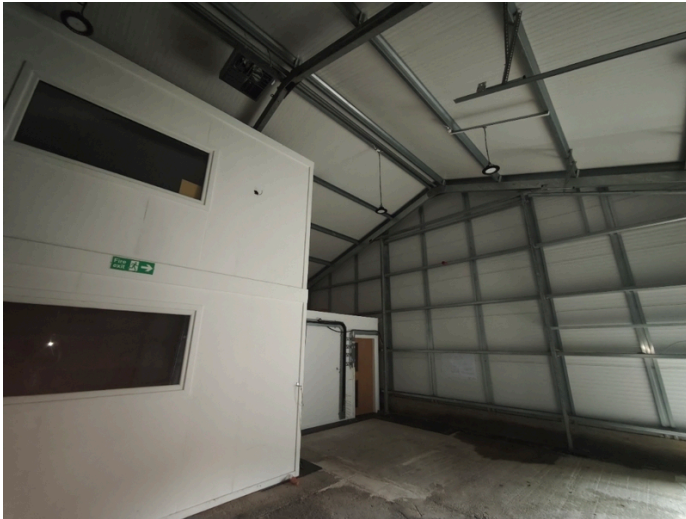
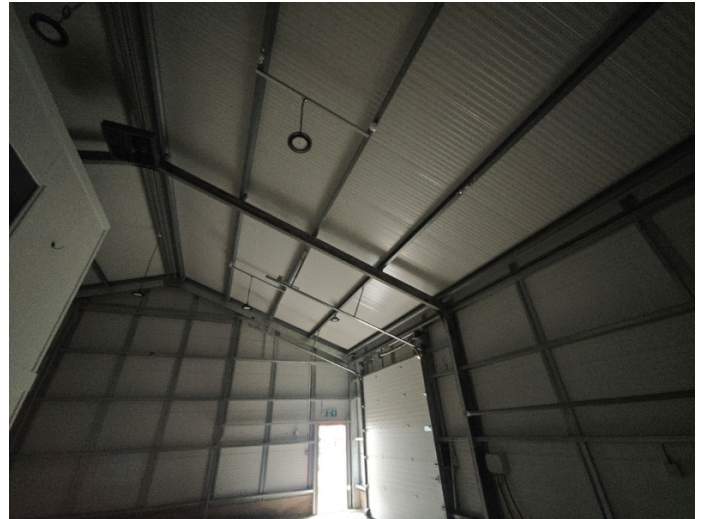
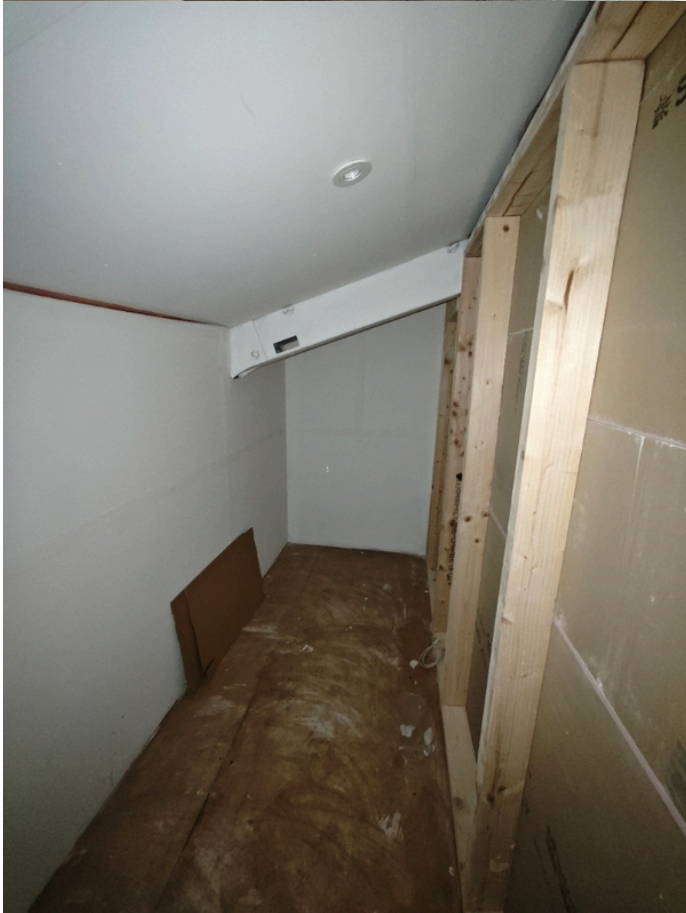
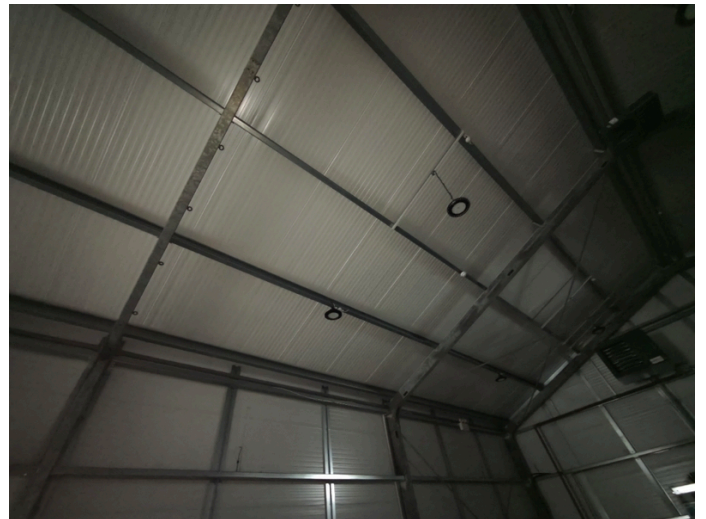
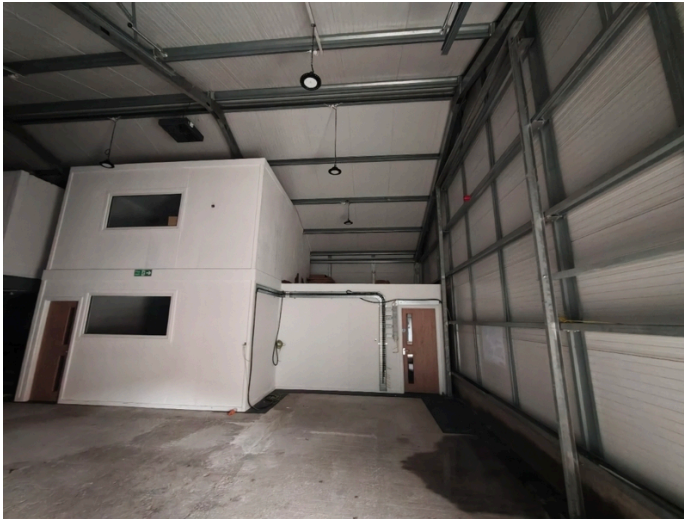
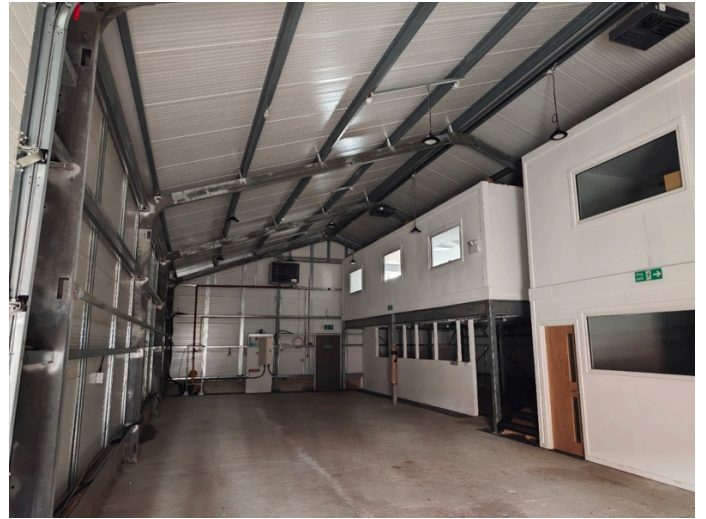
**Internal Photos**

| <b>Description of Internals</b> | A single, large room, with 2 small office rooms separated to one end. Bright conditions and no suitable potential roost features identified. |
| <b>Further Notes</b> | Two offices inside which are self contained units. No access for bats internally and the space was unsuitable for roosting bats. |

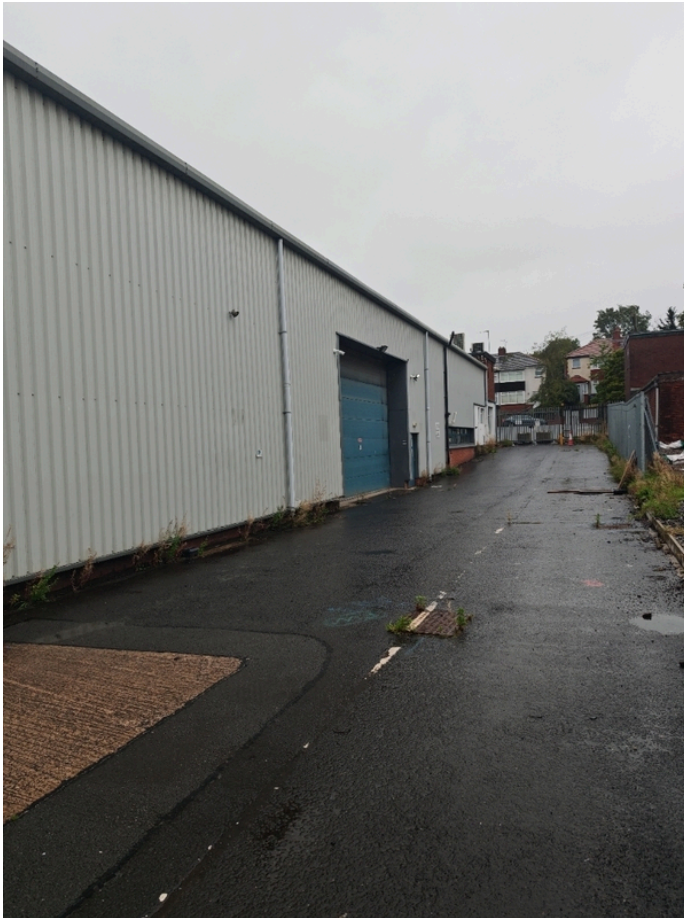
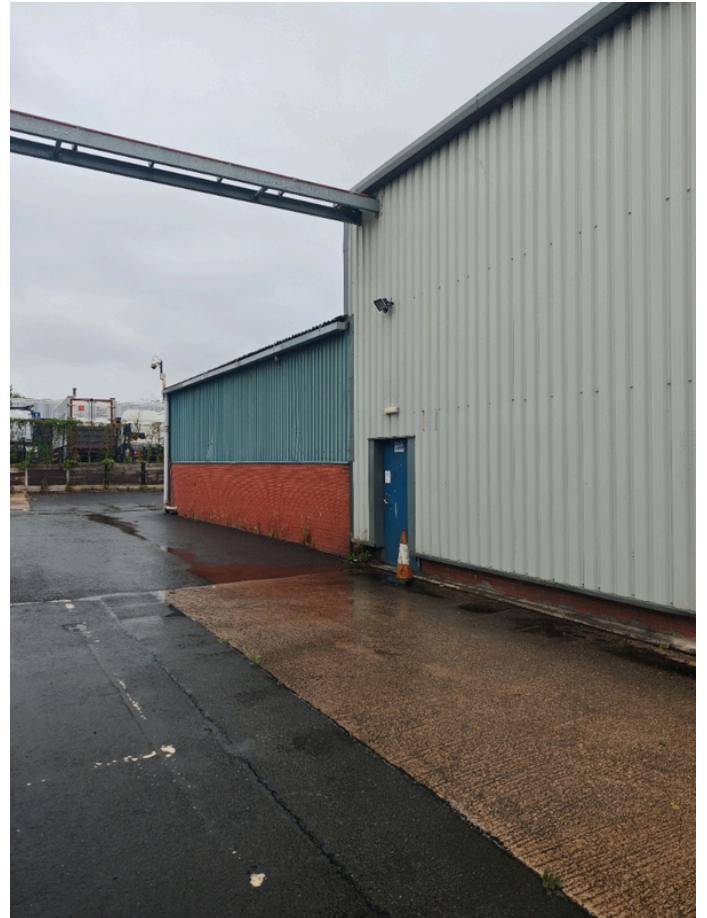
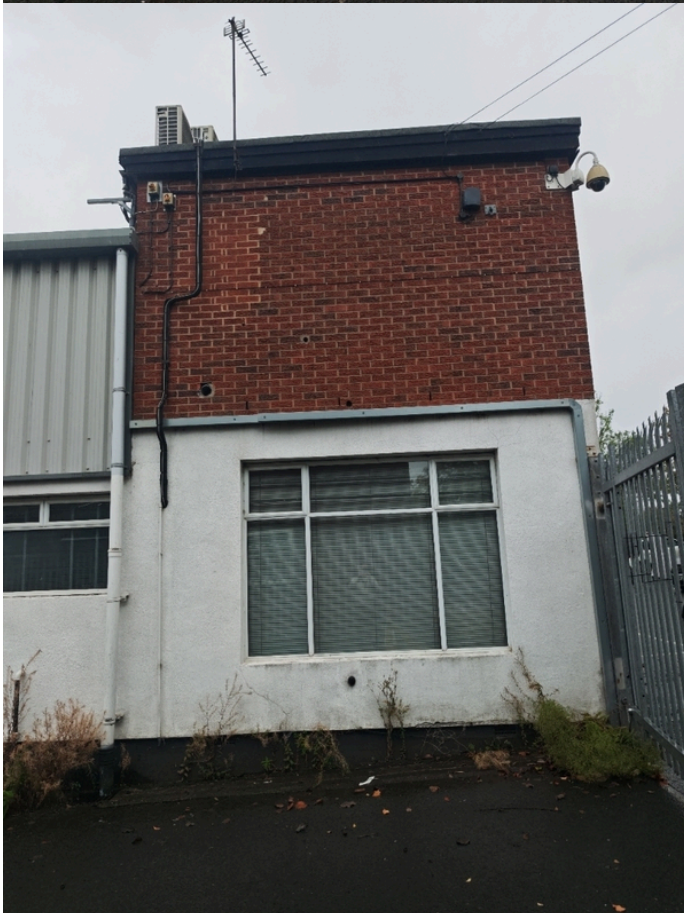
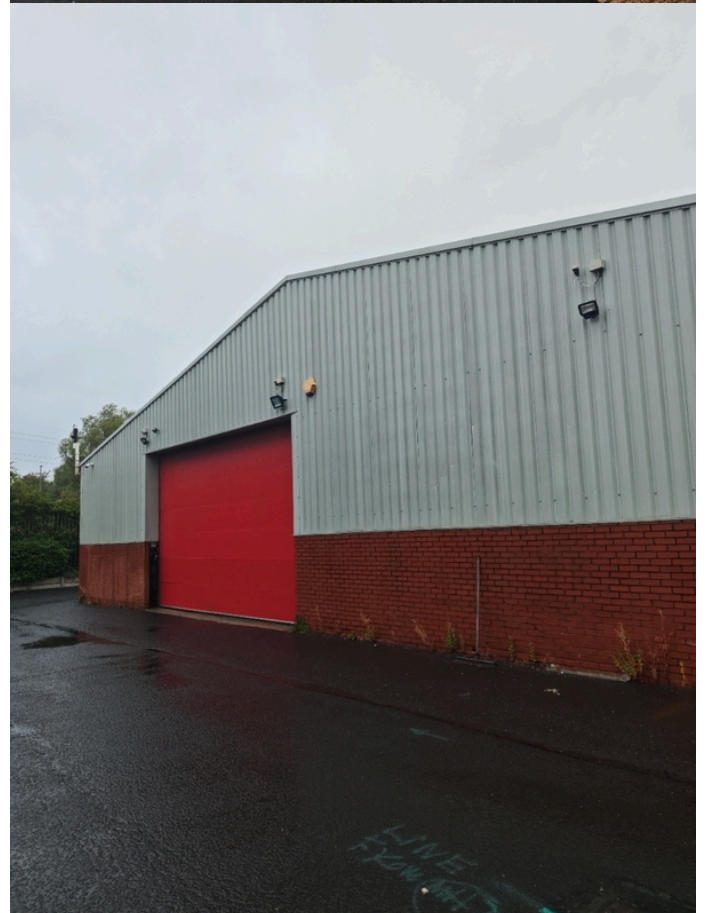
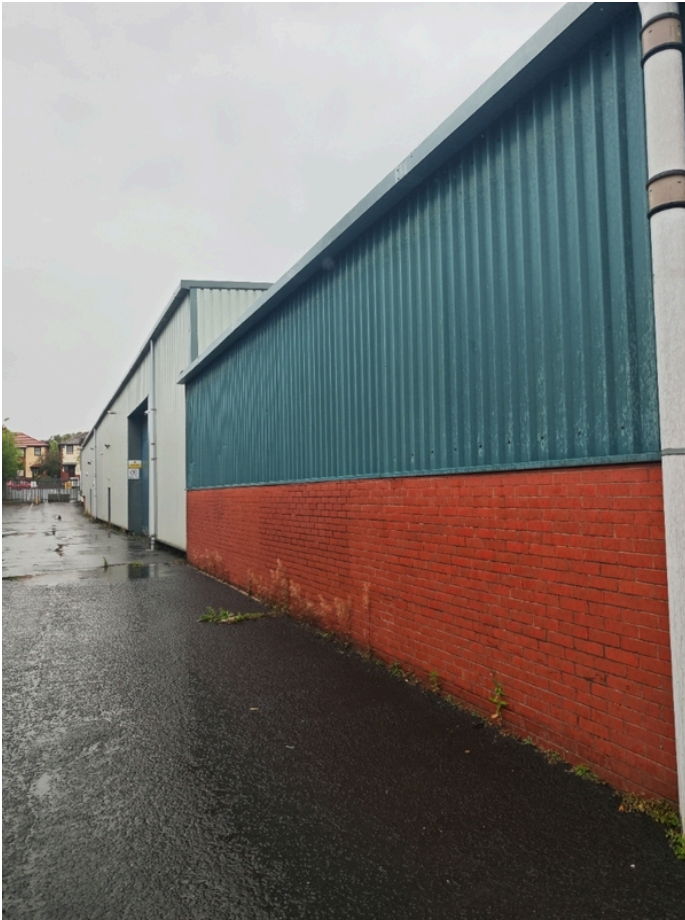
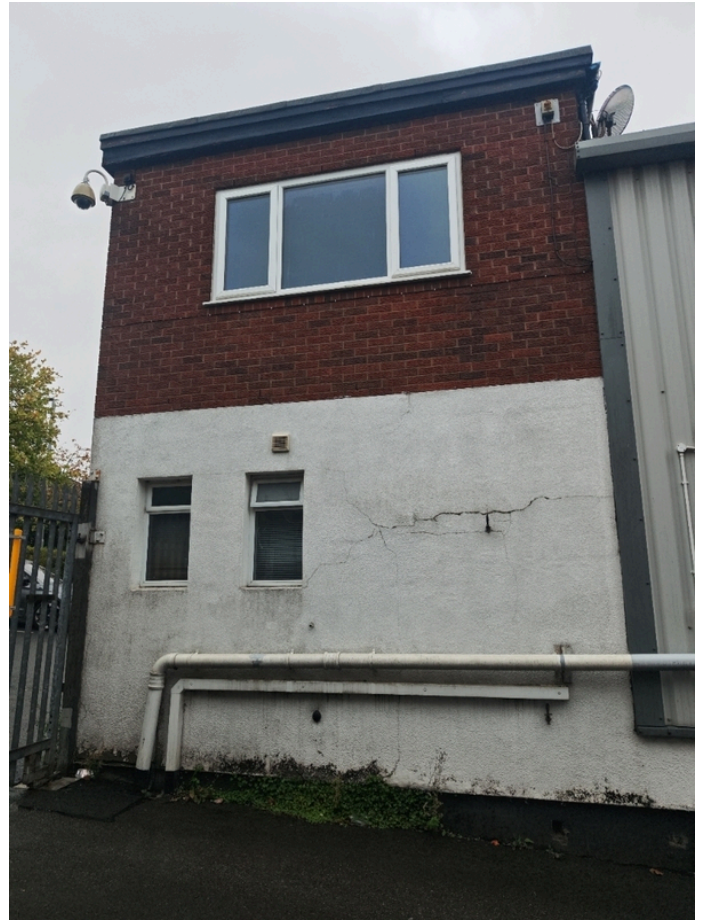
## External Photos

| <b>Further Notes</b> | Externally the building is completely sealed and internally the building is light and open. Metal beams and structure also makes for unsuitable roosting places as they tend to provide unstable conditions. Frontage is used as offices with false ceiling. |

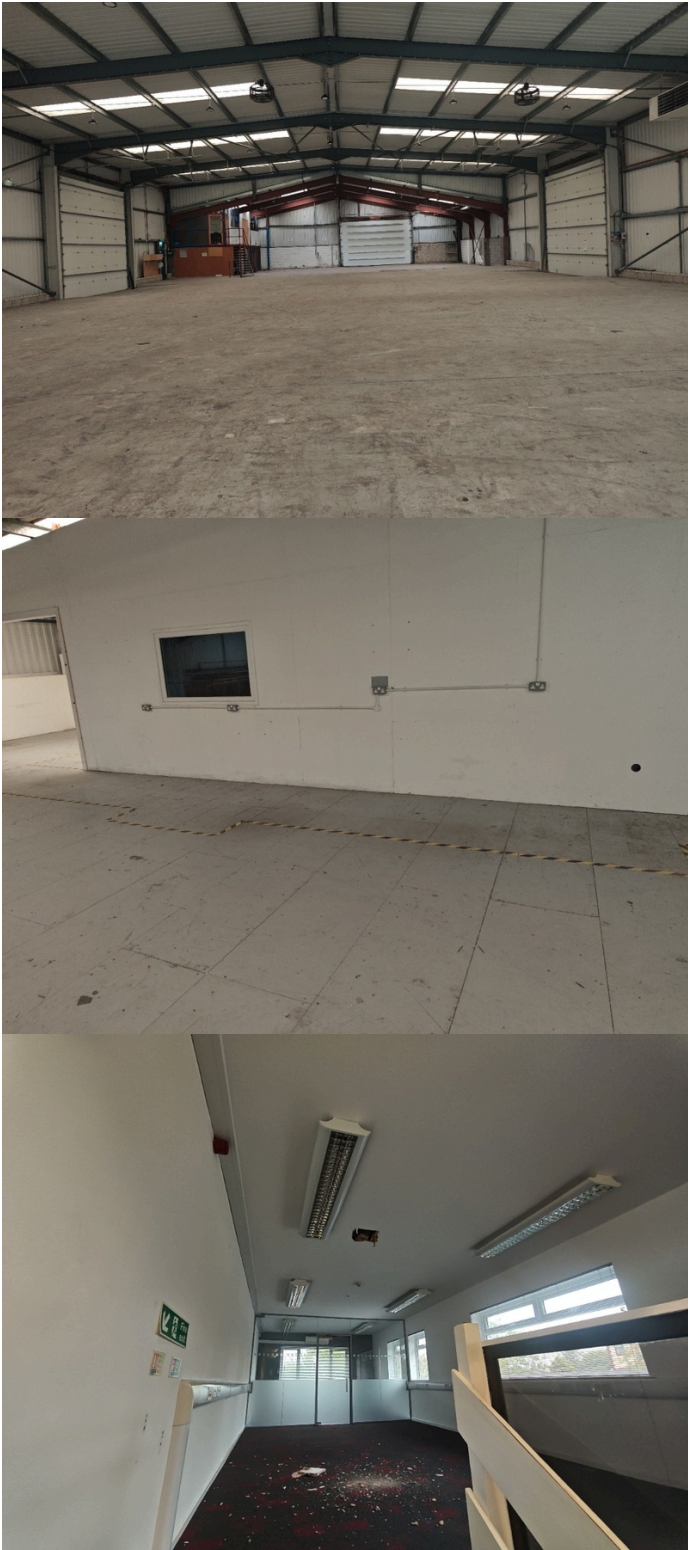
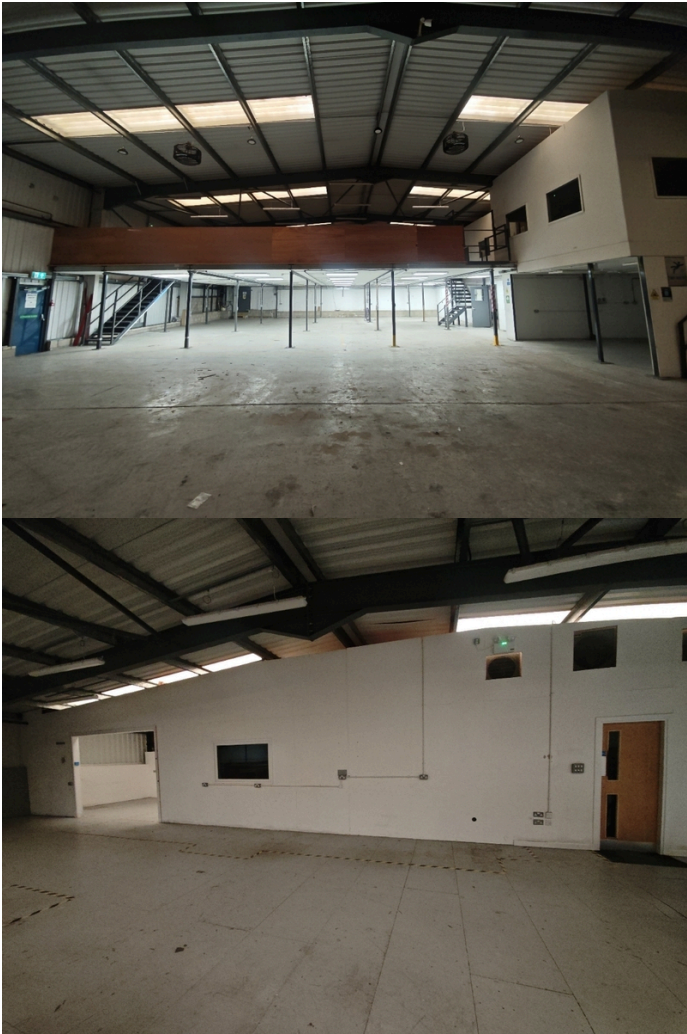
**Internal Photos**

| <b>Further Notes</b> | No evidence of bats or birds present and no suitable habitat identified. |
