# **Preliminary Roost Assessment and Bat Survey Report**

Unit 32,  
Stakehill Industrial Estate,  
Manchester

**PEG681-02B**

Stakehill Industrial Estate,  
Middleton, Manchester, M24 2RW

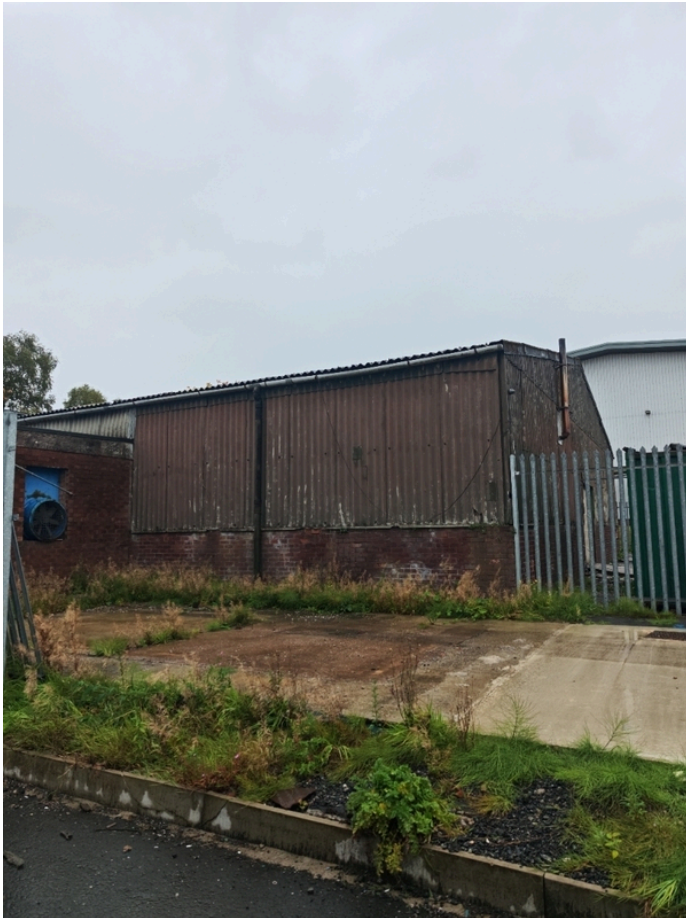
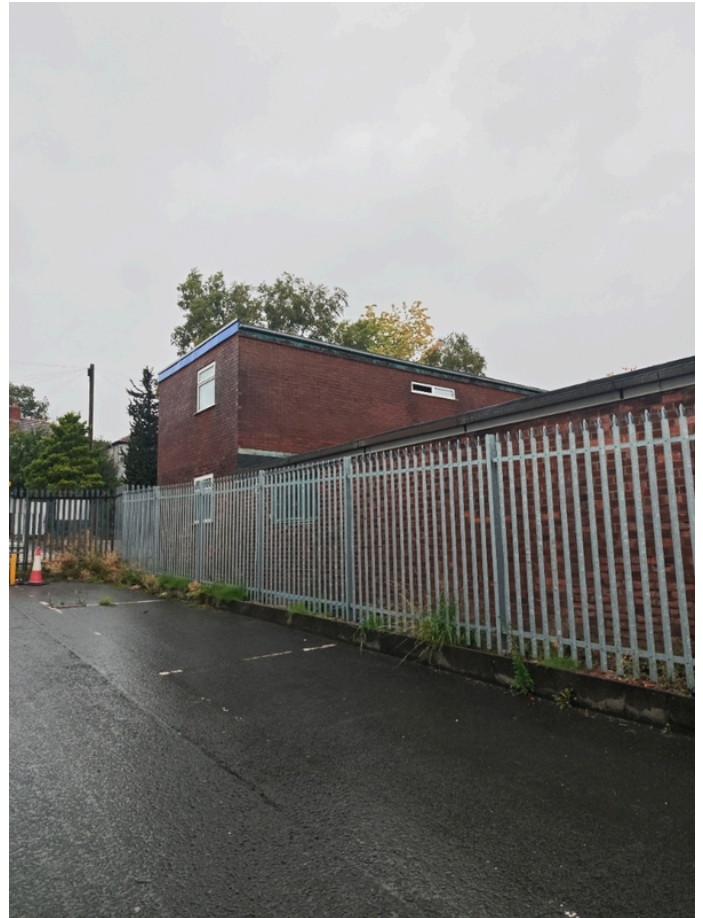
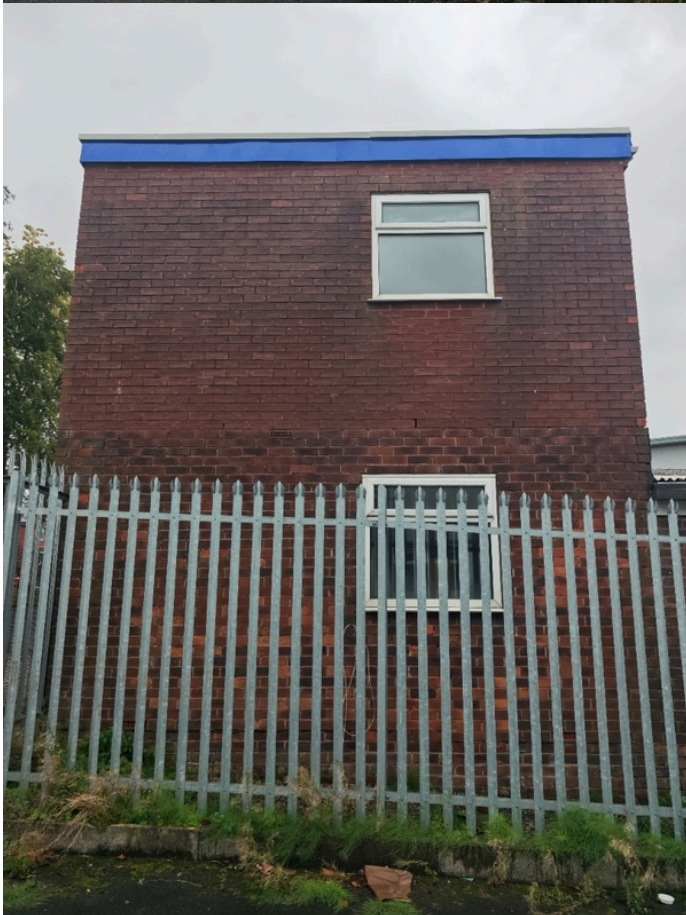
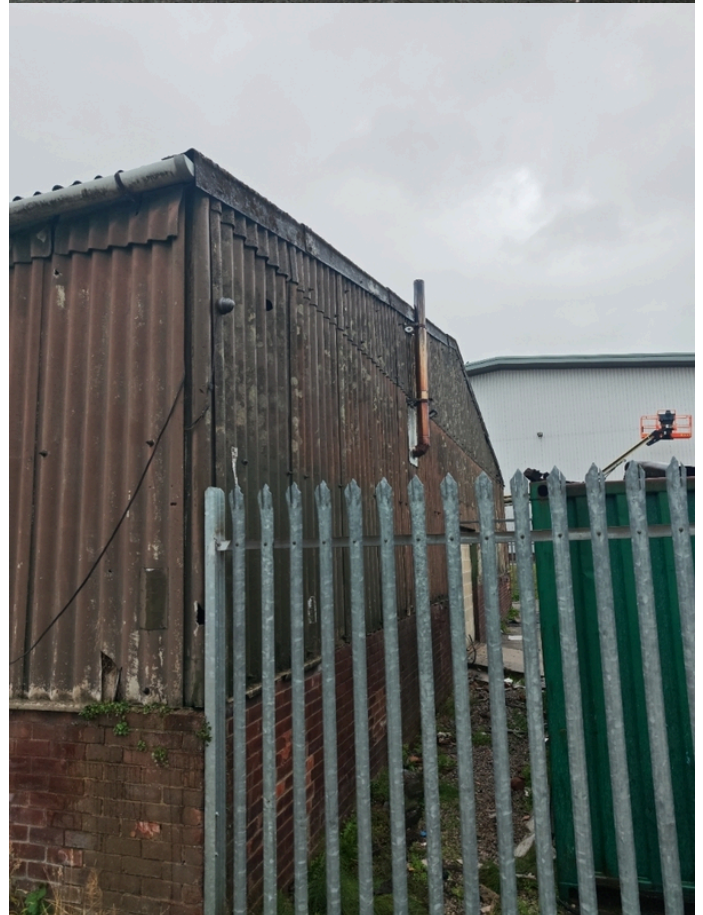
### External Photos

| <b>Further Notes</b> | No evidence of bats or birds identified, but potential roost features were found around the front portion of the structure. |

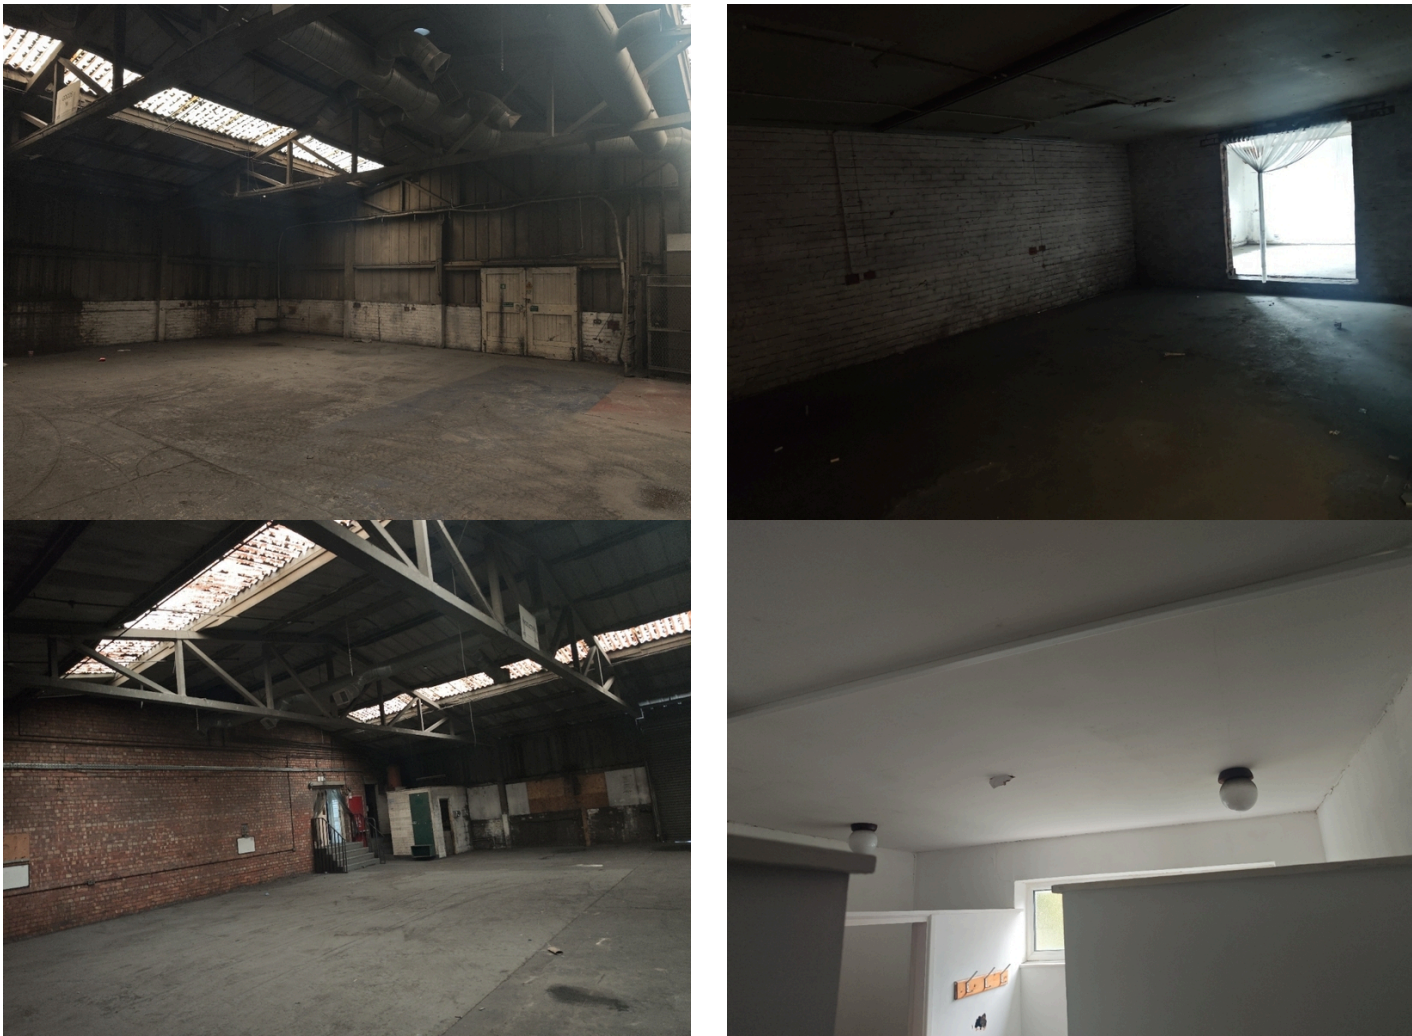
**Internal Photos**

| <b>Further Notes</b> | No internal PRFs or evidence of bats or birds identified. |

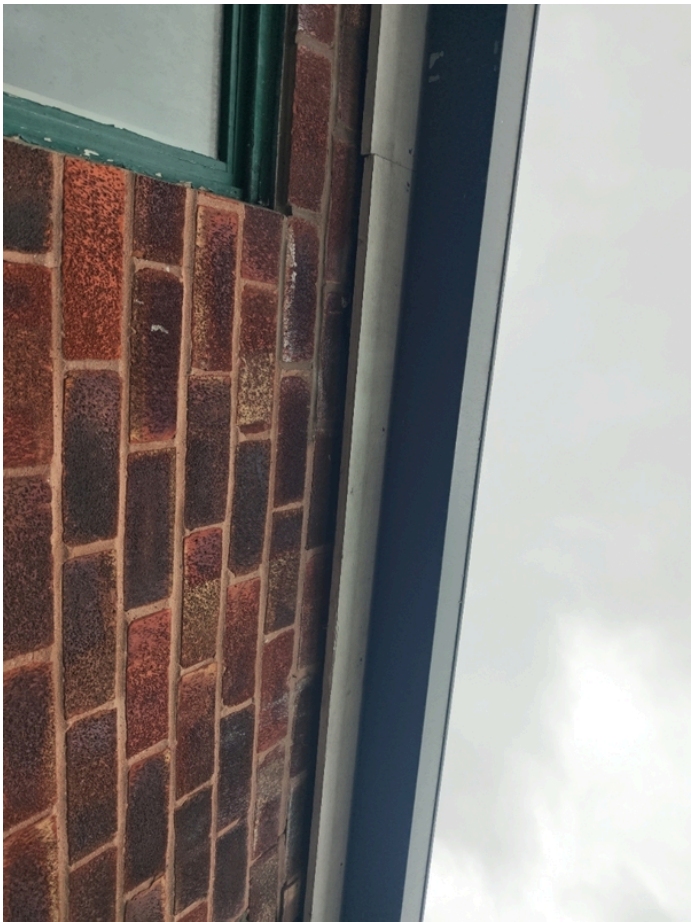
PRF - A

| Description | Single fascia board lifted which allows a gap behind. Gap enters approx 5cm and tapers to a point. No evidence of roosting but could support a single opportunistic bat. |

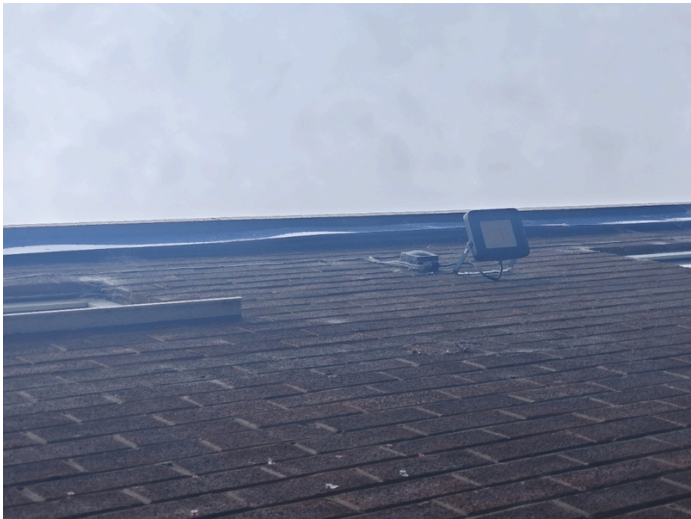
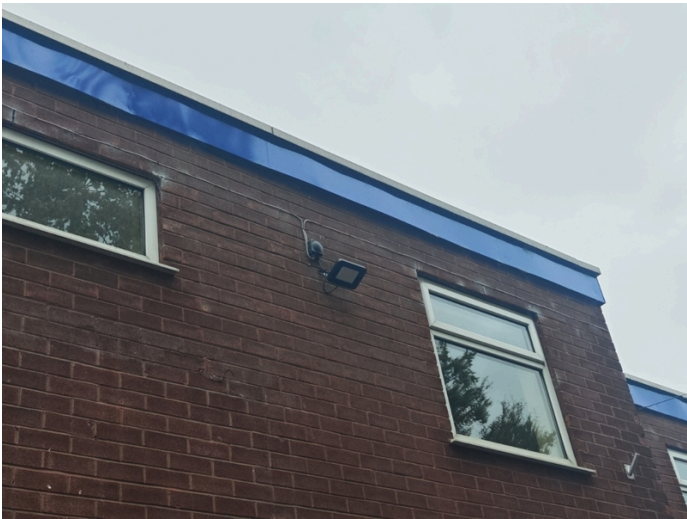
PRF - B

| Description | Fascia along the front is slightly lifted allowing access behind. |

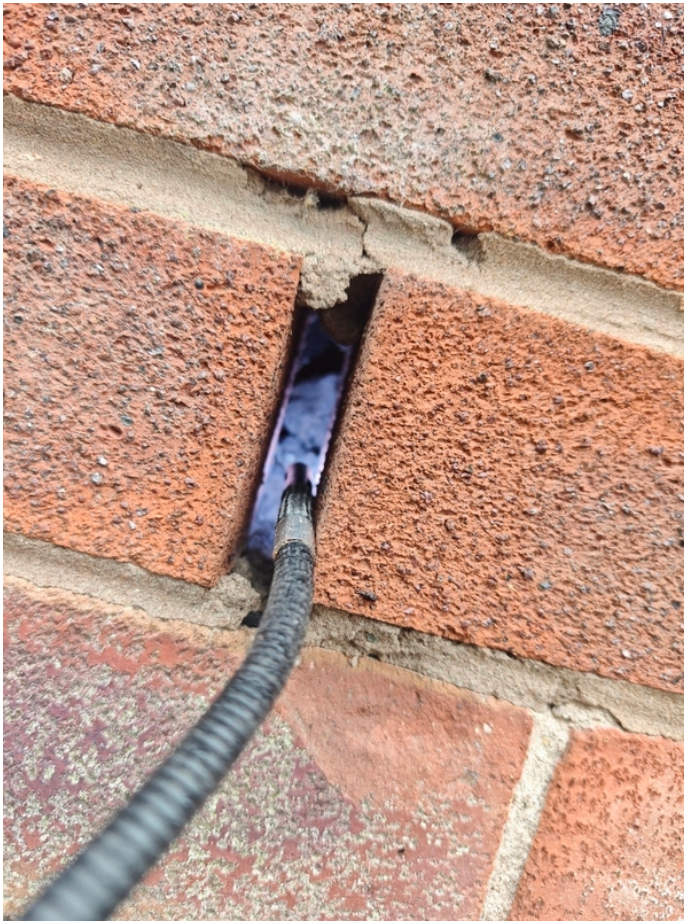
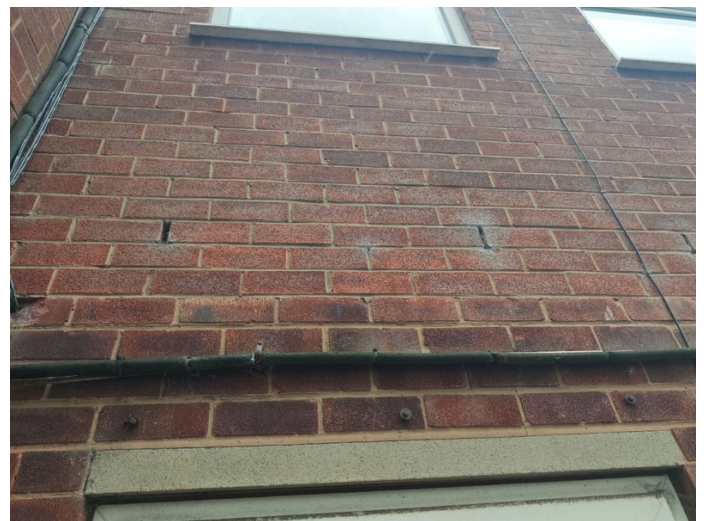
**PRF - C**

| <b>Description</b> | A line of weep holes approximately 3m high. Endoscope show the holes entering to 1 brick deep before meeting the damp proof membrane. |

| <b>Bat Roosting Potential</b> | Low |
