## Bat Emergence and Re-Entry Surveys (BERS)

The Church Inn, Castle Hill Road, Rochdale, Bury, Greater Manchester, BL9 6UH

This report is prepared to inform a planning application for the proposal described as: The conversion of a public house/restaurant to an office with an associated parking and landscaping.

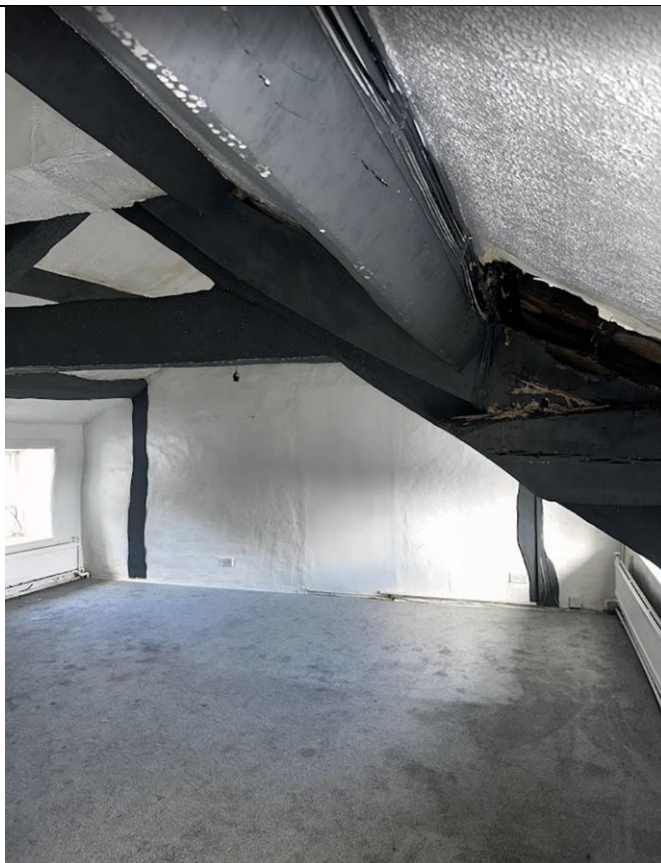
**B1 Loft:** Vaulted ceiling – internal view showing exposed beams.

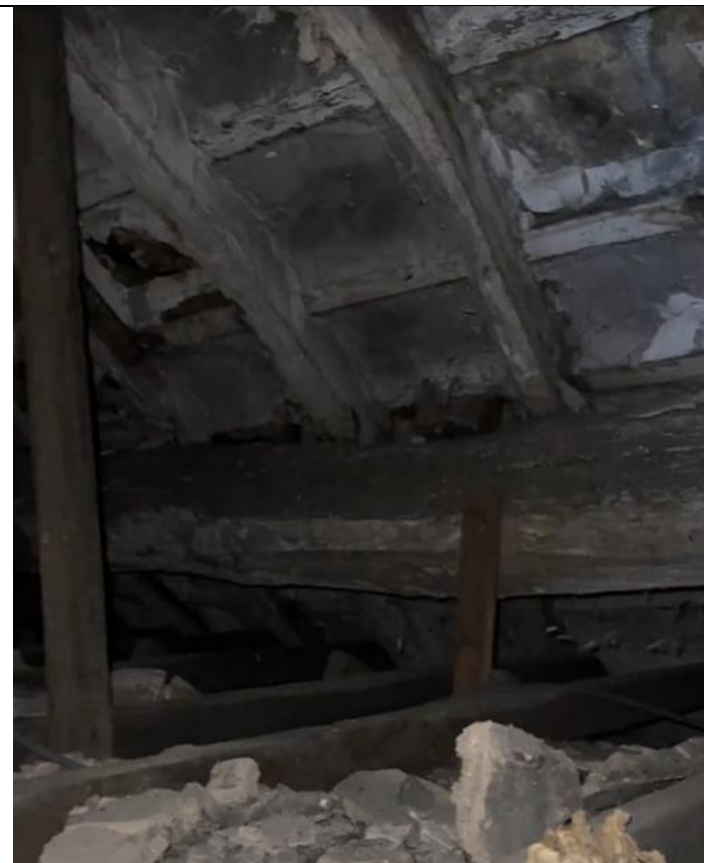
**B1 Loft:** Loft void – unlined roof with timber rafters and ridge beam.

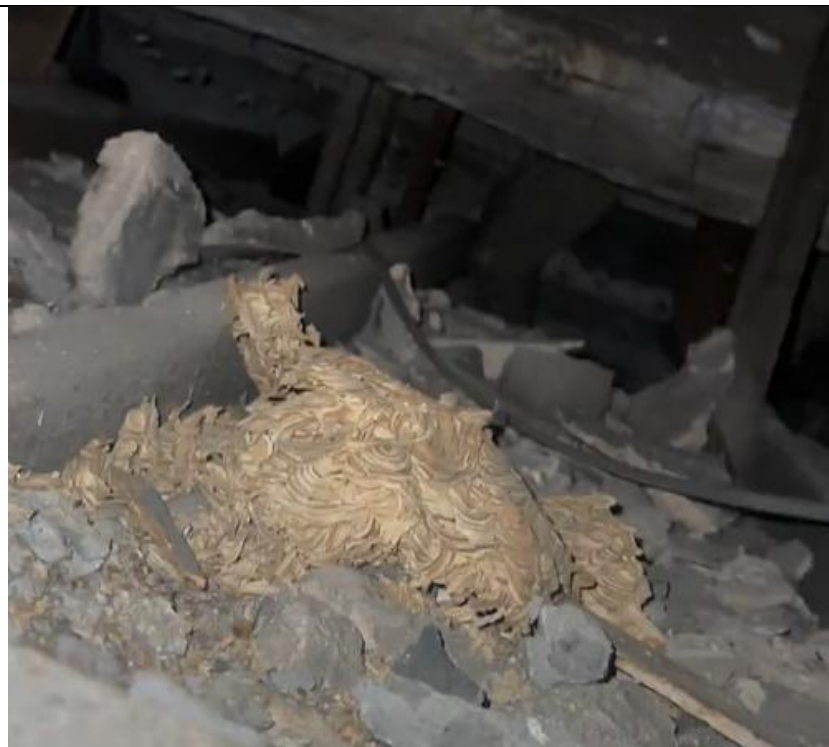
**B1 Loft:** Hornet's nest located on loft floor.

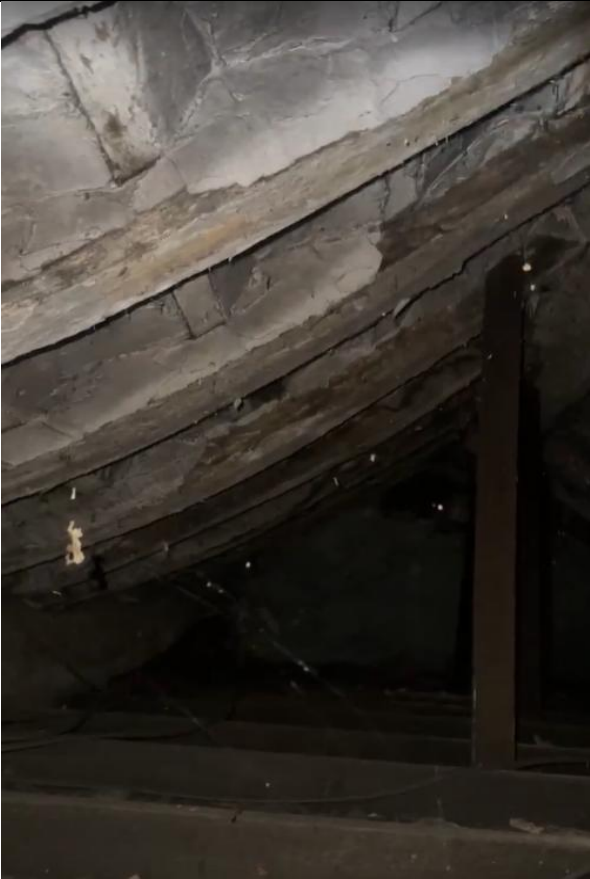
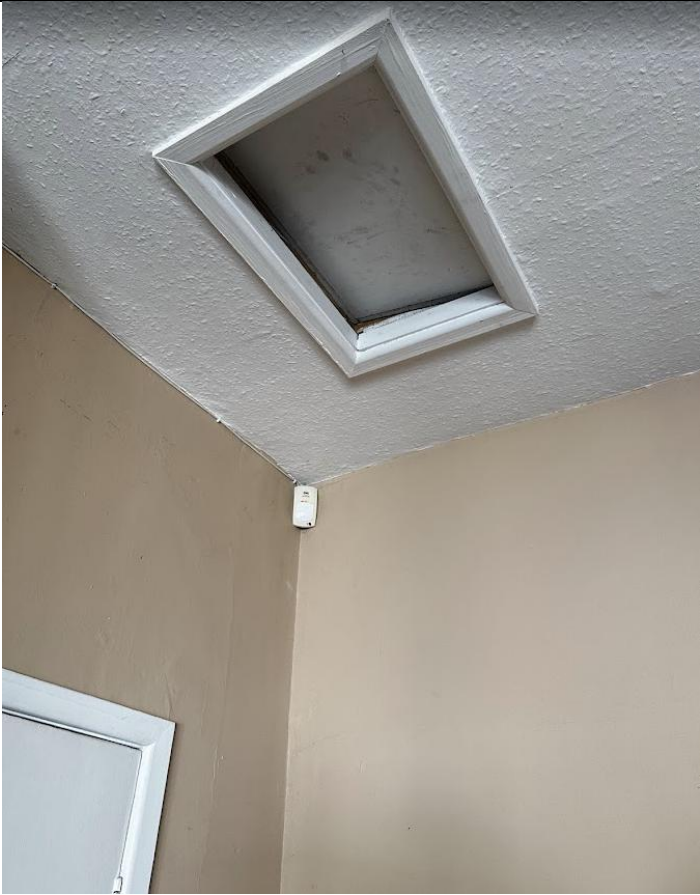
| | <p><b>B1 Loft:</b> View along unlined loft void showing open rafters.</p> | <p><b>B1 Loft:</b> Accessible loft hatch (central); western hatch sealed shut.</p> |

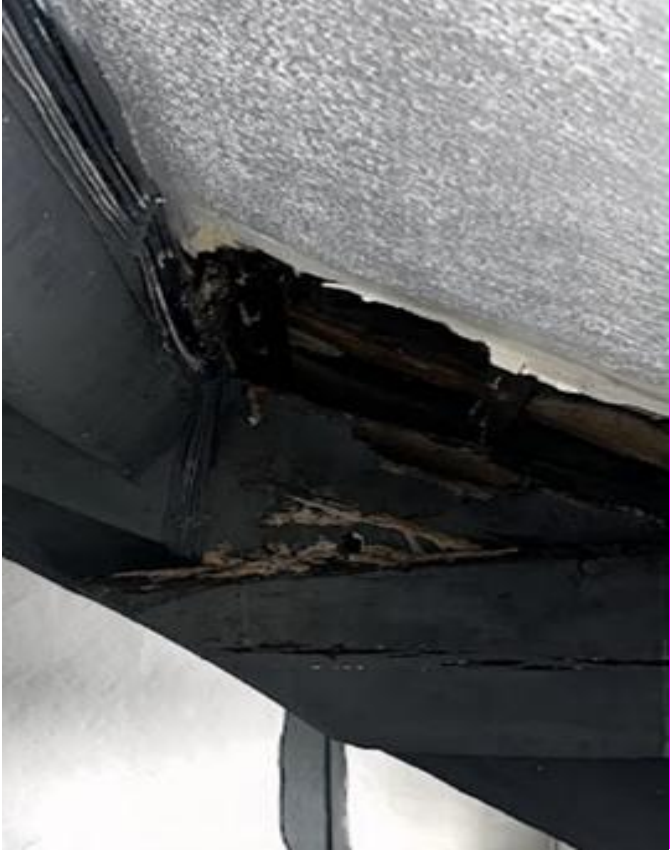
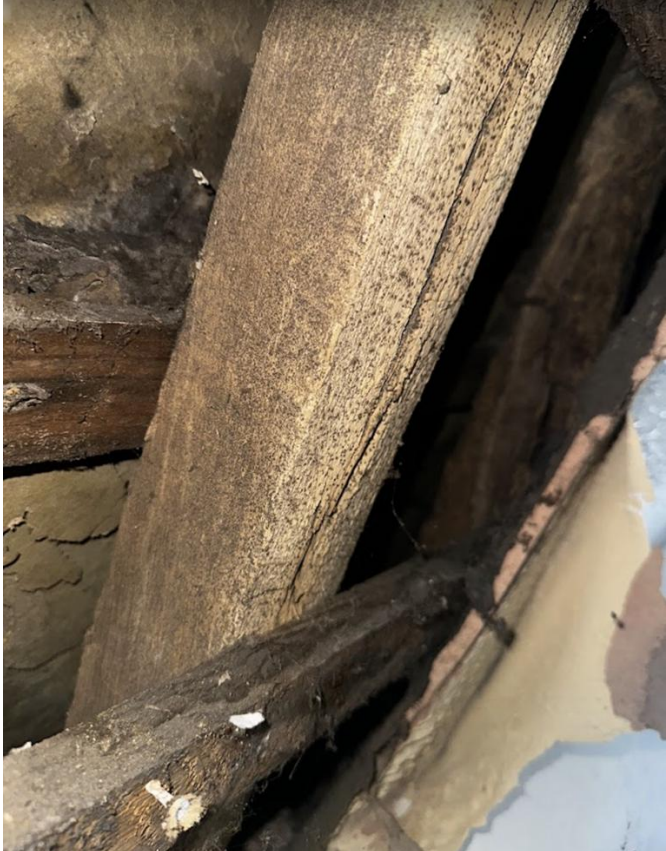
| | <b>B1 Loft:</b> Narrow cavity within the internal view loft of B1 – too restricted to inspect; no evidence of bat use observed | <b>B1 Loft:</b> Close-up view of the narrow cavity within the internal view loft of B1, showing limited space and restricted access for inspection |

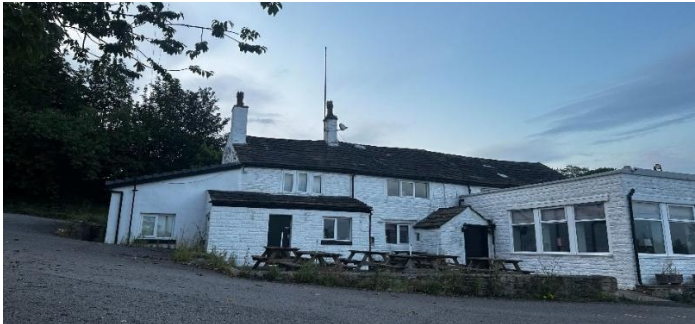
| Surveyor 1 | <p><b>Emergences observed:</b><br/>No emergences observed</p> <p><b>Summary of general activity:</b><br/>Species: common pipistrelle<br/>Flight paths:</p> <ul style="list-style-type: none"><li>Frequent passes along the roof ridge of B1 (southern elevation), commuting east–west</li><li>Repeated flight path from behind Position 1 over B2 roof towards Surveyor 4 and back</li><li>Passes across the car park (north to south)</li><li>Circling between chimneys on the southern elevation of B1</li><li>Occasional activity above flat roof structures on the southern elevation of B1</li></ul> <p>Foraging areas: Consistent foraging recorded in the vegetated area to the rear and left of Surveyor 1, confirmed by circling, prolonged presence, and social calls</p> <p><b>Additional notes:</b></p> <ul style="list-style-type: none"><li>First activity: Common pipistrelle pass at 22:10 along the roof ridge of southern elevation of B1</li><li>Regular activity continued throughout the evening, with up to three common pipistrelles active at once</li></ul> | | <p>Full elevation photo showing surveyor’s view.</p> | |

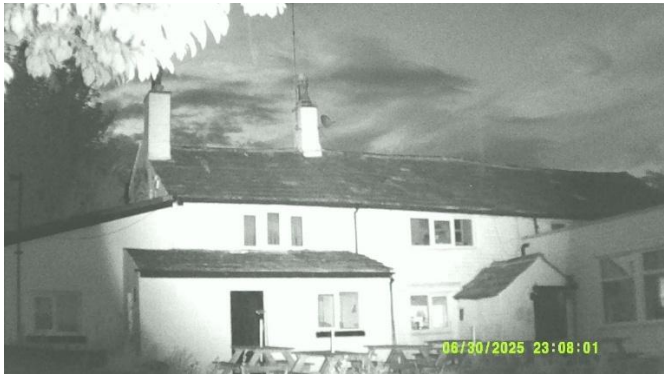
| <i>IR position 1</i><br><i>Nightfox whisker</i><br><i>IR camera and</i><br><i>X50 torch</i> | <p>Camera position: Observing southern elevation of B1</p> <p><b>Emergences observed upon review of footage:</b><br/> No additional observations or bat activity recorded upon review, confirms surveyor observations.</p> <p><b>Other notable bat activity:</b></p> <ul style="list-style-type: none"> <li>22:33 – Single bat foraging in front of elevation, west to northeast</li> <li>22:42 – Foraging from northeast to west in front of IR camera</li> <li>22:47 – Foraging from west to east in front of IR camera</li> <li>22:55 – Foraging again from northeast to west (likely same individual)</li> <li>23:04 – Foraging bat passed south to north in front of IR camera</li> </ul> | <p>Screenshot of darkest part of survey.</p> |

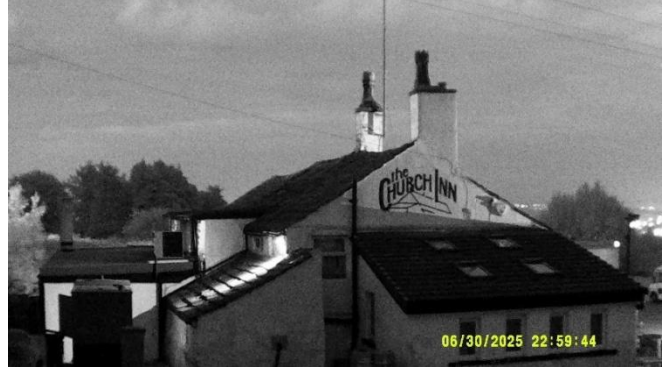
| <i>IR position 2</i><br><i>Nightfox whisker</i><br><i>IR camera and</i><br><i>X50 torch</i> | <p>Camera position: Observing northern and western elevation of B1.</p> <p><b>Emergences observed upon review of footage:</b><br/>No additional observations or bat activity recorded upon review, confirms surveyor observations.</p> | <p>Screenshot of darkest part of survey.</p> |

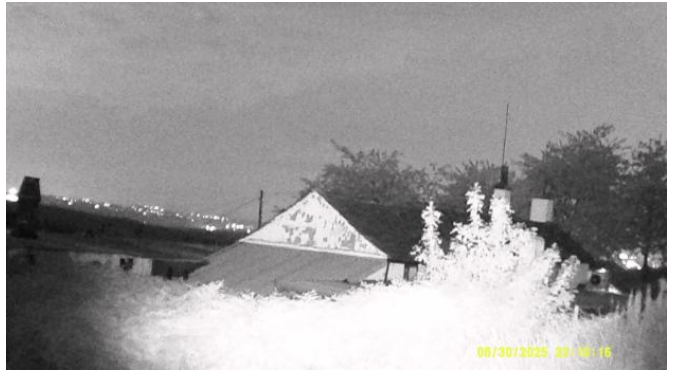
| <i>IR position 3</i><br><i>Nightfox whisker</i><br><i>IR camera and</i><br><i>X50 torch</i> | <p>Camera position: Observing northern and eastern elevations of B1.</p> <p><b>Emergences observed upon review of footage:</b><br/> No additional observations or bat activity recorded upon review, confirms surveyor observations.</p> | <p>Screenshot of darkest part of survey.</p> |

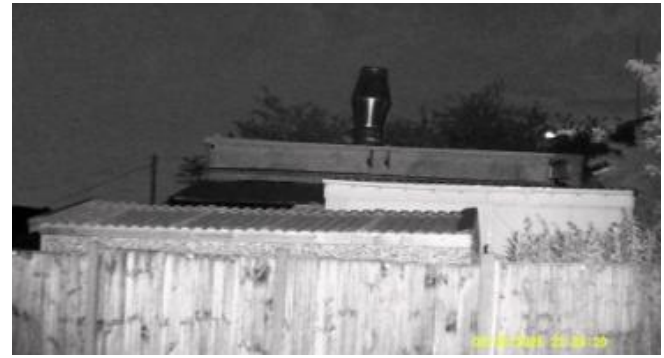
| <i>IR position 4</i><br><i>Nightfox whisker</i><br><i>IR camera and</i><br><i>X50 torch</i> | <p>Camera position: Observing eastern elevation of B1.</p> <p><b>Emergences observed upon review of footage:</b><br/> No additional observations or bat activity recorded upon review, confirms surveyor observations.</p> | <p>Screenshot of darkest part of survey.</p> |

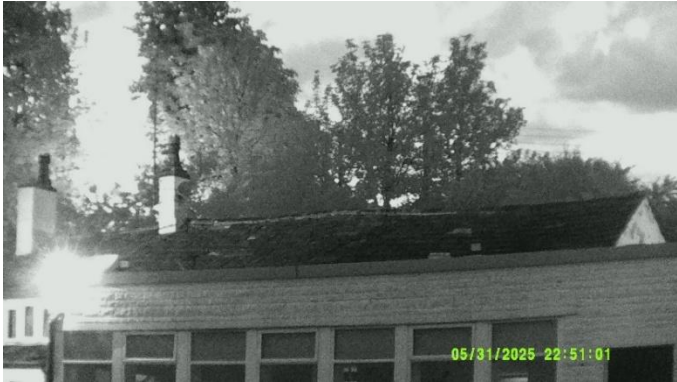
| <p><i>IR position 5</i><br/><i>Nightfox whisker</i><br/><i>IR camera and</i><br/><i>X50 torch</i></p> | <p>Camera position: Observing southeastern elevation of B1</p> <p><b>Emergences observed upon review of footage:</b></p> <p>No additional observations or bat activity recorded upon review, confirms surveyor observations.</p> <p><b>Other notable bat activity:</b></p> <ul style="list-style-type: none"> <li>• 21:42:32 – Bat travelling south over ridge</li> <li>• 22:07:58 – Bat crossed from south to north over IR field of view</li> </ul> <p>22:28:04, 22:30:30 – Bat passes south to north in front of IR</p> | <p>Screenshot of darkest part of survey.</p> |

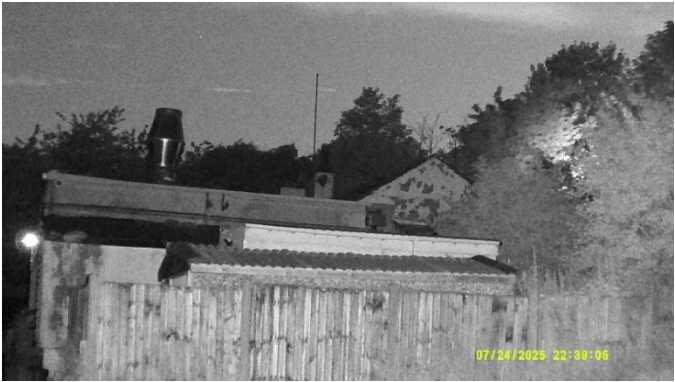
| <p><i>IR position 4</i></p> <p><i>Nightfox<br/>whisker<br/>camera<br/>and<br/>X50 torch</i></p> | <p>Camera position: Observing eastern elevation of B2.</p> <p><b>Emergences observed upon review of footage:</b><br/>No additional observations or bat activity recorded upon review, confirms surveyor observations.</p> | <p>Screenshot of darkest part of survey.</p> |

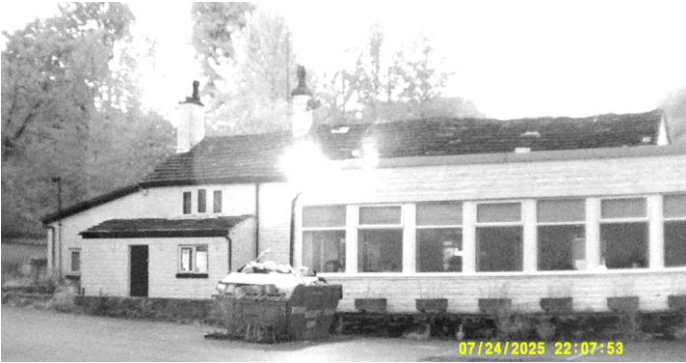
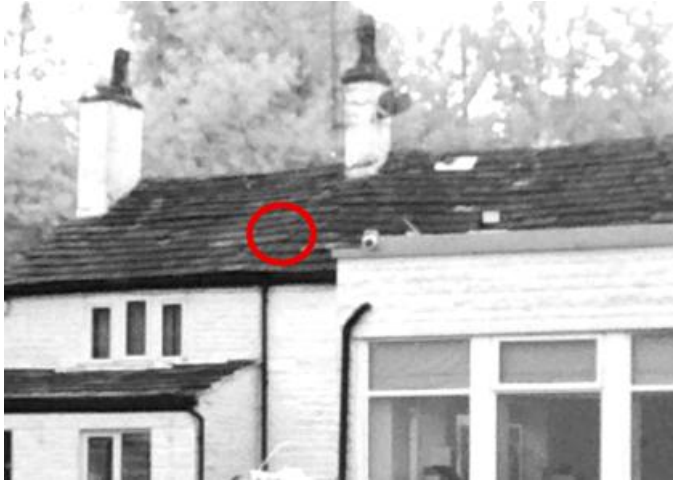
| <p><i>Surveyor 5</i></p> | <p><b>Emergences observed:</b><br/>No emergences observed by surveyor (confirmed emergence at 21:51 on IR review)</p> <p><b>Summary of general activity:</b><br/>Species: common pipistrelle, Noctule, Barn owl<br/>Flight paths:</p> <ul style="list-style-type: none"> <li>• 21:31 – Barn owl flew north to south over ridge of Building 1, northeast to southwest</li> <li>• 22:13 – Noctule heard not seen</li> <li>• 22:18 – common pipistrelle passed along southern elevation from southwest heading east</li> </ul> <p>Foraging areas: No distinct foraging activity observed</p> <p><b>Additional notes:</b><br/>At 21:51, a bat was observed by Position 3 flying close to the ridge of Building 1 (SW to E) – later confirmed on IR as an emergence</p> | <p>Full elevation photo showing surveyor's view.</p> |

| <p>IR position 5</p> <p>Nightfox<br/>whisker IR<br/>camera and<br/>X50 torch</p> | <p>Camera position: Observing southern elevation of B1.</p> <p><b>Emergences observed upon review of footage:</b></p> <p>Roost 2: Common pipistrelle day roost<br/>Number: 1<br/>Time: 21:51<br/>Location of access point: Lifted roof tile on roof of southern elevation Building 1<br/>Direction of travel on emergence: West to east<br/>Species ID confirmed as common pipistrelle by EMT on site.</p> | <p>Screenshot of darkest part of survey.</p> <div data-bbox="1330 287 2013 651"></div> <div data-bbox="1335 715 2007 1197"></div> <p>Emergence point circled in red*</p> |

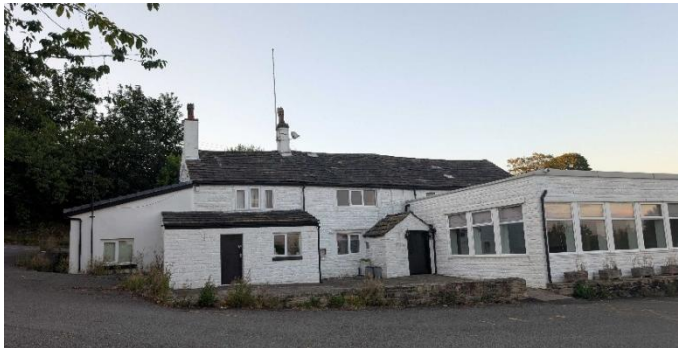
| Surveyor 1 | <b>Emergences observed:</b> yes<br><br>Roost 1: Common pipistrelle day roost<br><br>Number: 1<br>Time: 21:02<br>Location of access point: Furthest west rake tiles beneath the chimney stack on the south-facing roof slope of B1.<br>Direction of travel on emergence: West<br>Species ID confirmed as common pipistrelle by EMT onsite.<br><br><b>Summary of general activity:</b><br>Species: common pipistrelle<br>Flight paths: <ul style="list-style-type: none"><li>21:24 - Bat (suspected common pipistrelle) flew southwest over the roof of B1.</li></ul> | | Full elevation photo showing surveyor’s view.<br><br> | |

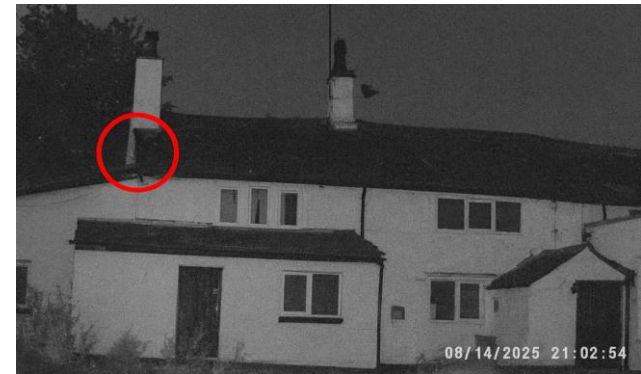
| <i>IR position 1</i><br><br><i>Nightfox whisker</i><br><i>IR camera and</i><br><i>X50 torch</i> | <p><b>Emergences observed: yes</b></p> <p><b>Roost 1:</b> Common pipistrelle day roost</p> <p>Number: 1<br/> Time: 21:02<br/> Location of access point: Location of access point: Furthest west lifted rake tiles beneath the chimney stack on the south-facing roof slope of B1.<br/> Direction of travel on emergence: West<br/> Species ID confirmed as common pipistrelle by EMT on site.</p> | <p>Screenshot of darkest part of survey.</p> |

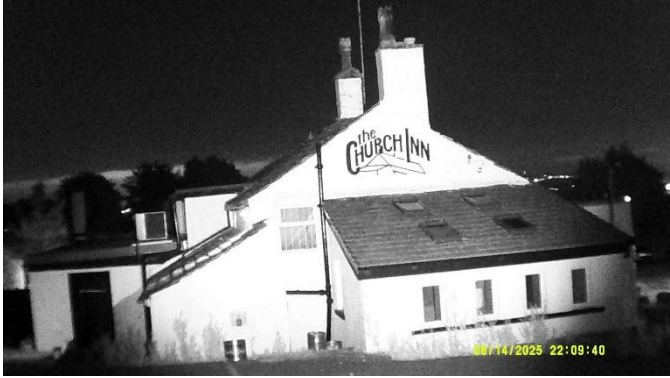
| <p><i>IR position 2</i></p> <p><i>Nightfox whisker</i></p> <p><i>IR camera and</i></p> <p><i>X50 torch</i></p> | <p>Camera position: Observing northern and western elevation of B1.</p> <p><b>Emergences observed:</b> yes</p> <p><b>Roost 1: Common pipistrelle day roost</b></p> <p>Number: 1<br/> Time: 21:02<br/> Location of access point: Furthest west lifted rake tiles beneath the chimney stack on the south-facing roof slope of B1.<br/> Direction of travel on emergence: Northwest<br/> Species ID confirmed as common pipistrelle by EMT on site.</p> | <p>Screenshot of darkest part of survey.</p> |

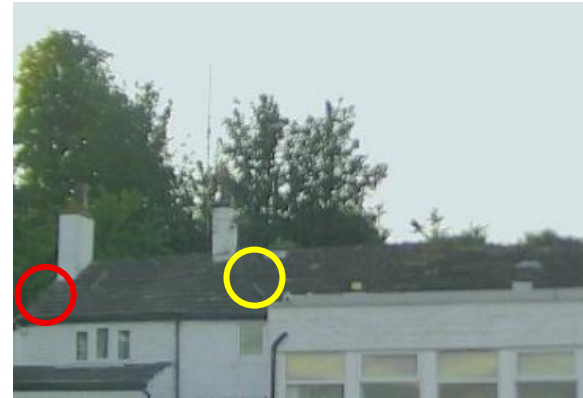
| Surveyor 5 | <p><b>Emergences observed:</b> yes</p> <p>Roost 1: Common pipistrelle day roost</p> <p>Number: 1</p> <p>Time: 21:02 (adjusted - IR time noted to be 1 min ahead when cross-checked)</p> <p>Location of access point: Furthest west lifted rake tiles beneath the chimney stack on the south-facing roof slope of B1.</p> <p>Direction of travel on emergence: West</p> <p>Species ID confirmed as common pipistrelle (by surveyors at positions 3 and 4 with EMT on site).</p> <p><b>Re-entries observed:</b> yes</p> <p>Roost 2: Common pipistrelle day roost (re-entry)</p> <p>Number: 1</p> <p>Time: Between 20:56-21:11 (IR footage shows a bat entering from the southwest into the middle roof tiles on the south elevation, adjacent to the single-storey structure)</p> | <p>Full elevation photo showing surveyor's view.</p> <p>Emergence point circled in red*, Re-entry point marked on in yellow*</p> |

| | <p>Location of access point: Middle section of roof tiles on the south elevation, next to the one-storey building<br/>Species ID confirmed as common pipistrelle by EMT on site.</p> <p><b>Summary of general activity:</b><br/>Species: common pipistrelle, Noctule<br/>Flight paths:</p> <ul style="list-style-type: none"> <li>• common pipistrelles commuting repeatedly west to east and east to west in front of the southeastern elevation.</li> <li>• Occasional common pipistrelle flights north to south across the roof ridge before continuing west.</li> </ul> <p>Foraging areas: In front of the southeastern elevation, with repeated commuting and circling flights west to east.</p> | |

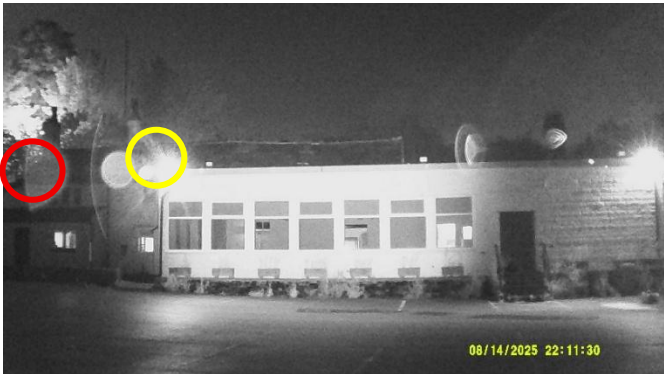
| <p><i>IR position 5</i></p> <p><i>Nightfox whisker</i><br/><i>IR camera and</i><br/><i>X50 torch</i></p> | <p>Camera position: Observing southeastern elevation of B1.</p> <p>Review confirms one emergence and one re-entry, with sustained commuting and foraging activity.</p> <p><b>Emergences observed:</b> yes</p> <p><b>Roost 1: Common pipistrelle day roost</b></p> <p>Number: 1<br/>Time: 21:02 (adjusted - IR timestamp approximately 1 min ahead)<br/>Location of access point: From lifted rake tiles at the western end of the roof, beneath the chimney stack<br/>Direction of travel on emergence: West<br/>Species ID confirmed as common pipistrelle by EMT on site.</p> <p><b>Re-entries observed:</b> yes</p> <p>Roost 2: Common pipistrelle day roost</p> | <p>Screenshot of darkest part of survey.</p> |

| | <p>Number: 1<br/> Time: Between 20:56 and 21:11<br/> Location of access point: Into roof tiles on the south elevation, middle roof section adjacent to single-storey building.<br/> Species ID confirmed as common pipistrelle by EMT on site.</p> <p><b>Additional notes:</b> Frequent common pipistrelle activity recorded after emergence, with commuting west to east and east to west in front of the elevation, and occasional flights north to south across the ridge. Review confirms one emergence and one re-entry.</p> | |

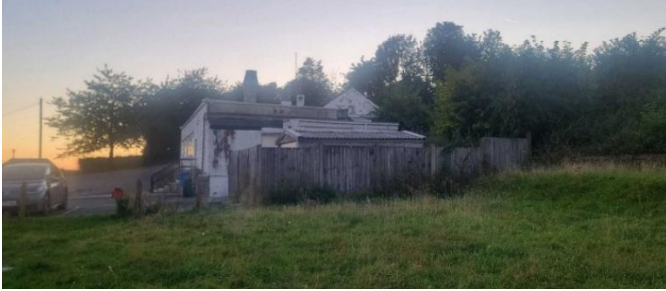
| <i>Surveyor 4</i> | <p><b>Emergences observed:</b> No emergences observed.</p> <p><b>Summary of general activity:</b><br/> Species: common pipistrelle<br/> Flight paths</p> <ul style="list-style-type: none"> <li>21:14 - common pipistrelle observed arriving from the northwest and foraging within the field to the east of B1</li> <li>21:19 - common pipistrelle passed from the south into the same field and began foraging</li> <li>21:23 &amp; 21:29 - common pipistrelles passed east to west in front of the south elevation of B1</li> <li>21:32 - common pipistrelle passed north to south across the field east of B1</li> </ul> <p>Foraging areas: Sustained foraging activity by at least three common pipistrelles within the field east of B1 from 21:19 until 21:50</p> | <p>Full elevation photo showing surveyor's view.</p> |

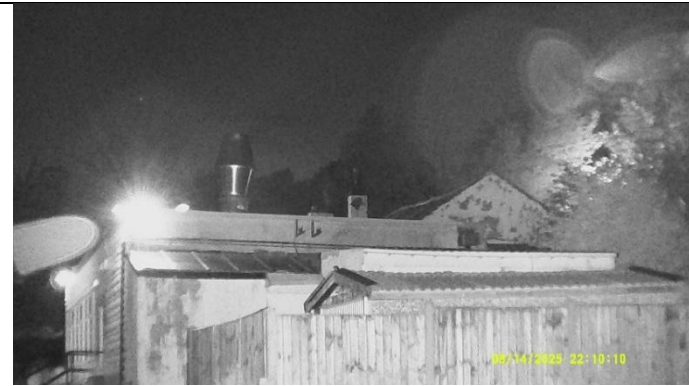
| <i>IR position 4</i><br><br><i>Nightfox whisker</i><br><i>IR camera and</i><br><i>X50 torch</i> | <p>Camera position: Observing eastern elevation of B2.</p> <p>No additional observations or emergences recorded. Confirms surveyor observations.</p> | <p>Screenshot of darkest part of survey.</p> |
