| PROJECT | SMP - St Mary's CE Primary School |
| TITLE | Elevation BB - Demolition & Repairs |
| NUMBER | SMP-SEV-XX-XX-DR-A-03011 |

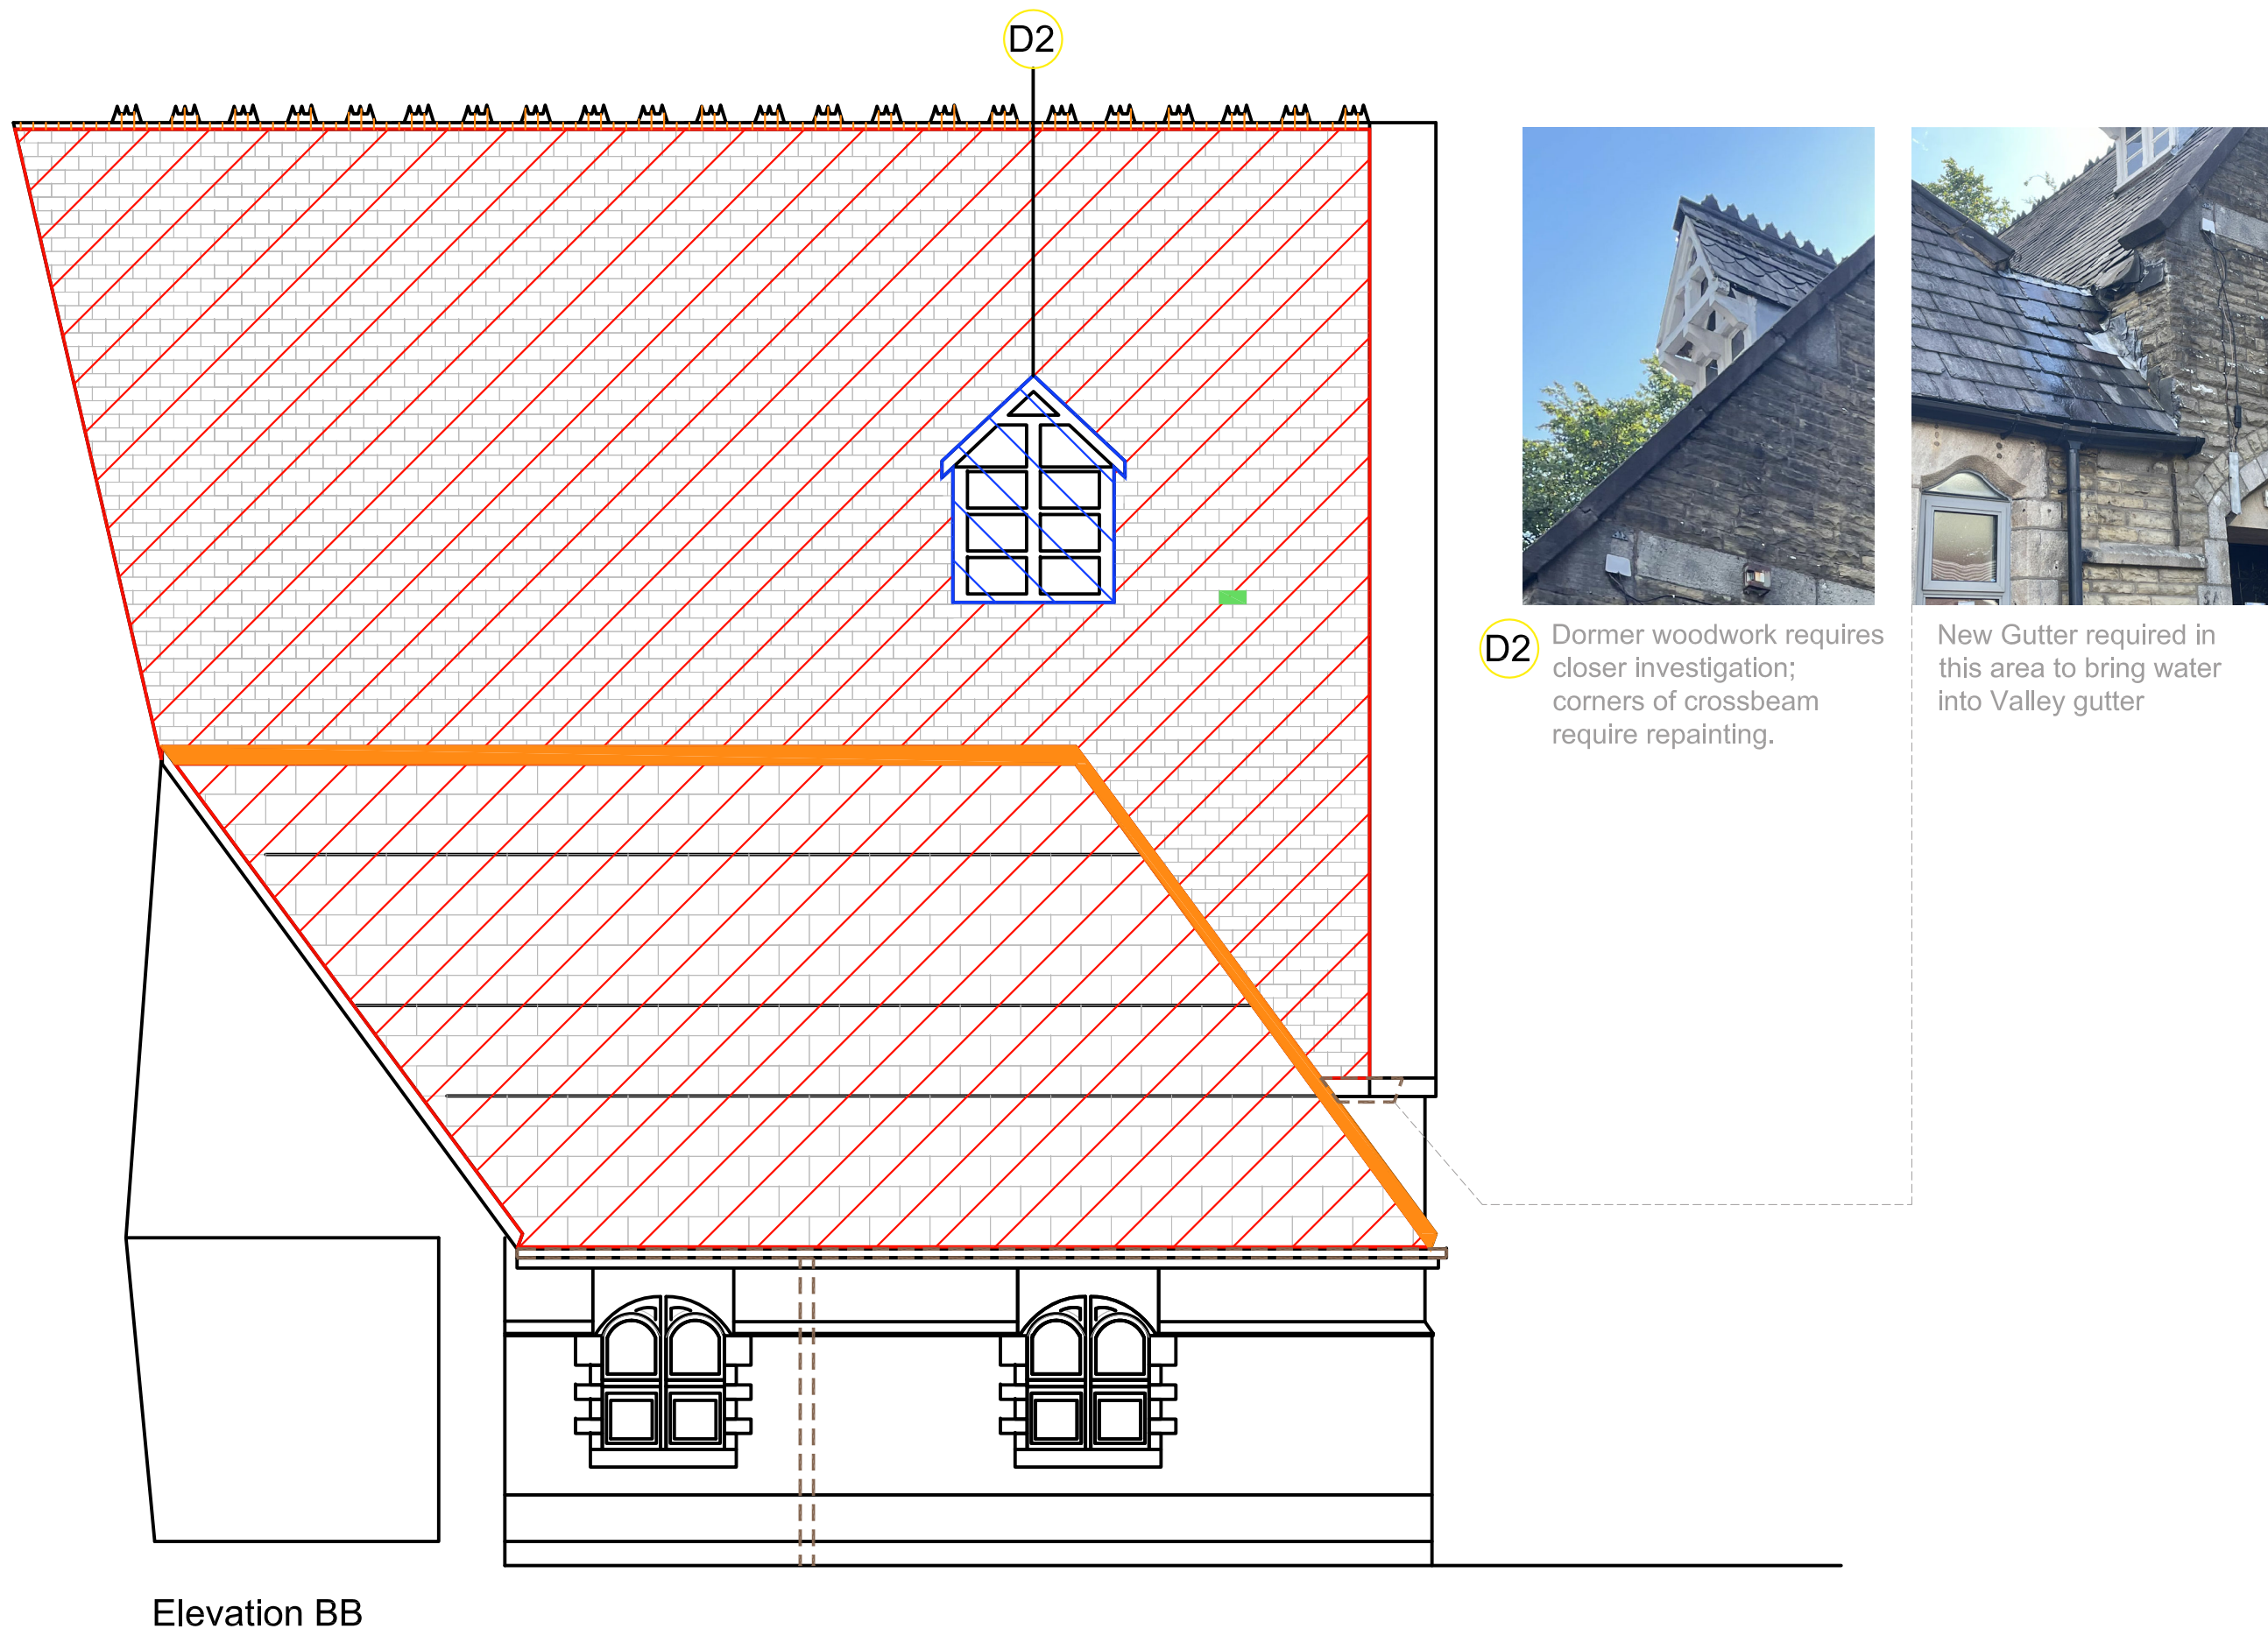
Elevation BB

- Roof Slate Restoration: 762sqm / 8220sqft  
Strip existing slate roof coverings and set aside salvaged slates for re-use. Strip existing battens, felt, lead-lined gutters and gutter structure then safely dispose of any defective material. Re-felt & batten existing roof slope. As per detail A-A in drawing SMP-SEV-XX-XX-DR-A-03100 (Typical Roof Build-Up)

- Dormer Window: 09 no.  
Splice in new timbers where appropriate. Access to be provided for detailed inspection and methodology agreed. Carefully sand down and repaint in appropriate materials as per the specification. Roofing section per detail F-F in drawing SMP-SEV-XX-XX-DR-A-03105 (Typical Dormer Window)

- Cupola: 01 no.  
Splice in new timbers where appropriate. Access to be provided for detailed inspection and methodology agreed. Carefully sand down and repaint in appropriate materials as per the specification. Cupola roofing is as per the building's other slate roof eaves, but is at a steeper gradient (assume larger area than in plan).

- Rainwater Goods: 18 no.  
Down-pipe to be removed and replaced with cast-iron rainwater goods allowing for increased diameter (6 inch) to mitigate increased rainfall. Existing cast-iron hoppers to be retained & refurbished where possible. Guttering per detail B-B in drawing SMP-SEV-XX-XX-DR-A-03100 (Typical External Gutter)

- Lead Flashing: 75 Lm  
Replace with new terne-coated stainless steel (TCSS) flashing where appropriate. Access to be provided for detailed inspection and methodology agreed.

- Decorative Ridge Tiles: 105 Lm  
Ridge tiles to be removed and set aside with salvaged tiles for re-use. Replace damaged tiles as per the existing style. Ridge ventilation provided with new linear vent. Ridge venting per detail F-F in drawing SMP-SEV-XX-XX-DR-A-03105 (Typical Dormer Window)

- Flat Ridge Tiles: 50 Lm  
Ridge tiles to be removed and set aside with salvaged tiles for re-use. Replace damaged tiles like-for-like.
- Bat Slate: [Dashed Hatch Approx. Location, Solid Hatch Exact Location]  
Integrated Bat access slate: metal vent to allow access for bats into roof void, with sufficient gap cut into roof structure underneath. Fitted within a hole cut to slate which is placed over the vent to reduce visual impact. 1no. Bat Slate located in area of observed bat emergence (west wing of the building, facing north, adjacent to Dormer D2) and then 3no. supplementary 'enhancement slates' along remaining wings (north, east, south).
