# ROAVR | GROUP

**Project:** 25\_PRA\_02\_67  
**Site:** Dewhirst House, Rochdale, OL12 9TX  
**Client:** Subhan Saleem

| Report Type: | Preliminary Roost Assessment Report [PRA]<br>Daytime Bat Walkover (DBW) |
| Site Address: | Dewhirst House, Rochdale, OL12 9TX |

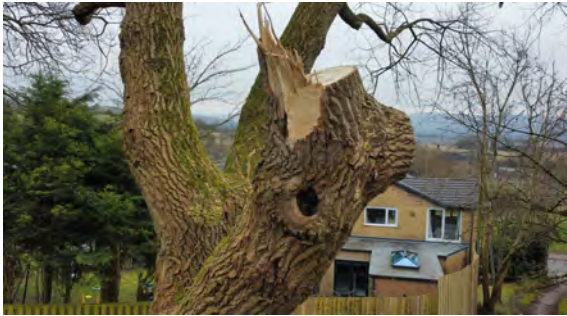
| Detail | Photograph |
|---|---|
| Image 1 - TN1 (PRF1) found in T1. | |

Tree T1 is a mature Manchester poplar (*Populus x canadensis*) located near the site entrance. The tree features a cavity at approximately five metres above ground level on a pruned limb. The cavity has the potential to provide a roosting opportunity for bats, particularly crevice-dwelling species such as common pipistrelle (*Pipistrellus pipistrellus*) or soprano pipistrelle (*Pipistrellus pygmaeus*). The presence of natural shading and shelter from surrounding vegetation may enhance its suitability as a roost site by maintaining stable microclimatic conditions.

Further assessment of the cavity would be required to determine any evidence of current or historic bat usage, such as staining, scratch marks, or droppings. Given the potential suitability of this feature, any tree works should be undertaken with caution and adhere to best practice guidance to minimise the risk of disturbing any roosting bats. TN1 is a cavity on a mature Manchester poplar (*Populus x canadensis*) located adjacent to the site access at what3words location Unrealistic.roofs.rushed. The cavity is positioned approximately five metres above ground level on a pruned limb. It has potential to support roosting bats, particularly crevice-dwelling species such as common pipistrelle (*Pipistrellus pipistrellus*). The feature appears to offer shelter and protection from the elements, creating stable microclimatic conditions suitable for roosting. Further assessment would be required to determine any evidence of bat activity, such as staining or droppings.

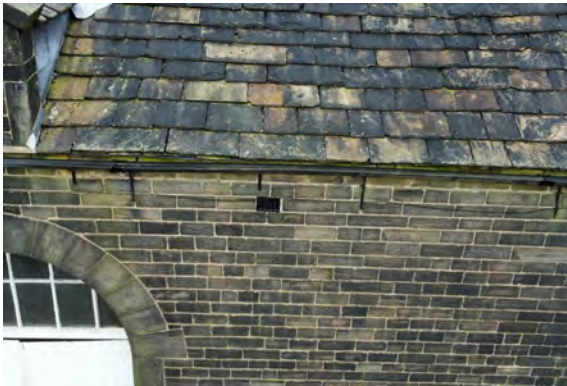
TN2 is a potential roost feature (PRF) situated on the northern elevation of B1. The feature consists of an air brick that provides direct access into the upper barn area. The air brick could act as an entry and exit point for bats accessing the roof void, offering a sheltered space with minimal disturbance. This type of PRF is commonly utilised by crevice-dwelling bat species, and its suitability should be further investigated through nocturnal surveys.

The northern elevation features an air brick leading directly into the upper barn area, presenting a potential roost feature (PRF) suitable for crevice-dwelling bat species. The brickwork and mortar joints show signs of wear, which may create additional opportunities for wildlife, including invertebrates and small mammals.

| Detail | Photograph |
|---|---|
| Image 2 - TN2 (PRF2) found on B1. | |

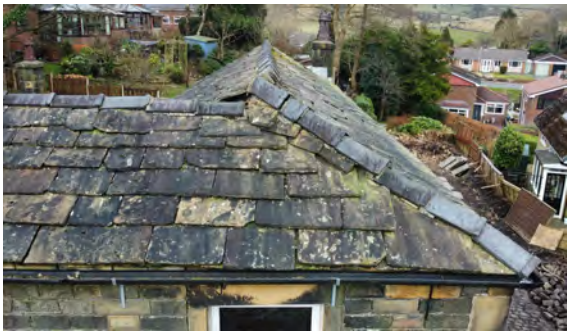
| Detail | Photograph |
|---|---|
| Image 3 - TN3 (PRF3) found on B1. | |

TN3 is a second PRF identified on the eastern elevation of B1. This feature consists of a gap within the masonry, which may allow access to internal cavities within the structure. The positioning of the void within a relatively sheltered aspect could enhance its potential for bat roosting. Close inspection would be necessary to determine signs of bat presence, such as fur oil staining around the entry point or accumulation of droppings beneath the feature.

TN3 is a second PRF identified on the eastern elevation of B1. This feature consists of a gap within the masonry, which may allow access to internal cavities within the structure. The positioning of the void within a relatively sheltered aspect could enhance its potential for bat roosting. Close inspection would be necessary to determine signs of bat presence, such as fur oil staining around the entry point or accumulation of droppings beneath the feature.

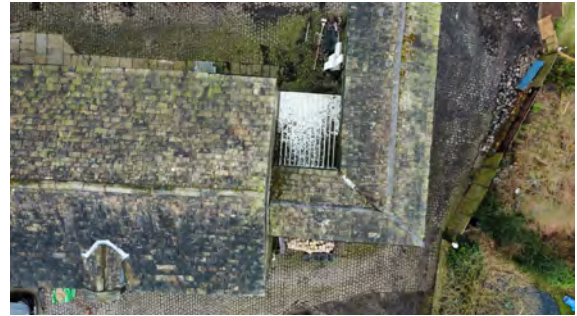
Image 5 - General condition of roof tiles on B1.

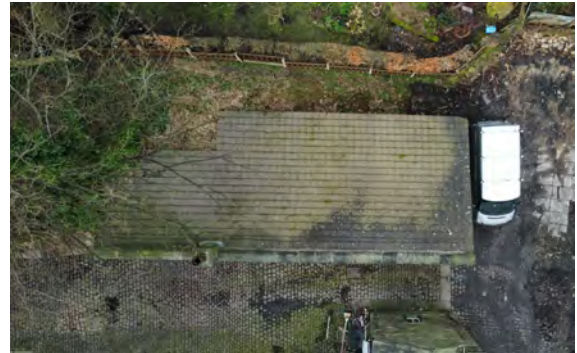
Image 6 - General condition of roof tiles on B2.

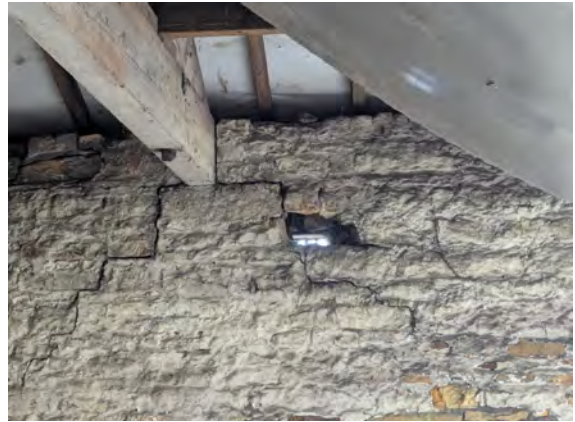
The internal roof structure of the barn area features wooden rafters with minor gaps and crevices where bats may roost. The presence of cobwebs in some recesses suggests limited disturbance, but no obvious bat droppings were noted during the inspection. However, the air brick on the northern elevation allows direct access into this space, providing a potential entry point for wildlife.

Image 9 - PRF2 internal view.

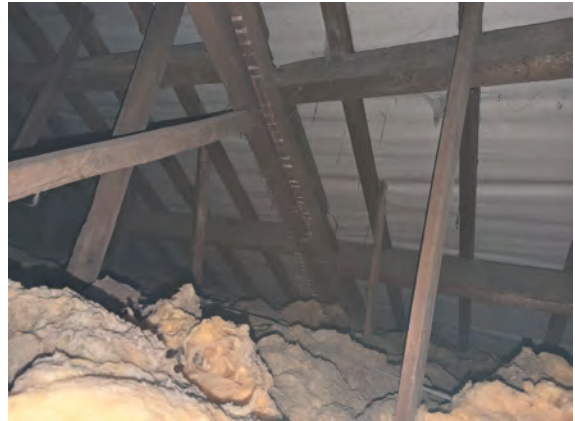
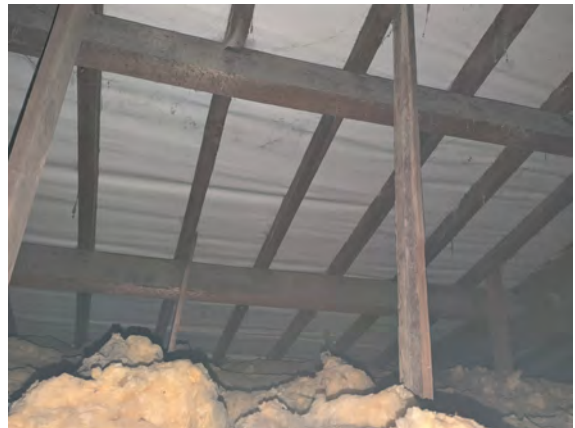
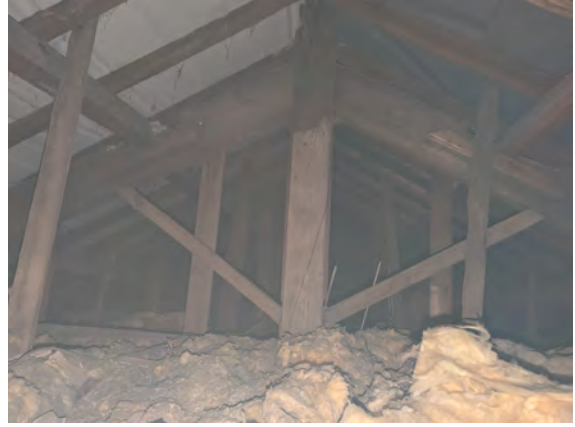
There was no known evidence of bats found during the internal inspection, including: staining, feed remains, droppings or bats (living or dead).

*Image 16 - Internal loft void of B1.*

*Image 17 - Internal loft void of B1.*

*Image 18 - Internal loft void of B1.*
