# DRAINAGE SCHEME DESIGN REPORT

112 CHURCH ST, LITTLEBOROUGH OL15 8AS

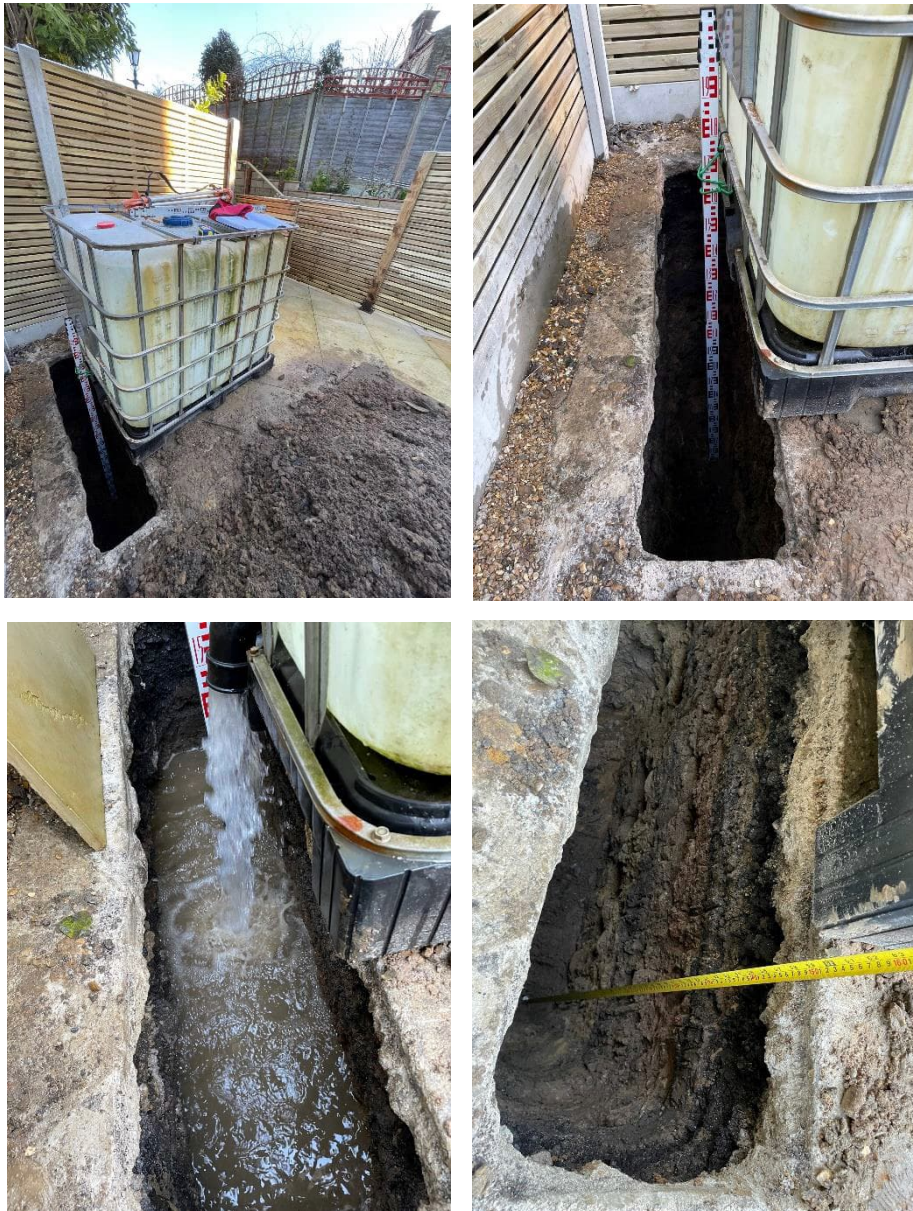
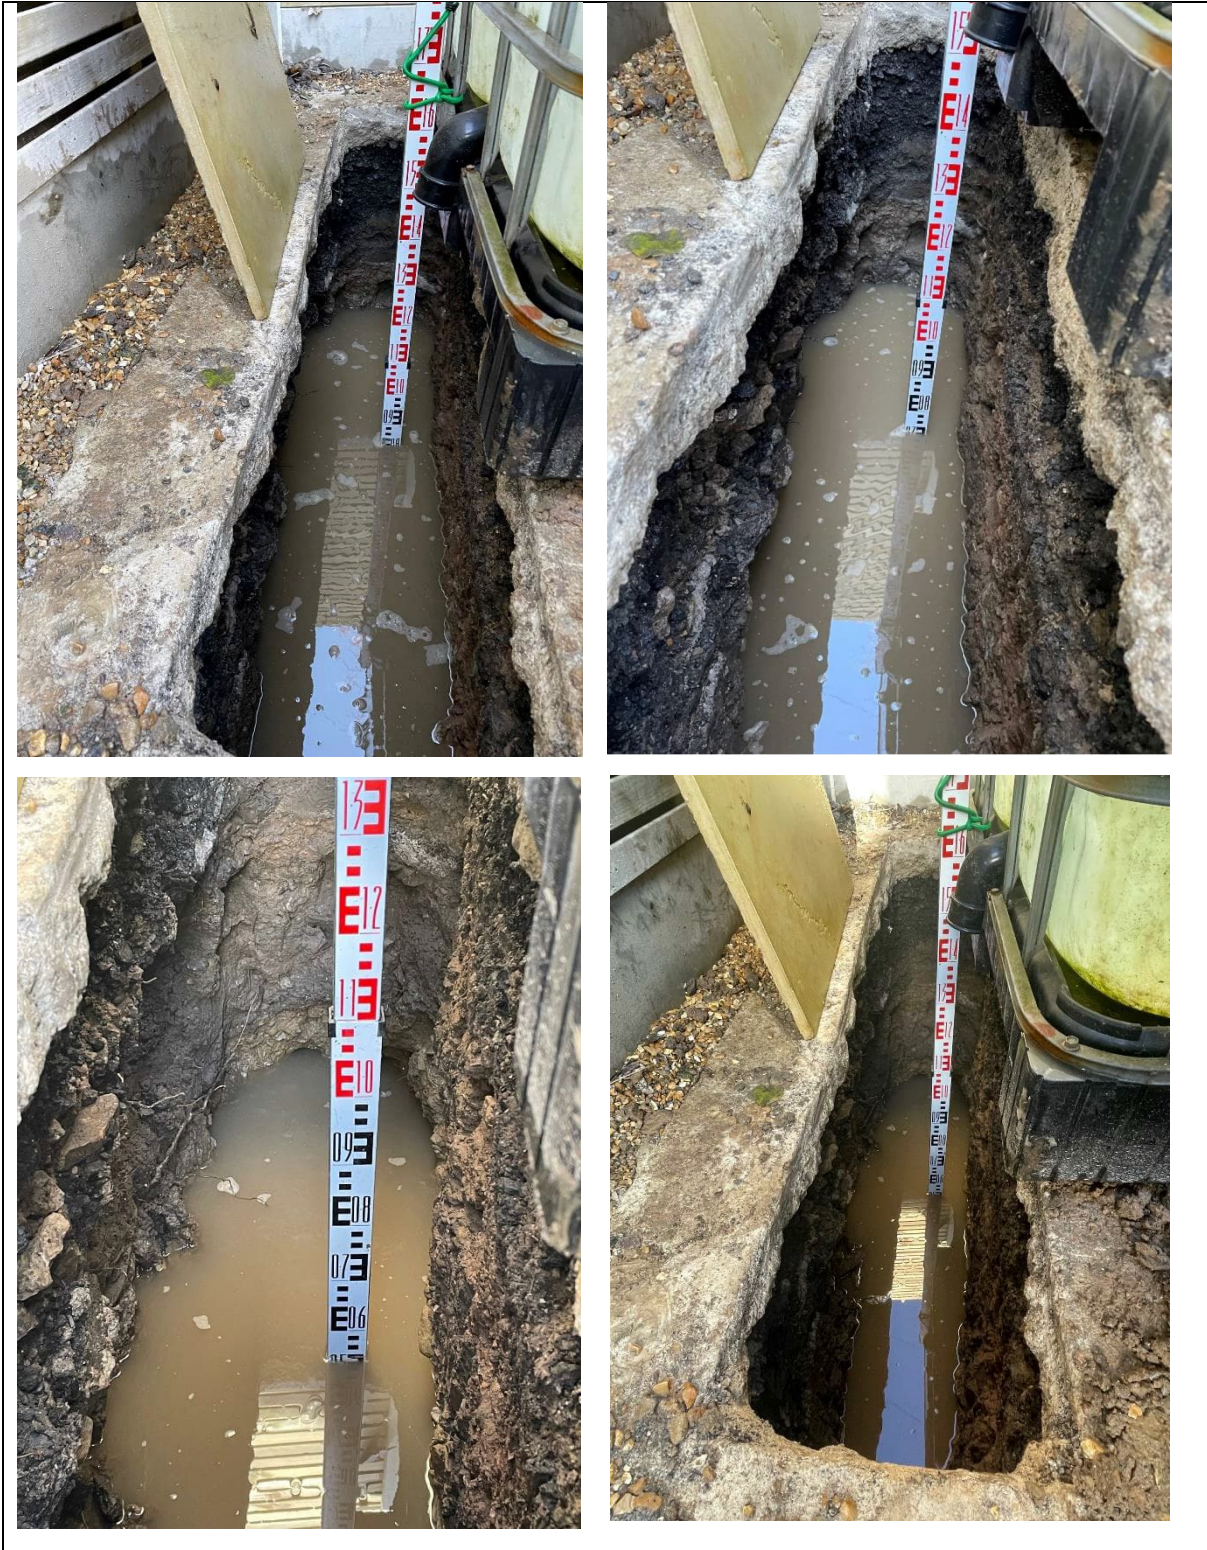
**Trial Pit 1 photos: 300W x 1500L x 1500D**

The trial pit was dug using hand tools due to the site access constraints, to enable the infiltration testing. The pit was dug, saturated prior to testing and then filled twice, on the same day. TP1 images pre and post testing can be seen below.

Poor percolation was found during testing. Both tests 1 and 2 had to be aborted due to the 6 hour cut off time being reached. The test was abandoned at pit 1 after 6 hours due to the underlying clay and resulting slow rate of infiltration.

There is existing clay soil at the depth below ground where infiltration would be required for a soakaway system, the clay ground conditions encountered has very fine particles that are tightly packed together, limiting the space for water to seep through. It was evident from the testing, that water will pool within the pit instead of draining effectively into the surrounding soil. Therefore, this would pose a high risk of localised flooding during periods of increased rain fall.

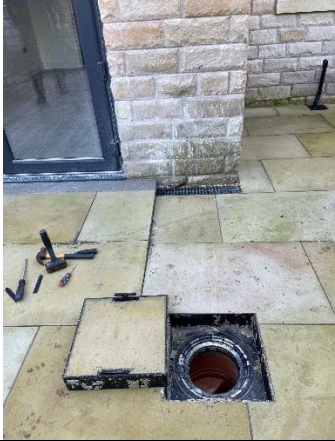
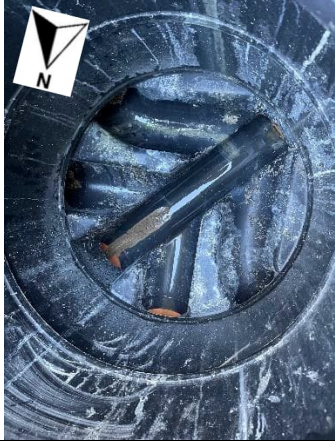
| Chamber | Location | |
|---|---|---|
| <p>1 – surface water run off from both properties.</p> <p>IL = 141.77</p> | | |

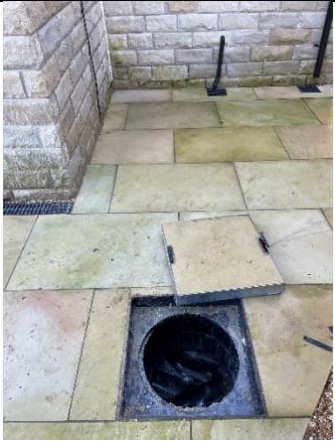
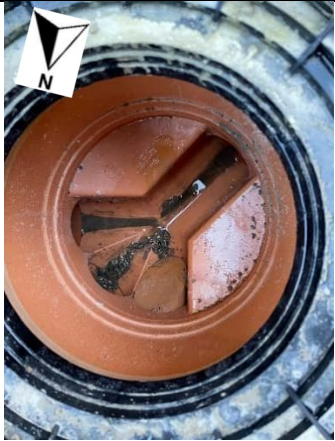
| Chamber | Location | |
|---|---|---|
| <p>2 – surface water run off from both properties.</p> <p>IL = 141.57</p> | | |

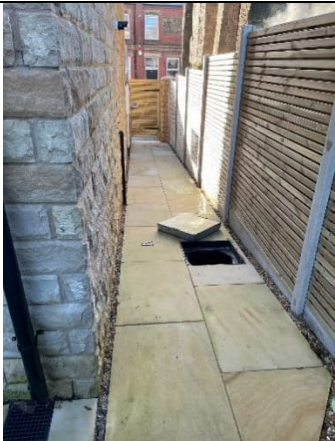
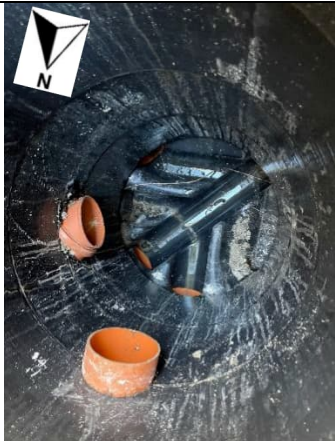
| Chamber | Location | |
|---|---|---|
| <p>3 – surface water run off and foul from both properties.</p> <p>IL = 140.97</p> | | |

As noted in the drainage strategy report for the site any existing sewer connections on the site should be investigated and its potential for reuse investigated. This will require the client to liaise and agree any connections with UU. The existing sewer is shown in Figure 3 manhole C3. The current site surface and foul water drainage has been connected into this sewer.

The foul water from both properties has also been connected into manhole C3.
