ROCHDALE HERITAGE ACTION ZONE – DRAKE STREET & SOUTH PARADE

ROCHDALE BOROUGH COUNCIL

HERITAGE STATEMENT AND PROPOSALS

DECEMBER 2019

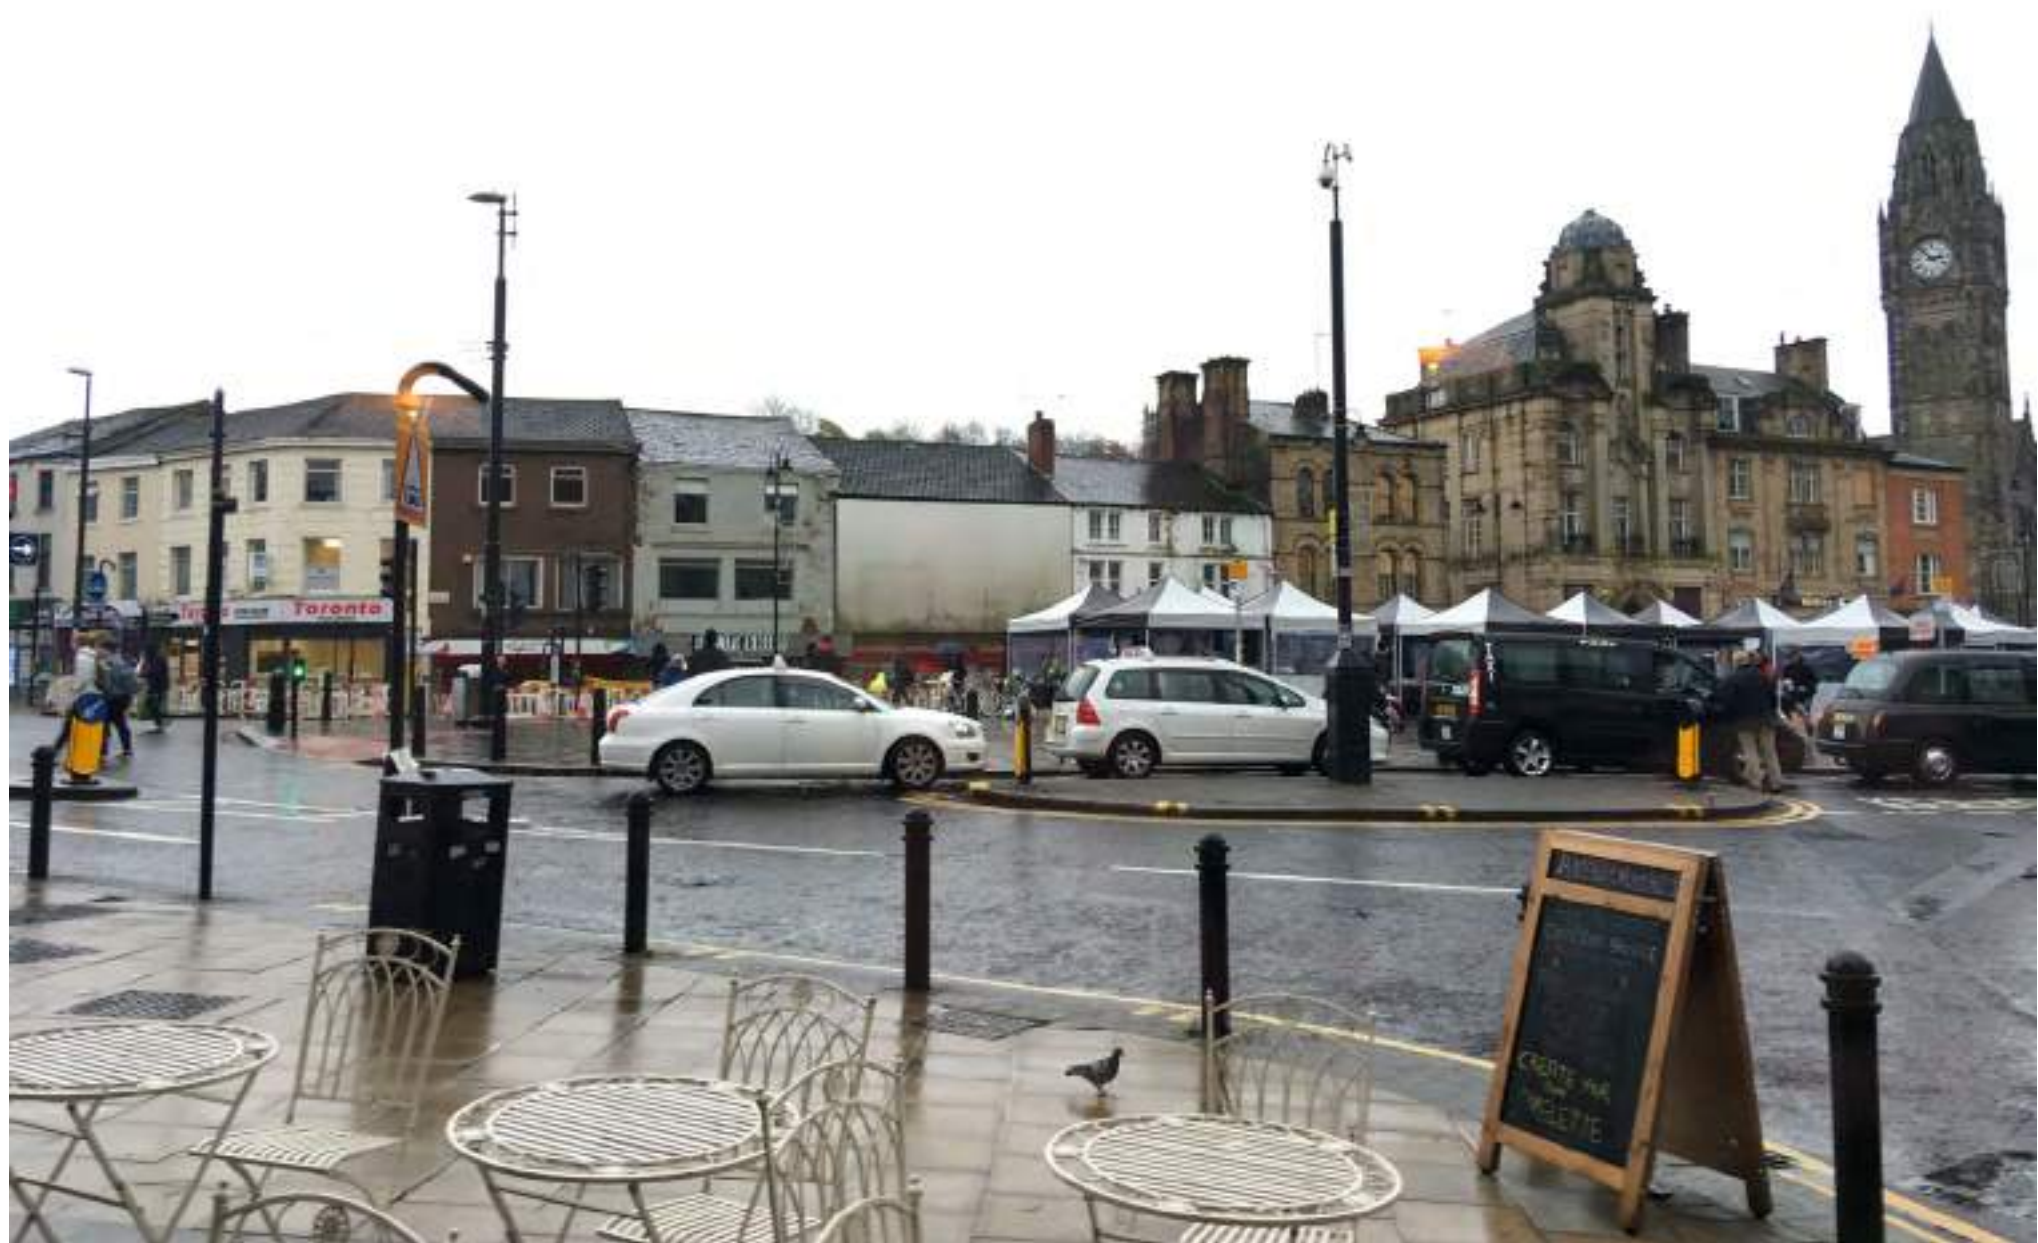
Figure 15: The existing streetscape of the study area along South Parade and Drake Street, comprising 19th century buildings with multiple alterations and an early 20th century-faced bank to the right (Source: Purcell 2019).

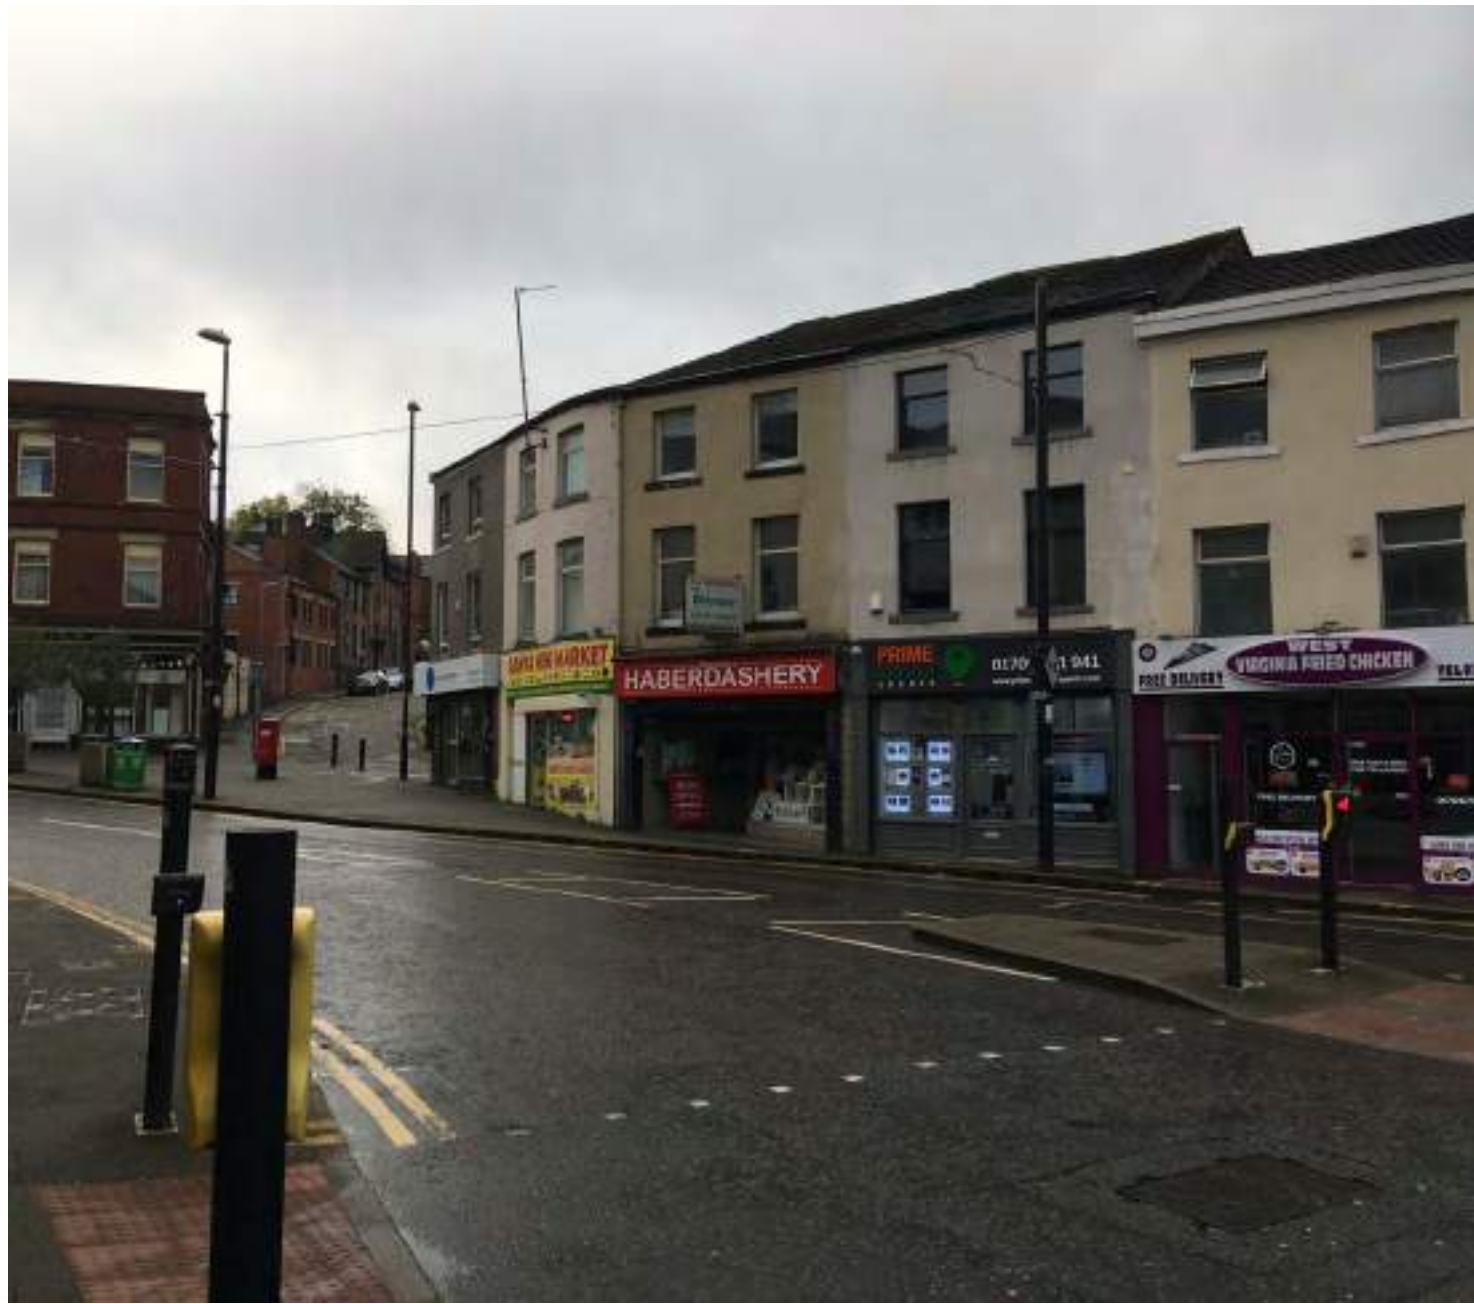
Figure 16: The existing streetscape of the study area along Drake Street, showing 2-12 Drake Street, which comprise 19th century buildings with cement-rendered first and second floor façades and multiple alterations to the ground floor shopfronts (Source: Purcell 2019).

- Where the first and second floor elevations have been cement-rendered, this render should be carefully removed as to not damage the brickwork and the brickwork left exposed (if in good repair) or covered with a lime-based stucco or render (preferably a hot lime mix) if in poor condition in order to ensure breathability of the building.

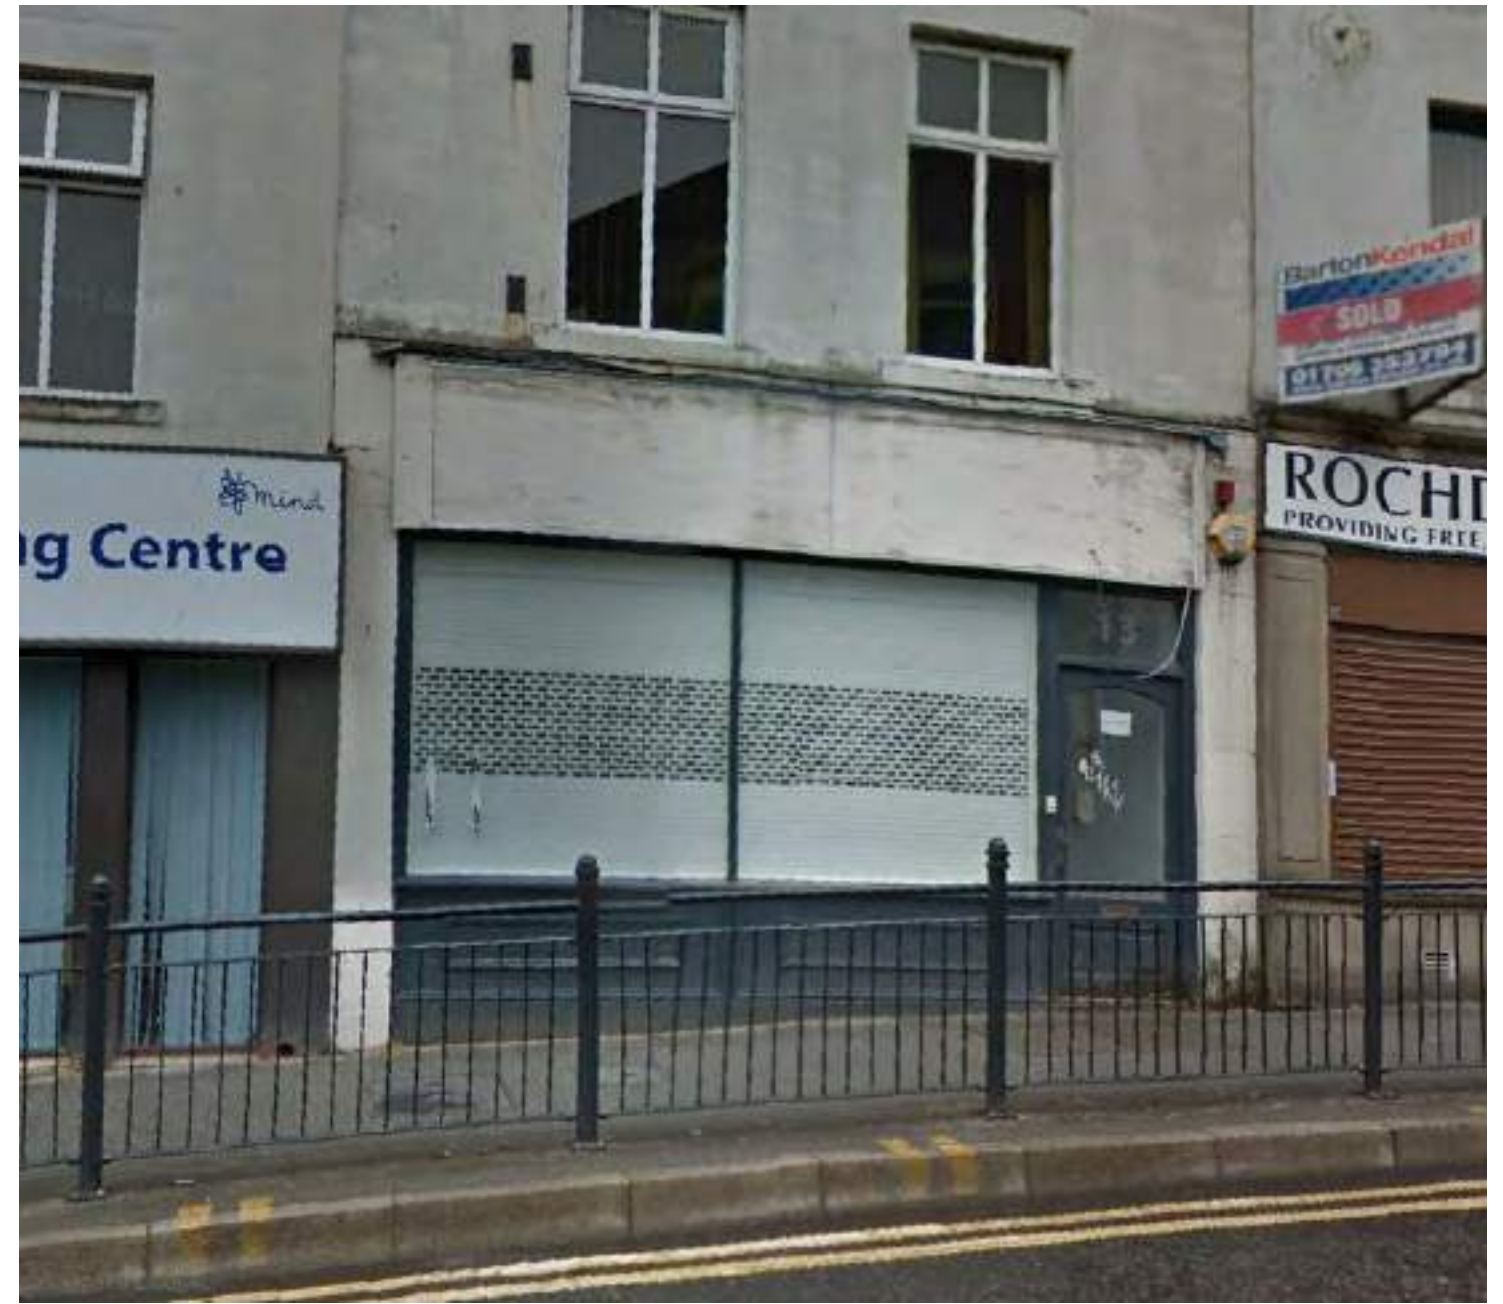
Figure 17: 13 Drake Street, showing the slightly recessed timber panelled stallriser, timber mullion separating two glass panes, fanlight above the door and timber door of the 19th century shopfront, though a number of elements appear to have been reproduced. However, the fascia is too deep and in poor condition and there are no pilasters (Source: Google 2018).

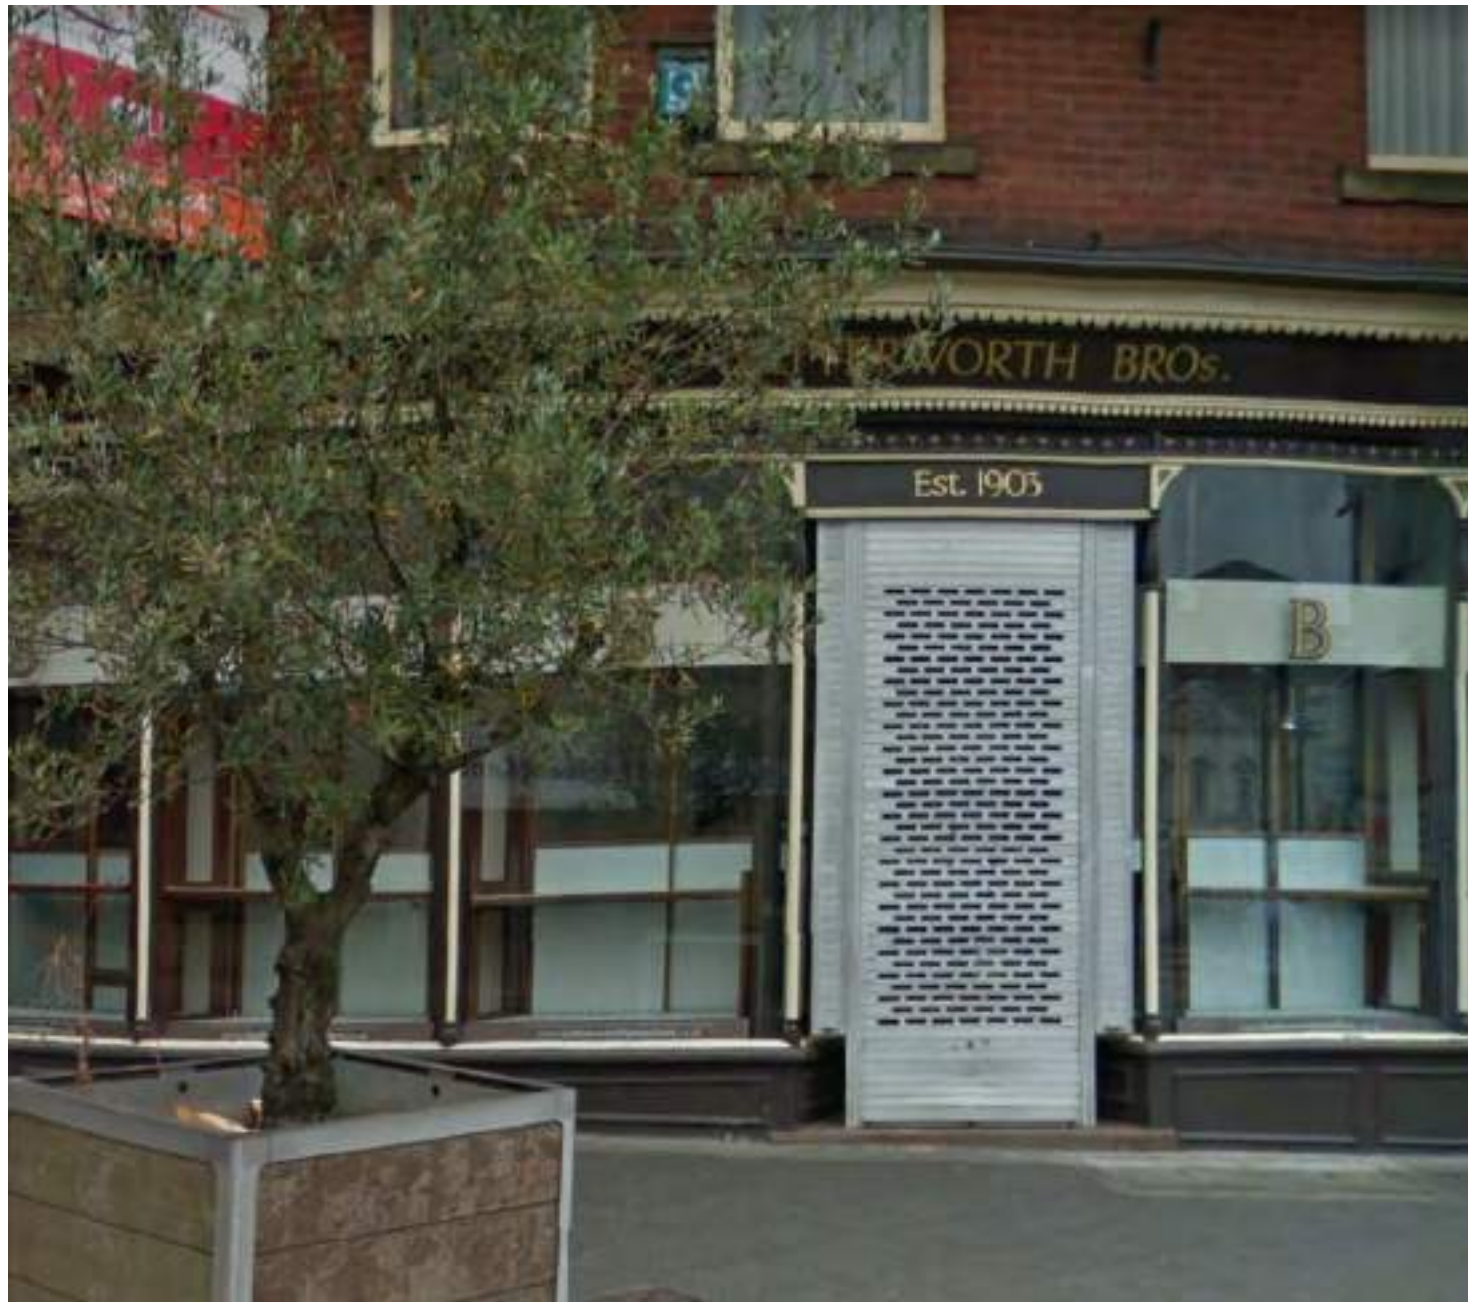
Figure 18: 14 Drake Street, showing the retained appearance of the historic 1903 shopfront of Butterworth Bros., with its decorative angled fascia and cornice above, decorative pilasters with plinth, capital, corbel and letterbox, timber panelled stallrisers, decorative timber mullions between glass pane and hand-painted signage directly onto the fascia (Source: Google 2018).

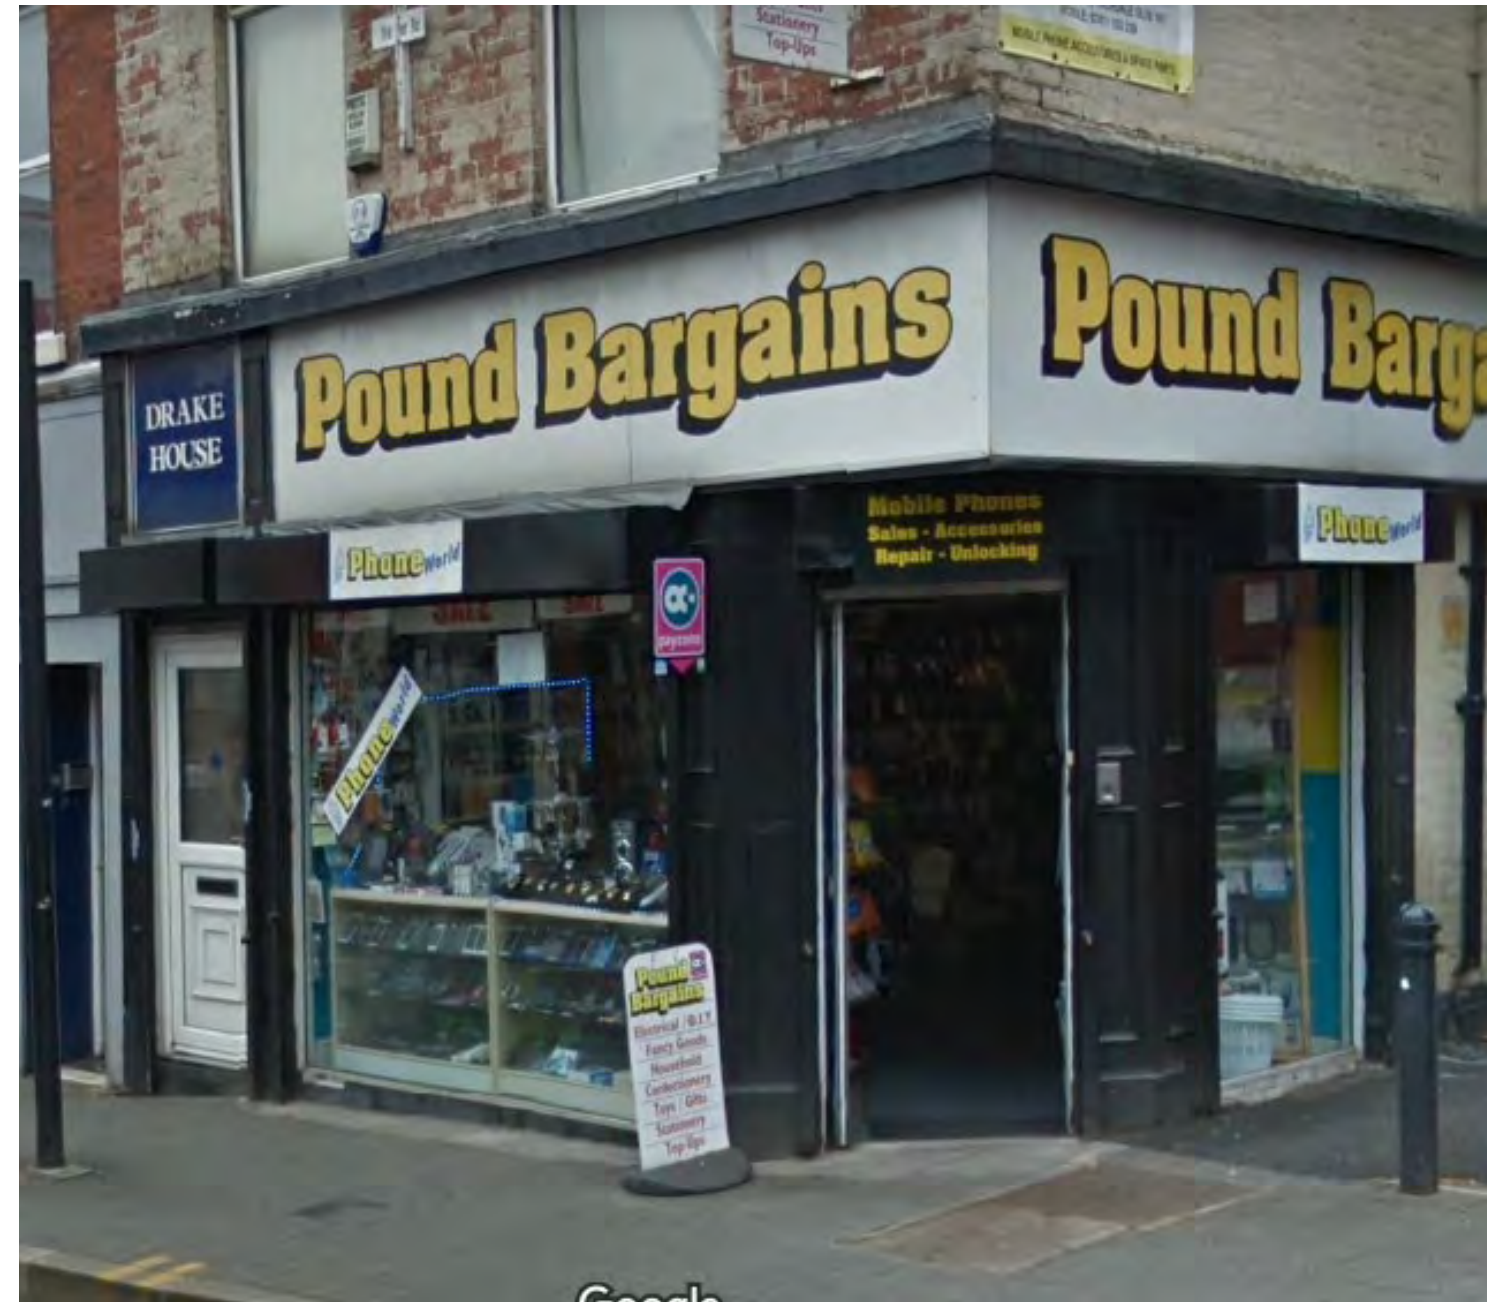
Figure 19: 21 Drake Street, showing timber panelled pilasters and a chamfered entrance as the only visible remains of a traditional shopfront, with unsympathetic deep fascia, projecting roller shutters and floor-length glass panes (Source: Google 2018).

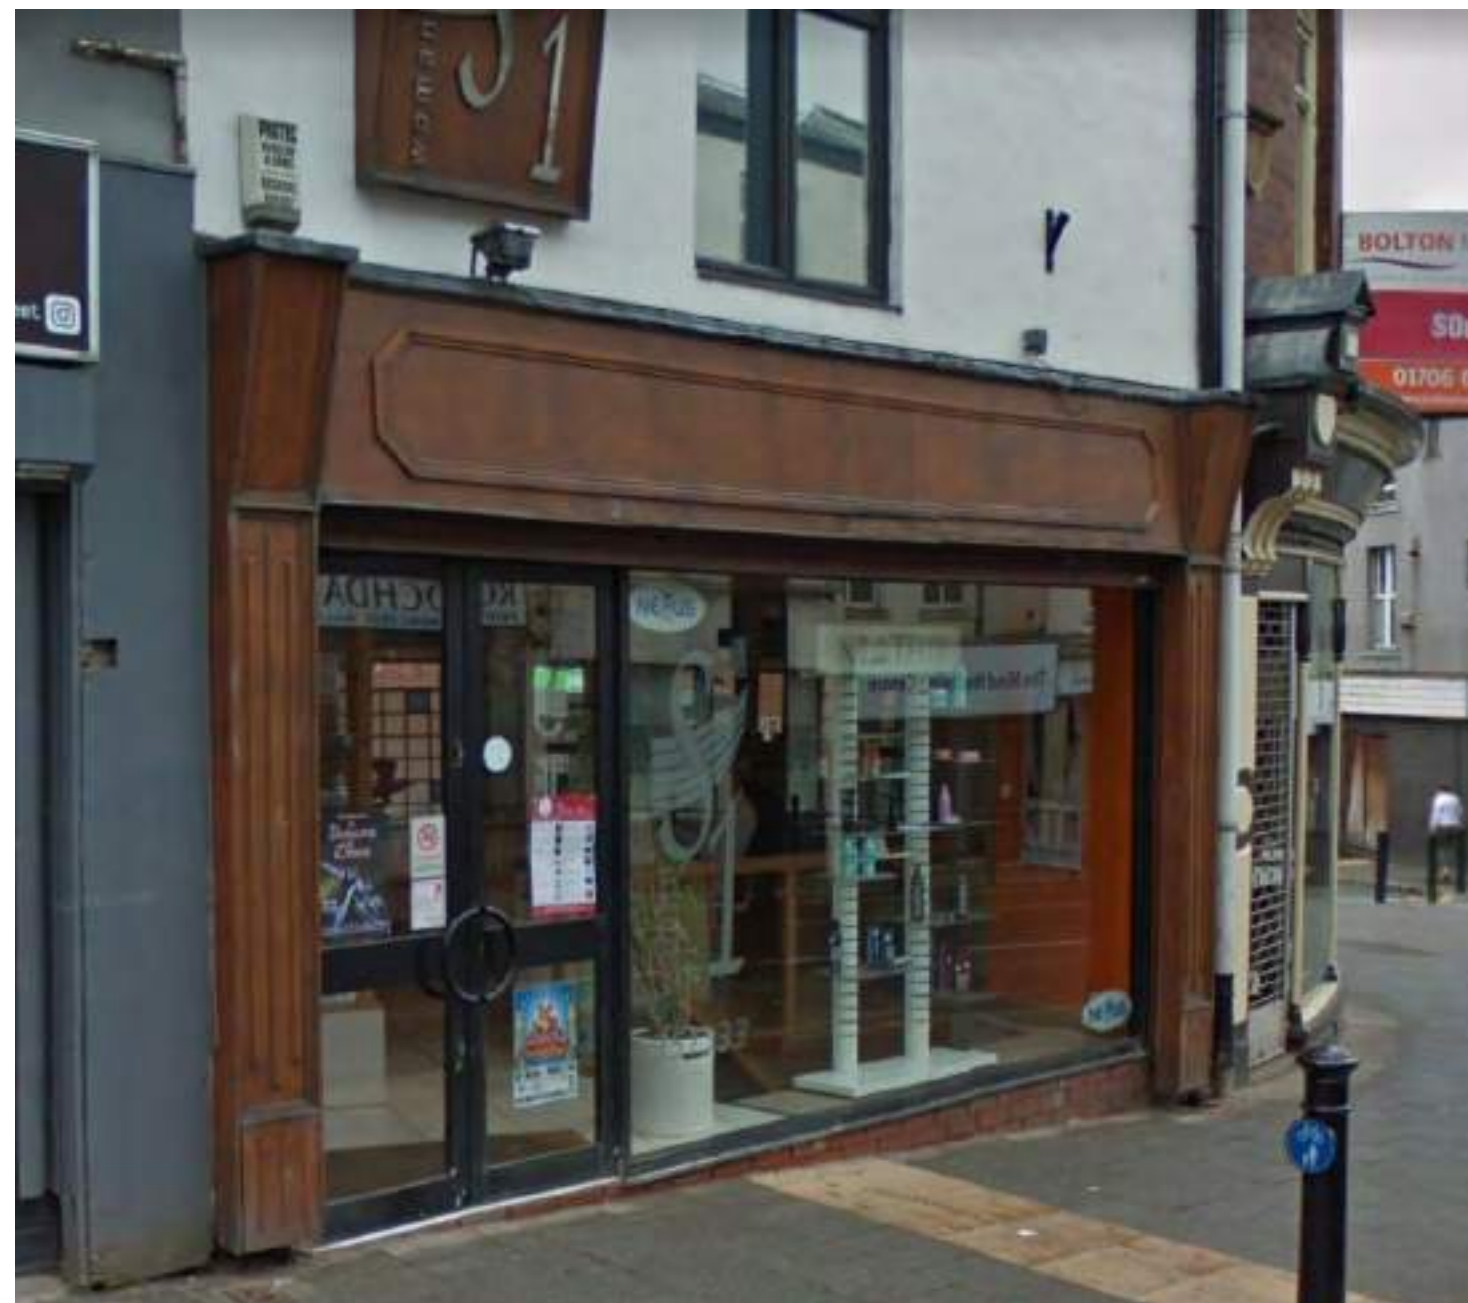
Figure 21: 16 Drake Street, showing a modern interpretation of a traditional shopfront, utilising timber fascia, plasters and corbels, inset with large unsympathetic aluminium-framed glass panes and door. (Source: Google 2018).

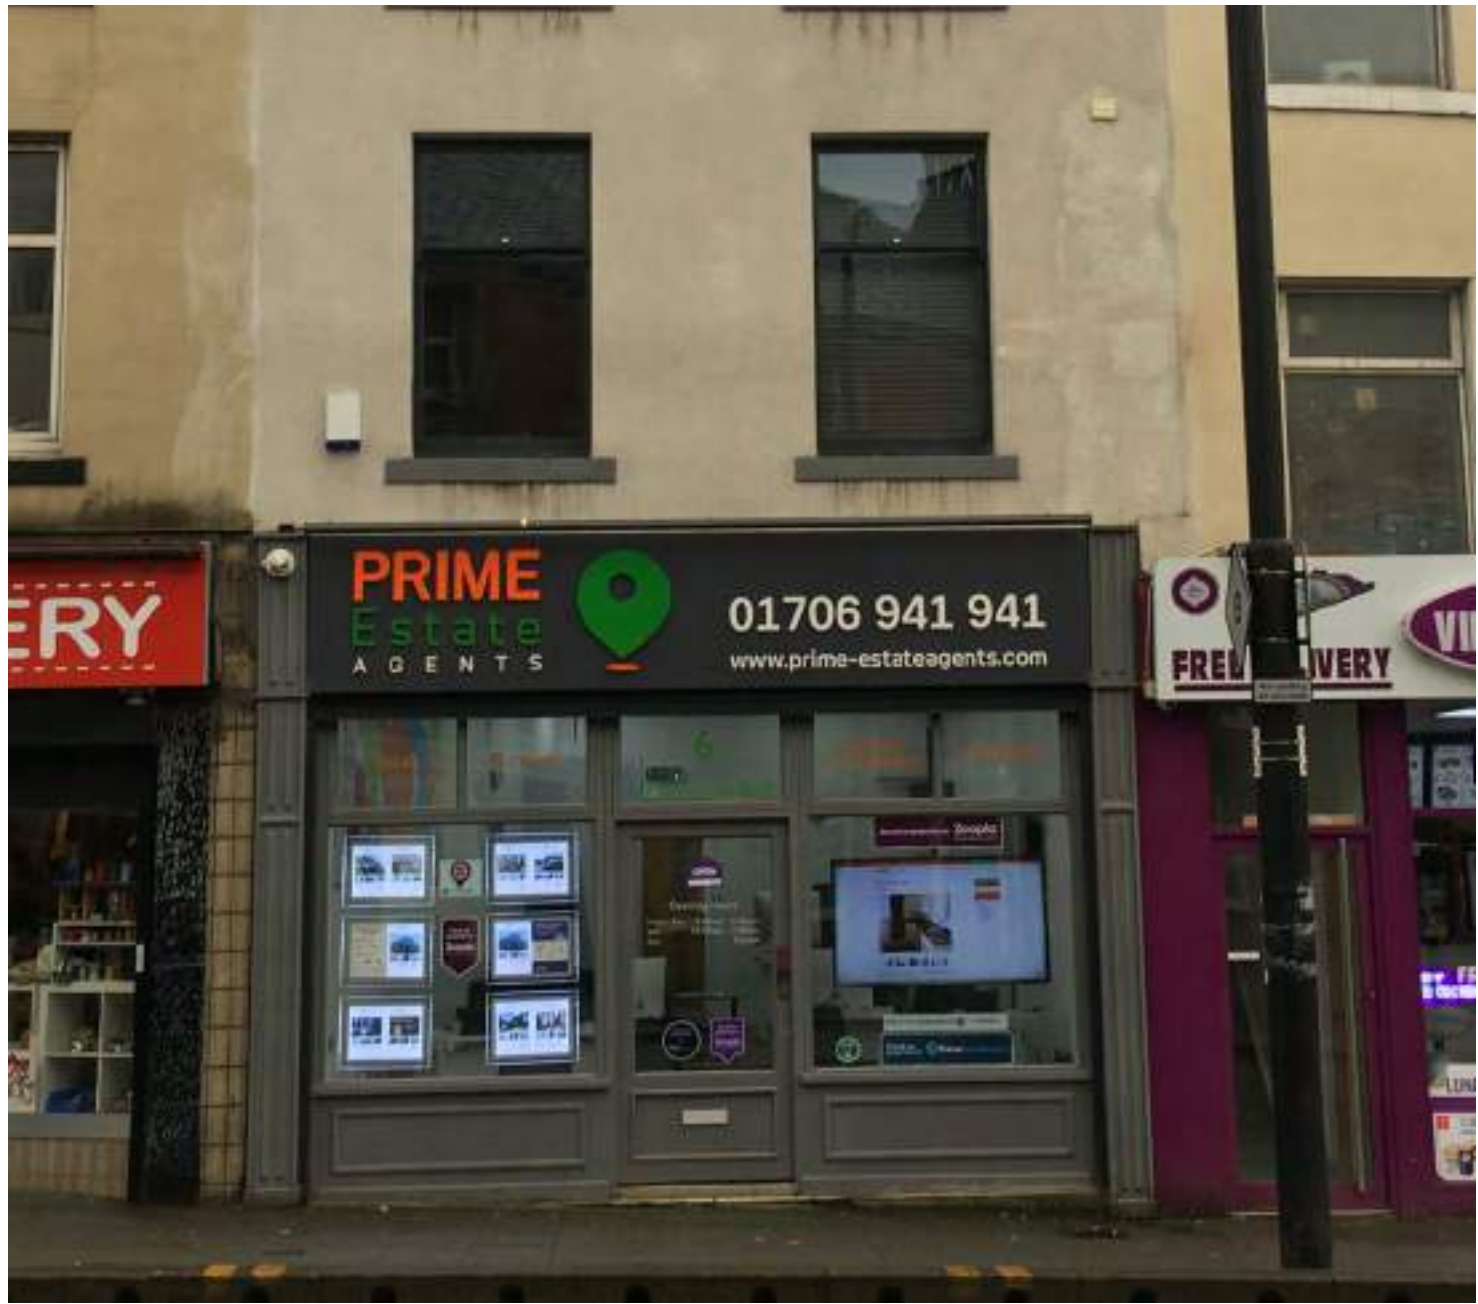
Figure 22: 6 Drake Street, showing the traditional style shopfront installed in 2018, utilising timber and good proportions and elements of a traditional shopfront, including: timber mullions separating the glass panes; a central door with a fanlight above; panelled stallrisers with cills; transom lights above the windows and doors; and decorative pilasters. (Source: Purcell 2019).

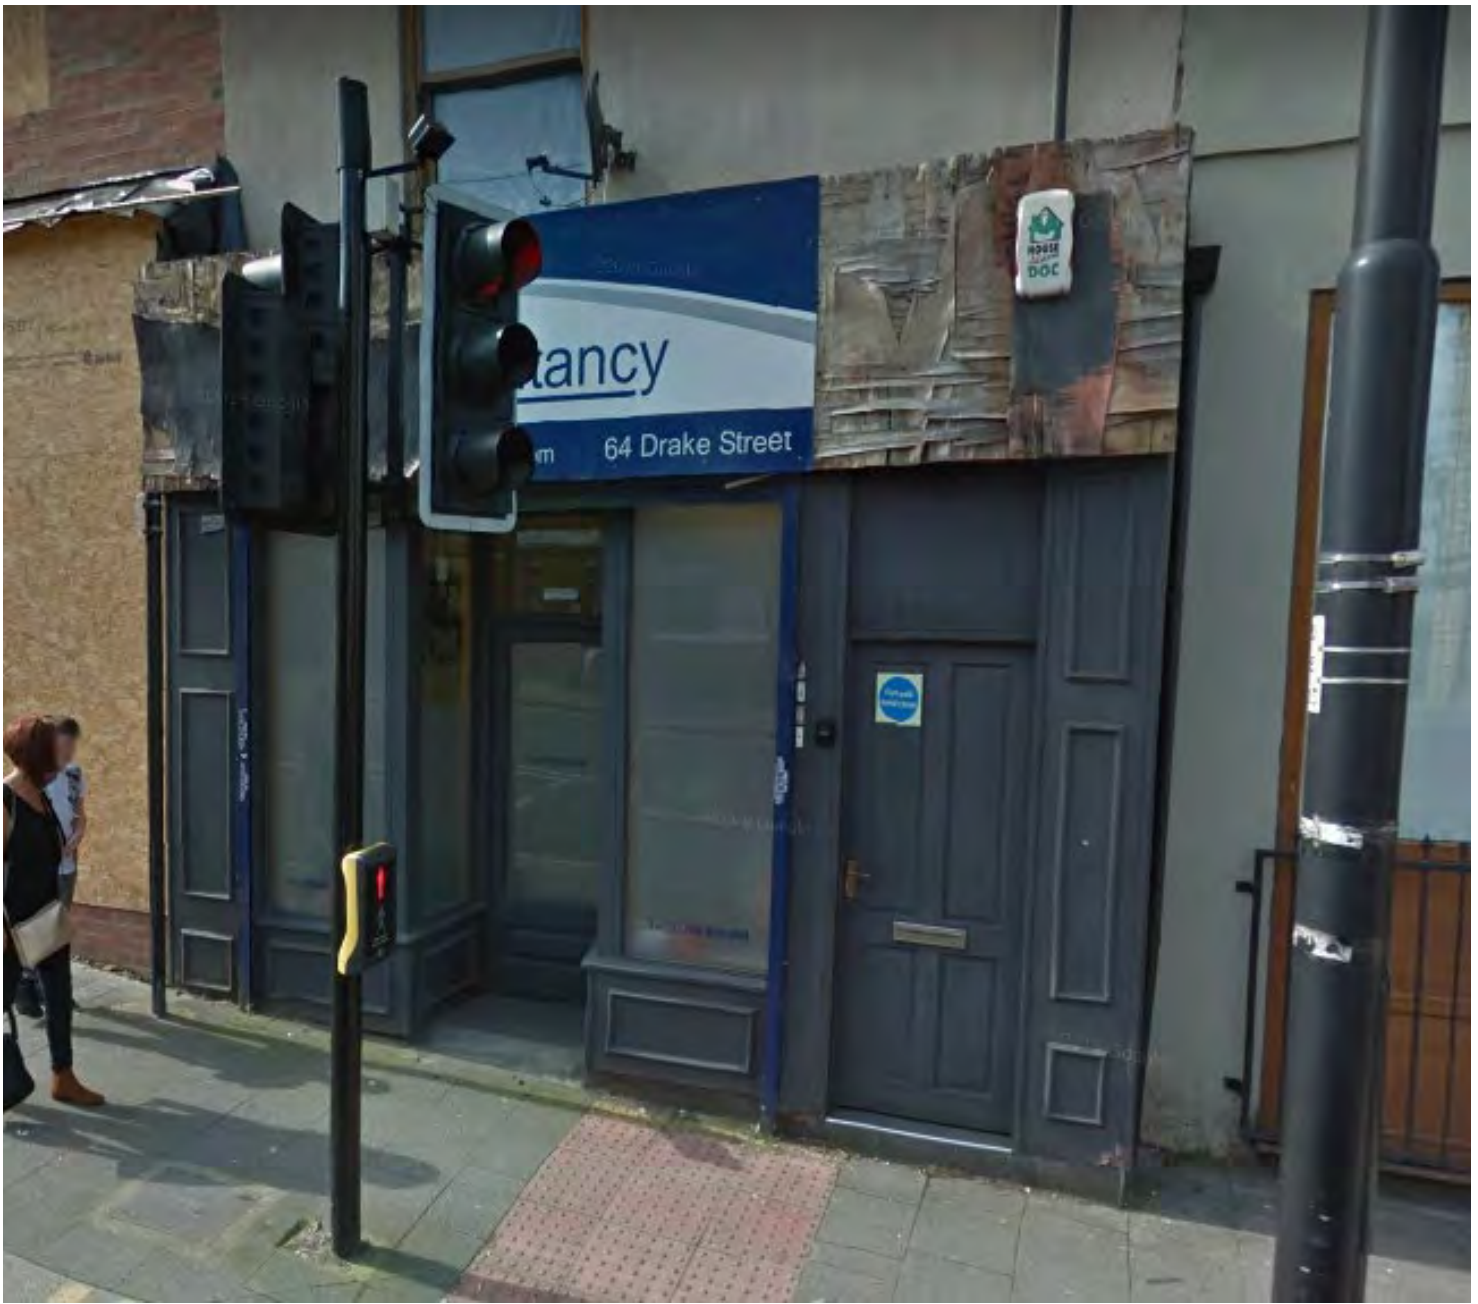
Figure 23: 64 Drake Street, showing a modern interpretation of a historic shopfront, with timber panelled pilasters and stallrisers, a recessed entrance and a timber-framed door with a fanlight above, but with an unsympathetic deep fascia made from poor materials and frosted glass panes (Source: Google 2018).

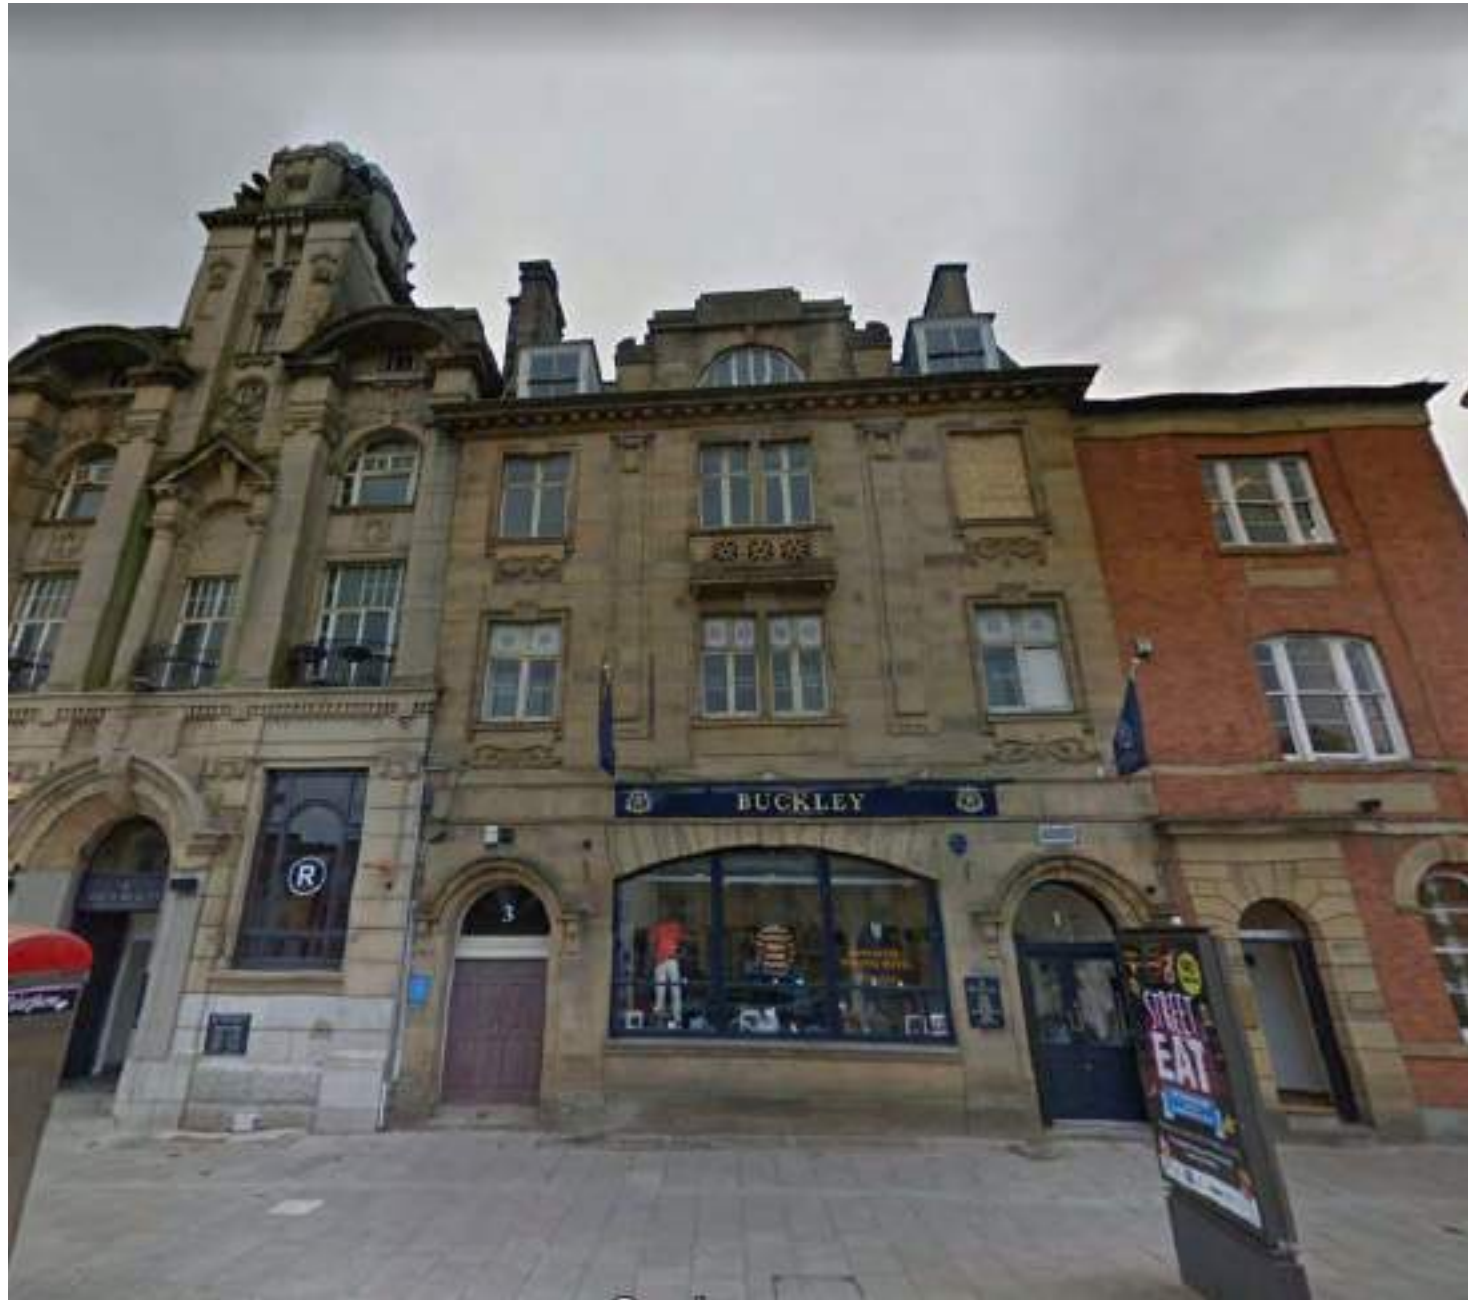
Figure 24: 1-5 South Parade, showing the retained early 20th century shopfronts (Source: Google 2019).

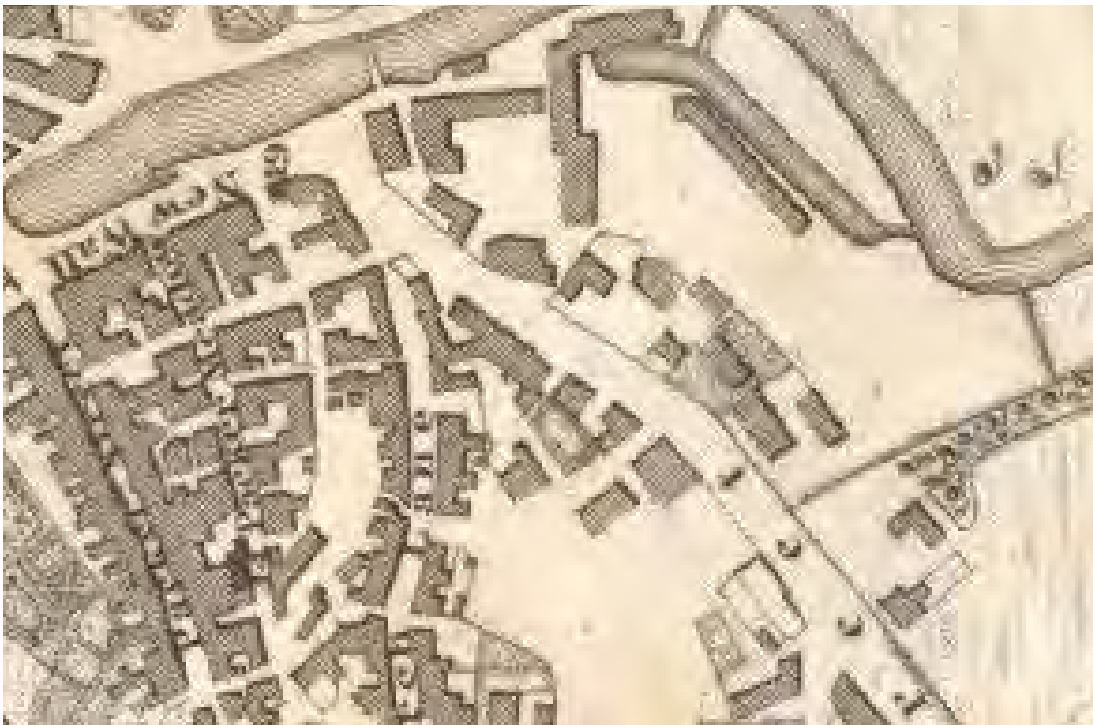
Figure 2: The W. Wales & Co 1825 plan of Rochdale in Baines 1825, surveyed in 1824 by William Swire, OS Town Plan of Rochdale showing the majority of properties at the corner of Drake Street and South Parade to have already been occupied by buildings by this time, whilst 55 Drake Street comprised what appears to have been a section of a set-back terrace (Source: Historic England 2019, 23).

A building at 7 South Parade appears to have originally been constructed as two connected properties prior to 1825 based on historical map evidence (Figure 2). At this time, 7 South Parade and the buildings to the rear of the site (now 3 King Street) appear to have been made up of a number of different properties (Figure 2 and Figure 3). By 1851, the rear buildings (now 3 King Street) appear to have been rebuilt and the eastern portion of the front building was used as the Robin Hood Public House, but this is likely to have moved to the adjacent 8 South Parade not long after this map was created (Figure 4). A bank utilised the rear buildings from 1892 and the Palatine Bank leased two of the shops from 1907<sup>01</sup>. The latter commissioned the architect, M. Wolstenhulme, to redesign the buildings for use by the Palatine Bank, leading to the construction of the existing rock-faced elevations on both the front and rear buildings, as well as internal alterations, in c.1907<sup>02</sup>. This resulted in the creation of three separate entrances, one on South Parade and two on King Street, creating what are now designated 1 and 3 King Street and 7 South Parade. 1 King Street was located within the footprint of the three-storey structure of 7 South Parade, while 3 King Street was located within a separate two-storey building to the rear. The building continued to be used as a bank following the amalgamation of the Palatine Bank with the Bank of Liverpool and Martins in 1919, but was taken over by the Burnley Building Society in 1935<sup>03</sup>. Following the Burnley Building Society's amalgamation into the National and Provincial Building Society in 1982, the building at 7 South Parade continued to be used for this purpose until c.1991<sup>04</sup>. In c.1991, Atherton Standring Taylor Solicitors (previously Standring Taylor Solicitors), which had occupied 1 King Street within this building since before 1968, took over both 7 South Parade and 1 King Street, amalgamating the offices into one property<sup>05</sup>. 7 South Parade is still used by Atherton Standring Taylor Solicitors, now AST Hampsons, as a solicitors' office. The ground floor front was altered in 1984 to comprise the extant marble-clad façade<sup>06</sup>, but the fascia and signage has since been altered a number of times (Figure 30, Figure 31 and Figure 32), with the most recent changes comprising the installation of roller shutters and shutter boxes over the door and window on the front façade (Figure 31).

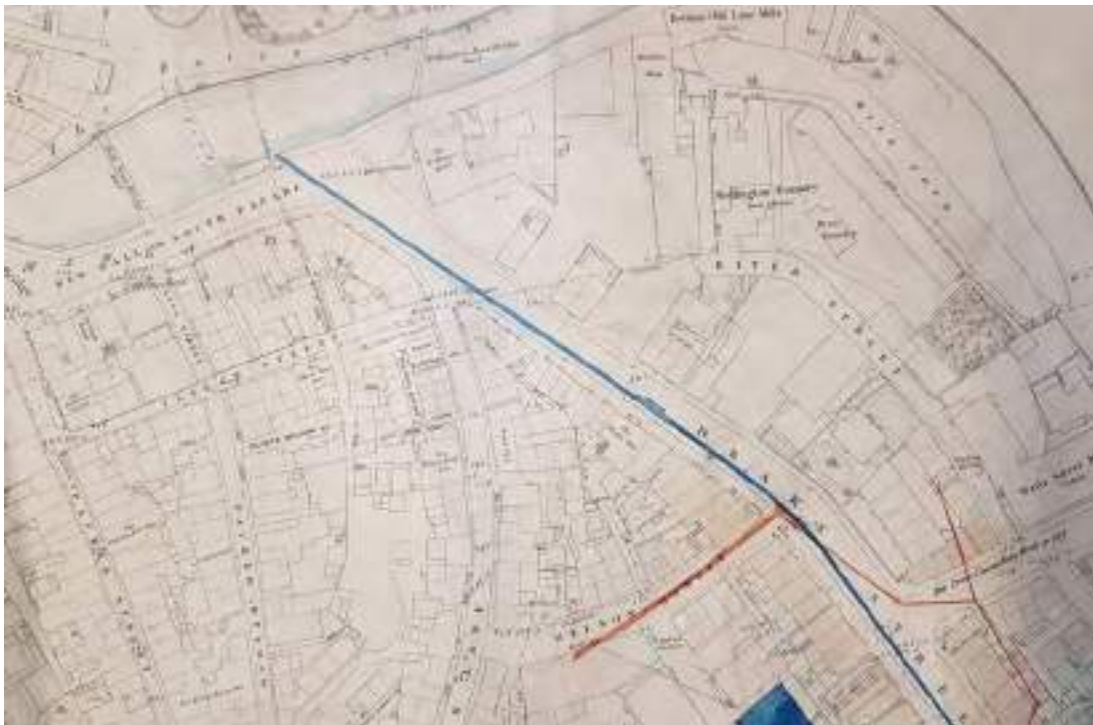
Figure 4: The 1851 OS Town Plan of Rochdale showing few changes to the properties at the corner of Drake Street and South Parade, whilst 55 Drake Street still comprised a section of a set-back terrace building with what appears to be a front garden wall (Source: TR R20).

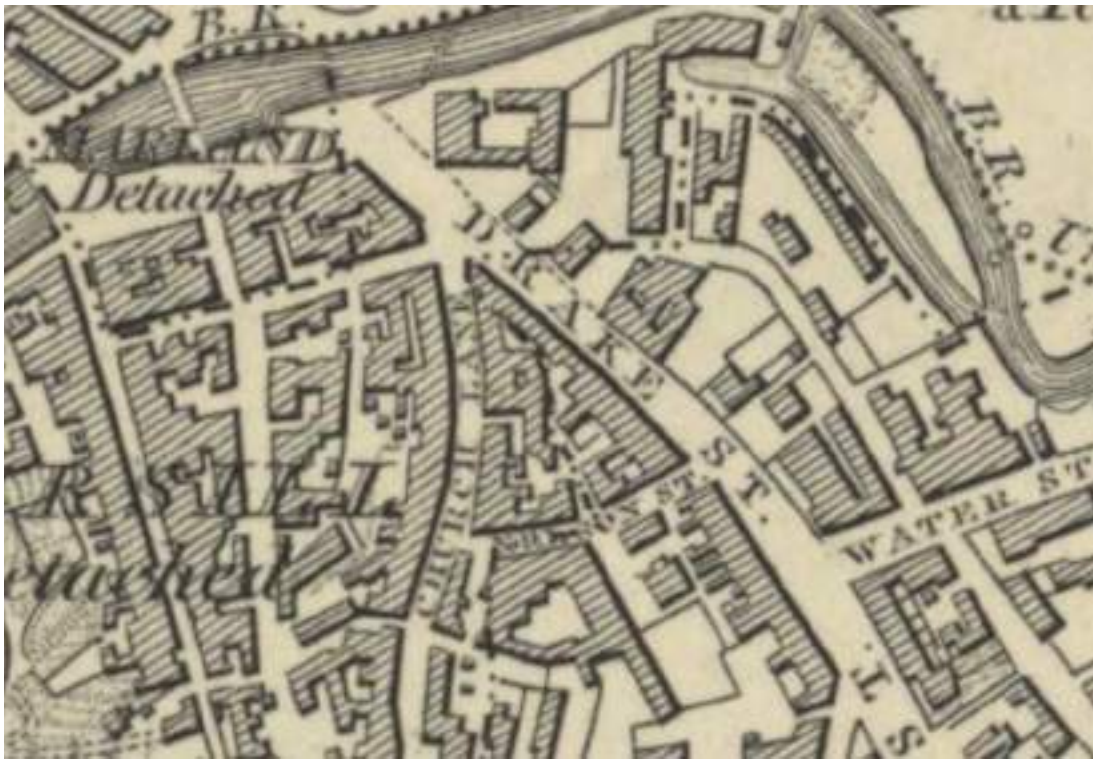
Figure 5: The 1851 OS map (surveyed 1844-1848), showing the properties at the corner of Drake Street and South Parade to have already been built by this time, whilst a previous building at 55 Drake Street was also extant (Source: NLS 2019a).

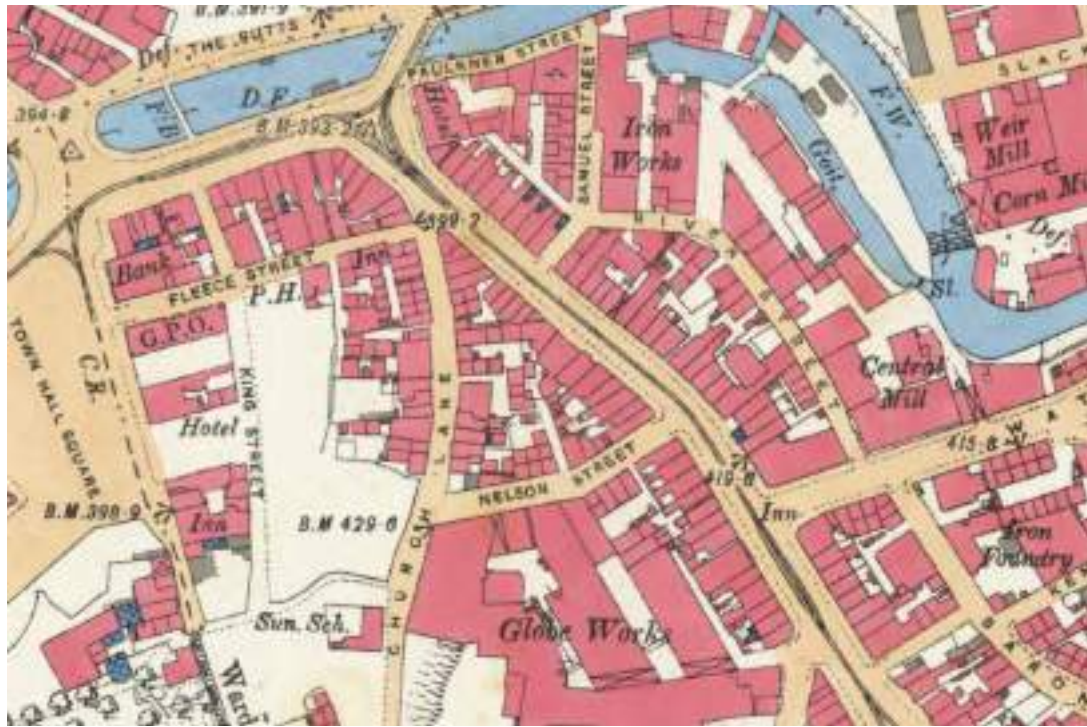
Figure 6: The 1893 OS Map (surveyed 1890-1891) showing the infilling of the vacant areas along the north-eastern side of Drake Street and the reconstruction, or at least the extension of the front of 55 Drake Street, to be in line with the adjoining properties (Source: NLS 2019b).]
