ROCHDALE HERITAGE ACTION ZONE – DRAKE STREET & SOUTH PARADE

ROCHDALE BOROUGH COUNCIL

HERITAGE STATEMENT AND PROPOSALS

DECEMBER 2019

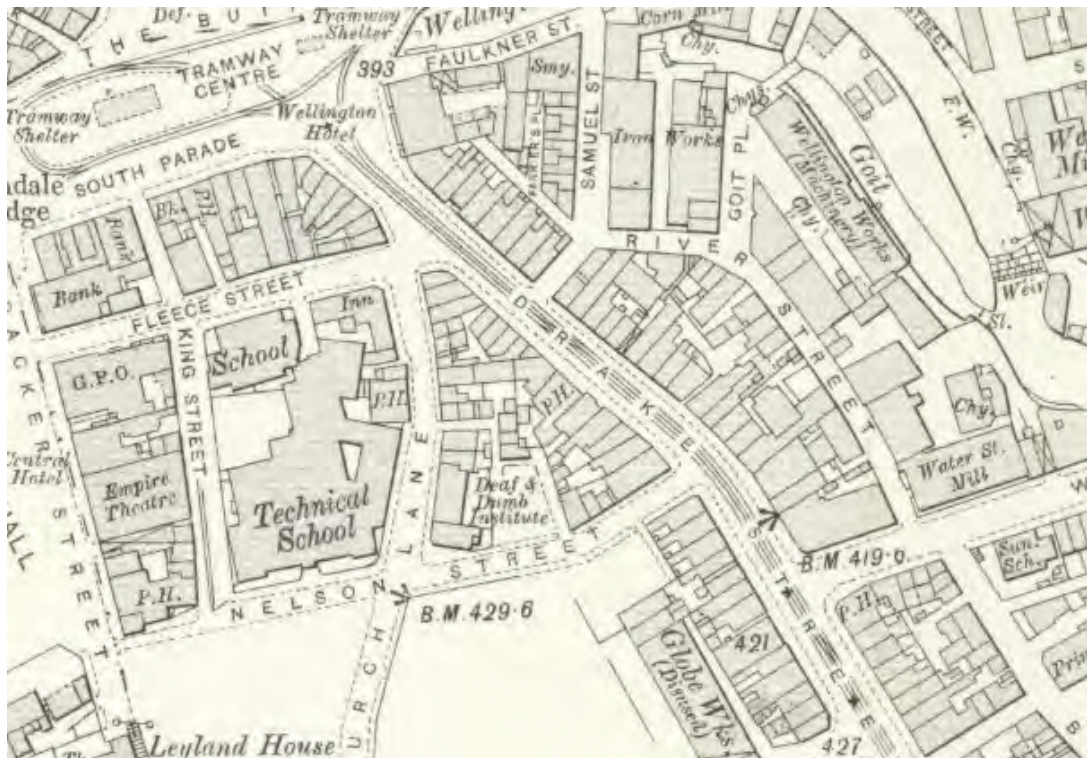
Figure 7: The 1910 OS Map (revised 1908), showing the internal rearrangement of 12 South Parade for the bank and the use of 11 South Parade as a public house (Source: NLS 2019c).]

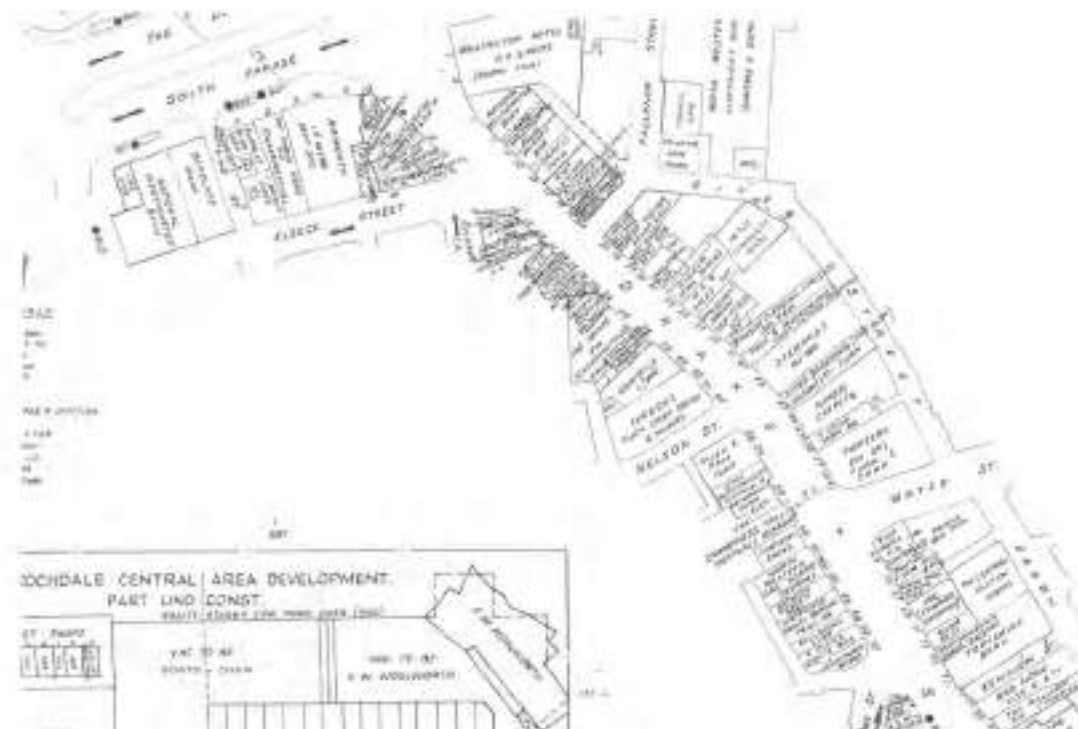
Figure 10: The 1968 Goad Plan (revised 1976) showing no apparent changes in the overall footprint of the properties, but showing the details of the uses of the shops and the expansion of Haworth Department Store into 9-12 South Parade (Source: TR S258a).]

A building at 8 South Parade appears to have originally been constructed prior to 1825 based on the map progression (Figure 11). Photographs from the early 20th century show 8 South Parade to have been used as the Robin Hood Hotel, comprising a three-bayed three-storey Georgian terraced building with exposed brickwork, timber framed double-hung sash windows and a slate tiled roof (Figure 33). The building had a central doorway in the middle bay of the ground floor with a decorative cornice over the lintel and no windows on the first and second floors in the middle bay (Figure 33). An advertising board was located above the doorway in the middle bay of the first floor and a timber parapet advertising its use as the Robin Hood Hotel was located at the top of the second storey (Figure 33). By c.1914, windows had been inserted into the central bay (Figure 34). In the c.1915-20, the façade of the building appears to have been re-faced or rebuilt, with exposed stretcher bonded brickwork and c.1915-20 multi-paned sash windows with leadlight upper sashes on the first floor windows (Figure 35 and Figure 36). By the 1960s, the façade was painted and windows on the second floor and the lower sashes of the first-floor windows were replaced with hinged casement windows (Figure 36). At this time, the shopfront was also replaced with a 1960s century frontage with a deep fascia and large windows, which was further altered in the 1970s (Figure 36, Figure 37 and Figure 38). By 1984, the Robin Hood Hotel had become Flicks Public House (Figure 20)<sup>01</sup>. In 1994, a new shopfront was installed for Flicks Public House, but this was replaced with the existing timber-panelled shopfront under the new name of The Revolution (Figure 39)<sup>02</sup>. After a number of years of vacancy, the shop became a Food Bank in c.2018.

A building at 11 South Parade appears to have originally been constructed after 1825 but prior to 1844, based on the map progression (Figure 11 and Figure 12). 11 South Parade appears to have been constructed as a three-storey late Georgian or early Victorian terraced house comprising two bays along South Parade with Flemish brick bonding, timber-framed sashed windows and a slate tiled roof (Figure 55). It was constructed following the adjoining terraced buildings, effectively filling a former street running between 9-10 and 12 South Parade (Figure 11, Figure 12 and Figure 55). The ground floor of 11 South Parade was converted into a symmetrical shopfront on South Parade prior to c.1855, demonstrating a mid-late 19th century shopfront with long thin timber-framed windows, low stallrisers and a narrow fascia with a thin cornice and a separate timber sign above (Figure 55). The building became the Temperance Hotel prior to c.1910, during the conversion of which it is likely that the eight-over-eight windows on the first and second floors were replaced with two-over-two light timber sashed windows (Figure 56 and Figure 57). By 1920, the building was used as the Broadway Café, but was sold to Mr C.T. Haworth in 1924/5 (Figure 57). The ground floor shopfront along South Parade was altered by c.1924-5 to include a deeper fascia for advertising Haworth Department Store which also utilised the ground floor of the adjoining 12 South Parade (Figure 58). Likely during the 1920s or 1930s, the sashed windows on the first floor of both 11 and 12 South Parade were replaced with larger windows with a timber-panelled surround and cornice above, indicating the use of both of these properties for Haworth (Figure 59, Figure 60). The shopfronts at 11 and 12 South Parade had been replaced with a continuous shopfront across these properties for Haworth by the 1950s, including an inclined fascia and large panes of glass (Figure 59 and Figure 60). This configuration of the shopfront was duplicated at 9-10 South Parade due to Haworth Department Store utilising 9 to 12 South Parade at this time. By 1968, Haworth Ladies and Menswear Department Store, the ground floor shopfront was altered again to include a box-shaped continuous awning and larger windows across 9 to 12 South Parade, while the windows on the first floor were replaced with aluminium-framed windows (Figure 62, Figure 63 and Figure 64). However, by 1985-6, 9-10, 11 and 12 had been reconverted into separate properties with new shopfronts, with 11 South Parade converted into a KFC takeaway and restaurant in 1984<sup>01</sup>, in accordance with the dwindling patronage of Drake Street and South Parade as a shopping destination (Figure 21). Since the late 20th century of early 21st century, 11 South Parade has been a privately-owned fried chicken restaurant of various names, with a new shopfront installed in 2018 (Figure 22, Figure 54 and Figure 66)<sup>02</sup>.

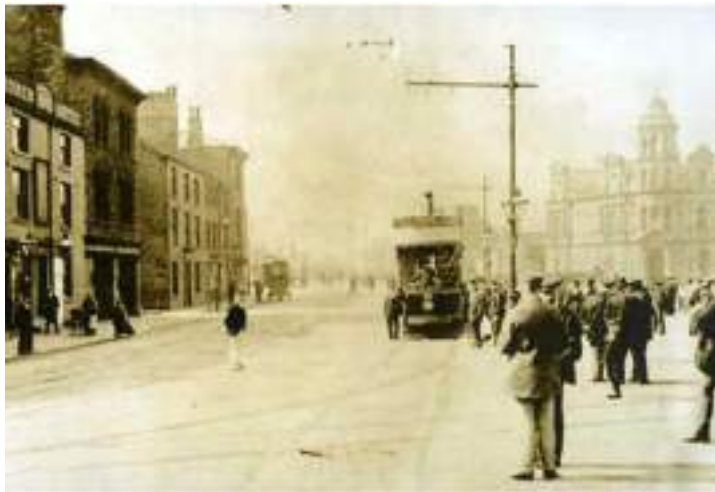
Figure 25: A historical photograph of 7 South Parade, c.1910, showing a three-storey two-bayed stone-faced building with double-windows on the first to second floors, a deep cornice above and what appears to be a timber-framed fascia and cornice above stone pilasters (Source: Rochdale Local Studies c.1910a).

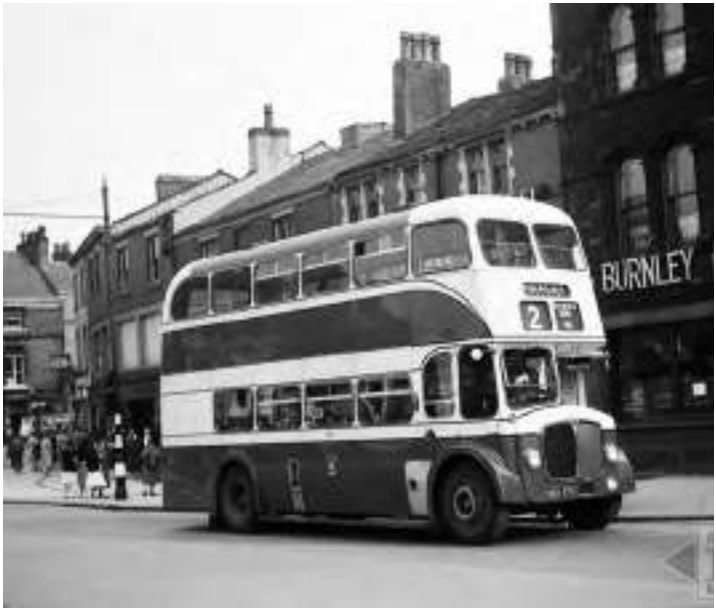
Figure 27: A c.1957 photograph of South Parade, showing the shopfront at 7 South Parade replaced with an early 20th century asymmetrical frontage with a stone fascia and cornice, tall stone and timber stallrisers, large timber-framed windows and a sign above the cornice (Source: Museum of Transport Greater Manchester c.1957).

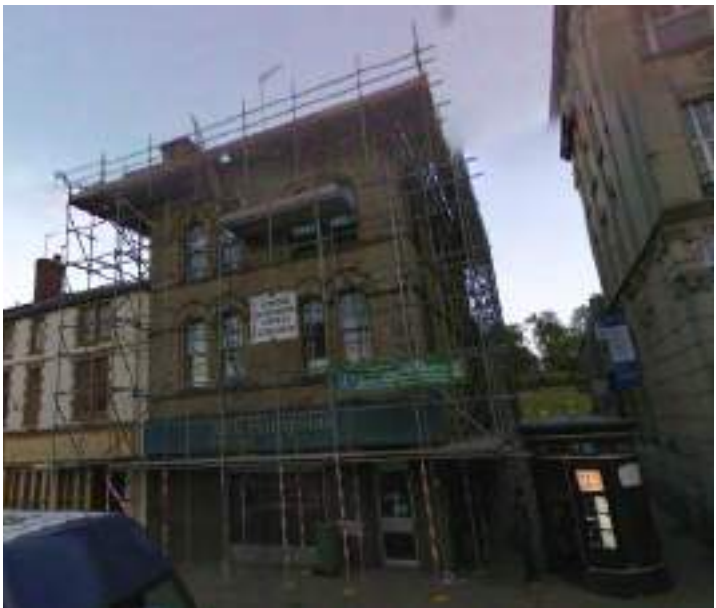
Figure 29: A 2008 Google Street View image of the front façade of 7 South Parade, showing the extant marble-clad shopfront and the earlier fascia signage (Source: Google 2008).

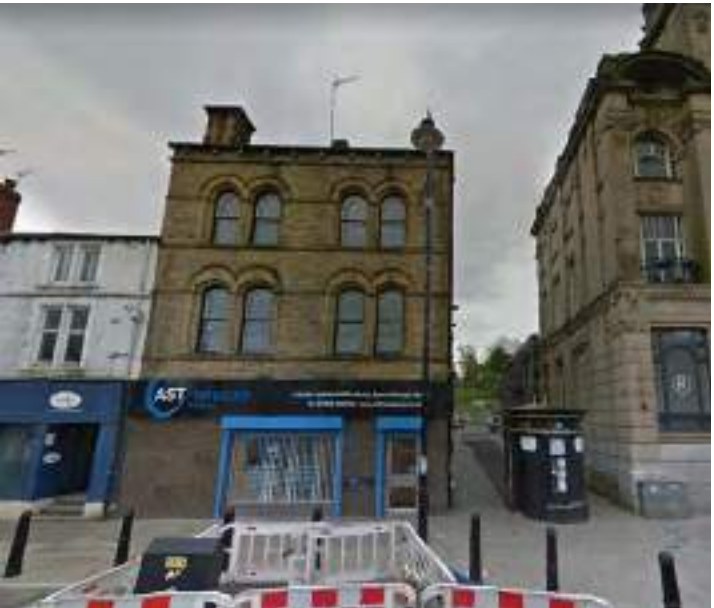
Figure 31: A 2019 Google Street View image of the front façade of 7 South Parade, showing the extant marble-clad shopfront, the existing fascia signage installed in 2017 and the roller shutter boxes installed in 2019 (Source: Google 2019).

A building at 7 South Parade appears to have originally been constructed as two connected properties prior to 1825 based on historical map evidence (Figure 2). At this time, 7 South Parade and the buildings to the rear of the site (now 3 King Street) appear to have been made up of a number of different properties (Figure 2 and Figure 3). By 1851, the rear buildings (now 3 King Street) appear to have been rebuilt and the eastern portion of the front building was used as the Robin Hood Public House, but this is likely to have moved to the adjacent 8 South Parade not long after this map was created (Figure 4). A bank utilised the rear buildings from 1892 and the Palatine Bank leased two of the shops from 1907<sup>01</sup>. The latter commissioned the architect, M. Wolstenhulme, to redesign the buildings for use by the Palatine Bank, leading to the construction of the existing rock-faced elevations on both the front and rear buildings, as well as internal alterations, in c.1907<sup>02</sup>. This resulted in the creation of three separate entrances, one on South Parade and two on King Street, creating what are now designated 1 and 3 King Street and 7 South Parade. 1 King Street was located within the footprint of the three-storey structure of 7 South Parade, while 3 King Street was located within a separate two-storey building to the rear. The building continued to be used as a bank following the amalgamation of the Palatine Bank with the Bank of Liverpool and Martins in 1919, but was taken over by the Burnley Building Society in 1935<sup>03</sup>. Following the Burnley Building Society's amalgamation into the National and Provincial Building Society in 1982, the building at 7 South Parade continued to be used for this purpose until c.1991<sup>04</sup>. In c.1991, Atherton Standring Taylor Solicitors (previously Standring Taylor Solicitors), which had occupied 1 King Street within this building since before 1968, took over both 7 South Parade and 1 King Street, amalgamating the offices into one property<sup>05</sup>. 7 South Parade is still used by Atherton Standring Taylor Solicitors, now AST Hampsons, as a solicitors' office. The ground floor front was altered in 1984 to comprise the extant marble-clad façade<sup>06</sup>, but the fascia and signage has since been altered a number of times (Figure 30, Figure 31 and Figure 32), with the most recent changes comprising the installation of roller shutters and shutter boxes over the door and window on the front façade (Figure 31).

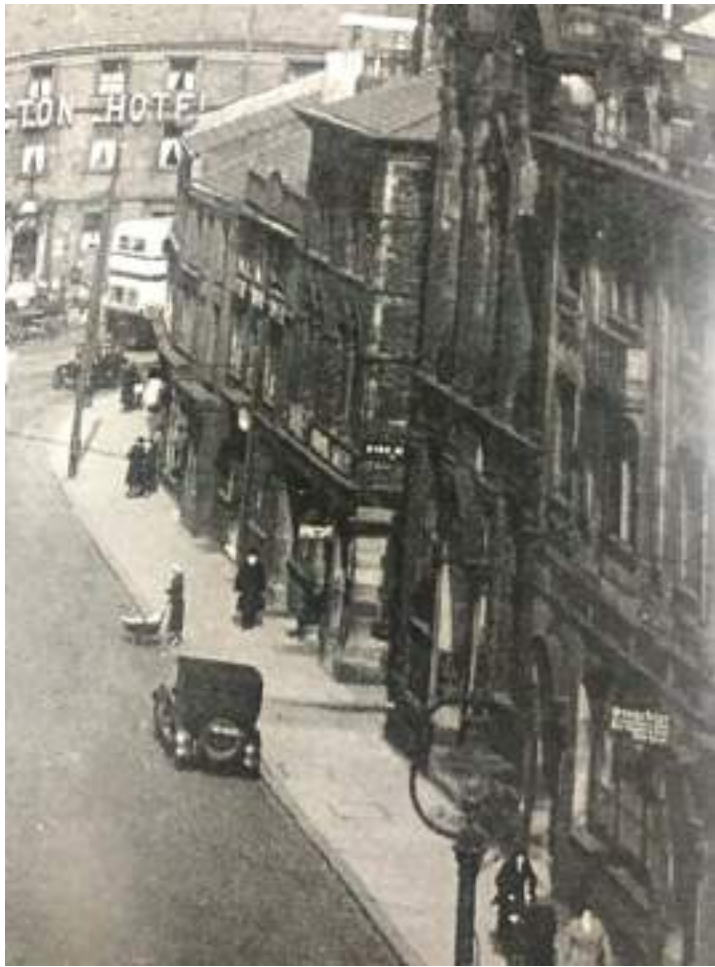
Figure 27: A historical photograph of 7 South Parade, c.1914, showing the earlier stone-faced frontage of the ground floor front elevation (Source: Rochdale Local Studies).

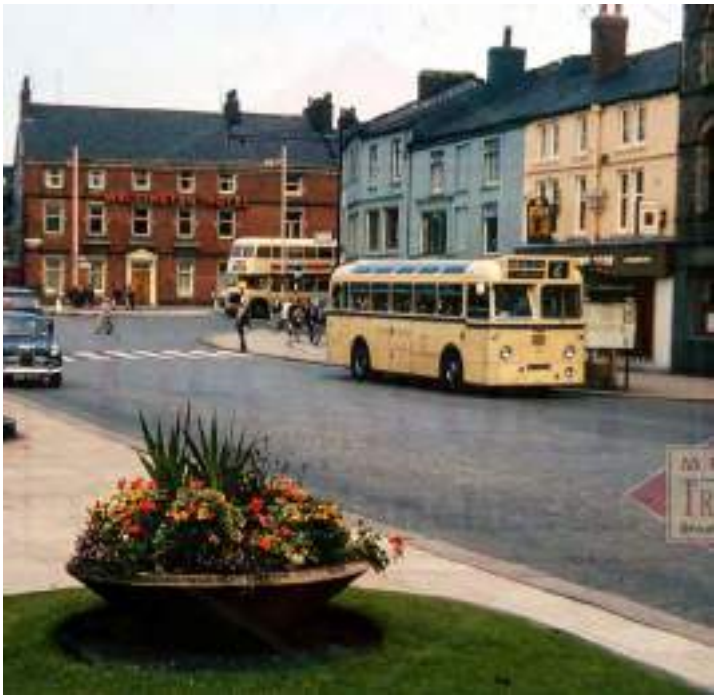
Figure 28: A 1960s photograph of South Parade, showing the shopfront at 7 South Parade replaced with a mid-20th century asymmetrical frontage with a deep fascia, wide panelling and recessed windows and doors (Source: Museum of Transport Greater Manchester c.1960).

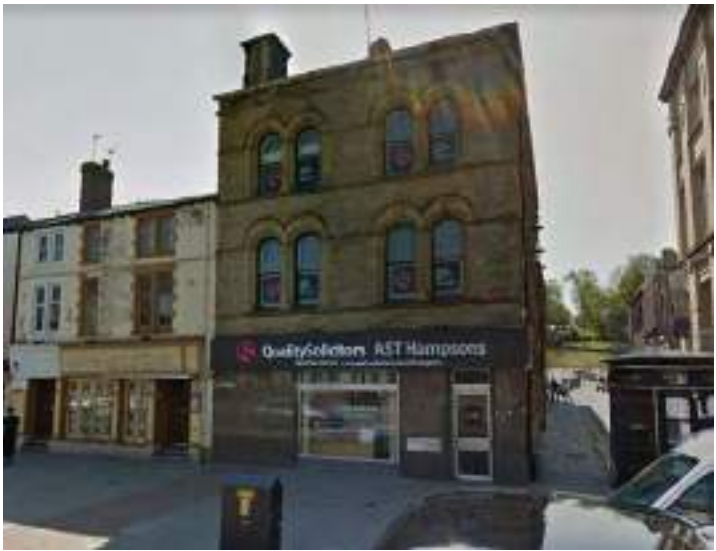
Figure 30: A 2012 Google Street View image of the front façade of 7 South Parade, showing the extant marble-clad shopfront and an earlier fascia signage (Source: Google 2012).

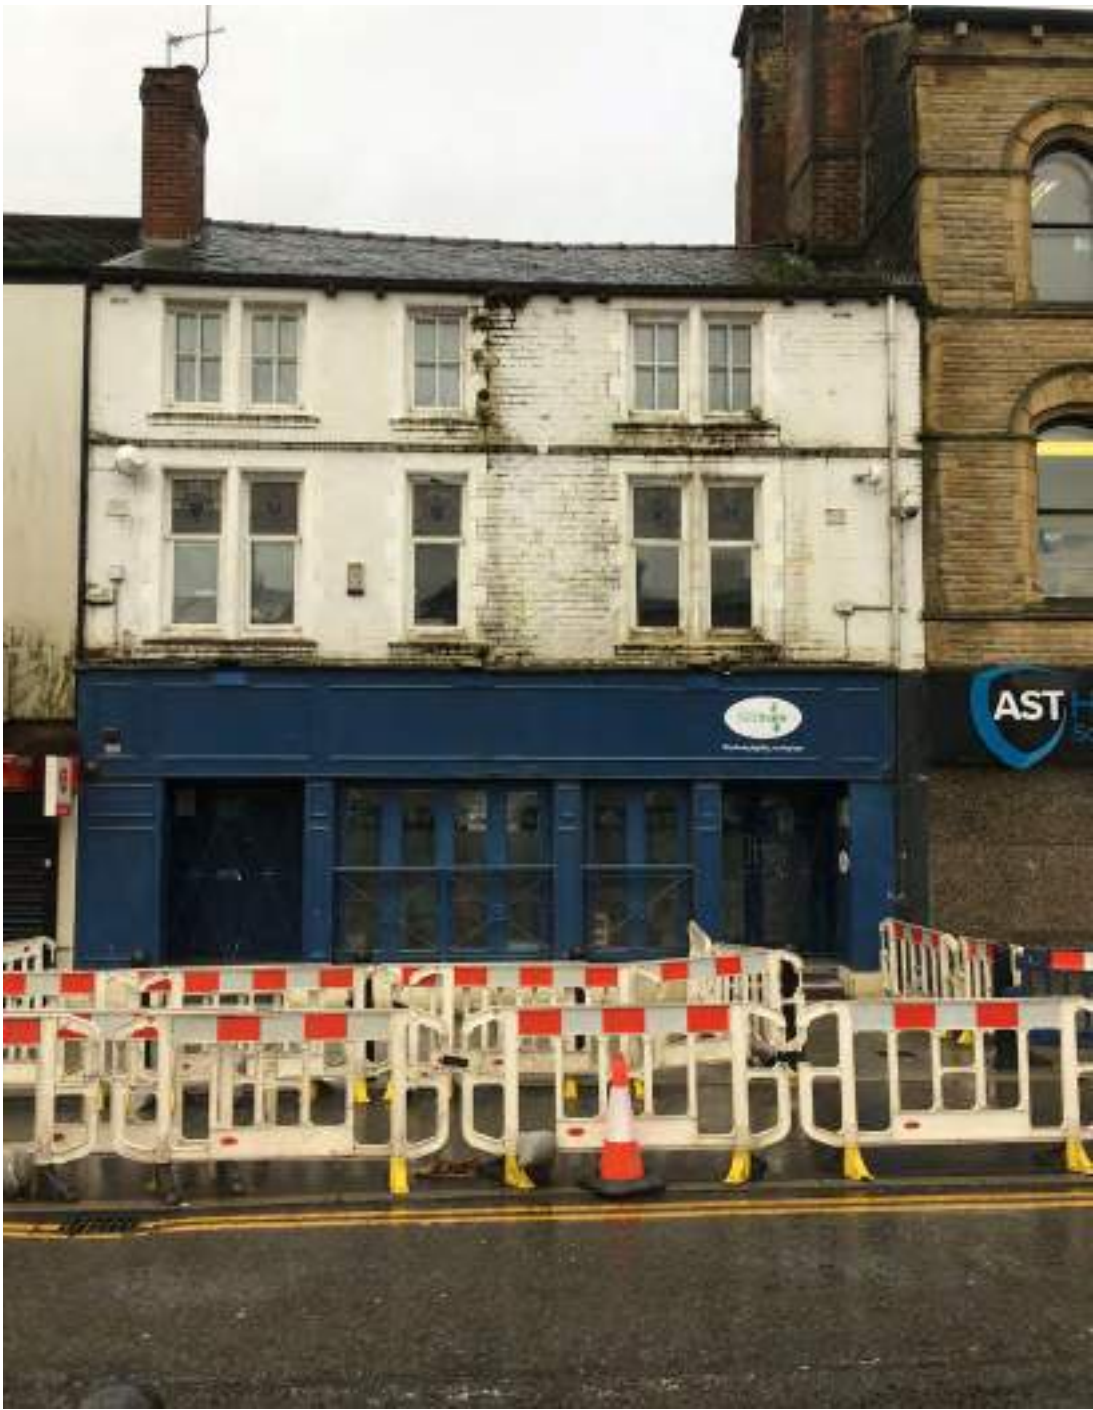
Figure 32: A current photograph of 8 South Parade (Source: Purcell 2019)

- The surface staining and vegetation growth on the front elevation, which has been likely caused by a combination of inadequate cleaning of the gutters, corrosion of the gutter and insufficient waterproofing between the connection between the gutter and the wall.

- The lintels of the windows on the first and second storeys appear to be in poor condition.
- The paintwork obscures the detail and brickwork on the first and second storeys of the front elevation and is also in poor condition.

- The white-painted pebble-finish to the plinth at the base of the wall is inappropriate.
- The vents on the first and second floor elevations.
- The lower sashes of the windows on the first floor have been replaced with inappropriate hinged casements.

The following detrimental features should be removed and replaced with more sympathetic counterparts in the new shopfront design:

- The poorly made c.1960s century hinged casement windows with reflective glazing in the first-floor windows.
- The c.1960s four-light timber casement windows on the second-floor elevation, which replaced earlier sashed windows.

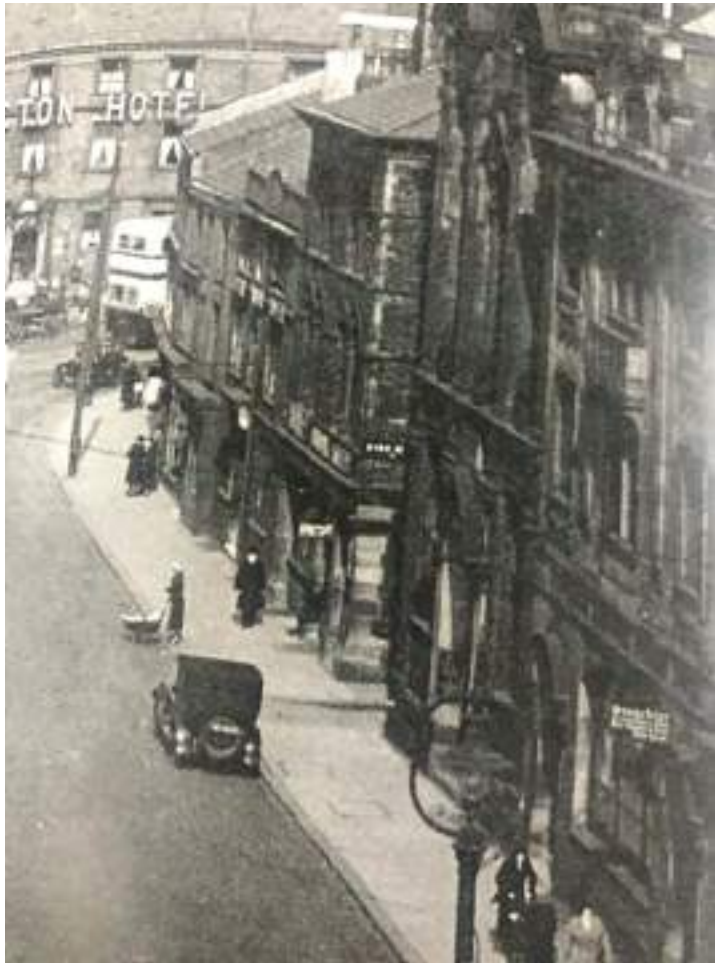
Figure 34: A historical photograph of 8 South Parade, c.1914, showing a central entrance into the ground floor front elevation with flanking windows. By this time, windows had been inserted into the central bay (Source: Rochdale Local Studies).

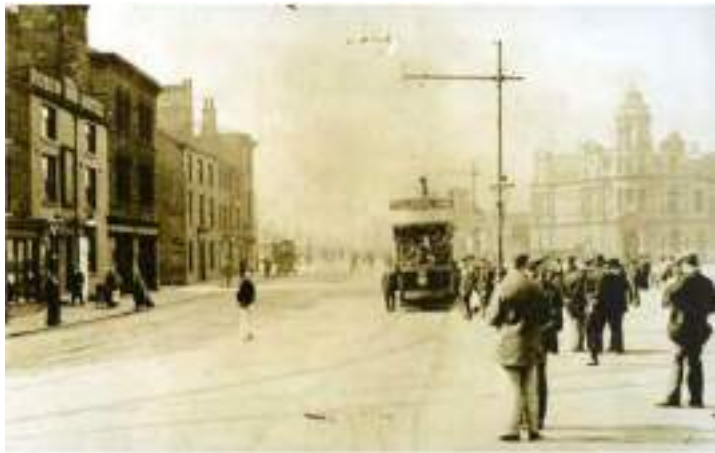
Figure 33: A historical photograph of 8 South Parade, c.1910, showing a three-storey two-bayed Georgian pub, known as the Robin Hood Hotel, with a central entrance on the ground floor front elevation with timber double-hung sashed windows on the ground to second floors, a timber parapet above the second floor and a central board fixed to the centre of the elevation (Source: Rochdale Local Studies c.1910a).

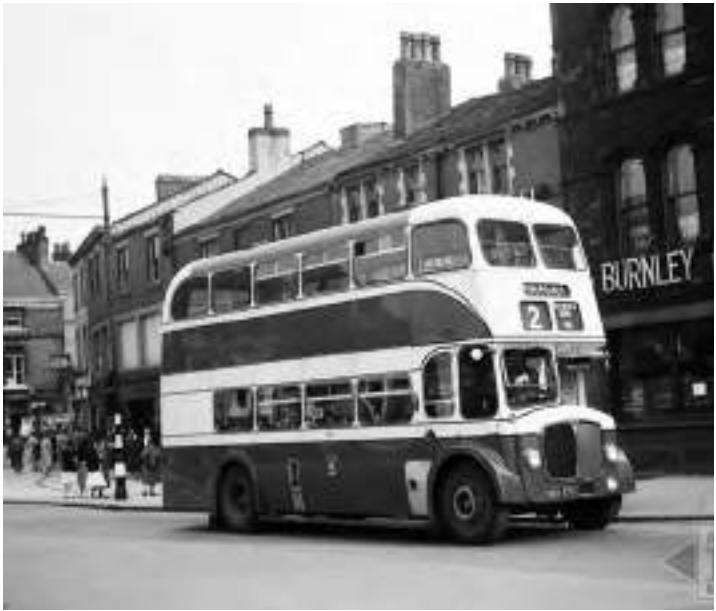
Figure 35: A c.1957 photograph of South Parade, showing the re-faced, or perhaps rebuilt, three-bayed front elevation at 8 South Parade replaced with stretcher bonded brickwork and c.1915-20 multi-paned sash windows with leadlight upper sashes on the first floor (Source: Museum of Transport Greater Manchester c.1957).

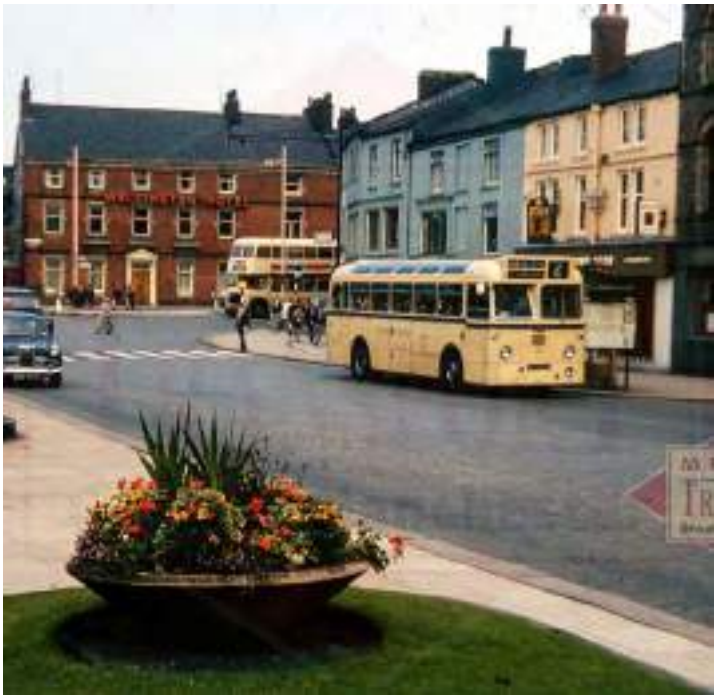
Figure 36: A 1960s photograph of South Parade, showing the shopfront at 8 South Parade replaced with a mid-20th century a frontage with a deep fascia and large windows, with the first and second floor elevation painted (Source: Museum of Transport Greater Manchester c.1960).

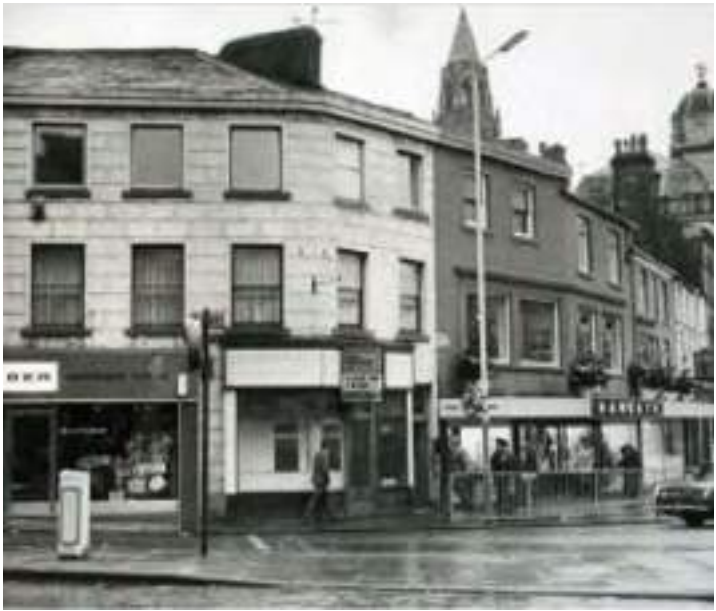
Figure 37: A c.1970s photograph of Drake Street and South Parade, showing 8 South Parade with a late-20th century shopfront, c.1930s windows and a hanging sign for the Robin Hood Public House (Source: Rochdale Local Studies c.1970a).

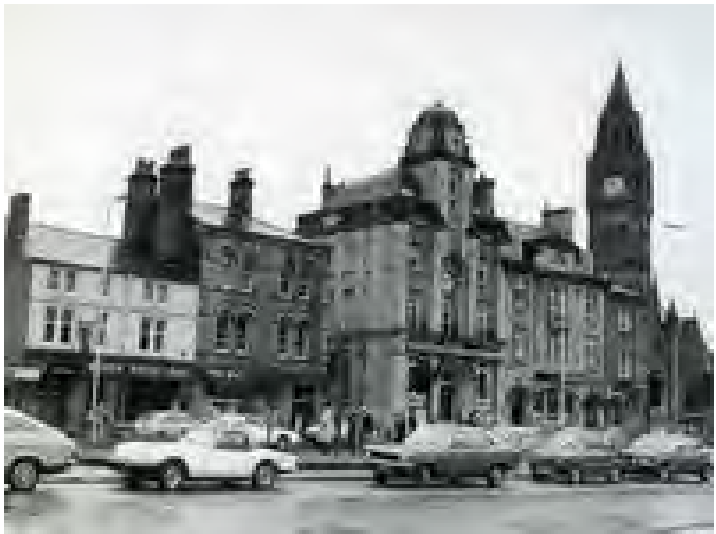
Figure 38: A c.1970s photograph of South Parade, showing 8 South Parade with the c.1930s windows and an asymmetrical shopfront with large recessed doors and a deep fascia (Source: Rochdale Local Studies c.1970b).

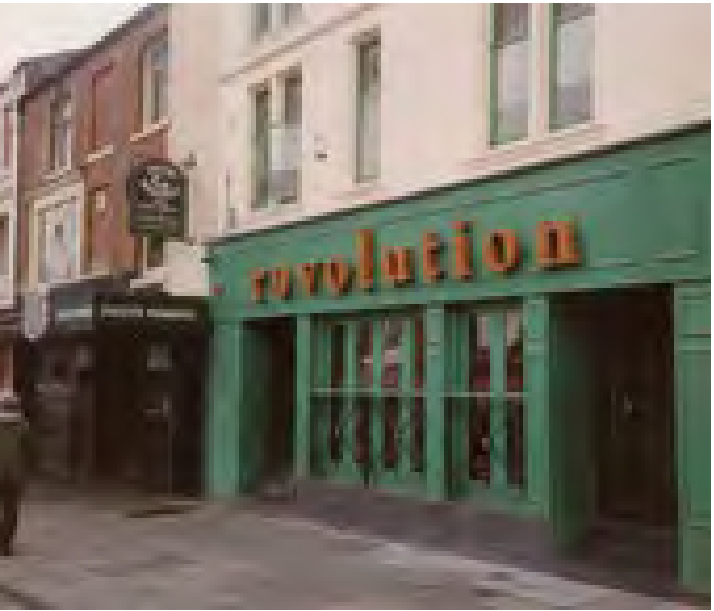
Figure 39: A 2000 photograph of South Parade, showing 8 South Parade with the c.1930s first and second floor windows, but with replaced glazing in the lower panes, as well as the existing timber-panelled shopfront with large recessed doors and a deep fascia (Source: Messenger 2000a).

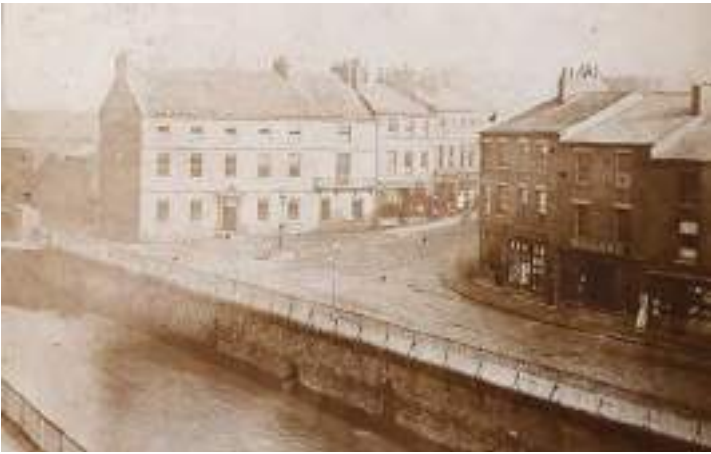
Figure 42: The earliest photograph obtained of the property, dating to c.1855, showing the corner of Drake Street and South Parade, showing the eastern end of the front elevation of 9-10 South Parade which was likely to have comprised a three-bayed three-storey Georgian terraced building with exposed brickwork, timber framed double-hung sash windows and a slate tile roof, with a ground floor mid-19th century symmetrical timber-framed shopfront on the ground floor (Source: TR Dig Streets 545).

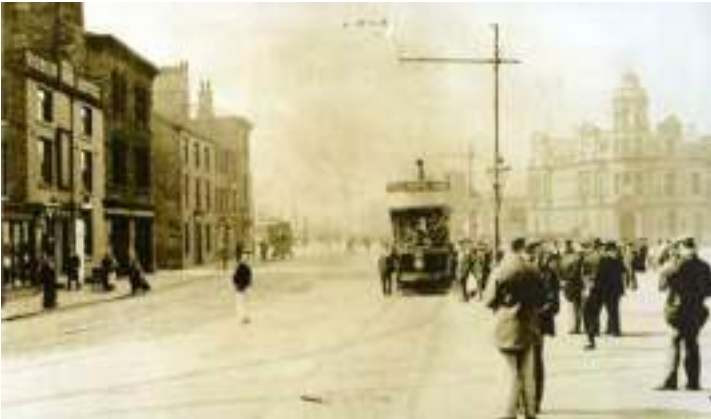
Figure 43: A historical photograph of a small section of the shopfront at 9 South Parade, dated to c.1910, showing a timber fascia and cornice above timber-framed windows and a timber pilaster on the ground floor (Source: Rochdale Local Studies c.1910a).

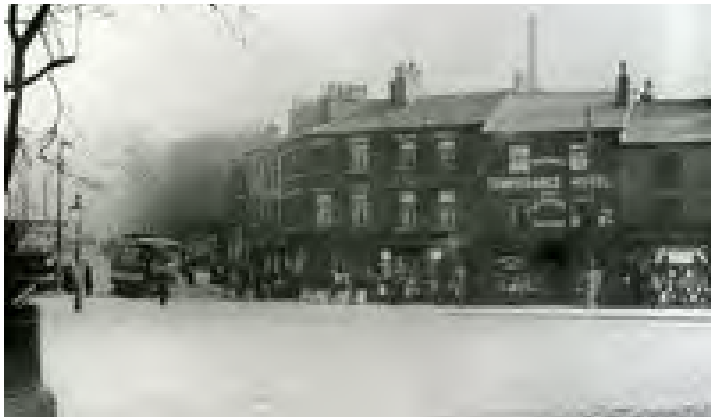
Figure 44: Photograph of South Parade c.1910, showing 10 South Parade with a 19th century shopfront and two bays above, with the western bay of windows blocked (Source: Rochdale Local Studies c.1910b).

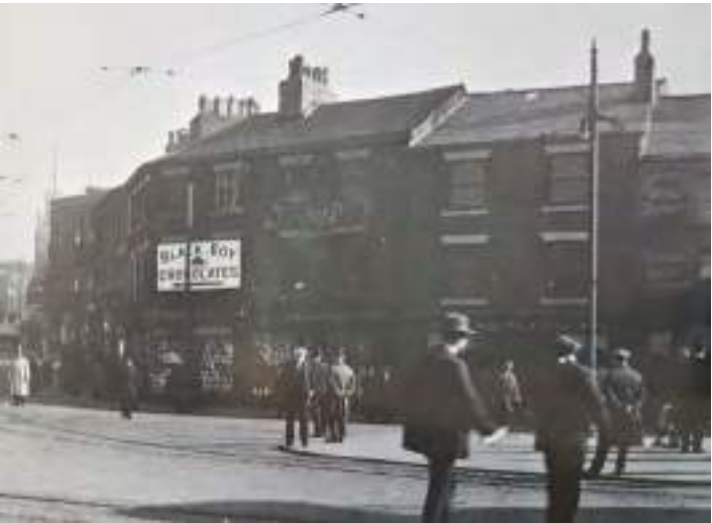
Figure 45: A c.1920s photograph of the corner of Drake Street and South Parade, showing only the eastern section of the front elevation of 9-10 South Parade. The windows on the first and second floors are eight-over-eight timber double-hung sashed windows, adjacent to a timber advertising board, but the ground floor shopfront is difficult to make out other than the glazing on the windows and the eastern door (Source: TR Dig Streets 501).

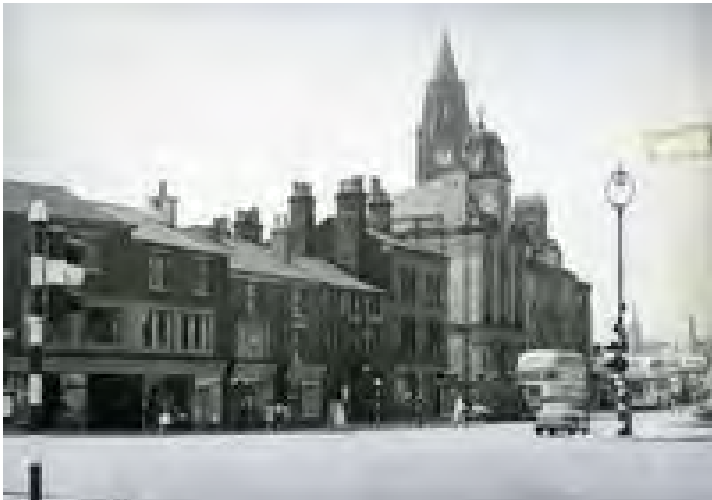
Figure 46: A c.1950s photograph of South Parade, showing the two asymmetrical shopfronts at 9-10 South Parade with matching mid-20th century inclined fascia (Source: Rochdale Local Studies n.d).

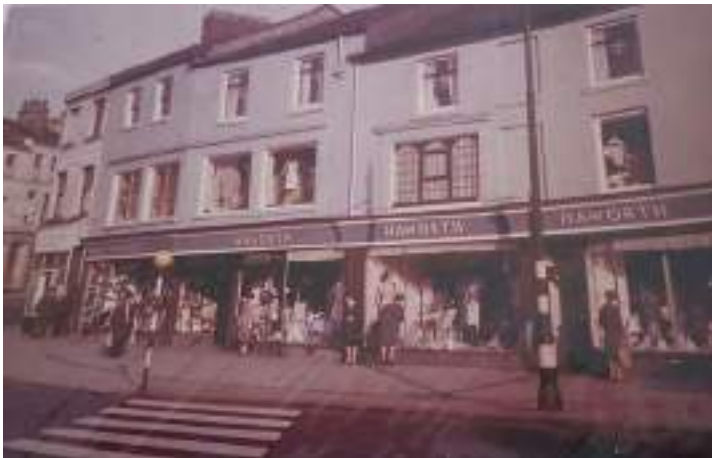
Figure 47: A c.1960 photograph of the front elevation at 9-12 South Parade, showing 9-10 South Parade to have infilled windows of the central bay on the first and second floors, as well as the c.1920s/early 1930s large window in the eastern bay of the first floor and the c.1940s timber-framed windows with hinged transoms (Source: 11-12 South Parade Archives c.1960).

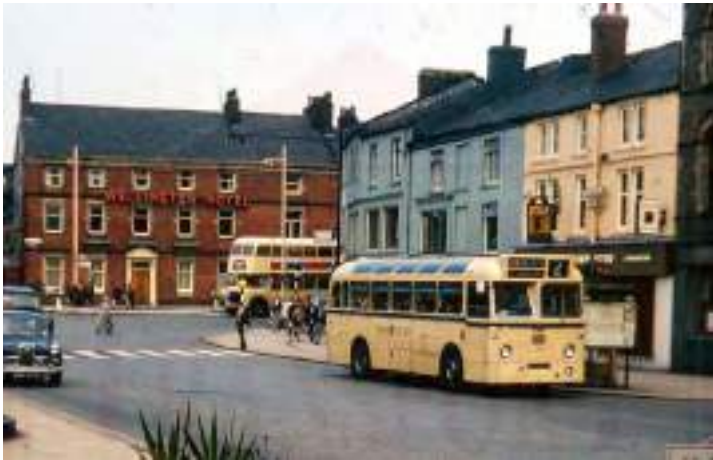
Figure 48: A 1960s photograph of South Parade, showing the front elevation at 9-10 South Parade with its infilled windows of the central bay on the first and second floors, as well as the c.1920s/early 1930s large window in the eastern bay of the first floor and the c.1940s timber-framed windows with hinged transoms (Source: Museum of Transport Greater Manchester c.1960).

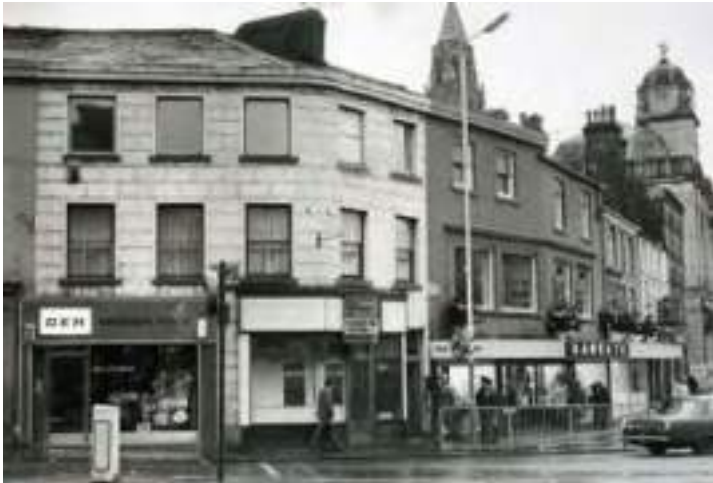
Figure 49: A c.1970s photograph of Drake Street and South Parade, showing 9-10 South Parade shopfront. By this time, the earlier shopfront had been replaced with a continuous 1968 shopfront extending from 9-12 South Parade (Source: Rochdale Local Studies c.1970a).

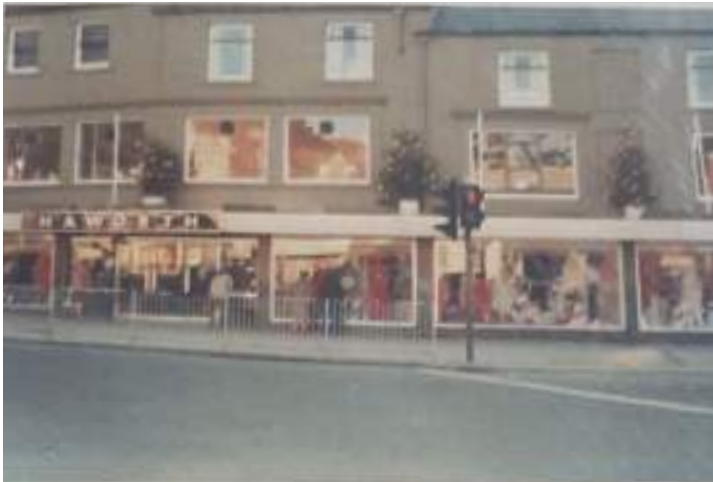
Figure 50: A c.1982 photograph of the front elevation at 9-12 South Parade, showing 9-10 South Parade to have to be reconfigured with the continuous awning along the front façade, as well as the alterations of the entrances and introduction of very large aluminium-framed windows (Source: 11-12 South Parade Archives c.1982).

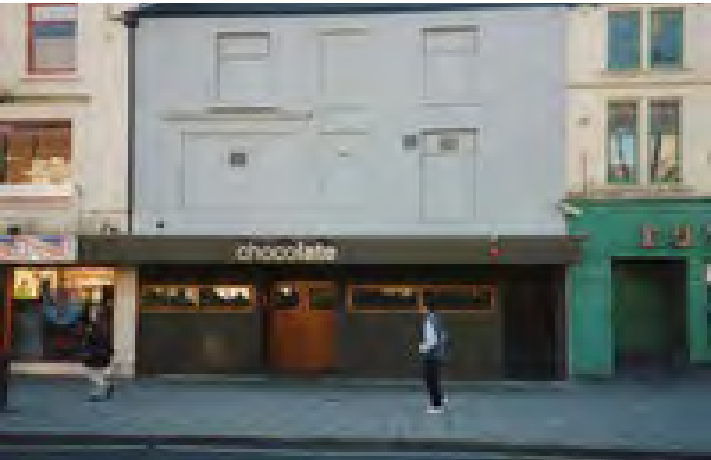
Figure 51: Photograph of 9-10 Drake Street in 2000, showing the infilled windows on the first and second floors, the cantilevered awning and the boxed-in shopfront, which were installed in 1993 (Source: Messenger 2000b).

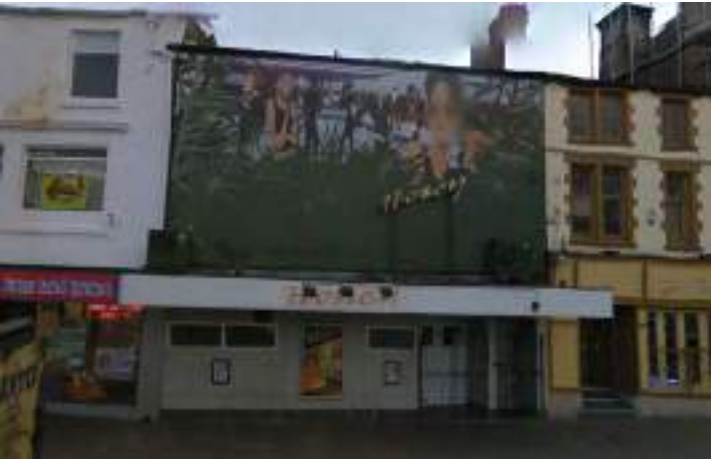
Figure 52: Photograph of 9-10 Drake Street in 2008, showing the painted canvas covering the first and second floors, the cantilevered awning and the tiled boxed-in shopfront (Source: Google 2008).

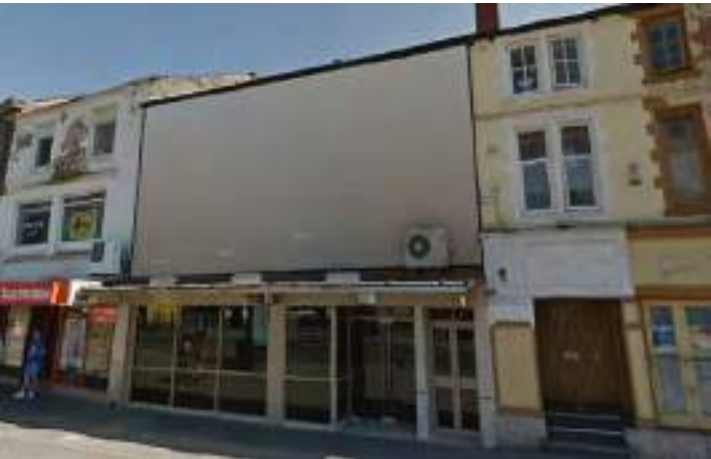
Figure 53: Photograph of 9-10 Drake Street in 2012, showing the re-painted canvas covering the first and second floors, a new cantilevered awning and a glazed aluminium-framed asymmetrical shopfront (Source: Google 2012).

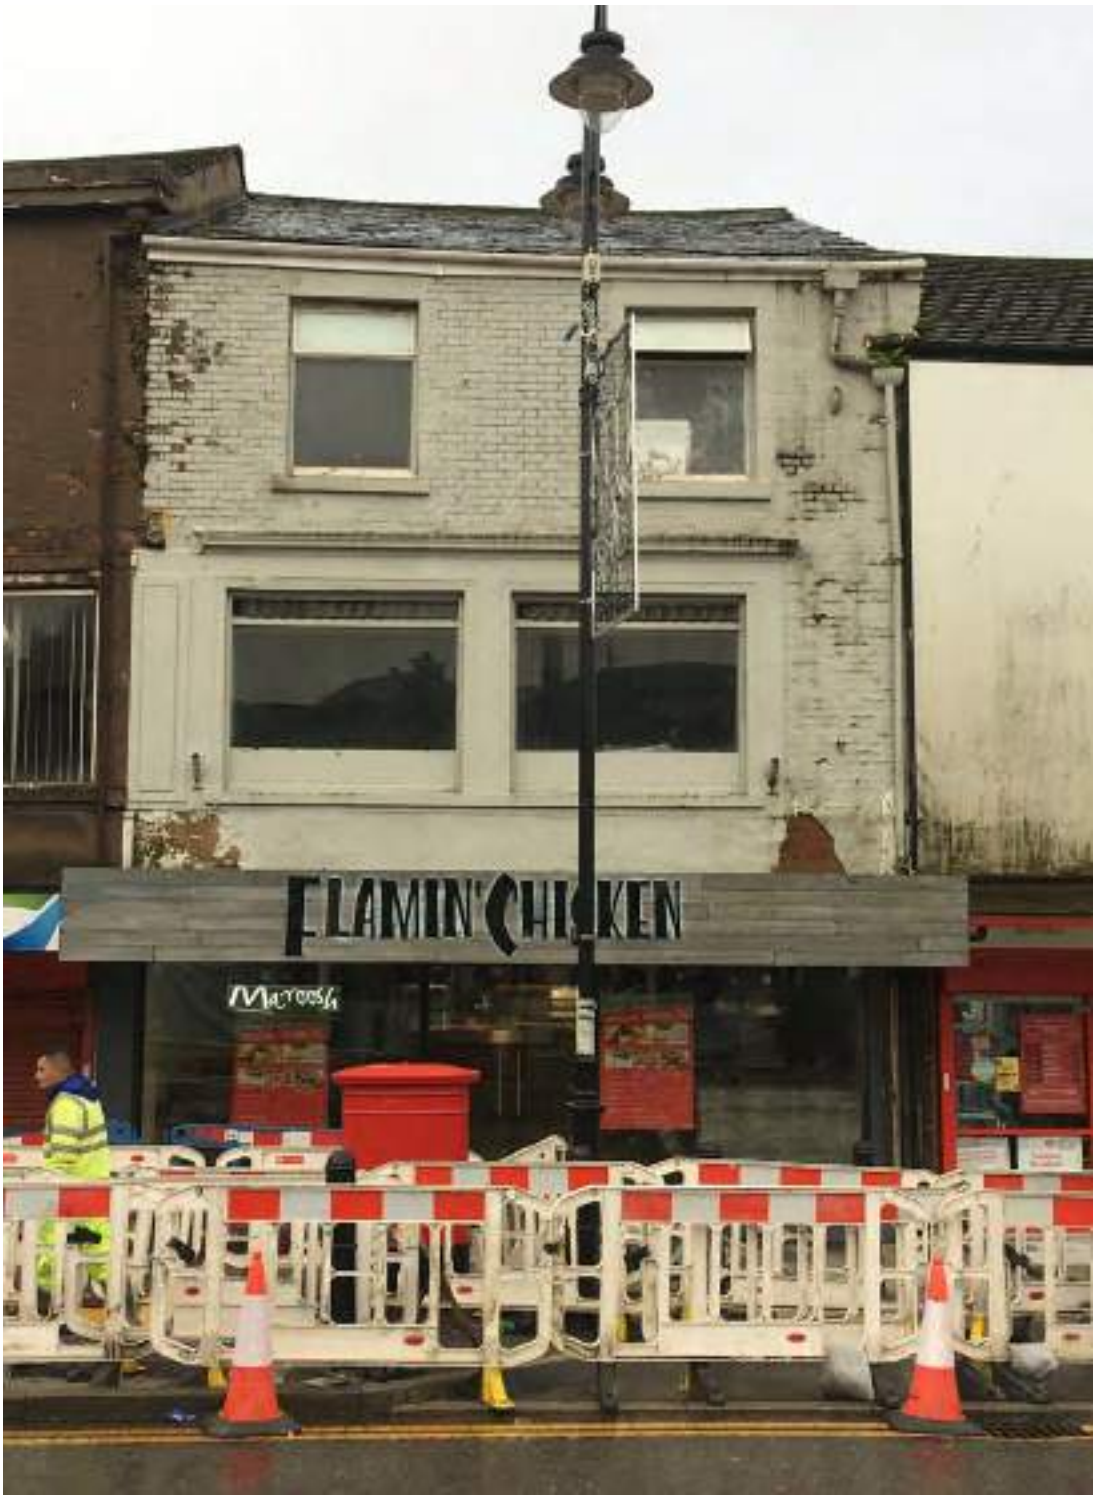
Figure 54: A current photograph of 11 South Parade (Source: Purcell 2019).

- The poor-quality gutters and downpipes.
- The surface staining and vegetation growth on the front elevation, which has been likely caused by inadequate cleaning of the gutters, corrosion of the gutter or insufficient connection between the gutter and the wall.

- The paint directly applied to the brickwork obscures the historic nature of the brickwork and its poor condition is detrimental to the aesthetics of the building.

The following detrimental features should be removed and replaced with more sympathetic counterparts in the new shopfront design:

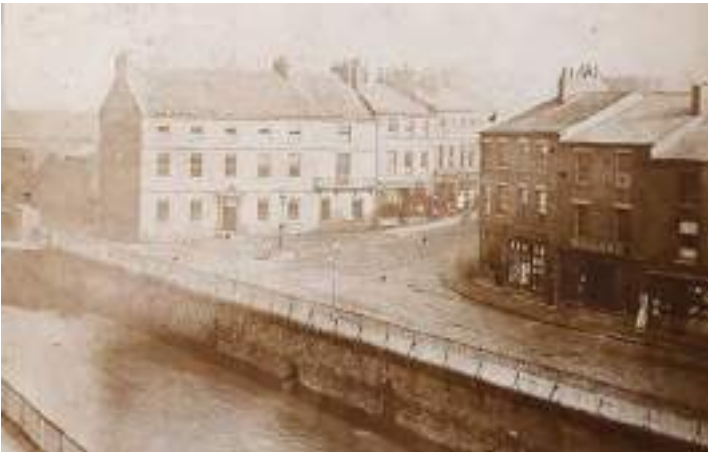
Figure 55: The earliest photograph obtained of the property, dating to c.1855, showing the corner of Drake Street and South Parade, showing the front elevation of 11 South Parade to comprise a two-bay three-storey Georgian terraced building with exposed brickwork and eight-over-eight paned vertically sliding timber sashed windows, with a symmetrical timber-framed shopfront on the ground floor (Source: TR Dig Streets 545).

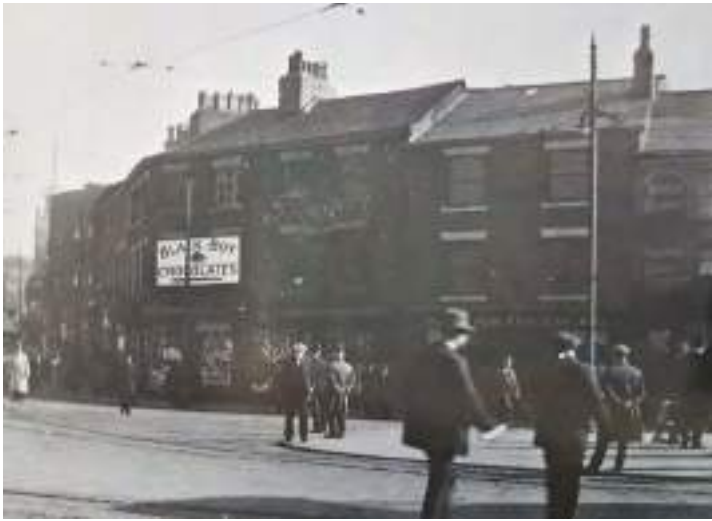
Figure 58: A c.1920s photograph of the corner of Drake Street and South Parade, showing the front elevation of 11 South Parade to comprise exposed brickwork with two-over-two paned sliding timber sashed windows. The shopfront appears to be a 19th century style timber-framed shopfront (Source: TR Dig Streets 501).

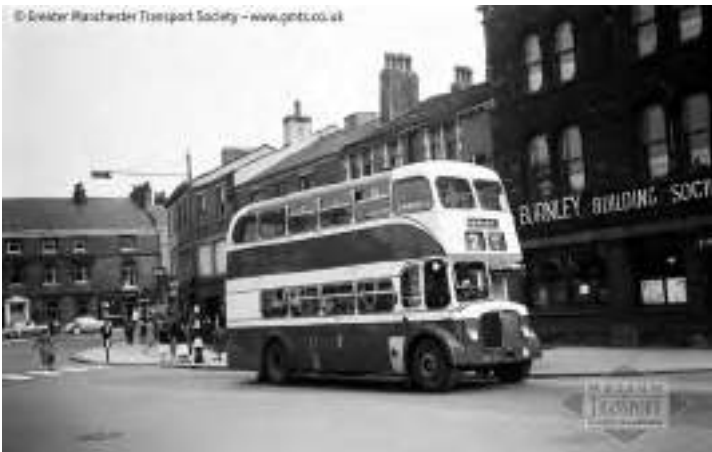
Figure 59: A c.1957 photograph of South Parade, showing the two-bayed front elevation at 11 South Parade with its c.1920s or 1930s large windows on the first floor and the c.1930s timber-framed windows with hinged transoms on the second floor (Source: Museum of Transport Greater Manchester c.1957).

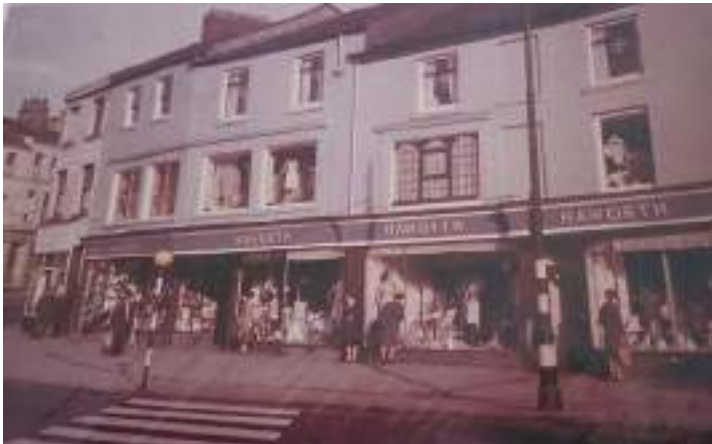
Figure 60: A c.1960 photograph of the front elevation at 9-12 South Parade, showing 11 South Parade to have new glazing in the first and second floors and a new shopfront (Source: 11-12 South Parade Archives c.1960).

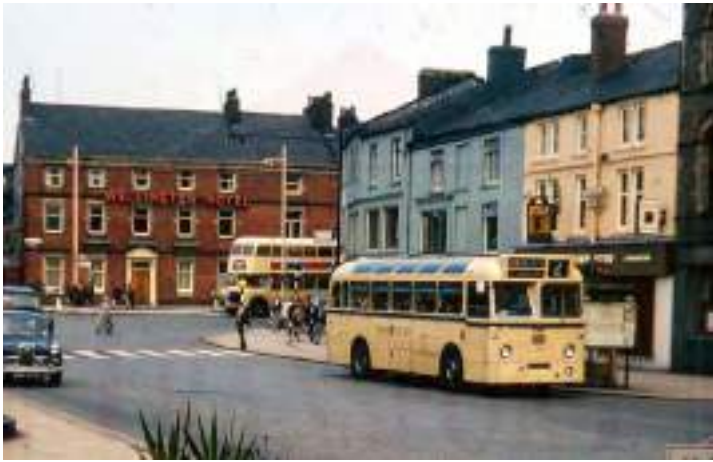
Figure 61: A 1960s photograph of South Parade, showing the front elevation at 11 South Parade with its c.1920s or 1930s large windows on the first floor and the c.1930s timber-framed windows with hinged transoms on the second floor (Source: Museum of Transport Greater Manchester c.1960).

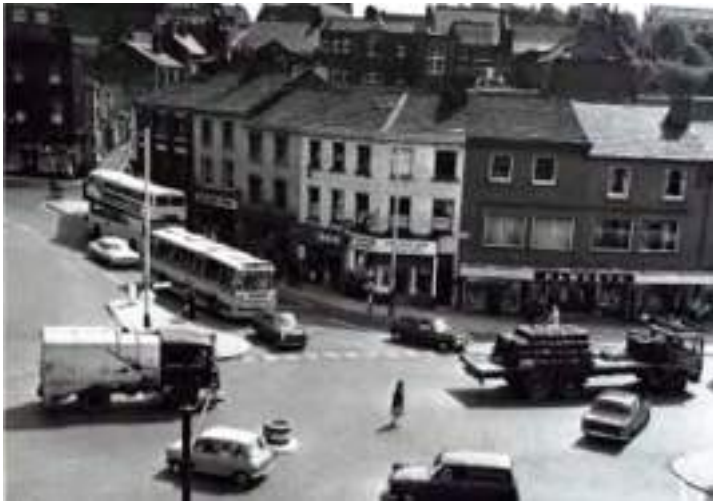
Figure 62: A 1966/67 photograph of Drake Street and South Parade, showing 11 South Parade occupied by Haworth on the ground floor, with altered first-floor windows and replaced frames in the second floor (Source: Rochdale Local Studies 1966/67).
