ROCHDALE HERITAGE ACTION ZONE – DRAKE STREET & SOUTH PARADE

ROCHDALE BOROUGH COUNCIL

HERITAGE STATEMENT AND PROPOSALS

DECEMBER 2019

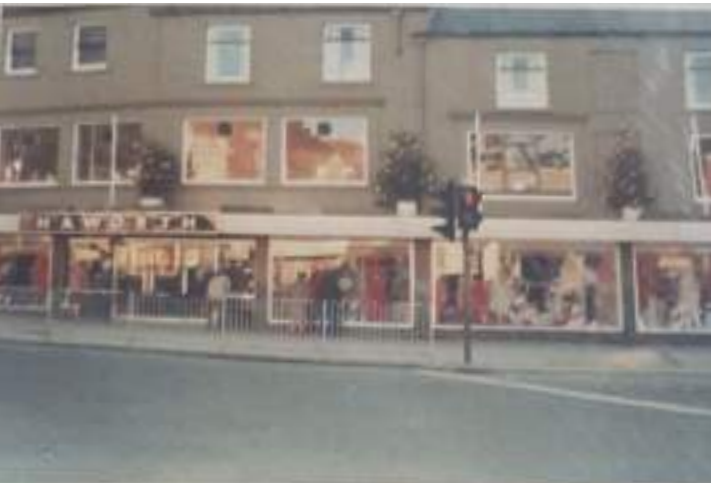
Figure 65: A c.1982 photograph of the front elevation at 9-12 South Parade, showing 11 South Parade to have to be reconfigured with the continuous awning along the front façade, as well as the alterations of the entrances and introduction of very large aluminium-framed windows (Source: 11-12 South Parade Archives c.1982).

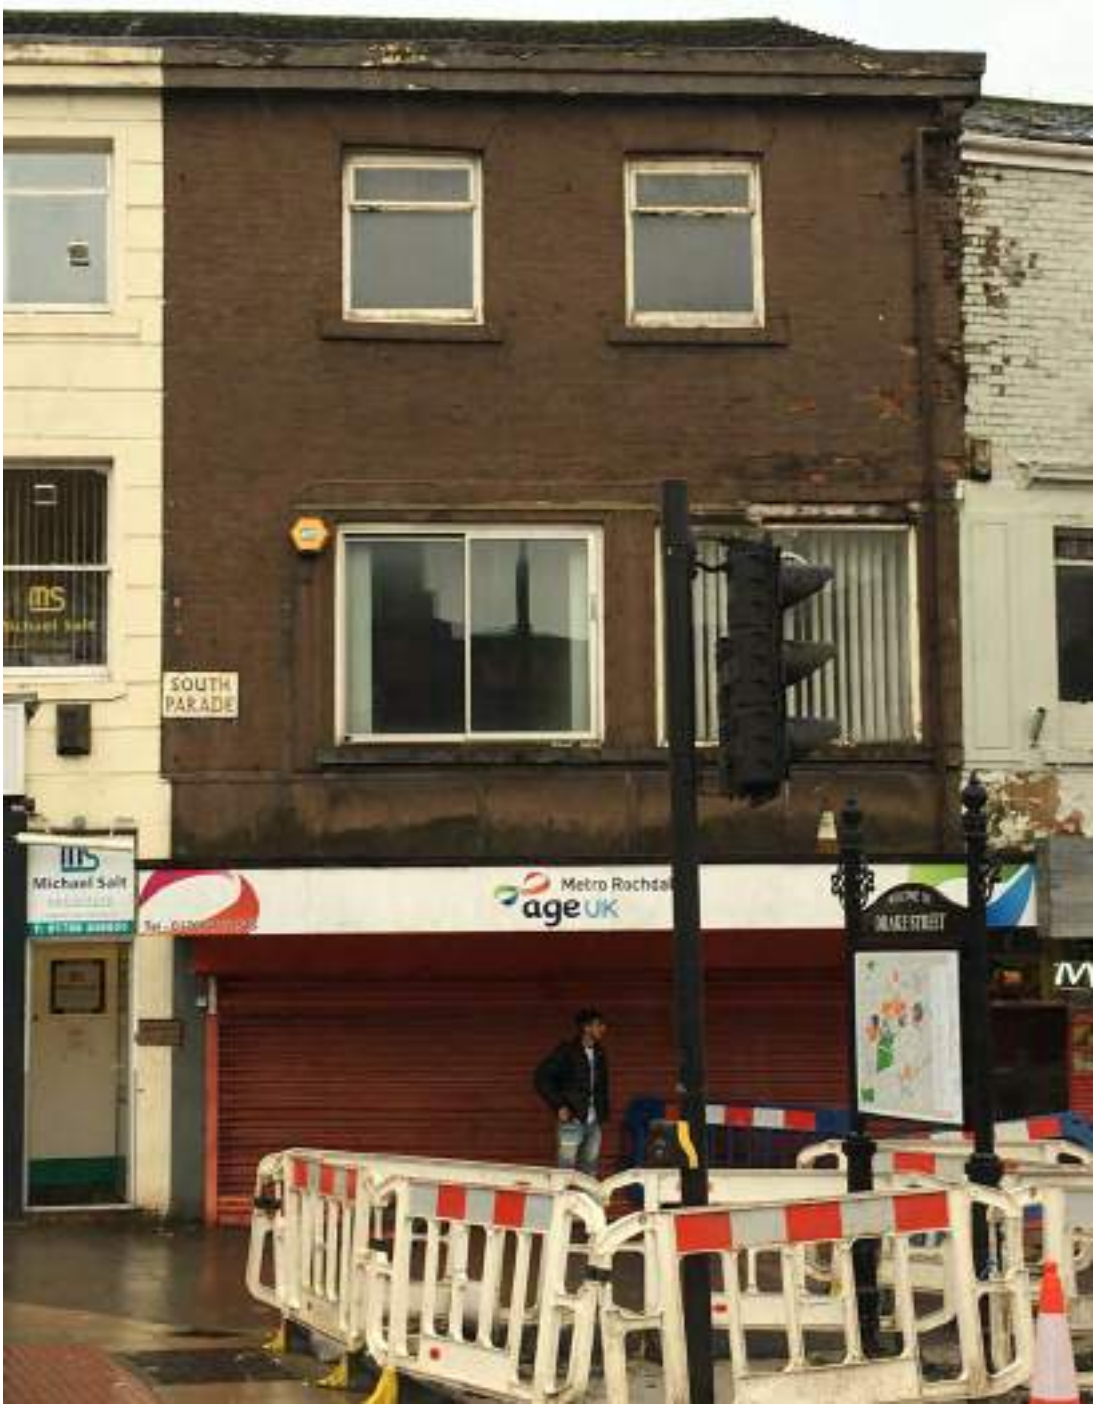
Figure 67: A current photograph of 12 South Parade (Source: Purcell 2019).

- The poor-quality gutters and downpipes.
- The fascia above the existing awning is of poor-quality materials and is in poor condition.
- The vegetation growth on the front elevation, which has been likely caused by inadequate cleaning of the gutters and downpipes or corrosion of the gutter and downpipe.

- The paint directly applied to the brickwork obscures the historic nature of the brickwork and its poor condition is detrimental to the aesthetics of the building.

- The framing and glazing of the windows on the first and second storeys are inappropriate.
- The condition of the cornice, which is now missing, and the panelling surrounding the first-floor windows is in poor condition, which is detrimental to the aesthetic significance of the building.

The following detrimental features should be removed and replaced with more sympathetic counterparts in the new shopfront design:

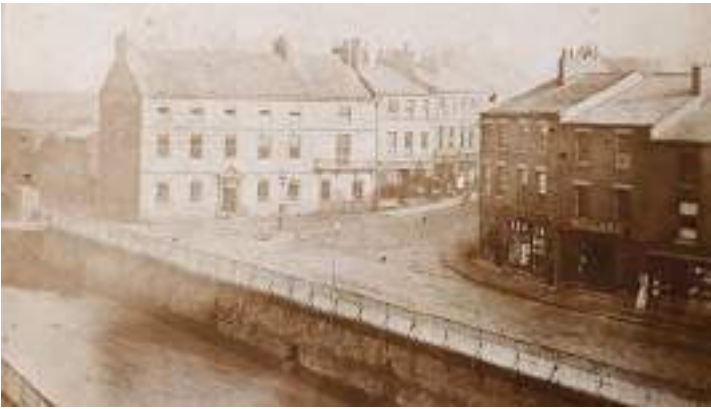
Figure 68: The earliest photograph obtained of the property, dating to c.1855, showing the corner of Drake Street and South Parade, showing the front elevation of 12 South Parade to comprise a two-bay three-storey Georgian terraced building with exposed brickwork and timber framed windows, with a ground floor mid-19th century symmetrical timber-framed shopfront on the ground floor. The windows on the first floor were likely extended in length in the Victorian period to provide more light in the room (Source: TR Dig Streets 545).

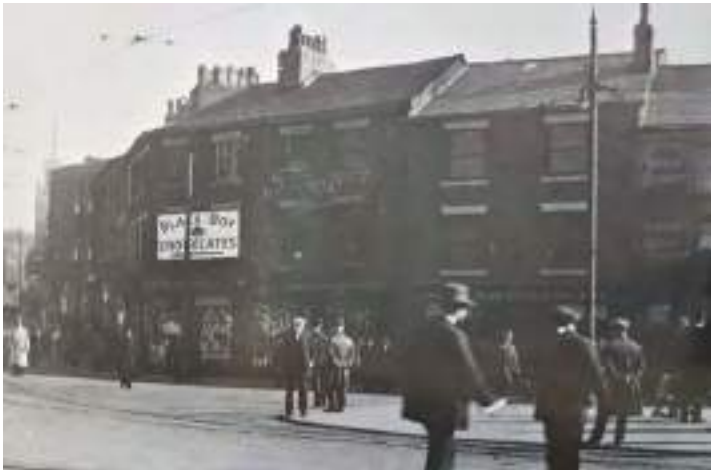
Figure 69: A c.1920s photograph of the corner of Drake Street and South Parade, showing the front elevation of 12 South Parade to comprise a two-bay three storey building exposed brick with single-paned double-sashed timber sashed windows on the first and second floors. The shopfront appears to be a late 19th century style timber-framed shopfront with a thin fascia, used by Haworth, a clothing store (Source: TR Dig Streets 501).

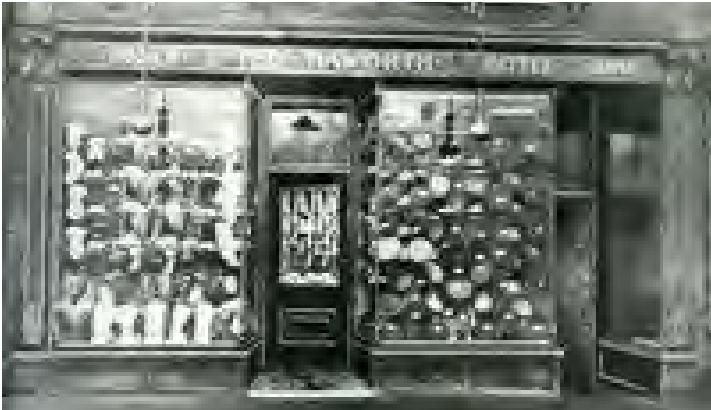
Figure 70: A c.1910s photograph of Ted Haworth's Hat and Hosiery shop at 12 South Parade, showing the shopfront of 12 South Parade, which appears to be a late 19th century style timber-framed shopfront with a thin fascia, short timber stall-rises, two doorways (one for the first and second floors) and decorative corbels above the pilasters (Source: Rochdale Local Studies c.1910c).

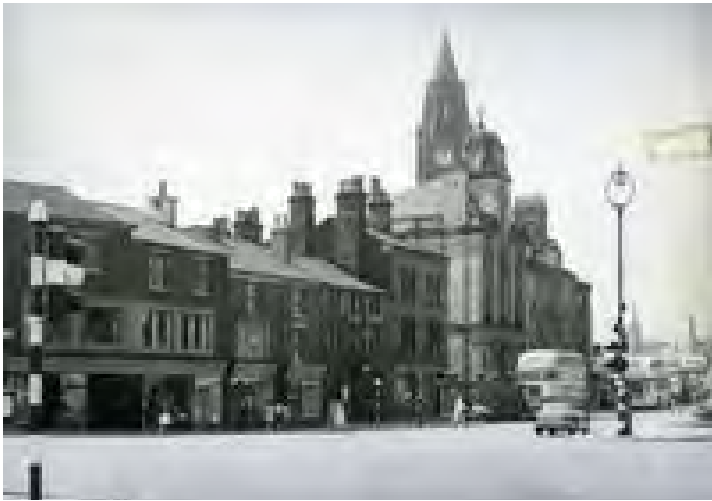
Figure 71: A c.1950s photograph of South Parade, showing the windows on the first floor of 12 South Parade to have been opened in the 1920s or 1930s, together with those of 11 South Parade, to allow more light into the rooms and to demonstrate the use of these properties for Haworth, a clothing store, indicating their connection from the first half of the 20th century (Source: Rochdale Local Studies n.d.)

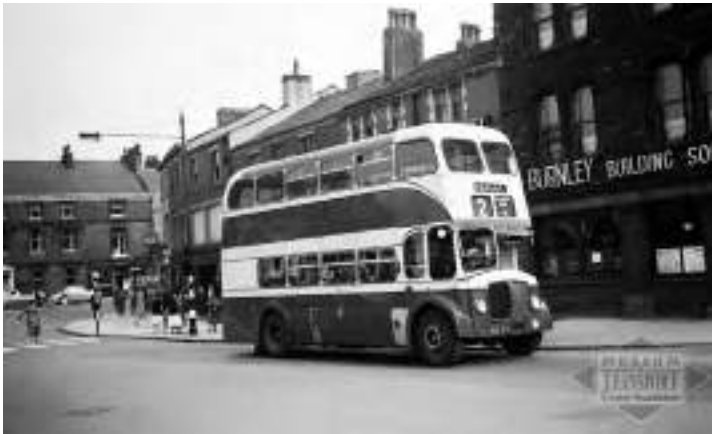
Figure 72: A c.1957 photograph of South Parade, showing the two-bayed front elevation at 12 South Parade with its c.1920s or 1930s large windows on the first floor (Source: Museum of Transport Greater Manchester c.1957).

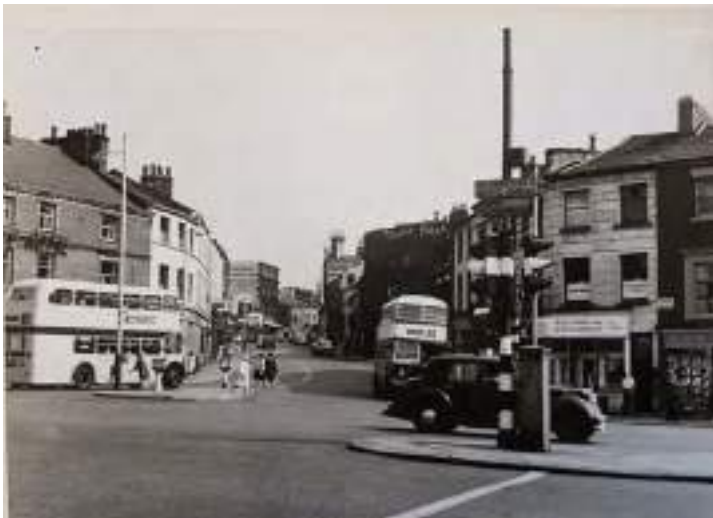
Figure 75: A c.1965 photograph of Drake Street, showing 12 South Parade still occupied by Haworth, with a deep inclined fascia and large glass panes (Source: TR Dig Streets 114).

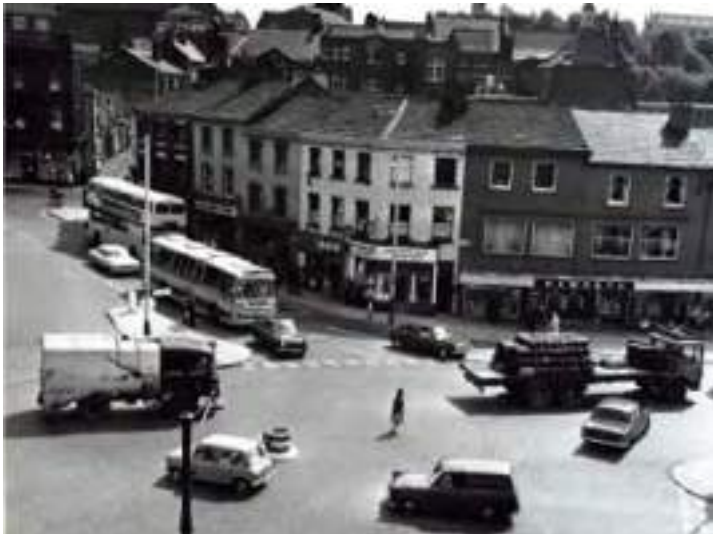
Figure 76: A late 1960s/early 1970s photograph of Drake Street and South Parade, showing 12 South Parade still occupied by Haworth with a c.1960s shopfront and awning extending from 9-12 South Parade (Source: Rochdale Local Studies 1966/67).

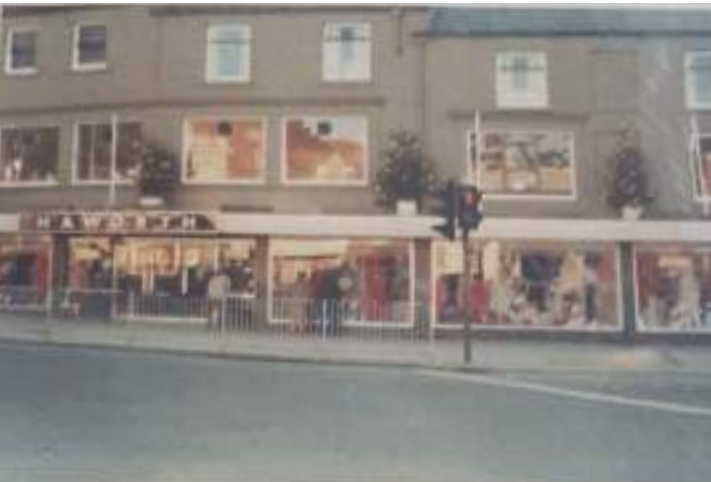
Figure 78: A c.1982 photograph of the front elevation at 9-12 South Parade, showing 12 South Parade to have to be reconfigured with the continuous awning along the front façade, as well as the alterations of the entrances and introduction of very large aluminium-framed windows (Source: 11-12 South Parade Archives c.1982).

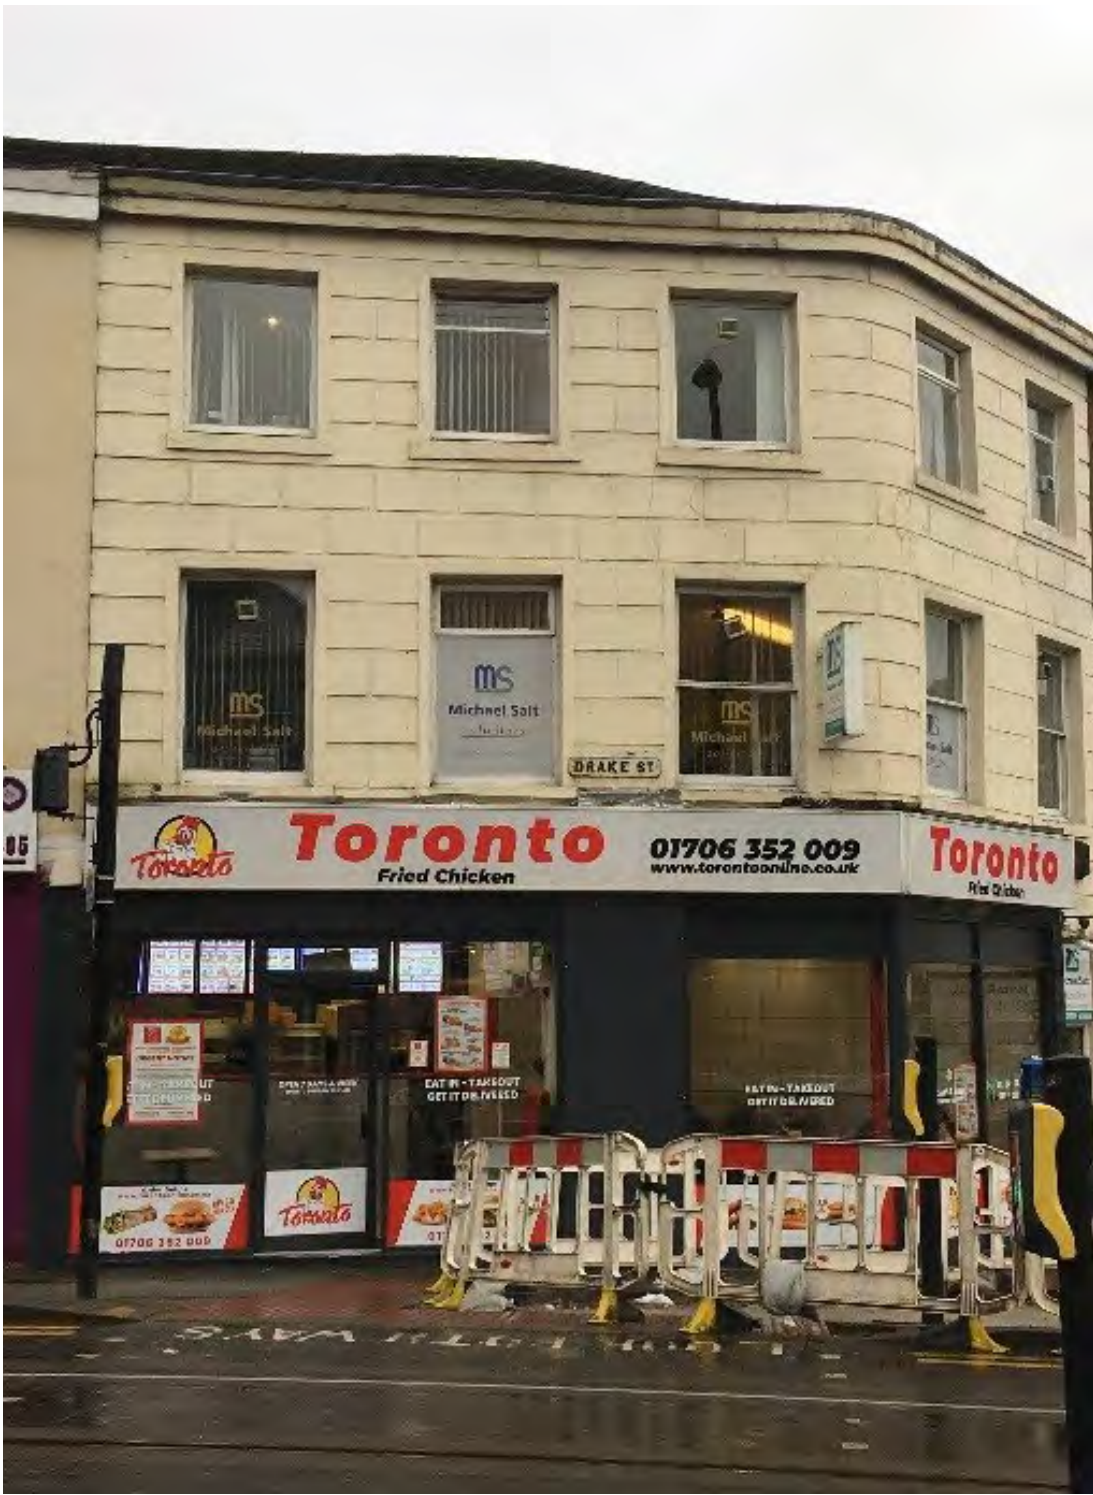
Figure 80: A current photograph of 13 South Parade/2 Drake Street (Source: Purcell 2019).

- The poor-quality gutters and flashing.
- The internally illuminated hanging sign on the first-floor elevation.
- The framing and glazing of the windows on the first and second storeys are inappropriate and should be replaced with timber-framed windows as shown in Figure 83 and Figure 84 .

- The large glass panes and their framing for the windows and door are not sympathetic to the desired character of the shopfronts.
- The signage and broken awning above the aluminium-framed door on the South Parade end of the property.

- The deeply scoured stone-imitation render brick façade on the first and second storeys of the front façade should be retained, repaired and conserved as an example of early 20th century change to the buildings. However, if the render is cementitious and is causing harm to the brickwork beneath, it should be removed.
- The windows on the first and second floor elevations, including the cills and the (now) rendered lintels.
- The 'Drake Street' sign on the first-floor elevation.
- The panelling around the 20th century windows, despite its poor condition.
- Any remains of the brick façade on the ground floor.
- The extant slate tile roof.

The following detrimental features should be removed and replaced with more sympathetic counterparts in the new shopfront design:

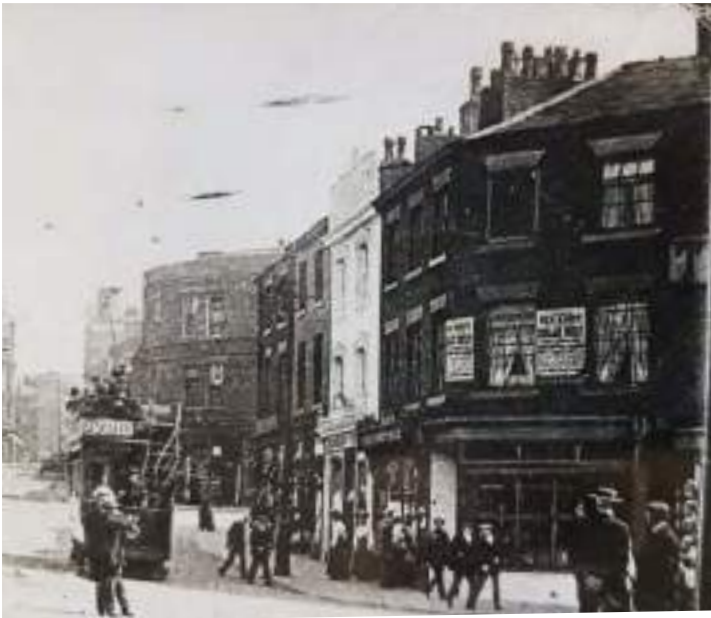
Figure 82: A c.1910 photograph of Drake Street from South Parade, showing the front elevation of 13 South Parade and 2 Drake Street to comprise exposed brick with timber sashed windows and advertising signs next to the windows. The shopfronts appear to be 19th century style timber-framed shopfronts with diagonal fascia at 13 South Parade and an early 20th century style box fascia at 2 Drake Street (Source: TR Dig Streets 518).

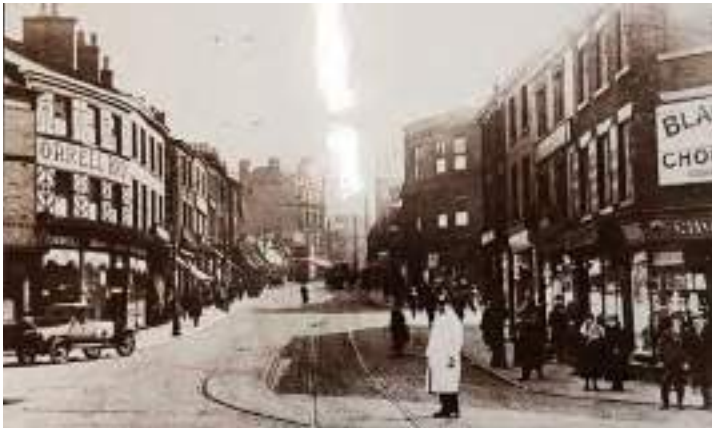
Figure 83: A c.1920s photograph of Drake Street from South Parade, showing the front elevation of 13 South Parade and 2 Drake Street to comprise exposed brick with timber sashed windows and advertising boards fixed next to and in front of windows. The shopfronts appear to be 19th century style timber-framed shopfronts with diagonal fascia at 13 South Parade and an early 20th century style box fascia at 2 Drake Street (Source: TR Dig Streets 2167).

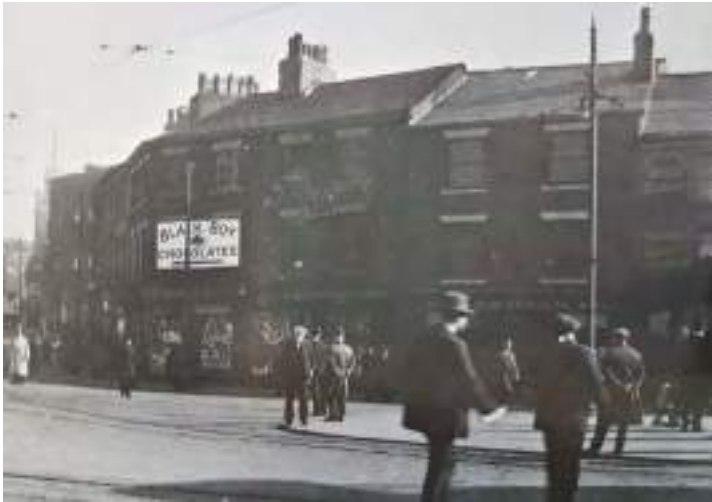
Figure 84: A c.1920s photograph of the corner of Drake Street and South Parade, showing the front elevation of 13 South Parade and 2 Drake Street to comprise exposed brick with timber sashed windows and advertising board fixed next to and in front of windows. The shopfronts appear to be 19th century style timber-framed shopfronts with diagonal fascia at 13 South Parade and an early 20th century style box fascia at 2 Drake Street (Source: TR Dig Streets 501).

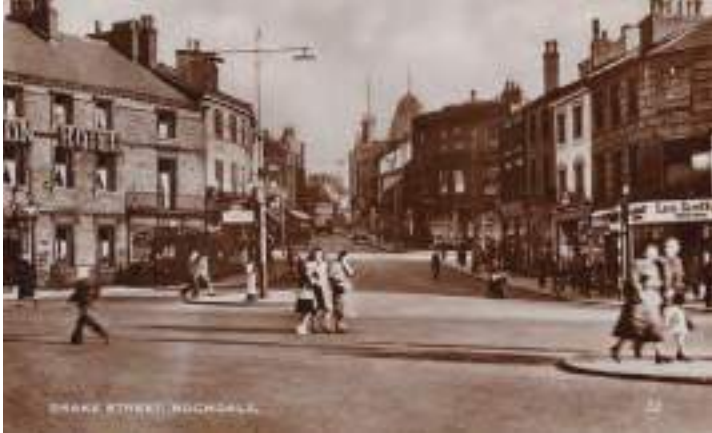
Figure 85: A mid-1930s photograph of Drake Street, showing the front elevations of 13 South Parade and 2 Drake Street to have been rendered with a deeply scoured stone ashlar pattern continuing across both properties, likely undertaken in the 1920s or 1930s, indicating their connection from the first half of the 20th century. The ground floor shops were used by Lea-Scott Opticians and what appears to be O. Loyts, with the first floor and second floor used by J.W. Dutton and a hairdressers, respectively (Source: Ashworth 2018).

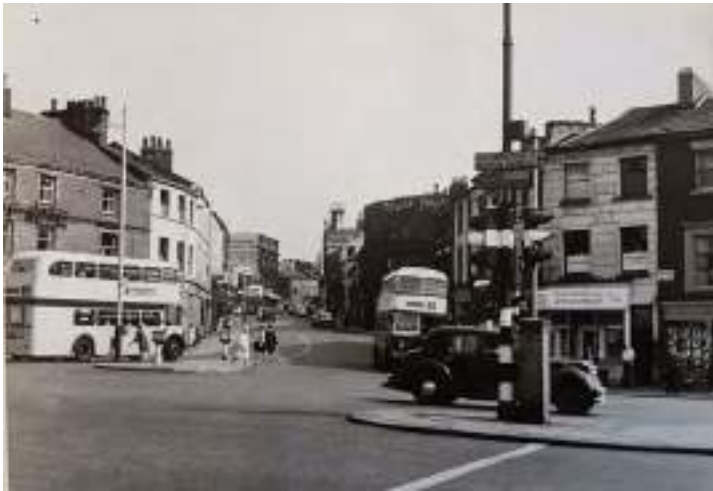
Figure 86: A c.1965 photograph of Drake Street, showing 13 South Parade occupied by Dollond and Aitchison Ltd on the ground floor and J.W. Dutton and Son on the first floor. By this time, the earlier shopfront had been replaced with a mid-20th century symmetrical frontage with a tall, deep fascia (Source: TR Dig Streets 114).

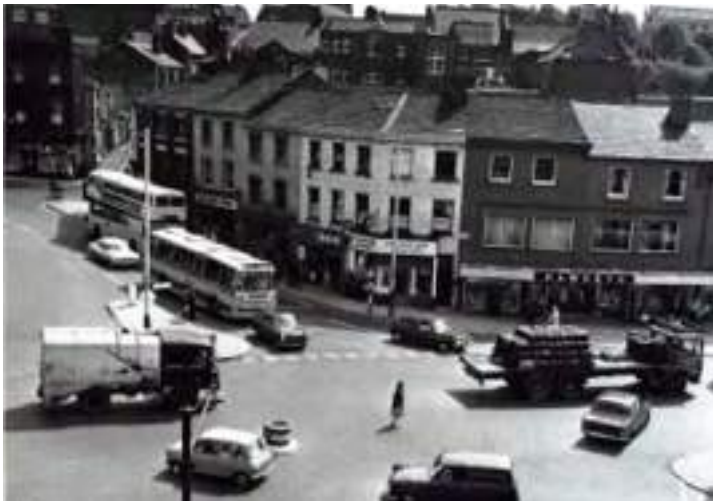
Figure 87: A 1966/67 photograph of Drake Street and South Parade, showing 13 South Parade/2 Drake Street occupied by Dollond and Aitchison Ltd on the ground floor and J.W. Dutton and Son on the first floor. By this time, the earlier shopfront had been replaced with a mid-20th century frontage with a tall, deep fascia. The occupant of the eastern side of 2 Drake Street is not clear (Source: Rochdale Local Studies 1966/67).

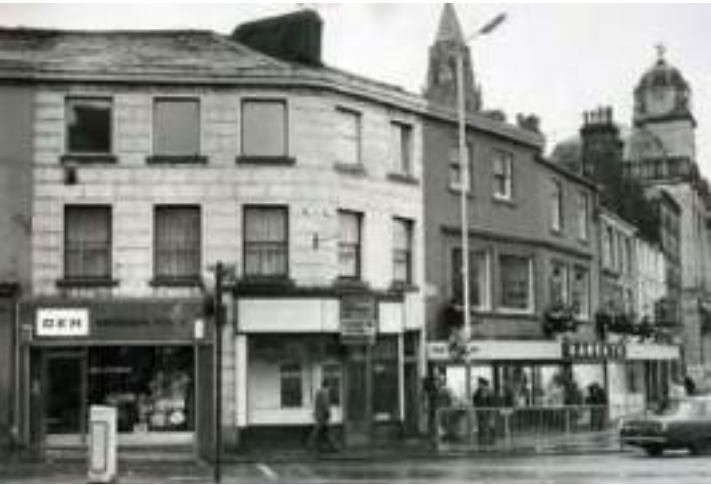
Figure 88: A c.1970s photograph of Drake Street and South Parade, showing 13 South Parade/2 Drake Street unoccupied on the ground floor with a much-altered shopfront. By this time, the earlier shopfront at the eastern side of 2 Drake Street had been replaced with a mid-20th century frontage with a deep fascia (Source: Rochdale Local Studies c.1970a).

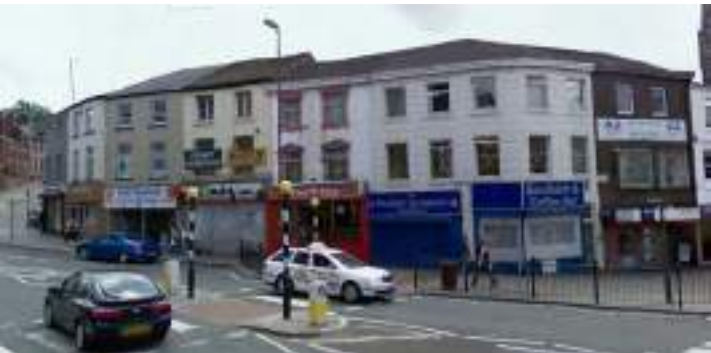
Figure 89: A 2008 Google Street View image of 13 South Parade/2 Drake Street through to 12 Drake Street, showing the Sandwich and Coffee Bar and its unsympathetic shopfront at 13 South Parade/2 Drake Street, including partially perforated roller shutters (Source: Google 2008).

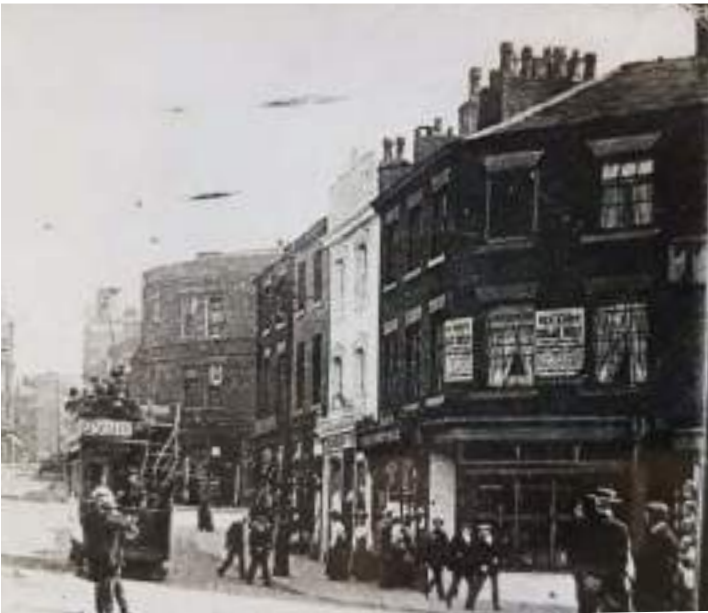
Figure 91: A c.1910 photograph of Drake Street from South Parade, showing the front elevation of 4 Drake Street to comprise a rendered façade with pedimented window surrounds on the first and second floors, a decorative parapet above the second floor, and a 19th shop frontage with a timber fascia and cornice, an ornamental pediment above the cornice, a recessed doorway and timber-framed glazing (Source: TR Dig Streets 510).

A building at 4 Drake Street appears to have originally been constructed prior to 1825 based on the map progression (Figure 11). 4 Drake Street appears to have been constructed as a three-storey Georgian terraced house comprising two bays, likely built at the same time as 13 South Parade/2 Drake Street (Figure 91). The front access appears to have been at the eastern end of the front façade in c. 1851, indicating an asymmetrical frontage, but it is unclear as to whether or not the ground floor was a shop or residence at this time (Figure 13). Prior to c.1910, the front façade was altered, including rendering, a decorative parapet installed above the front elevation, pedimented window surrounds installed on the first and second floors, a decorative parapet above the second floor; and a shop frontage with a timber fascia and cornice, an ornamental pediment above the cornice, a recessed doorway and timber-framed glazing (Figure 91). These alterations appear to date to the late 19th century. By the 1920s, the parapet above the second-floor elevation was replaced with a timber-framed sign between the first and second floors (Figure 92). The shop was used as a Cigar Merchant from the late 19th century through to 1987, when it was converted into a hot food takeaway (Figure 21)<sup>01</sup>. The historic shopfront may have survived at least partially intact as late as 1994, as a planning application records the replacement of the shopfront in 1994<sup>02</sup>. Since the late 20th century, the shop has been used for a variety of takeaway restaurants, resulting in multiple changes to the shopfront and the front elevation (Figure 21, Figure 23, Figure 90 and Figure 97). In 2015, the first and second floors were converted to from storage to offices including new shop front in 2015<sup>03</sup>.

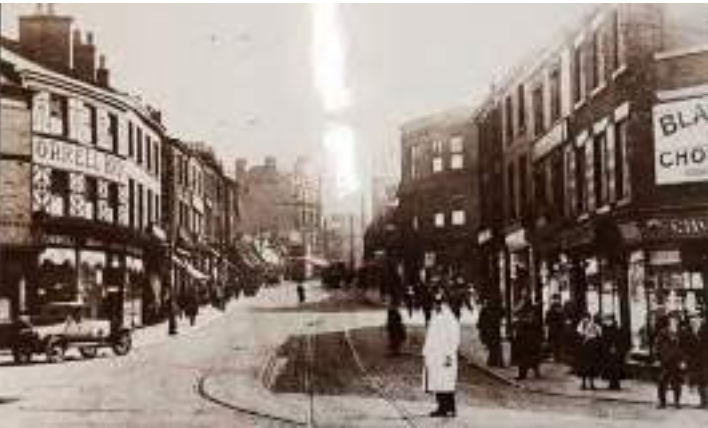
Figure 92: A c.1920s photograph of Drake Street from South Parade, showing the front elevation of 4 Drake Street to comprise a rendered first and second storey with decorated Art Deco surrounds around the originally Georgian windows and a mid-19th century style timber-framed shopfront with a wide fascia, narrow glass panes and a small parapet and balustrading above a projecting cornice (Source: TR Dig Streets 2167).

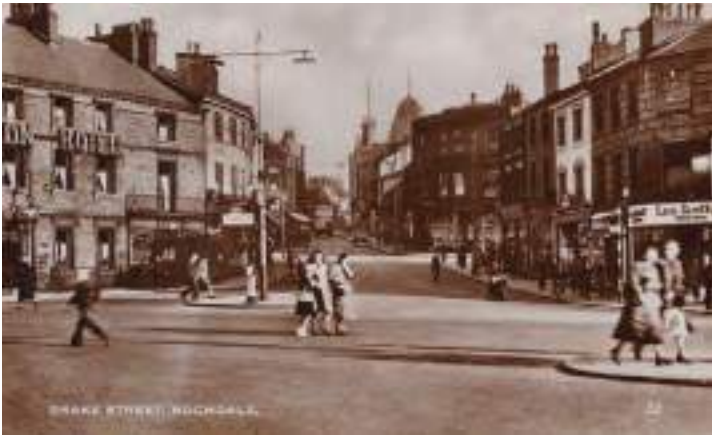
Figure 93: A mid-1930s photograph of Drake Street, showing the rendered front elevation and Art Deco window surrounds of 4 Drake Street to have been retained, as well as the 19th century shopfront for the Cigar Merchants (Source: Ashworth 2018).

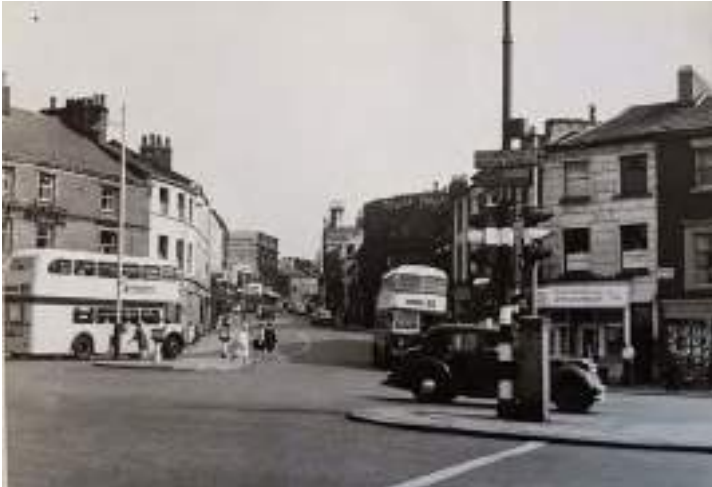
Figure 94: A c.1965 photograph of Drake Street, showing the rendered front elevation and Art Deco window surrounds of 4 Drake Street to have been retained, as well as the 19th century shopfront (Source: TR Dig Streets 114).

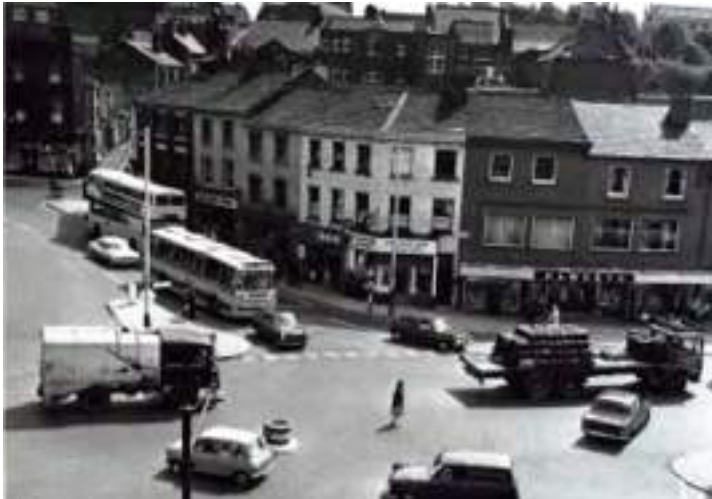
Figure 95: A c.1966/67 photograph of Drake Street and South Parade. The rendered front elevation and Art Deco window surrounds of 4 Drake Street appears to have been retained, as well as the 19th century shopfront (Source: Rochdale Local Studies 1966/67).

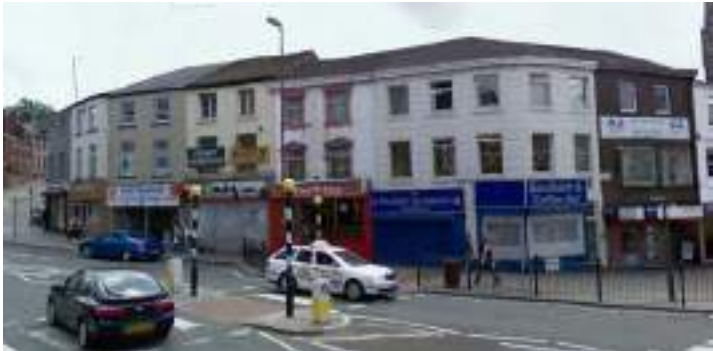
Figure 97: A 2008 Google Street View image of 13 South Parade/2 Drake Street through to 12 Drake Street, showing the Pizza King and its unsympathetic shopfront at 4 Drake Street, installed in 1994 (Source: Google 2008).

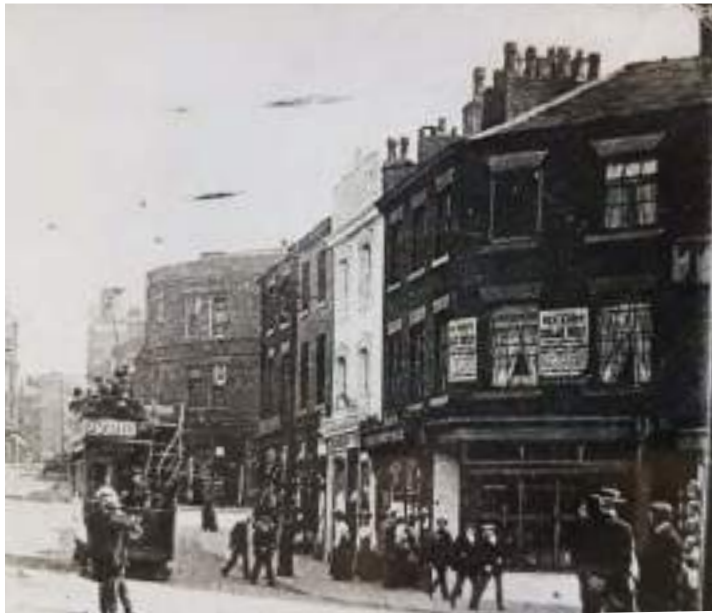
Figure 99: A c.1910 photograph of Drake Street from South Parade, showing the front elevation of 8 Drake Street to comprise exposed brick with timber sashed windows. The shopfront appears to be 19th century style timber-framed shopfront (Source: TR Dig Streets 518).

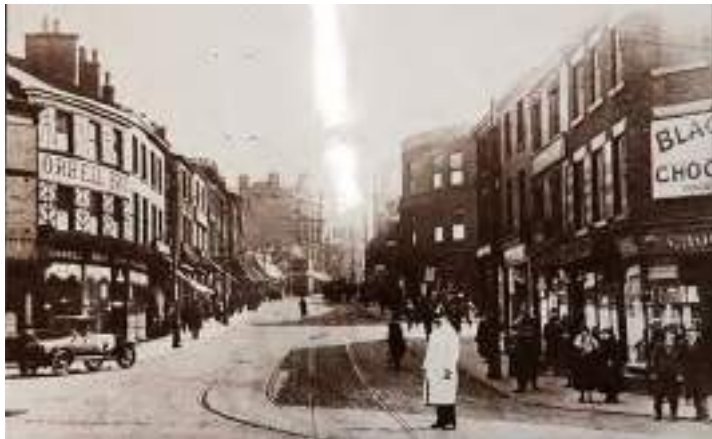
Figure 100: A c.1920s photograph of Drake Street from South Parade, showing the front elevation of 8 Drake Street to comprise exposed brick with timber sashed windows. The shopfront appears to be a 19th century style timber-framed shopfront with a protruding box fascia (Source: TR Dig Streets 2167).

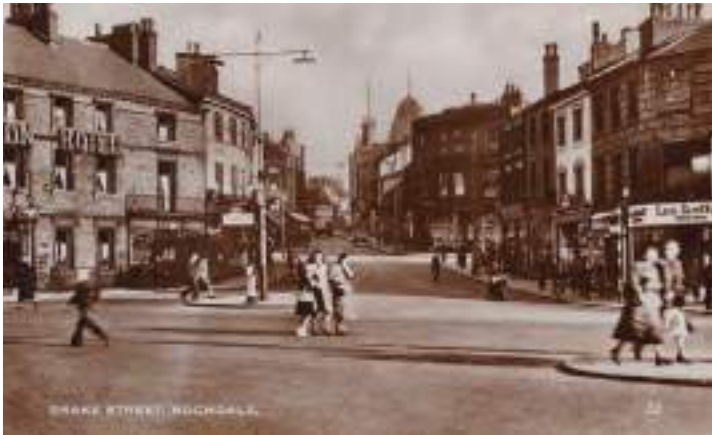
Figure 101: A mid-1930s photograph of Drake Street, showing the front elevation of 8 Drake Street to comprise exposed brick with timber sashed windows. The shopfront appears to be a 19th century style timber-framed shopfront with an inclined fascia (Source: Ashworth 2018).

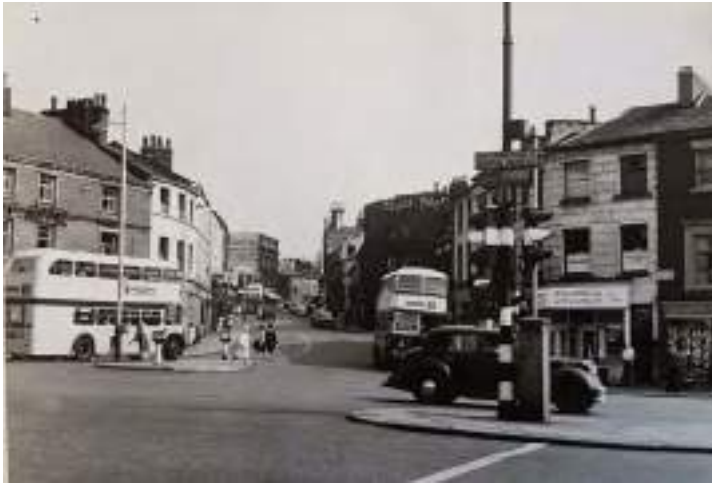
Figure 102: A c.1965 photograph of Drake Street, showing the earlier shopfront at 8 Drake Street to have been replaced with a mid-20th century symmetrical frontage with a tall, deep inclined fascia. The first and second floor elevations still comprised exposed brickwork at this time (Source: TR Dig Streets 114).

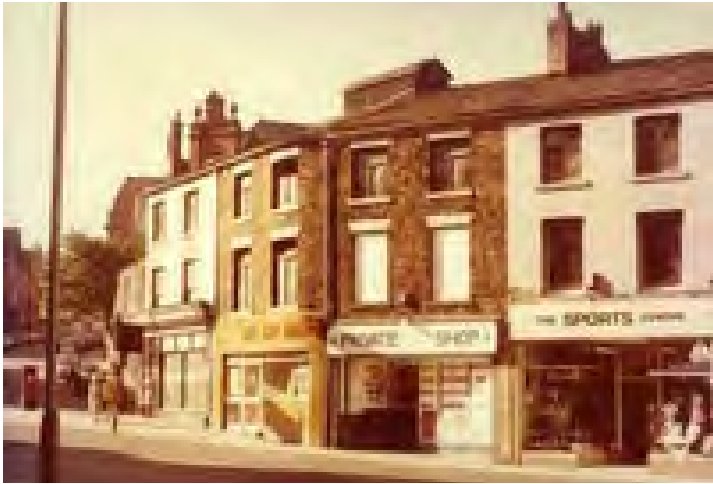
Figure 104: A 1981 photograph of Drake Street, showing 8 Drake Street to be exposed brick but with its windows replaced on the first and second floors and a c.1970s asymmetrical shopfront with a deep fascia (Source: Anstess 1981b).

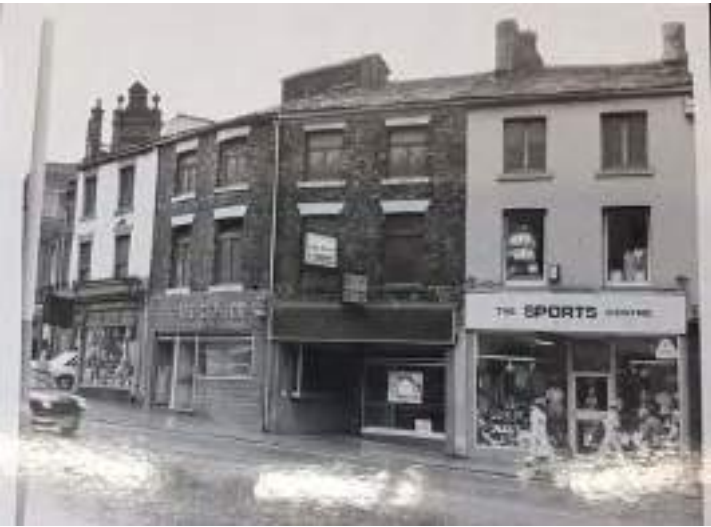
Figure 105: A photograph taken prior to 1984, showing the asymmetrical splayed shopfront at 8 Drake Street (Source: TR Dig Streets 515).

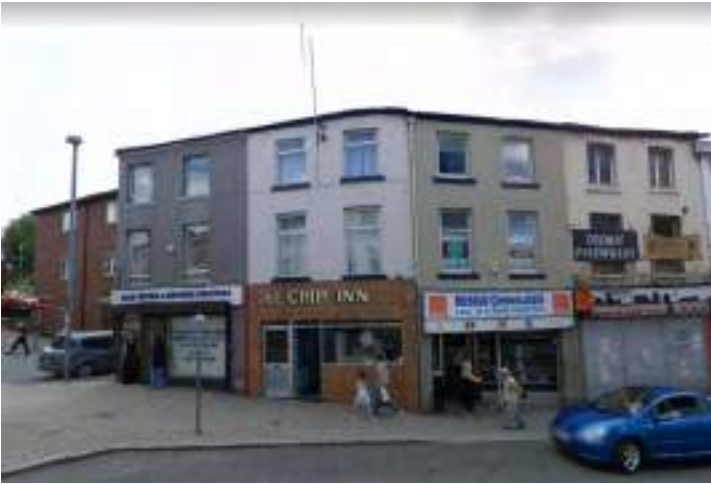
Figure 106: A 2008 Google Street View image of 6 to 12 Drake Street, showing the Rochdale Communications and its unsympathetic c.1970s shopfront and 1980s tiles at 8 Drake Street (Source: Google 2008).

A building at 8 Drake Street appears to have originally been constructed prior to 1825 based on the map progression (Figure 11). 8 Drake Street appears to have been constructed as a three-storey Georgian terraced house comprising two bays, likely built at roughly contemporaneously with the rest of the properties at the corner of Drake Street and South Parade (Figure 99). The front access appears to have been at the eastern end of the front façade in c. 1851, indicating an asymmetrical frontage, but it is unclear as to whether or not the ground floor was a shop or residence at this time (Figure 13). Prior to c.1910, a late 19th century timber-framed symmetrical shopfront was constructed (Figure 99). By the 1920s, a new fascia was installed above the cornice (Figure 100) and by the 1930s, an inclined fascia was installed, covering the cornice and earlier fascia (Figure 101), though the rest of the shopfront appears to have survived intact at this time. The shop appears to have been a menswear shop until the 1980s, when it became an Adult Bookshop briefly before its conversion into an Estate Agent office in 1984 (Figure 19, Figure 20, Figure 21, Figure 104 and Figure 105)<sup>01</sup>. The shopfront appears to have been altered drastically in the c.1970s, but has changed little since that date other than changes in signage and the addition of tiling in the 1980s and alterations to the windows in the 1980s and again in the 2000s (Figure 104, Figure 105 and Figure 106Figure 21). The shop has been used as various retail outlets since the early 2000s (Figure 106).

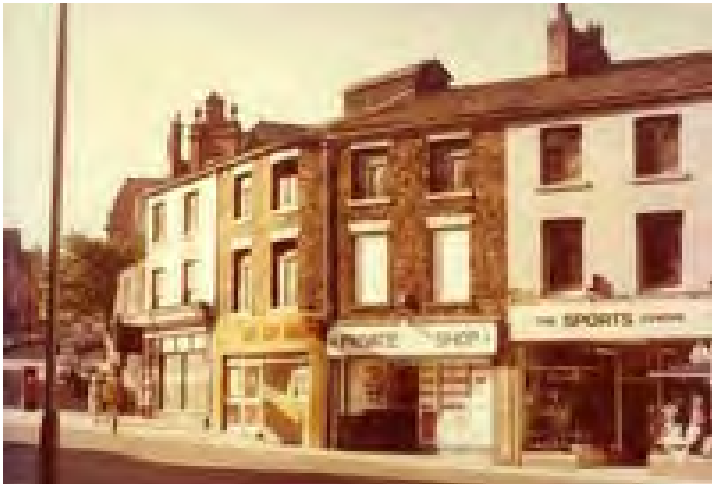
Figure 110: A 1981 photograph of Drake Street, showing 10 Drake Street with exposed brickwork and the windows on the first and second floor elevations to have been replaced in the 1970s. The shopfront appears to be a 1970s tiled shopfront with aluminium-framed glass (Source: Anstess 1981a).

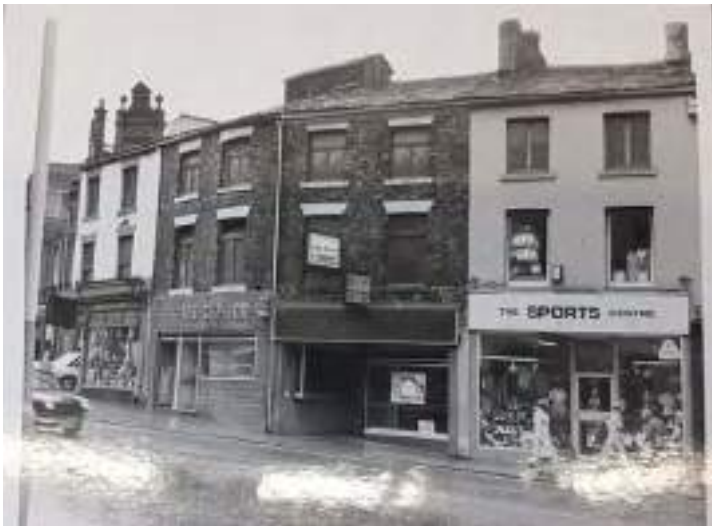
Figure 111: A photograph taken prior to 1984, showing the asymmetrical shopfront at 10 Drake Street (Source: TR Dig Streets 515).

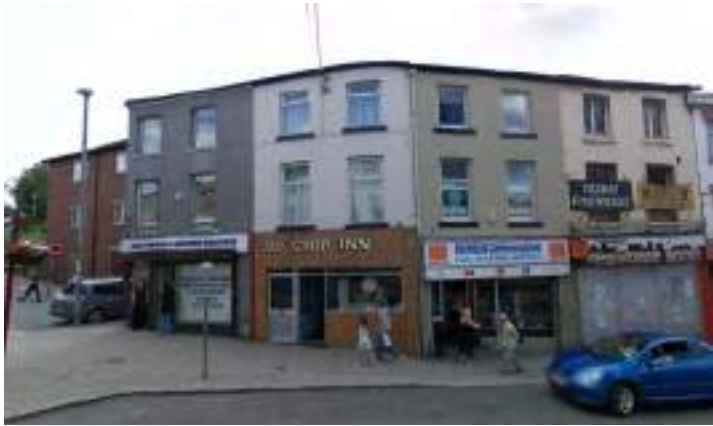
Figure 112: A 2008 Google Street View image of 6 to 12 Drake Street, showing the Chip Inn and its unsympathetic c.1970s shopfront at 10 Drake Street (Source: Google 2008).

A building at 10 Drake Street appears to have originally been constructed prior to 1825 based on the map progression (Figure 11). 10 Drake Street appears to have been constructed as a three-storey Georgian terraced house comprising two bays, likely built at roughly contemporaneously with the rest of the properties at the corner of Drake Street and South Parade, particularly 6 and 12 Drake Street. The front access is not shown in the 1851 map, so it is unclear as to whether or not the frontage was symmetrical or asymmetrical and if it was a shop or residence at this time (Figure 13). The earliest photograph obtainable showing the front elevation dates to 1966/7 and only shows the western bay of the first and second floors of the front elevation, so little is known about the nature of the shopfront prior to the 1980s (Figure 108). The shop on the ground floor appears to have been used as The Chip Inn, a fast food restaurant, from at least 1968 through to 2018 (Figure 113), which has since been changed to a Mini Market (Figure 107). The first and second floor elevations were likely painted in the early 2000s and the window frame and glazing replaced at multiple occasions during the late 20th and early 21st centuries (Figure 112).

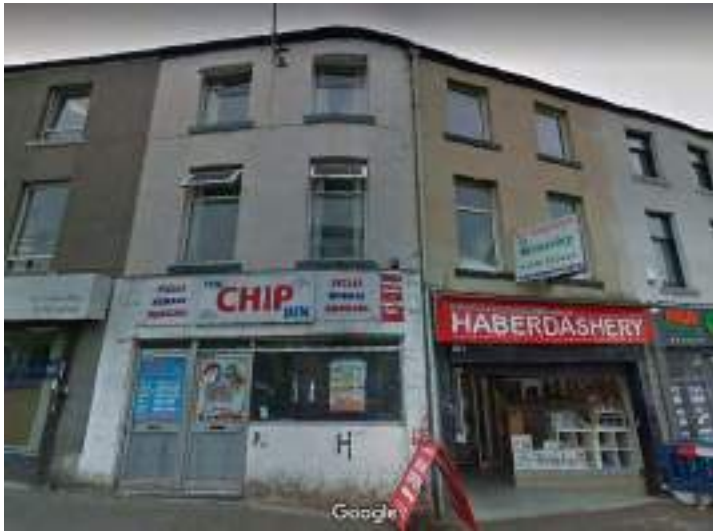
Figure 113: A 2018 Google Street View image of 10 Drake Street, showing the Chip Inn and its poorly painted and maintained c.1970s shopfront (Source: Google 2018).

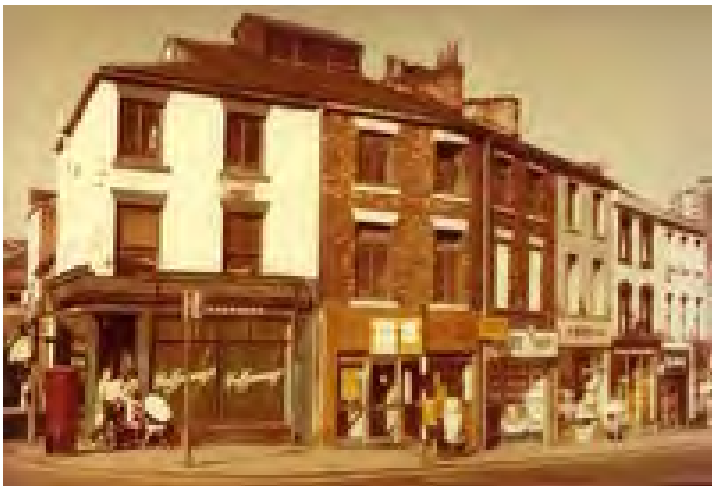
Figure 118: Photograph of 2-12 Drake Street, with 12 Drake Street in the foreground, showing the front façade to have been rendered and the windows on the first and second floor to have been replaced in the 1970s, but the historical timber-framed shopfront to still be extant (Source: Anstess1981a).

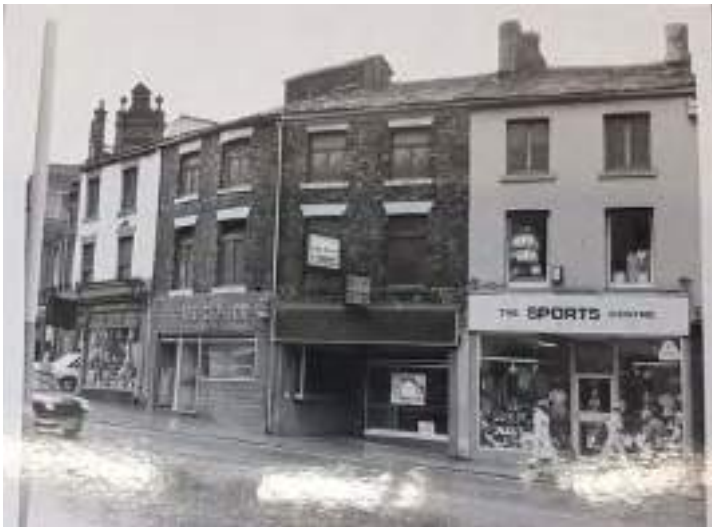
Figure 119: A photograph taken prior to 1984, showing the retained 19th century shopfront at 12 Drake Street (Source: TR Dig Streets 515).

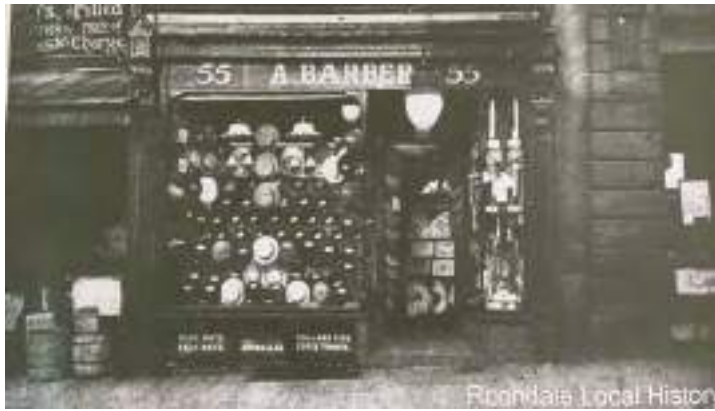
Figure 123: A c.1910 photograph of 55 Drake Street, showing the 19th-century timber-framed asymmetrical shopfront with a deep cornice, narrow fascia, a large open window, recessed splayed doorway, a timber stallriser and decorative corbels above the pilasters (Source: Rochdale Local History c.1910).

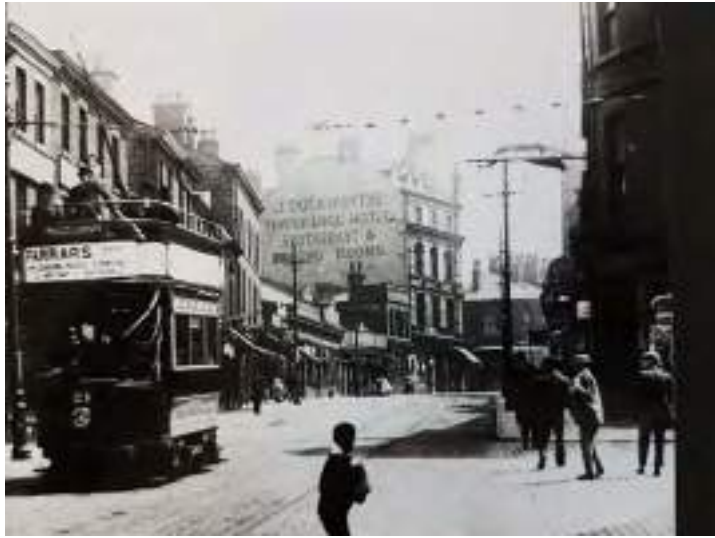
Figure 124: A c.1910 photograph along Drake Street near the junction at Fleece Street, showing the front and northern elevation of 55 Drake Street with a parapet and signage above the first floor. The shopfront appears to be a 19th century style timber-framed shopfront (Source: TR Dig Streets 513).

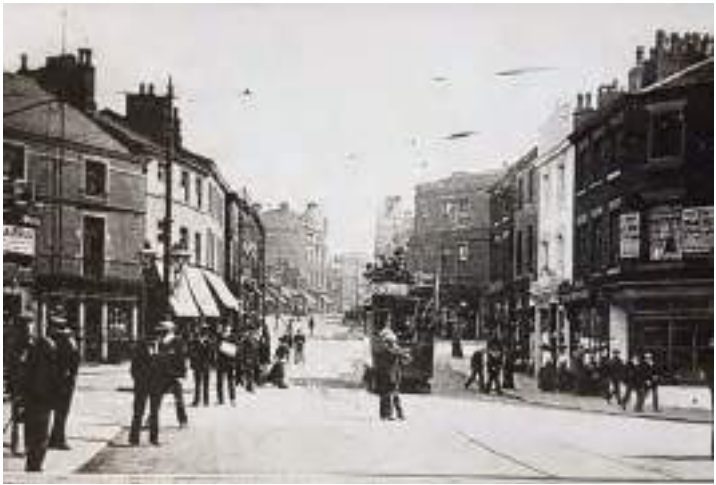
Figure 125: A c.1910 photograph of Drake Street from South Parade, showing 55 Drake Street with a retractable canvas awning (Source: TR Dig Streets 518).

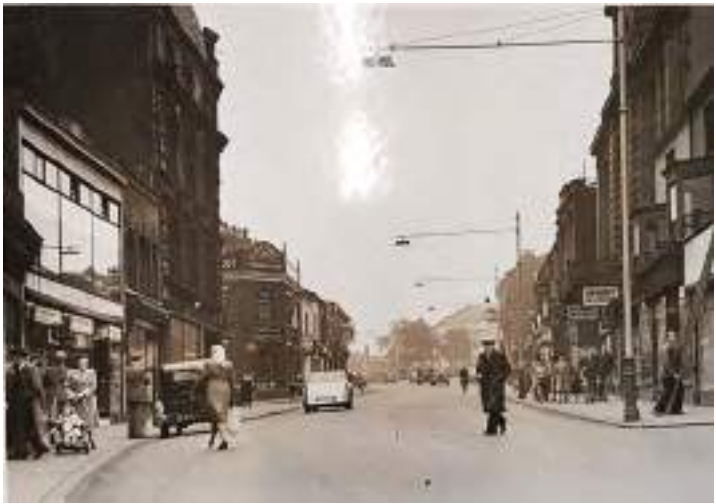
Figure 126: A 1955 photograph along Drake Street, showing the front elevation of 55 Drake Street with the earlier parapet and signage above the first floor to have been removed, but the shopfront appears to have retained its 19th century style timber-framed shopfront (Source: TR Dig Streets 513).

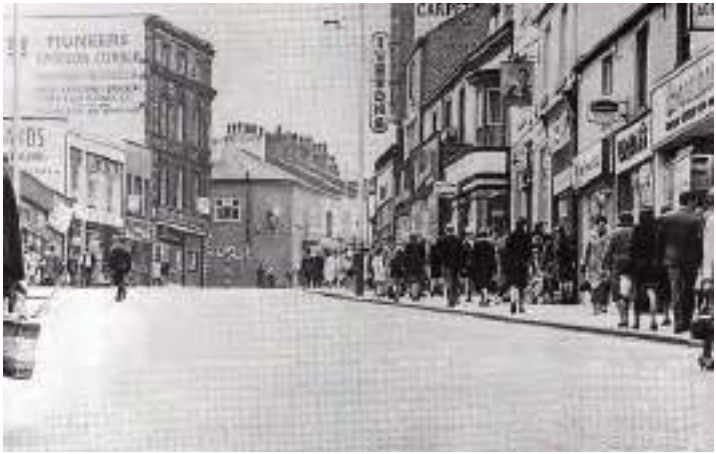
Figure 127: A 1965 photograph along Drake Street, showing the front elevation of 55 Drake Street showing shopfront to have been replaced with an unsympathetic shopfront (Source: Rochdale Local Studies).
