ROCHDALE HERITAGE ACTION ZONE – DRAKE STREET & SOUTH PARADE

ROCHDALE BOROUGH COUNCIL

HERITAGE STATEMENT AND PROPOSALS

DECEMBER 2019

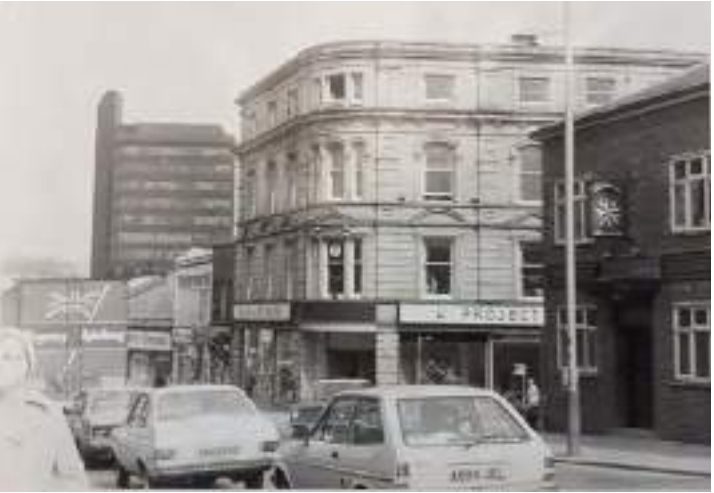
Figure 129: A 1980s photograph of Drake Street, showing 55 Drake Street on the right-hand side, with a large box awning installed above the shopfront (Source: TR Dig Streets 2159).

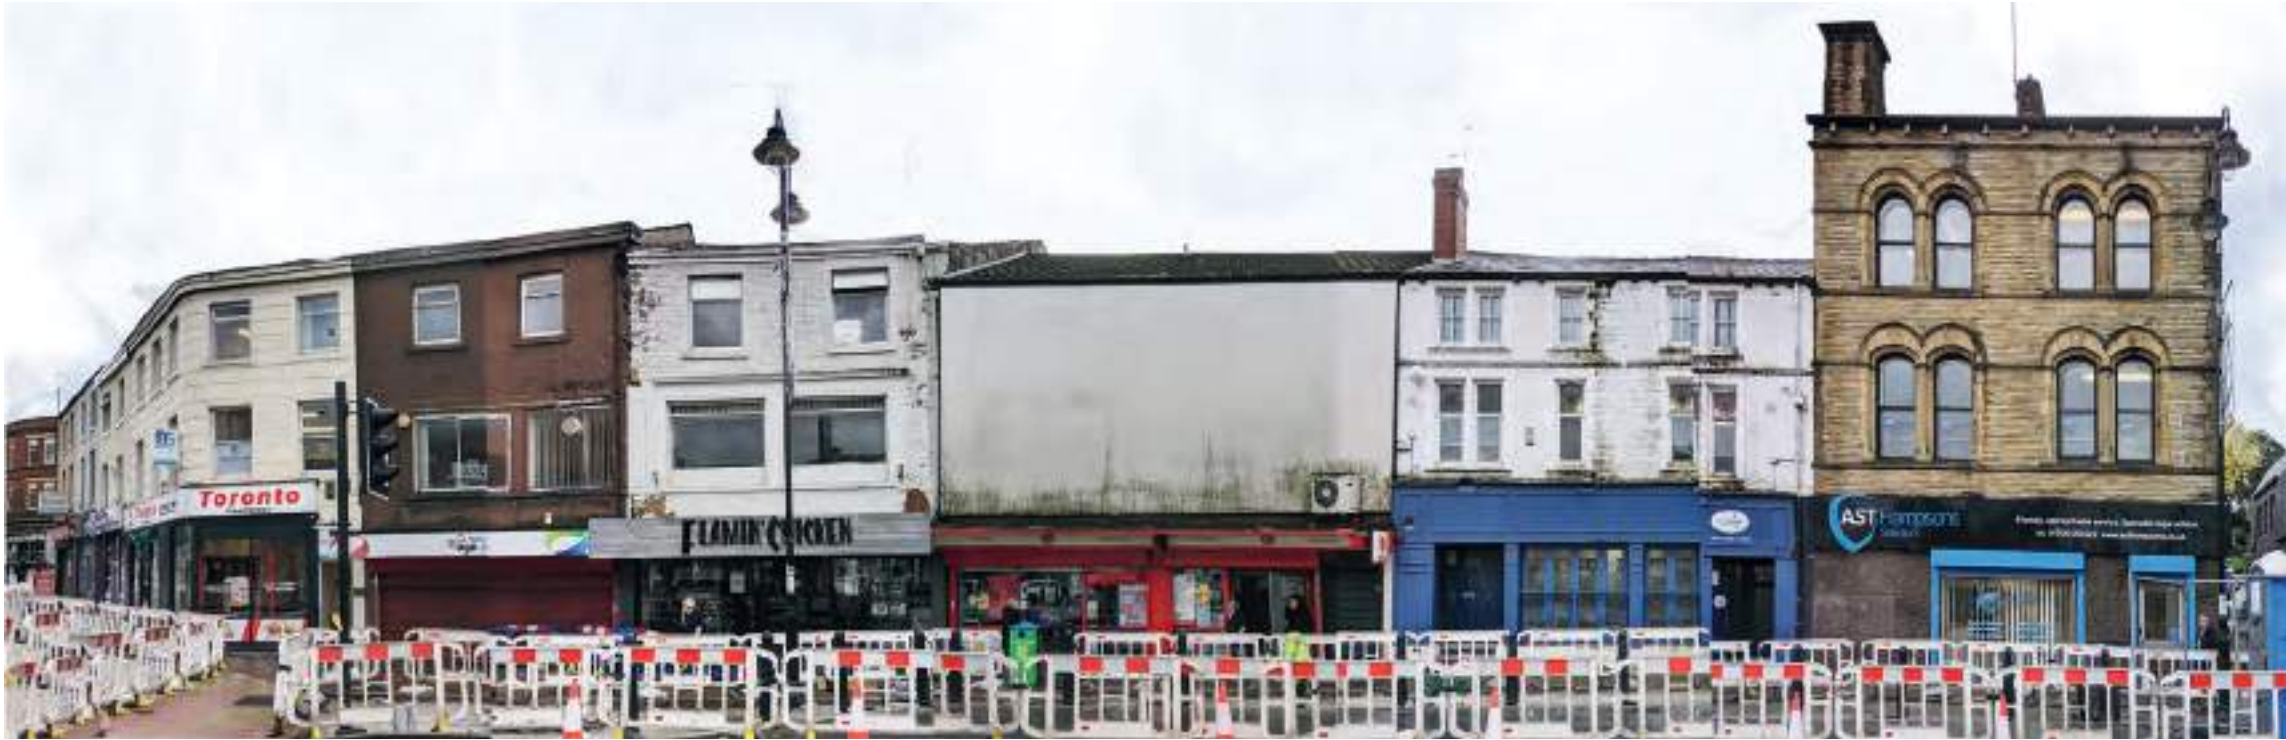
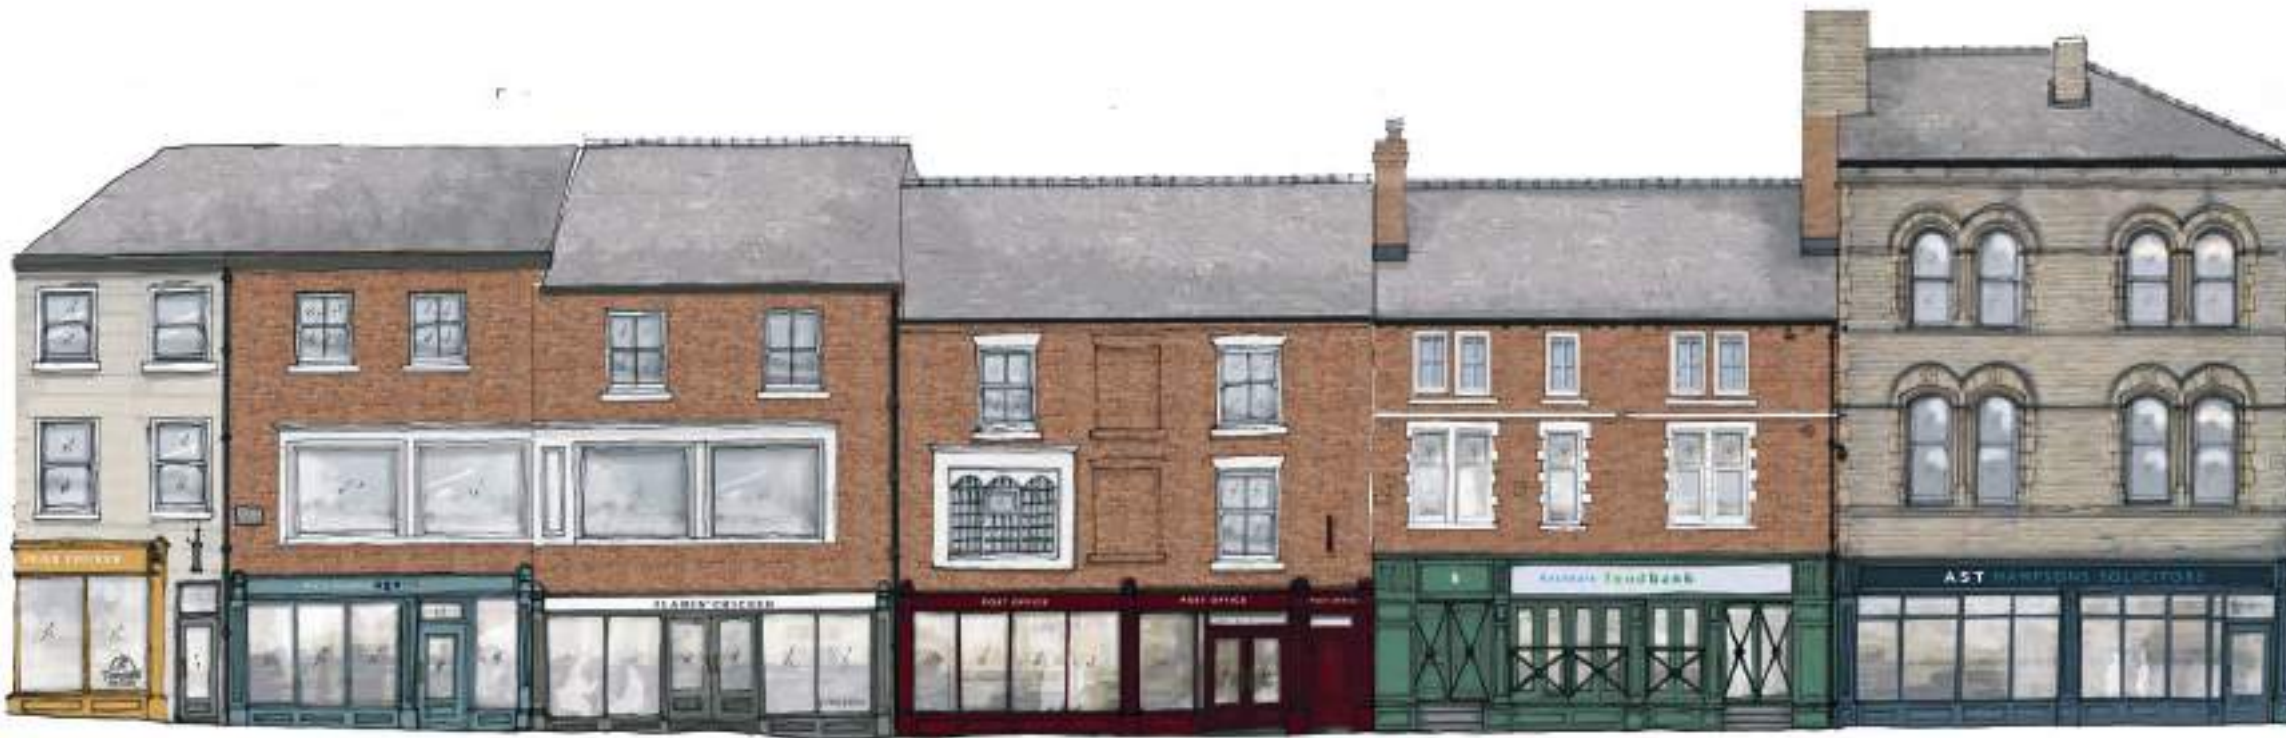
AS EXISTING

AS PROPOSED

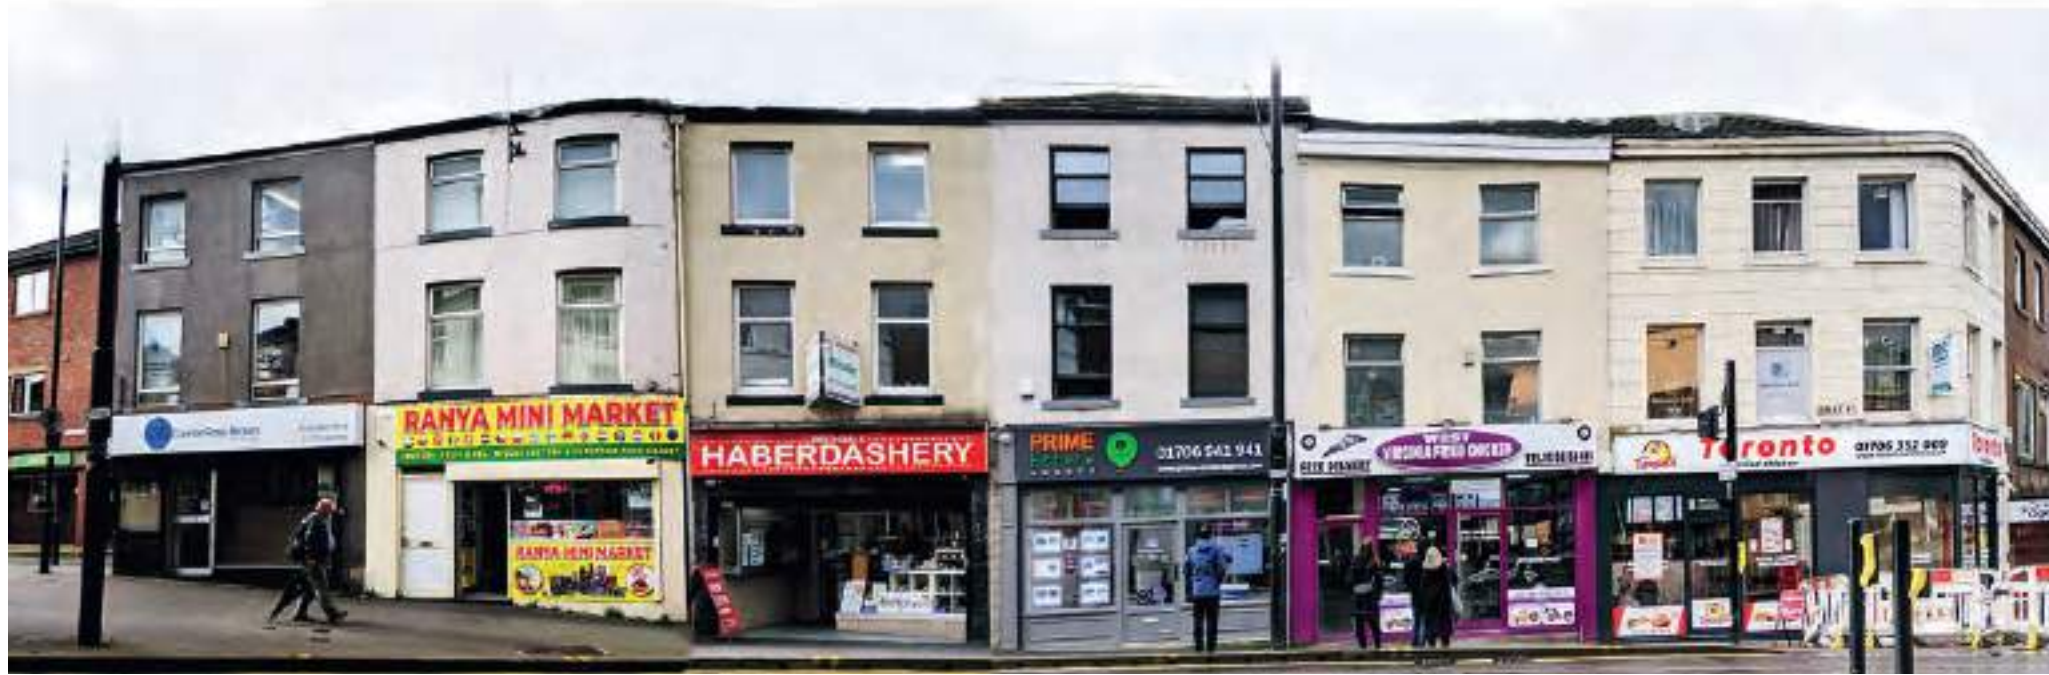
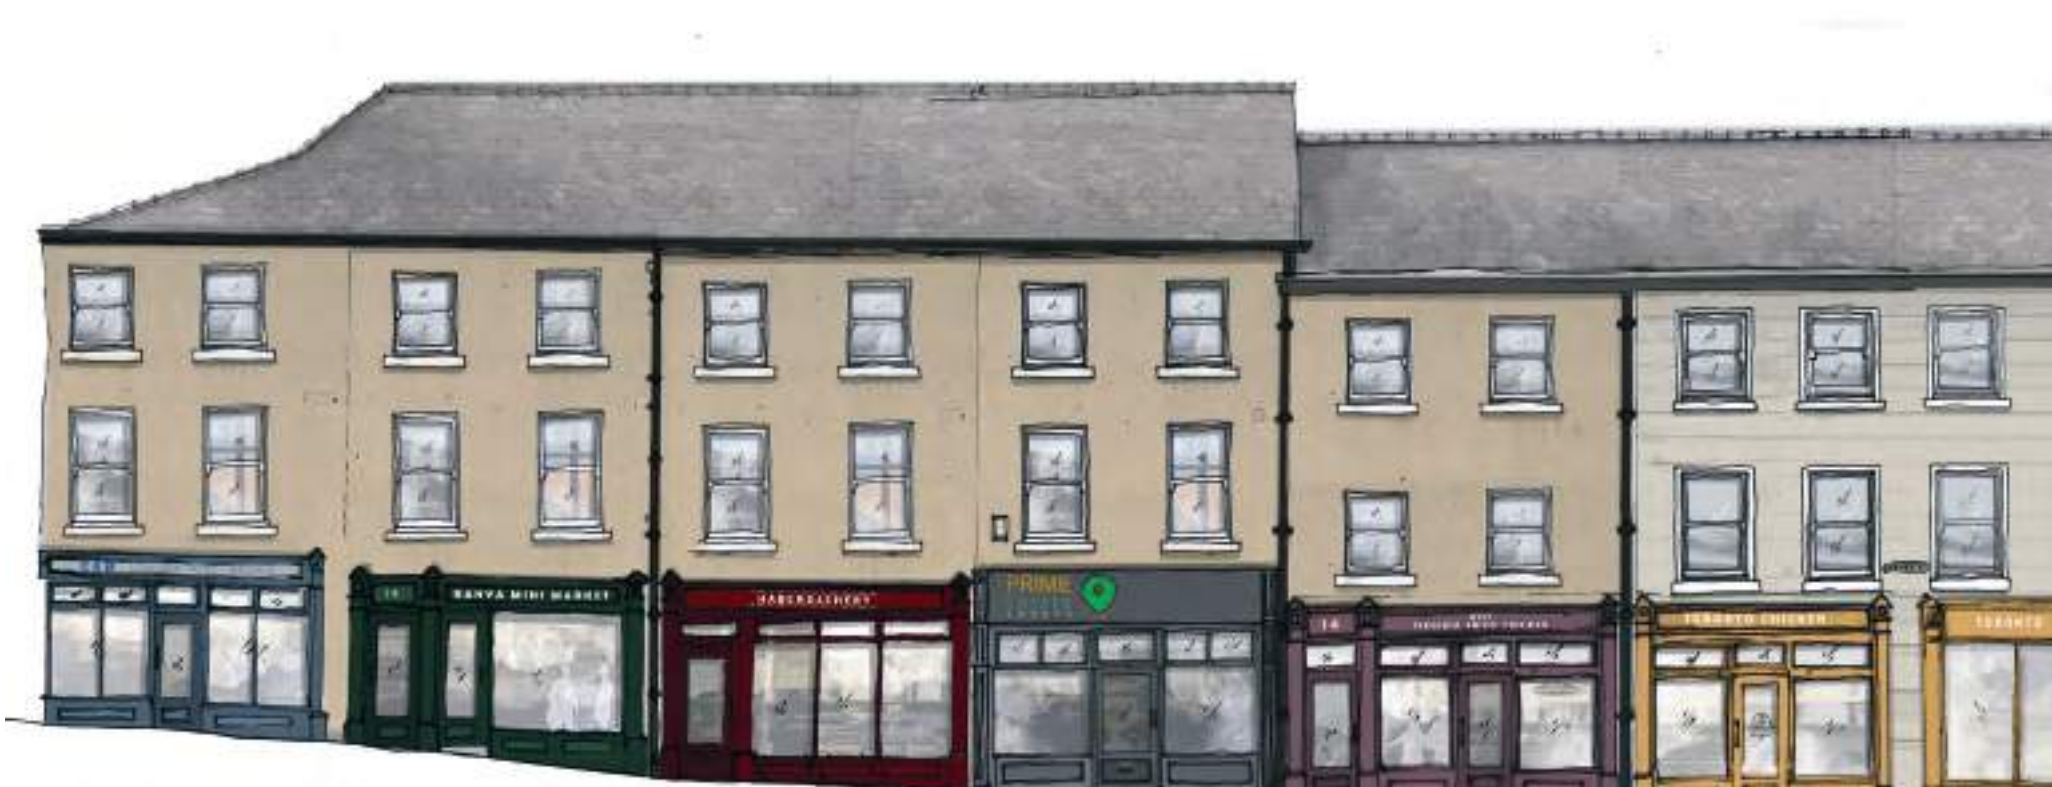
AS EXISTING

AS PROPOSED

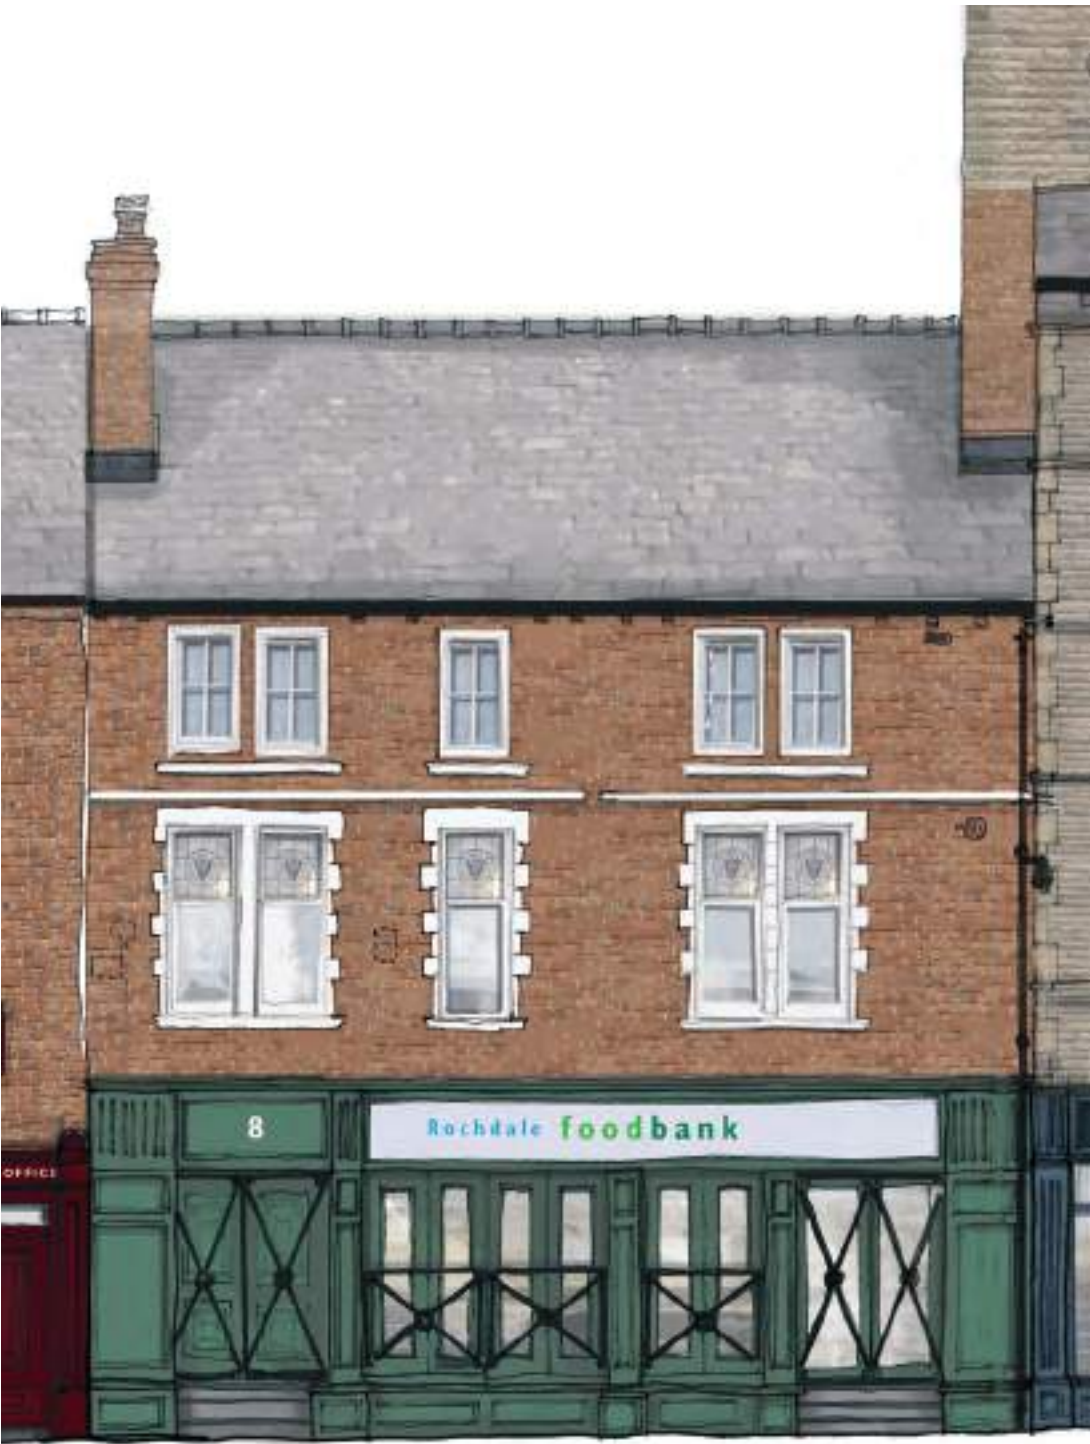
8 SOUTH PARADE

AS PROPOSED

Allow to replace / re-in force ridge beam.

Carefully strip existing roof and allow for the replacement of 50% of Reclaimed Welsh Slate to match existing size and colour. Install new Tyvec Supro membrane, treated 25x50mm timber batten and provide new welsh slates in accordance with BS-EN 12326-1. Copper annular nails. Code 4 lead stepped flashings to chimneys.

Allow for 30 No brick indents to be complete to repair damaged brickwork below. If in use, replace with black cast iron air bricks.

Overhaul windows and allow for repairs to timber frames. ,

Remove existing fascia board existing shopfront and lights. Provide new fascia as per drawing built using Medite Tricoya. New terme coated stainless steel cappings and flashings.

Carefully remove existing modern render to plinth to full width of building. Replace with a flush render with beading and redecorate.

Redecorate 3 No sets of railings and 2 No sets of doors in Dulux Weathershield – Black.

Provisional sum for works to steelwork and other elements upon removal of shop front.

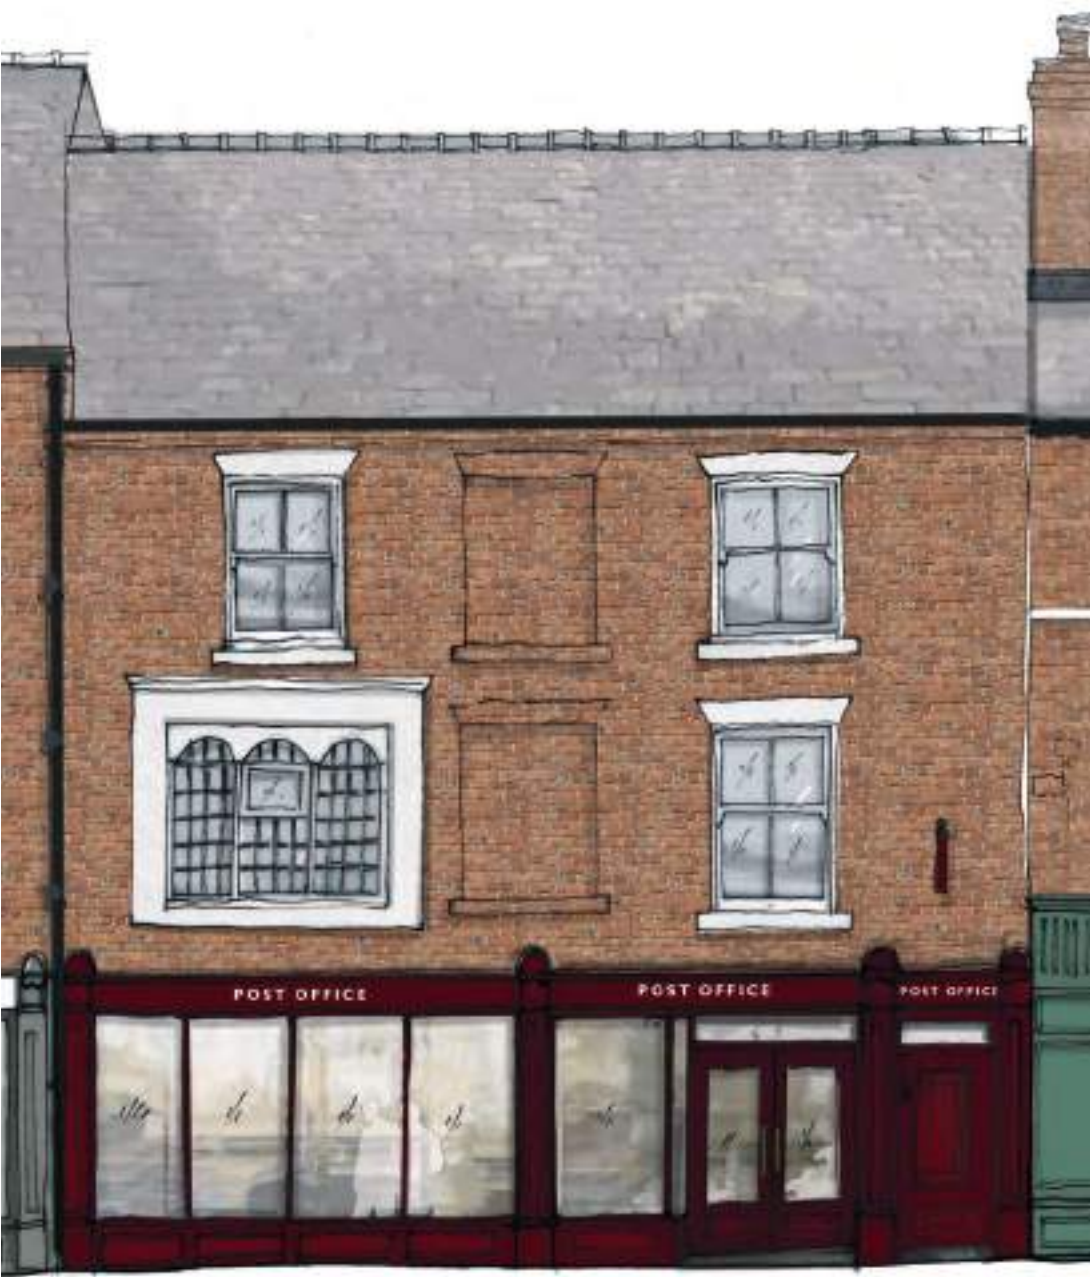
AS PROPOSED

Carefully remove existing gutter and replace with new cast iron ogee gutter on brackets. Allow for new 90-degree cast iron elbow to connect into adjacent downpipe.

Allow for 30 No brick indents to repair damaged brickwork.

Remove 3 No existing modern windows and insert new 3 No new Victorian 2 over 2 sash windows (with central bead), slimline double glazing. Accoya timber. Slimline double glazing. Traditional sash cord and weights. Traditional burn sand mastic joint.

Allow to remove one no large window and replace with a bespoke traditional leaded light window with Accoya timber frame and arched heads. Allow for window to blanked out behind with new partition painted black.

Provisional sum for works to steelwork and other elements upon removal of shop front due to condition.

New timber shop front and fascia with Terne coated stainless steel cappings and flashings. Laminated toughened glass. One recessed entrance with double glazed panelled doors. One new timber panelled door: Accoya timber and Medite Accoya. Antique brass ironmongery including kick plate, door handle, letterbox and self-closing device.

Remove existing modern square tiles to lobby and replace with stone to match highway.

Carefully remove approx. 1m2 of tiles in front of access door and replace with one piece of stone.

Install 3 No new metal grilles to interior of shop front.

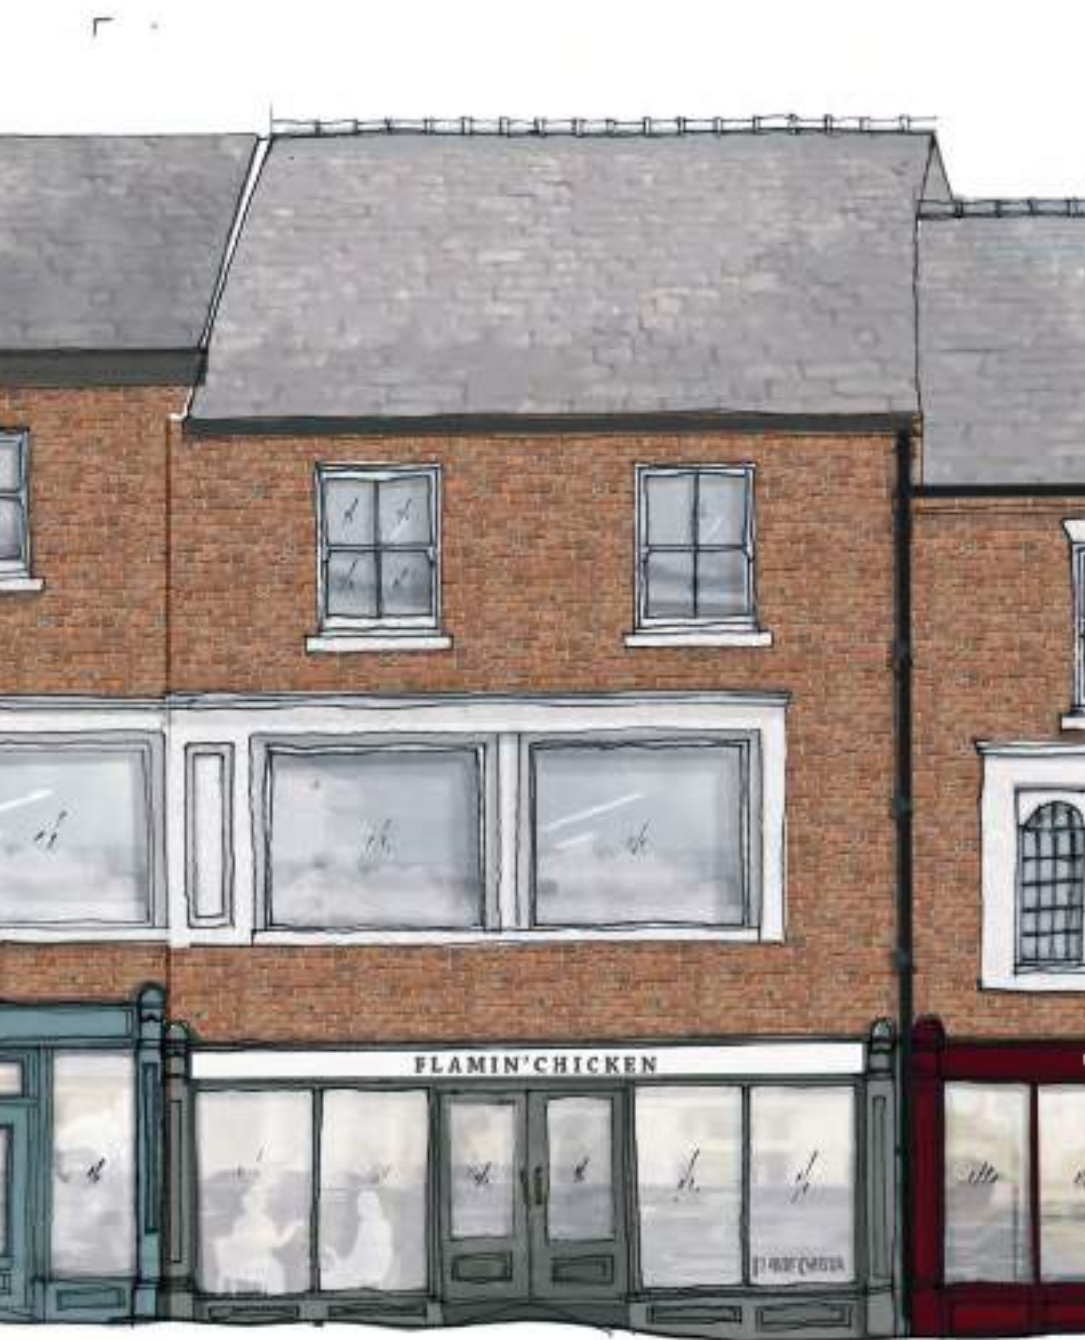
II SOUTH PARADE

AS PROPOSED

Hack off existing cementitious render to the West gabled end of property (adjoining 9-10 South Parade) to full extent of roof. Provide new terne coated stainless steel cladding.

Carefully strip existing roof and allow for the replacement of 50% of Reclaimed Welsh Slate to match existing size and colour. Install new Tyvec Supro membrane, treated 25x50mm timber batten and provide new welsh slates in accordance with BS-EN 12326-1. Copper annular nails. Code 4 lead stepped flashings and soakers to abutment on East side. Traditional slate verge detail to West.

Carefully remove existing gutter and barge board and replace with new cast iron ogee gutter on brackets decorated black.

Allow for 40 No brick indents to be complete to repair damaged brickwork throughout elevation.

Install new 2 No new Victorian 2 over 2 sash windows (with central bead), slimline double glazing. Accoya timber: Slimline double glazing. Traditional sash cord and weights. Traditional burn sand mastic joint. Allow for internals works.

Provisional sum for works to steelwork if in poor condition upon removal of shopfront.

New timber shop front and fascia with Terne coated stainless steel cappings and flashings. Laminated toughened glass. Accoya timber and Medite Accoya. Antique brass ironmongery including kick plate, door handle, letterbox and self-closing device.

Remove existing tiles to doorway (set back) and replace in stone.

Provisional sum – replace existing steel lintels above 2 No. Windows. Poor condition.

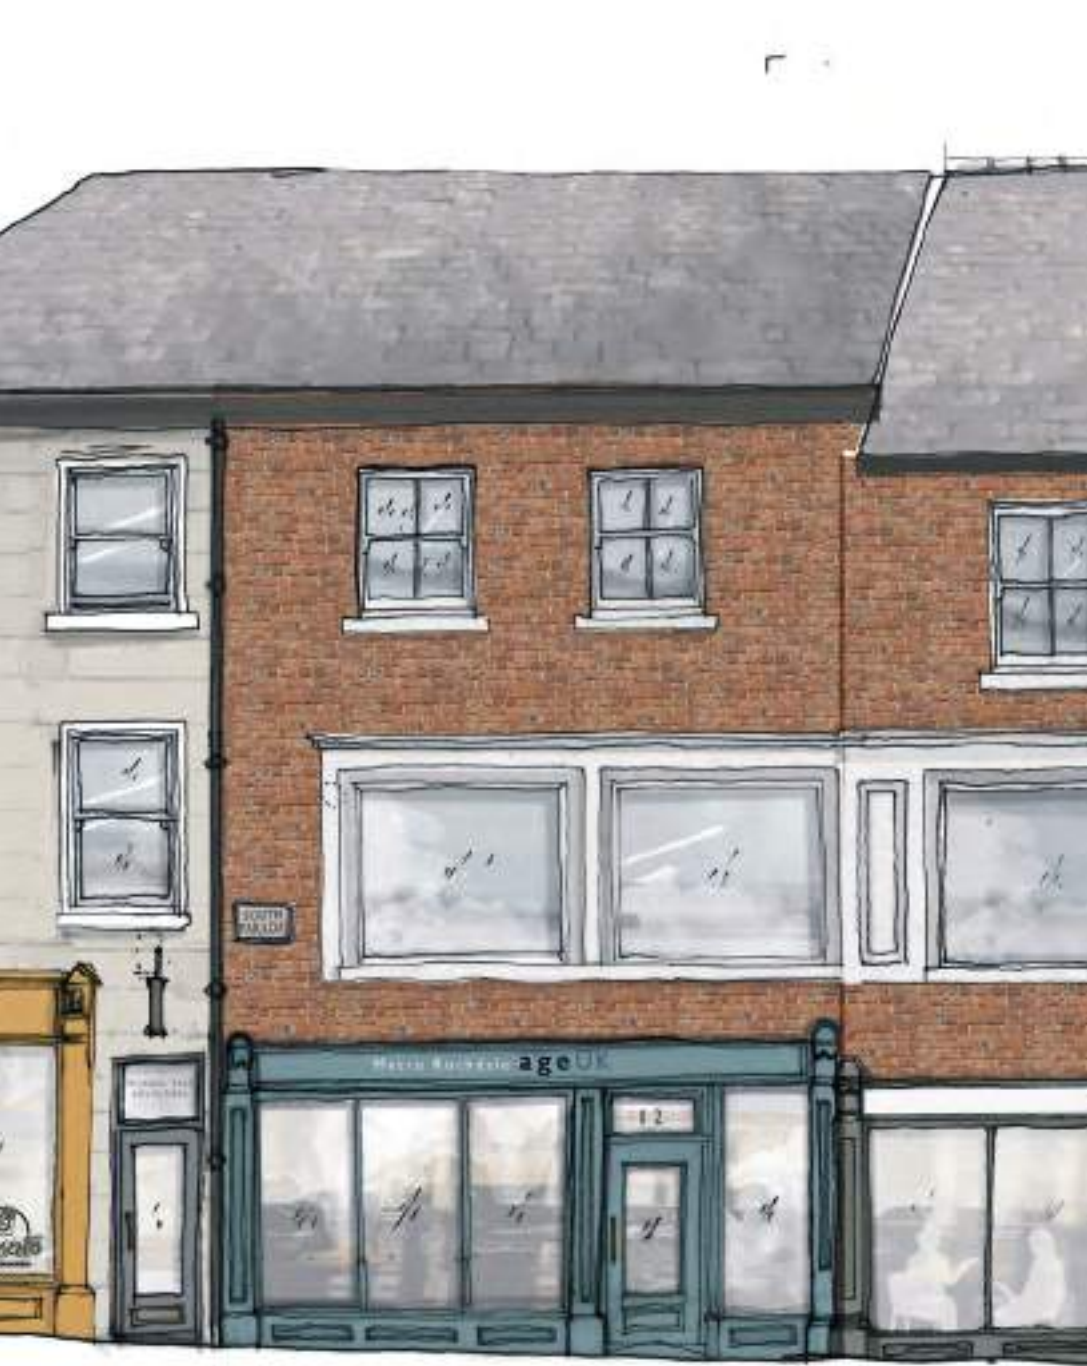
AS PROPOSED

PROPOSED WORKS

West verge to roof. Remove cementitious render to property. Install terne coated stainless steel cladding approx. 500mm high above lead soakers of neighbouring property. Traditional slate verge detail.

Carefully dismount existing timber gutter. Allow for repairs to joist ends. Re-instate in Accoya timber with a modern EPDM fleeced backed membrane. Falls to be adjusted to work new downpipes. Redecorate new gutter.

Remove 2 No. existing modern top casement to top floor and replace with traditional timber sash windows to match historic details. Accoya timber. Slimline double glazing. Traditional sash cord and weights. Traditional burn sand mastic joint. Allow for renewal to internal windowsill and reveals.

Remove 2 No. large modern sliding casements to first floor and replace with modern steel slimline double-glazed windows. Ventilation requirements and type of opening to be confirmed.

New timber shop front and fascia with Terne coated stainless steel cappings and flashings. Laminated toughened glass. Accoya timber and Medite Accoya. Antique brass ironmongery including kick plate, door handle, letterbox and self-closing device.

Allowance for bespoke new signage to fascia.

Renew existing external flooring outside door with natural stone to match highway. Approx 5m2.

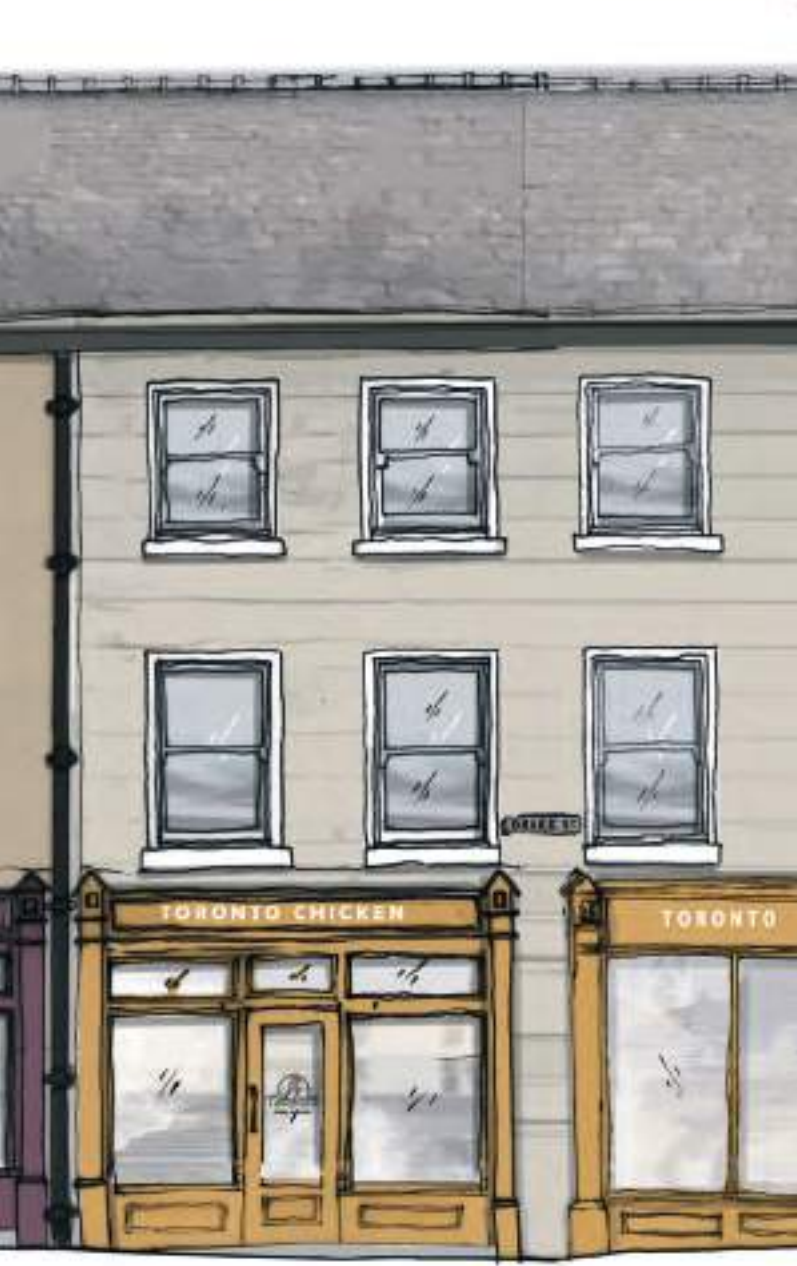
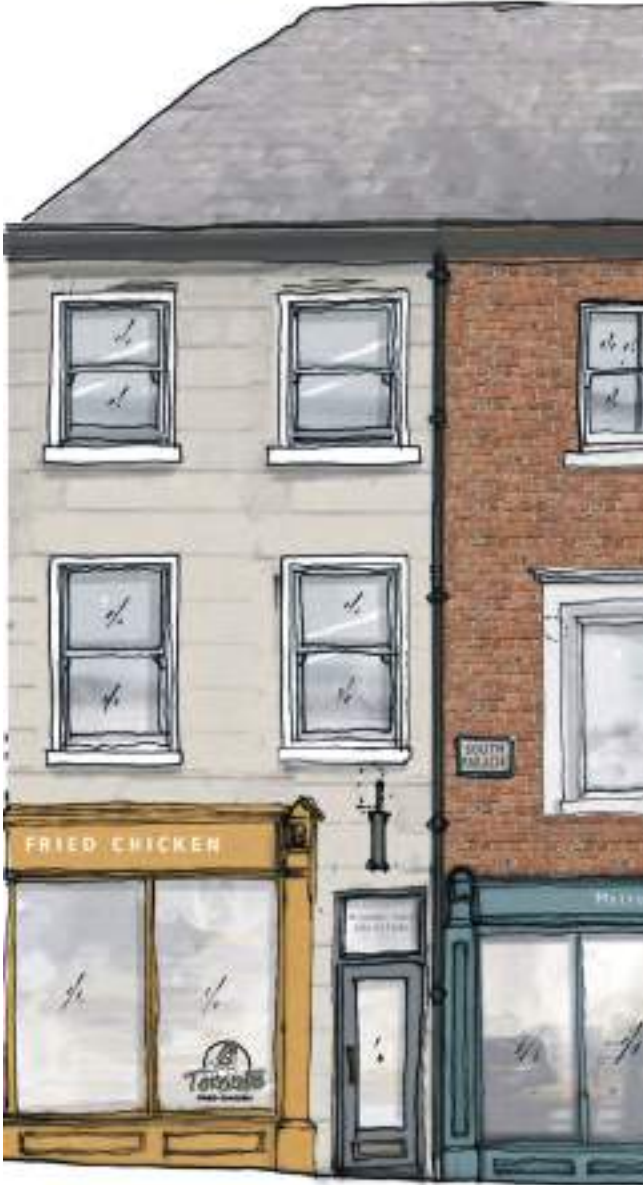
AS PROPOSED

PROPOSED WORKS

Carefully dismount existing timber gutter. Allow for repairs to joist ends. Re-instate in Accoya timber with a modern EPDM fleeced backed membrane. Falls to be adjusted to work new downpipes. Redecorate new gutter.

Remove existing modern illuminated sign and replace with 1 No new traditional timber handing painted sign above existing door. Allow for LED lighting.

Minor cracks within existing rendered surface. Fill with a render repair system. Allow provisional sum.

Carefully remove 7 no modern timber fixed / casement windows and replace with new off white traditional double sliding timber sash windows. Accoya timber. Slimline double glazing. Decoration. Traditional sash cord and weights. Traditional burn sand mastic joint to external perimeter. Pulleys, Sash lifts, sash stops and the like. Allow for new surrounds internally / making good and re-decorated.

3 Existing timber sash windows. Carefully remove modern single glazing, route out and replace with slimline double glazing. Overhaul sashes, allow for renewed sash cord and weights. Brush existing ironmongery down or renew. Redecorate off white. Provisional sum of £400 per sash to be allowed for additional repairs to timber.

New timber shop front and fascia with Terne coated stainless steel cappings and flashings. Laminated toughened glass. Accoya timber and Medite Accoya. Antique brass ironmongery including kick plate, door handle, letterbox and self-closing device.

Redecorate existing corner cylinder hollow section on corner.

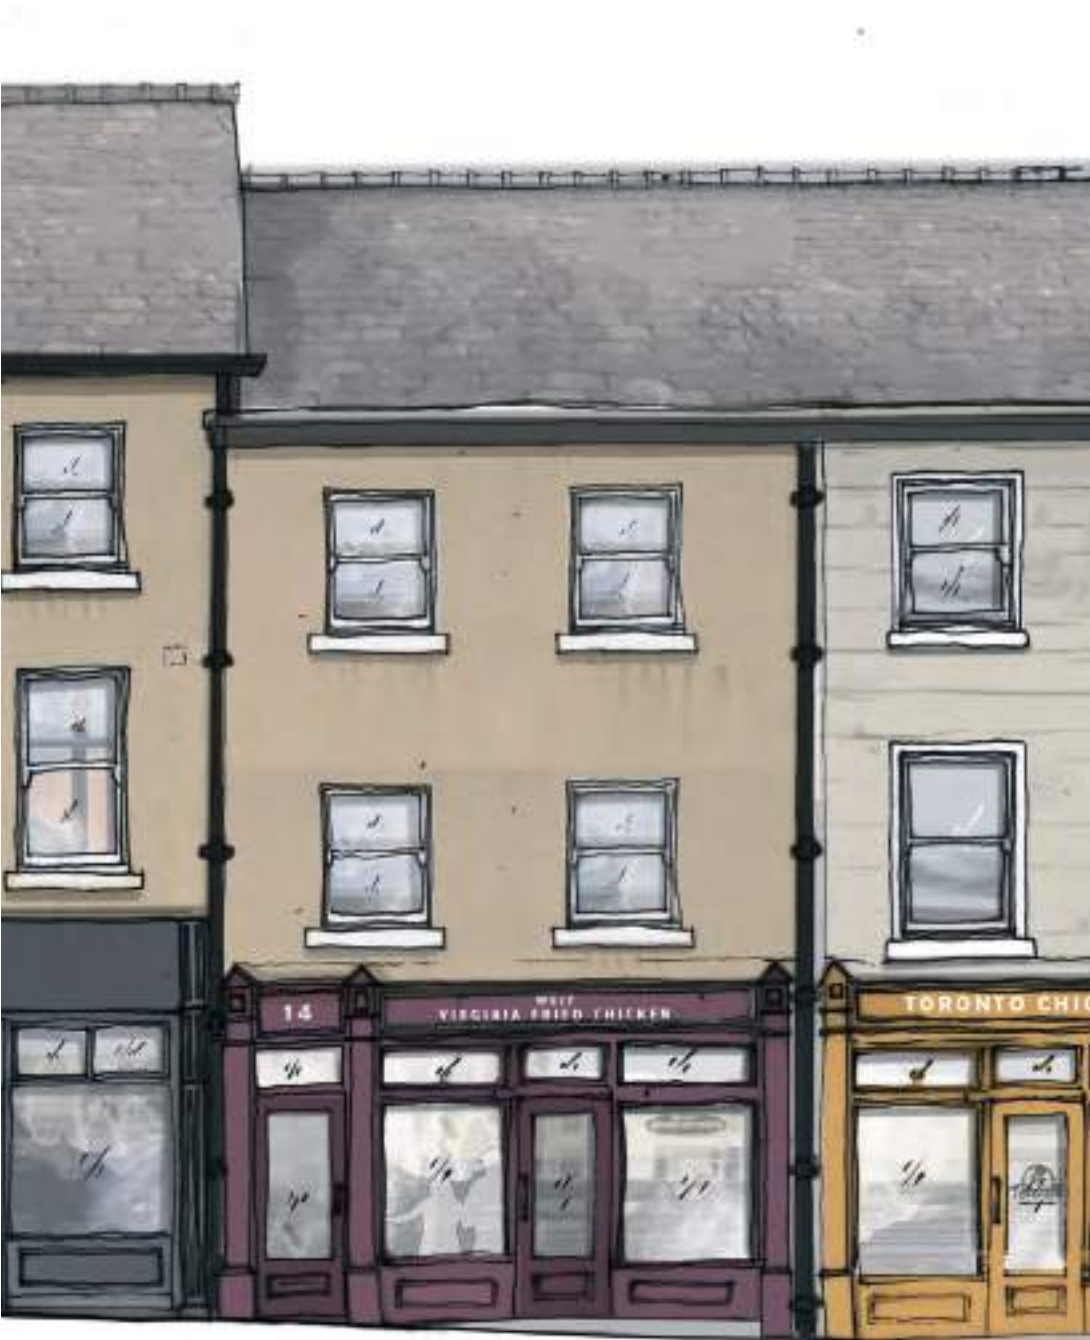
AS PROPOSED

PROPOSED WORKS

Ridge member to be strengthened or replaced.

Carefully dismount existing timber gutter. Allow for repairs to joist ends. Re-instate in Accoya timber with a modern EPDM fleeced backed membrane. Falls to be adjusted to work new downpipes. Redecorate new gutter.

Allow for patch repair to render at high level upon removal of barge board. Say 4 m2 in NHL 3.5.

Replace 4 no modern PVC windows with 4 No traditional timber sash windows to match historic details. Accoya timber. Slimline double glazing. Traditional sash cord and weights. Traditional burn sand mastic joint. Allow for renewal to internal windowsill and reveals.

Second floor - Carry out further levelling of floor once recommendations at first floor have been carried out. Lift all floorboards

New timber shop front and fascia with Terne coated stainless steel cappings and flashings. Laminated toughened glass. Accoya timber and Medite Accoya. Antique brass ironmongery including kick plate, door handle, letterbox and self-closing device.

Allowance for bespoke new signage to 1 fascia with associated LED lighting.

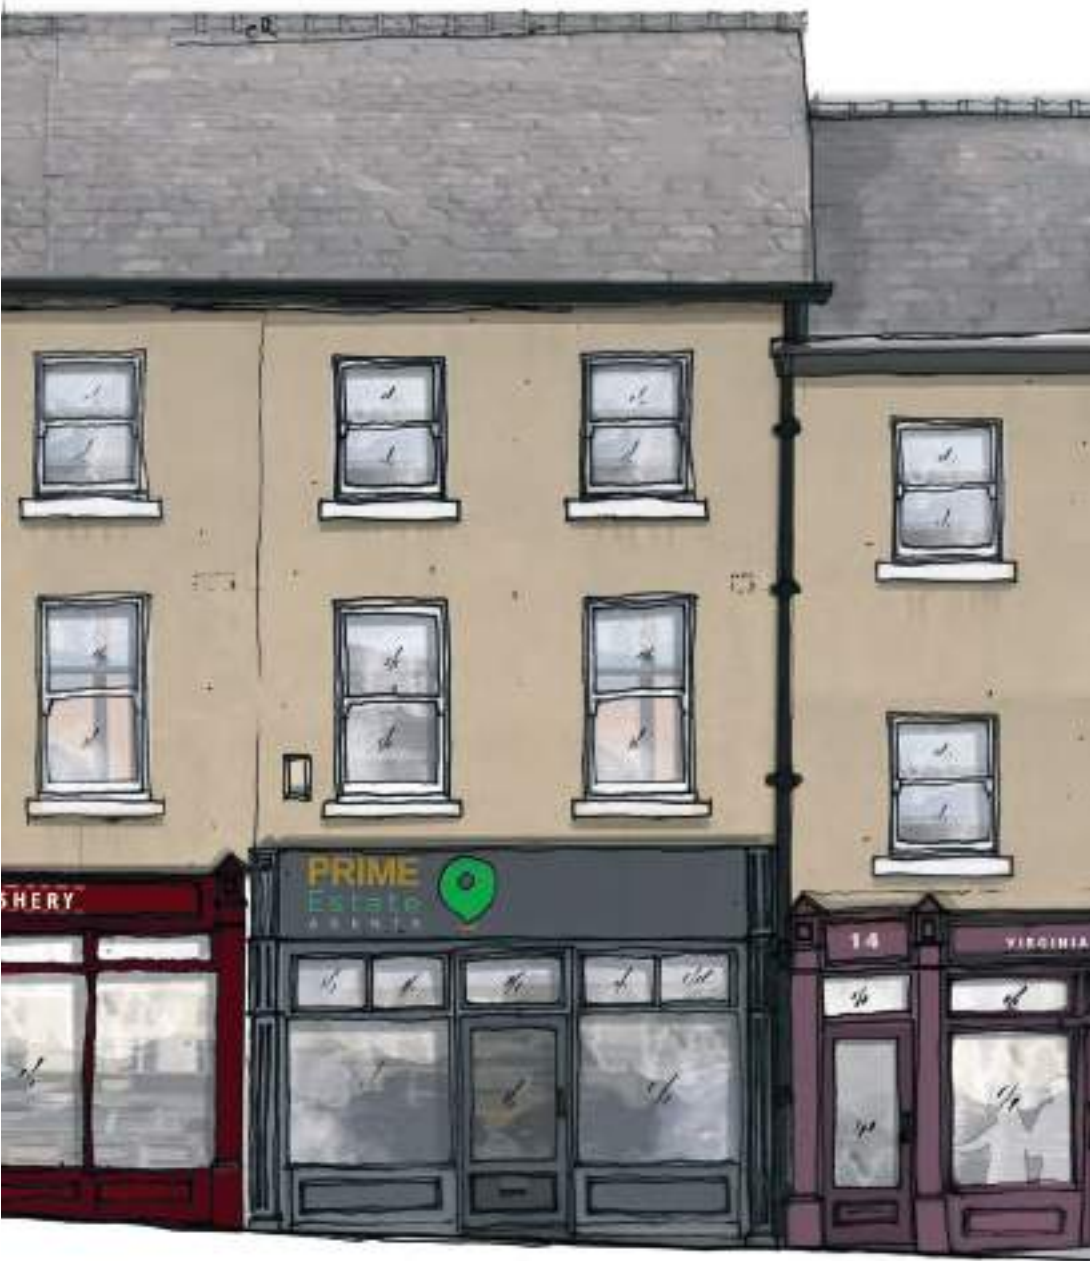
AS PROPOSED

PROPOSED WORKS

Carefully strip existing roof and allow for the replacement of 50% of Reclaimed Welsh Slate to match existing size and colour. Install new Tyvec Supro membrane, treated 25x50mm timber batten and provide new welsh slates in accordance with BS-EN 12326-1. Copper annular nails. Code 4 lead stepped flashings and soakers to abutment on East side. Traditional slate verge detail to West.

Adjust console brackets?

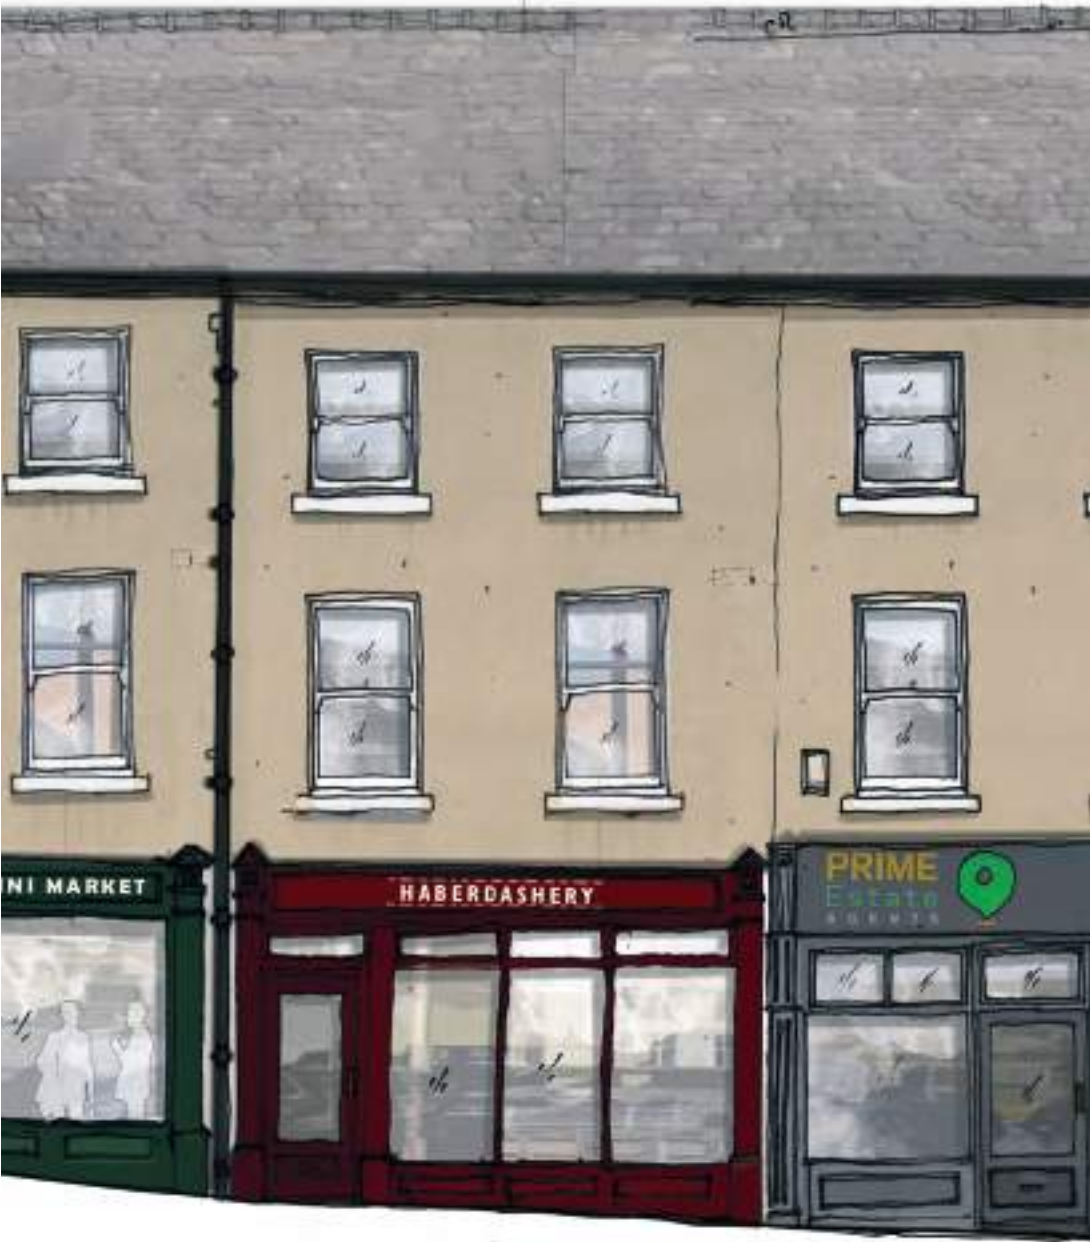
AS PROPOSED

PROPOSED WORKS

Allow for 20 No brick indents to be complete to repair damaged brickwork throughout elevation.

Allow for internal metal grilles to interior of shopfront.

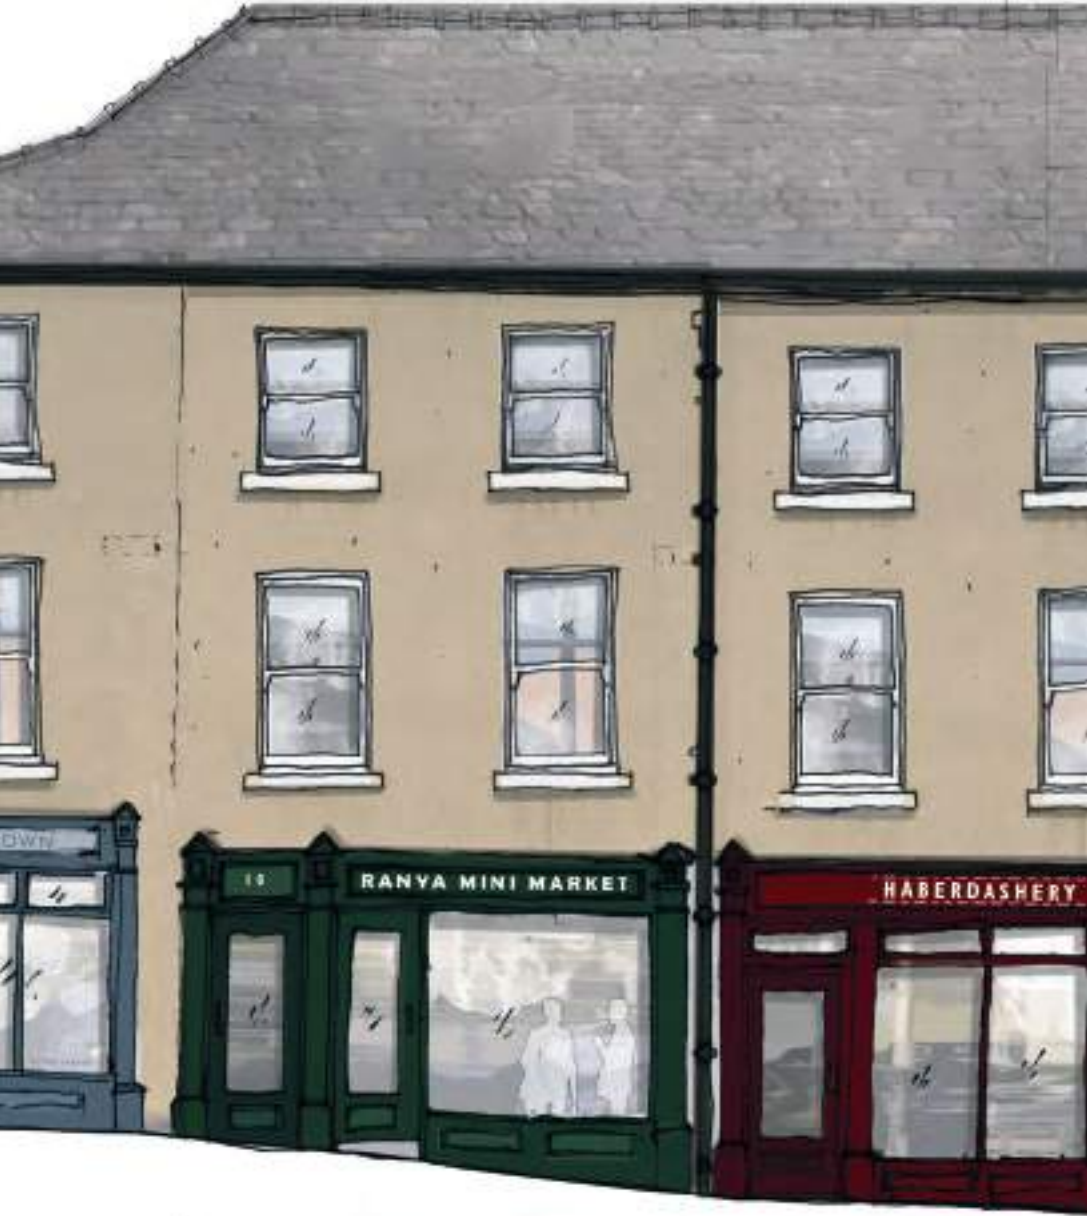
AS PROPOSED

PROPOSED WORKS

Allow for internal metal grilles to interior of shopfront.
