ROCHDALE HERITAGE ACTION ZONE – DRAKE STREET & SOUTH PARADE

ROCHDALE BOROUGH COUNCIL

HERITAGE STATEMENT AND PROPOSALS

DECEMBER 2019

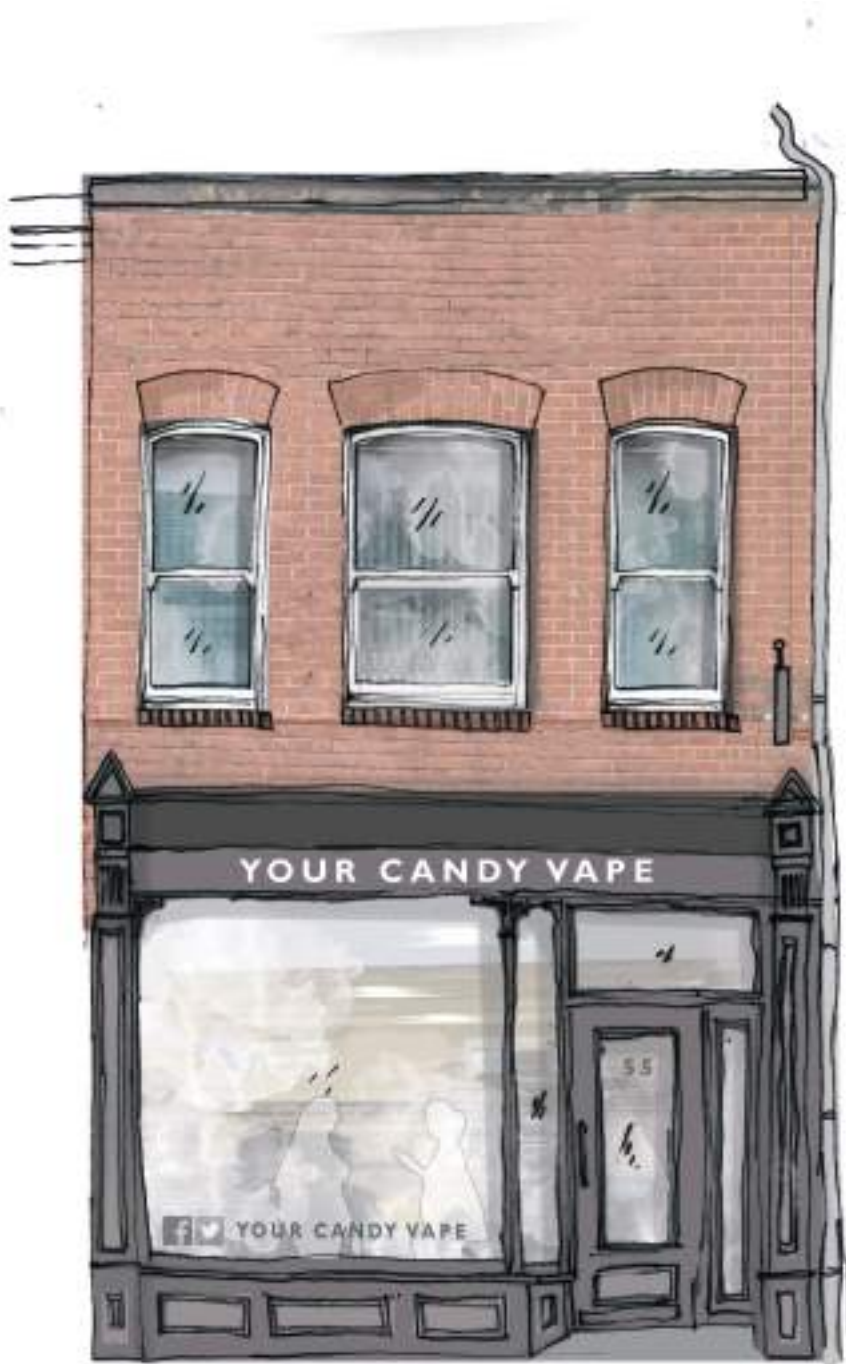
AS PROPOSED

Allow for double sided metal entrance gate to entrance door for security

Consider replacing 3 No. brick sills with new stone sills.

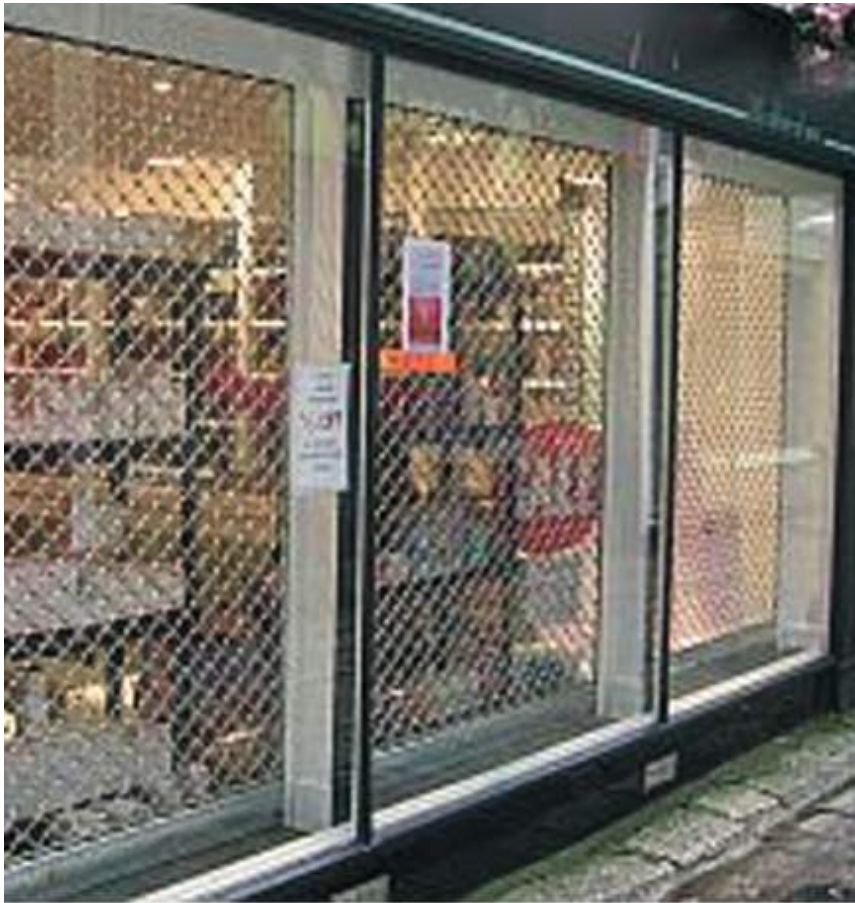
INTERNAL SECURITY GRILLES

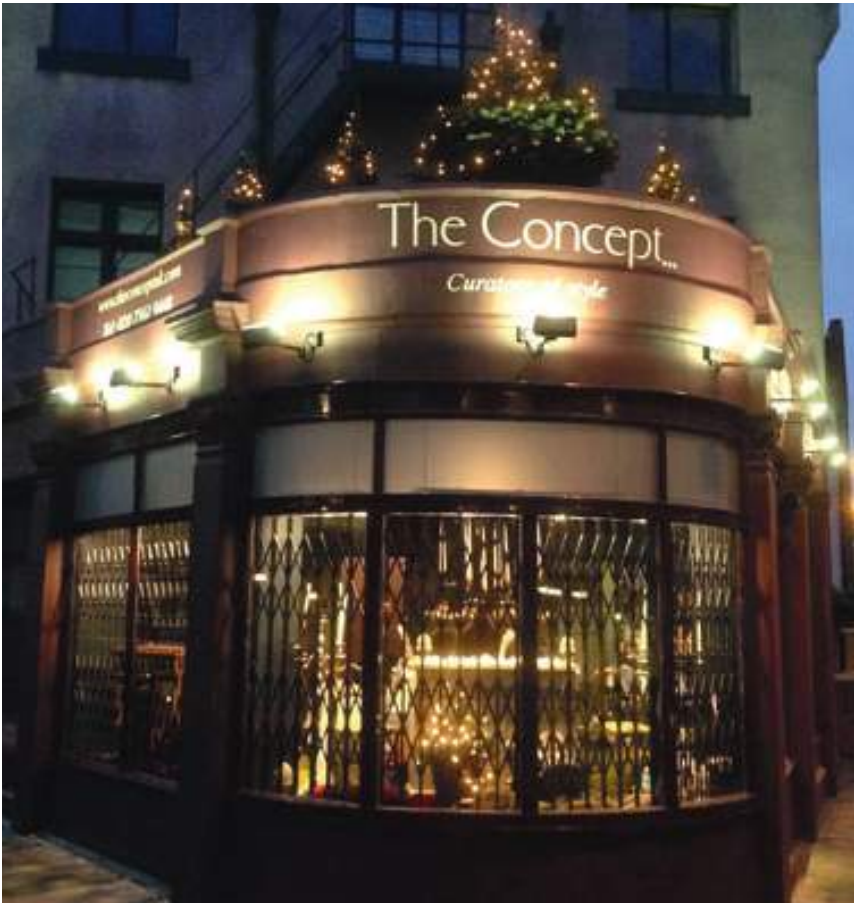
TRADITIONAL INTERNAL GRILLES

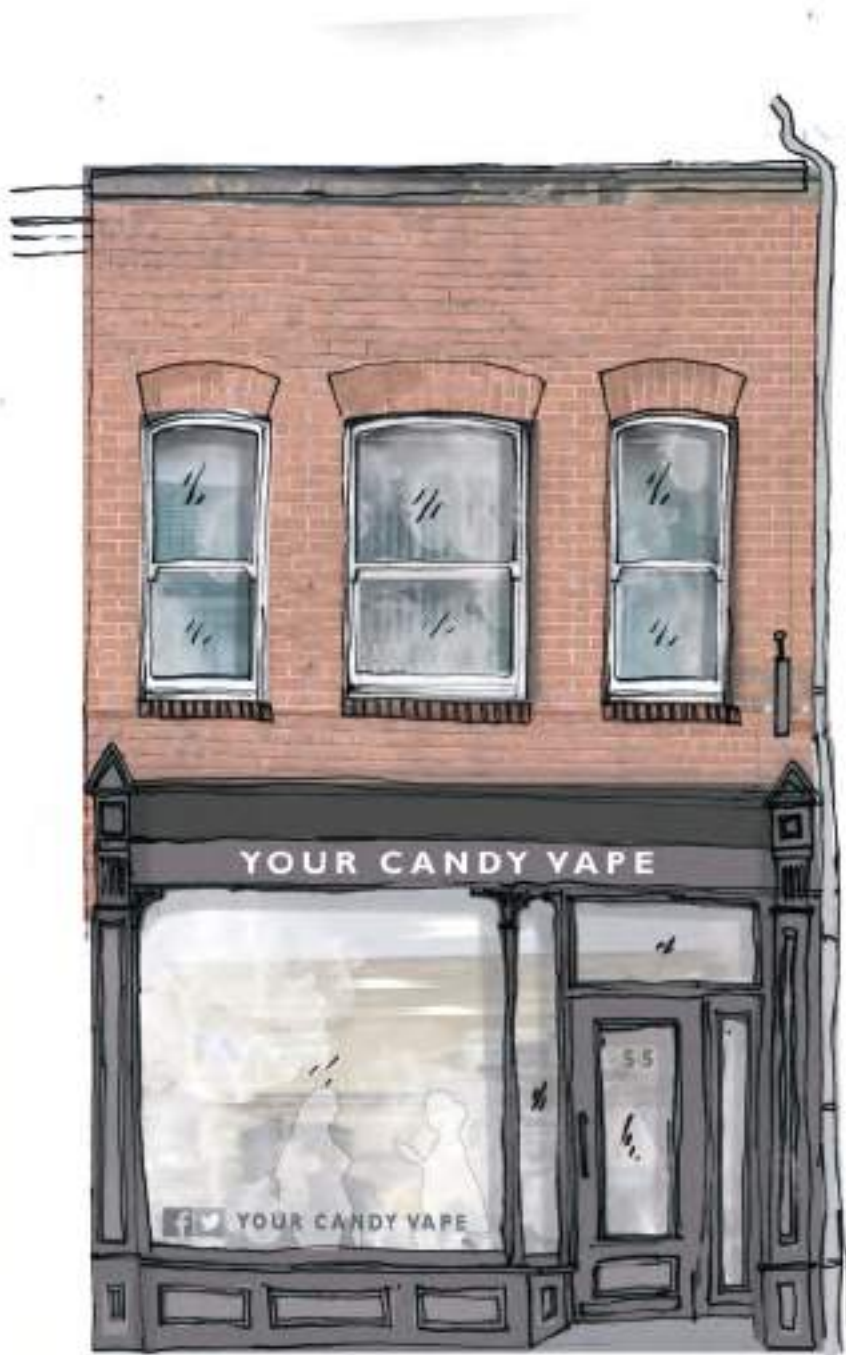
AS PROPOSED

Allow for double sided metal entrance gate to entrance door for security

Consider replacing 3 No. brick sills with new stone sills.

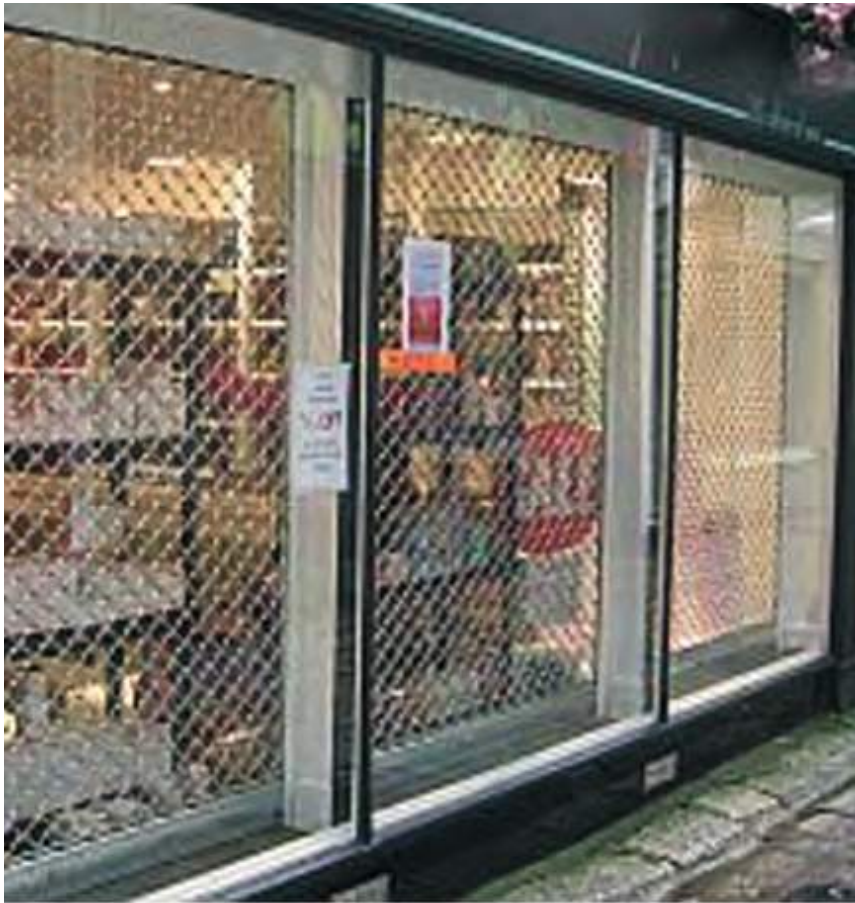
INTERNAL SECURITY GRILLES

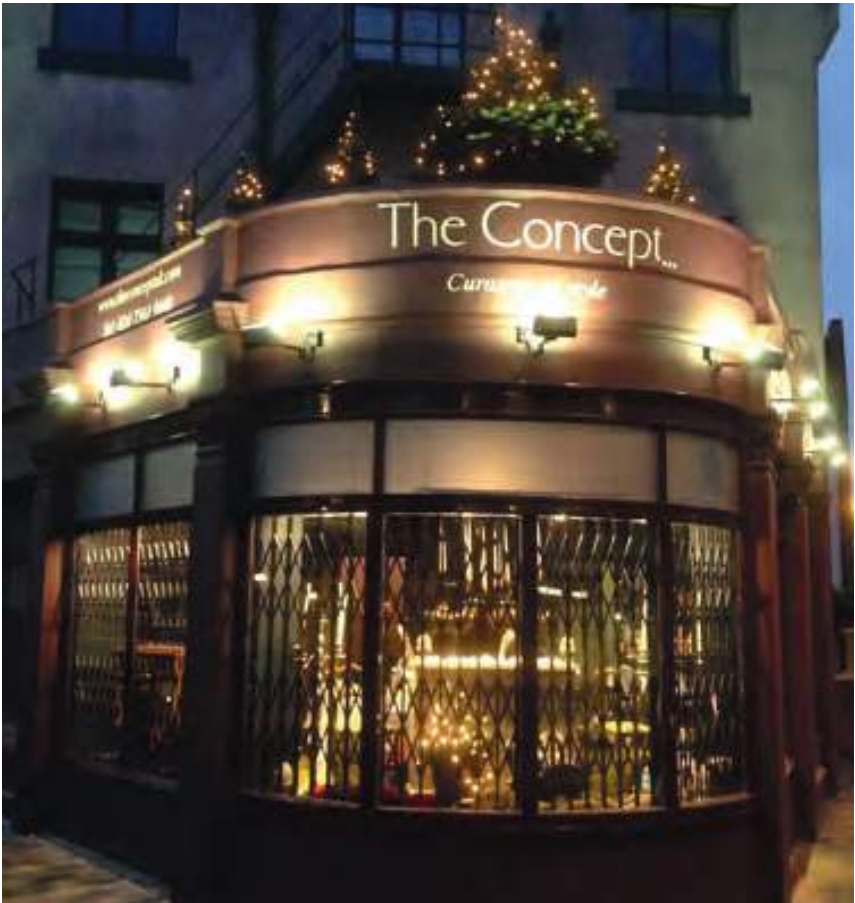
TRADITIONAL INTERNAL GRILLES
