TRIANGLE  
ARCHITECTS

| WHI - TRI - ZZ - ZZ - DR - A - 3001 | | | 21-032 / Whitworth Road, Rochdale |
| | | | Site Constraints Diagram |

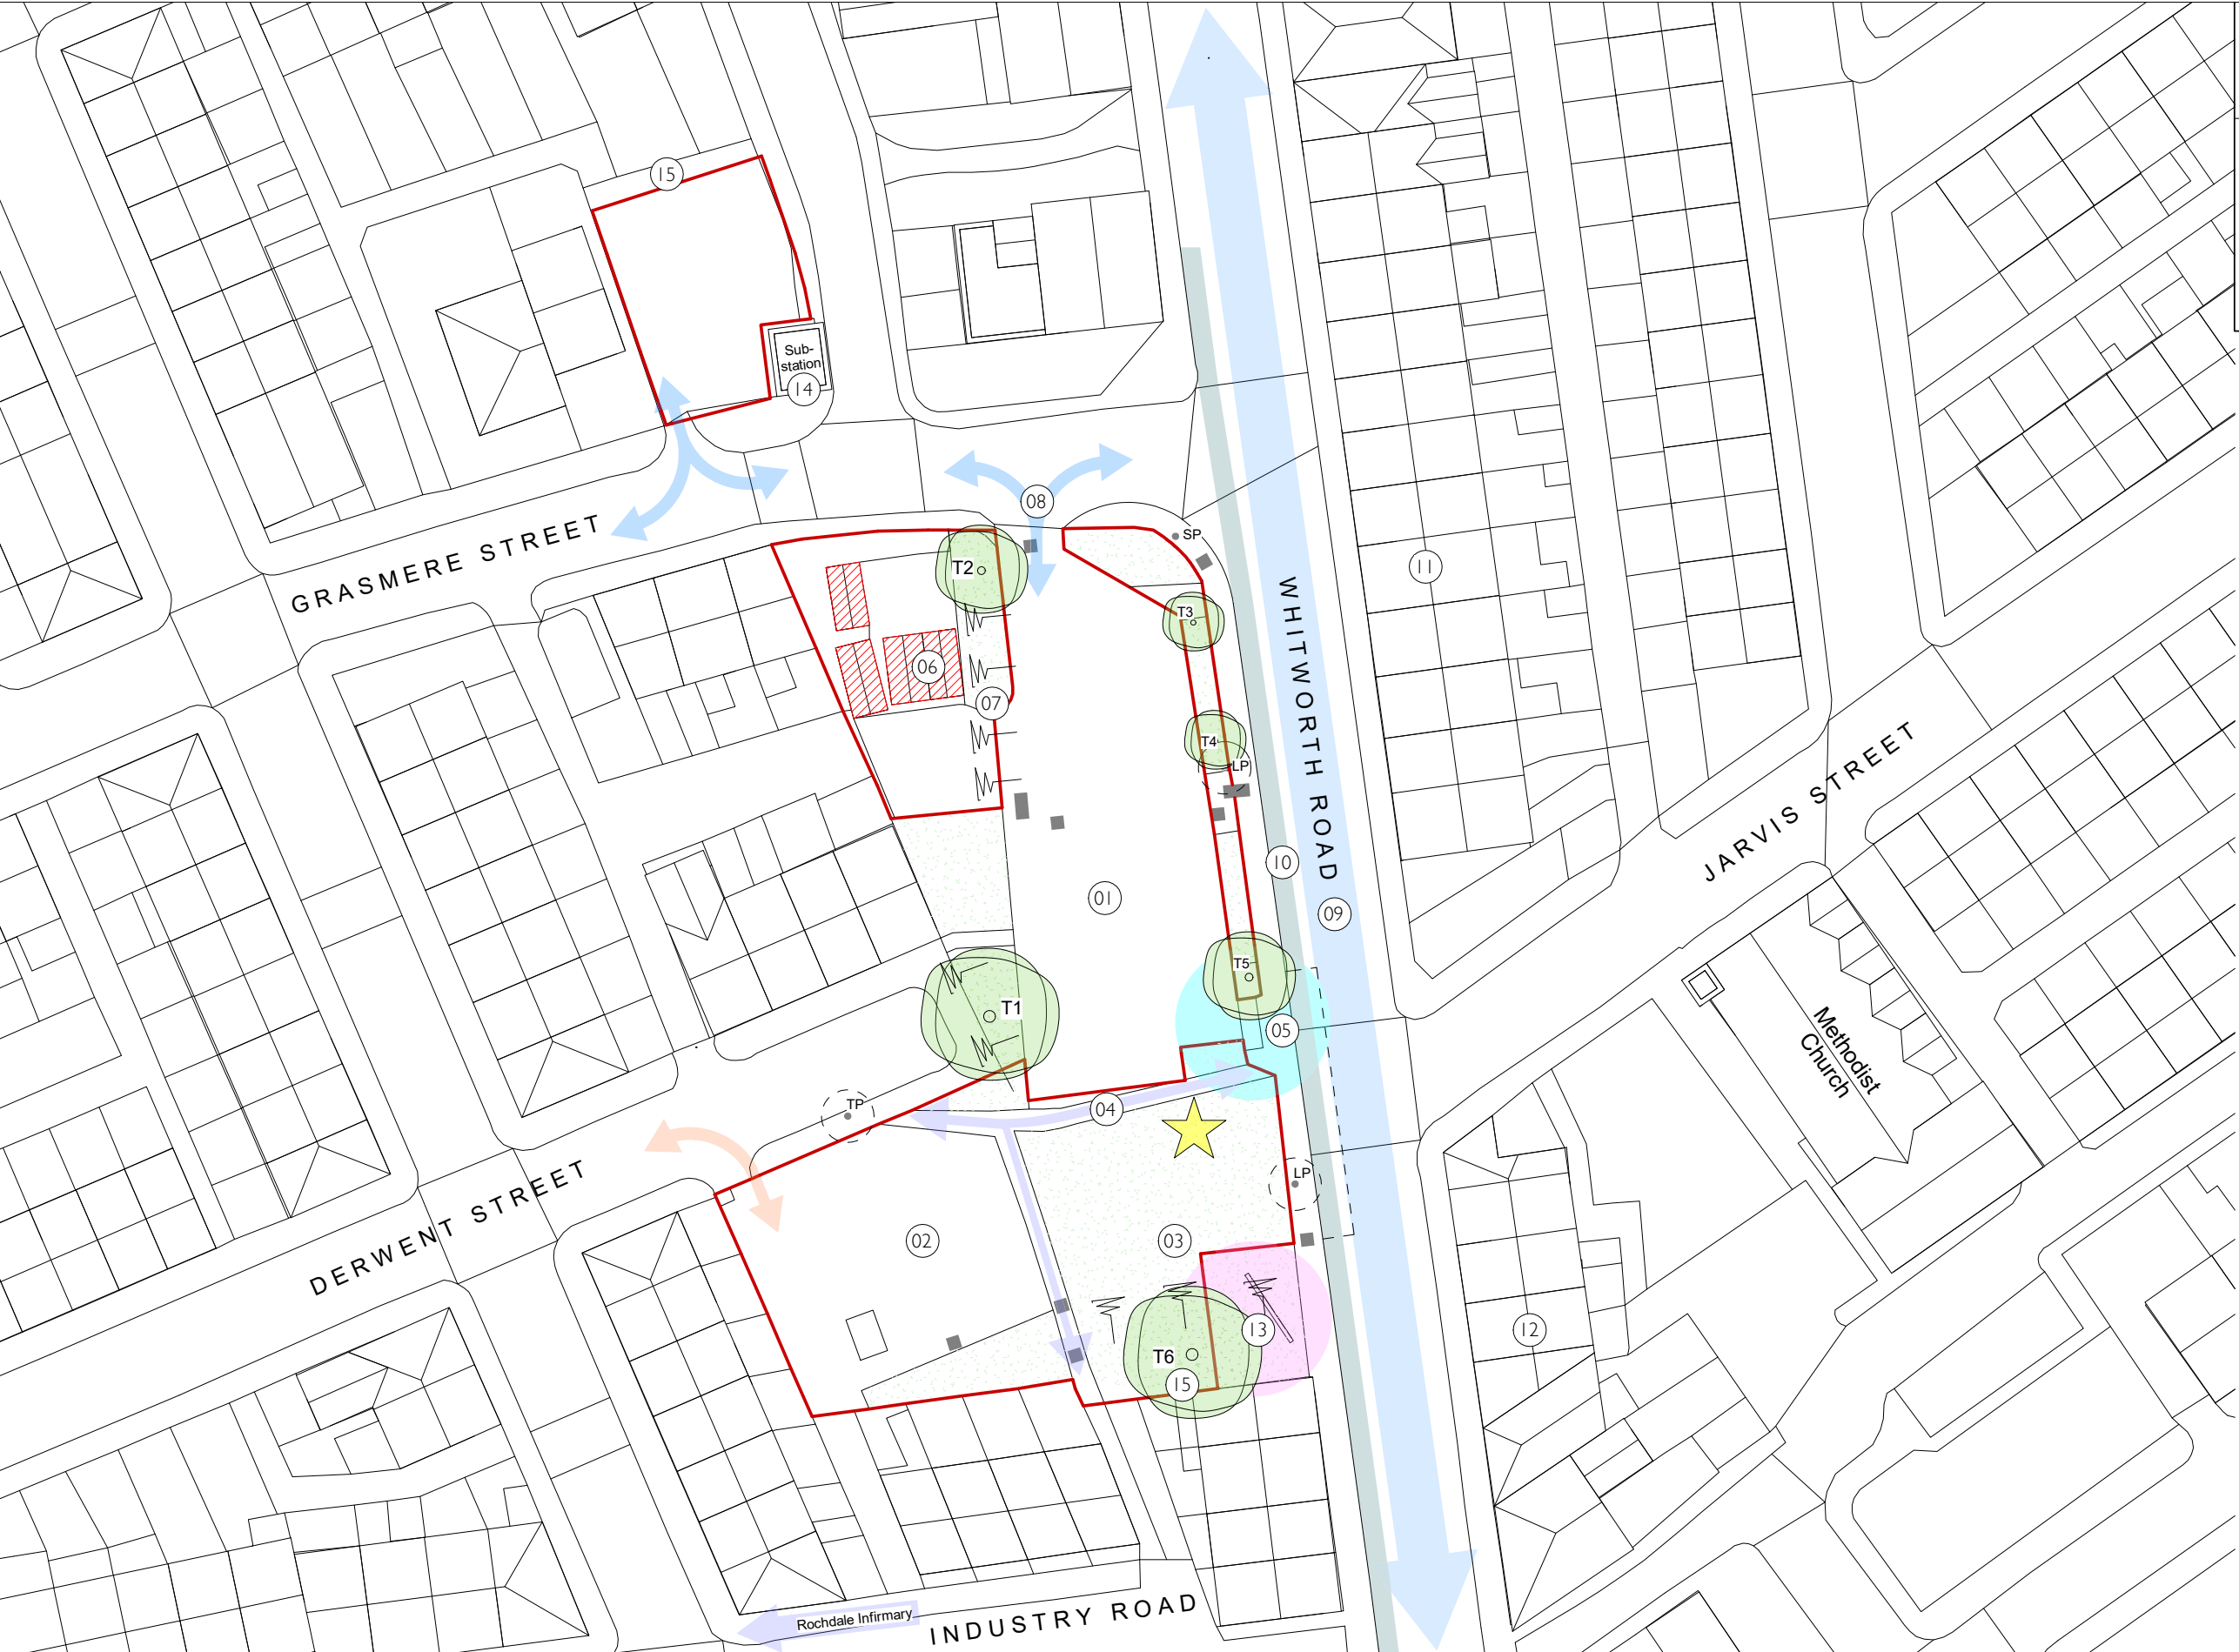
- 01 Car Park
- 02 Former Playground
- 03 Grass \*level drops at south edge
- 04 Public footpath \*right of way might need to be retained?
- 05 Bus Stop
- 06 Existing sheds to be removed \*owners need to be consulted
- 07 Site slopes down from west to east
- 08 Current car park access
- 09 Frequent traffic on Whitworth Road
- 10 Cycle lane
- 11 Shops & dwellings
- 12 Shops, possibly dwellings on first floor
- 13 Advertising sign
- 14 Substation
- 15 Existing access to rear gardens

- ★ Principal corner \*key view from Whitworth Road corridor
- Trees
- SP Lampost/Telegraph pole
- LP/TP Signpost
- Services cover (drain/electric/telecoms etc.) \*Indicative only, utilities survey information required

| T1 | Large tree, appears in good condition, and is in a good location at the end of Derwent St. *suggest retaining this tree |
| T2 | Small tree/cluster of trees |
| T3 | Small tree, poor condition |
| T4 | Small tree |
| T5 | Small/medium tree, appears okay condition and good location next to bus stop, *suggest retaining if possible |
| T6 | Large tree, appears in good condition, *suggest retaining this tree |
