# Contaminated Land Phase One Desk Study for proposed three storey building comprising retail unit (Class E) to ground floor and two one-bed self-contained apartments on upper floors at 52 Manchester Street, Heywood, OL10 1DL.

February 2023

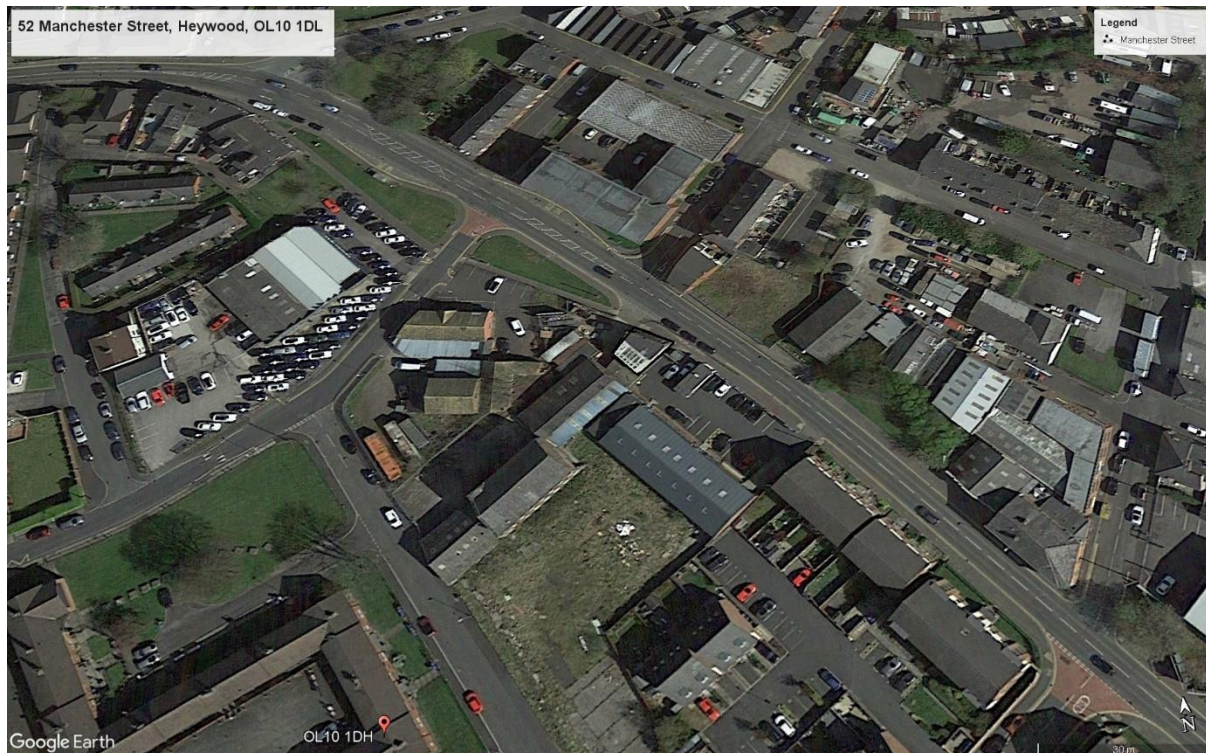
**Figure 1 – Aerial Photograph**

An aerial photograph of the site is included in Figure 1.

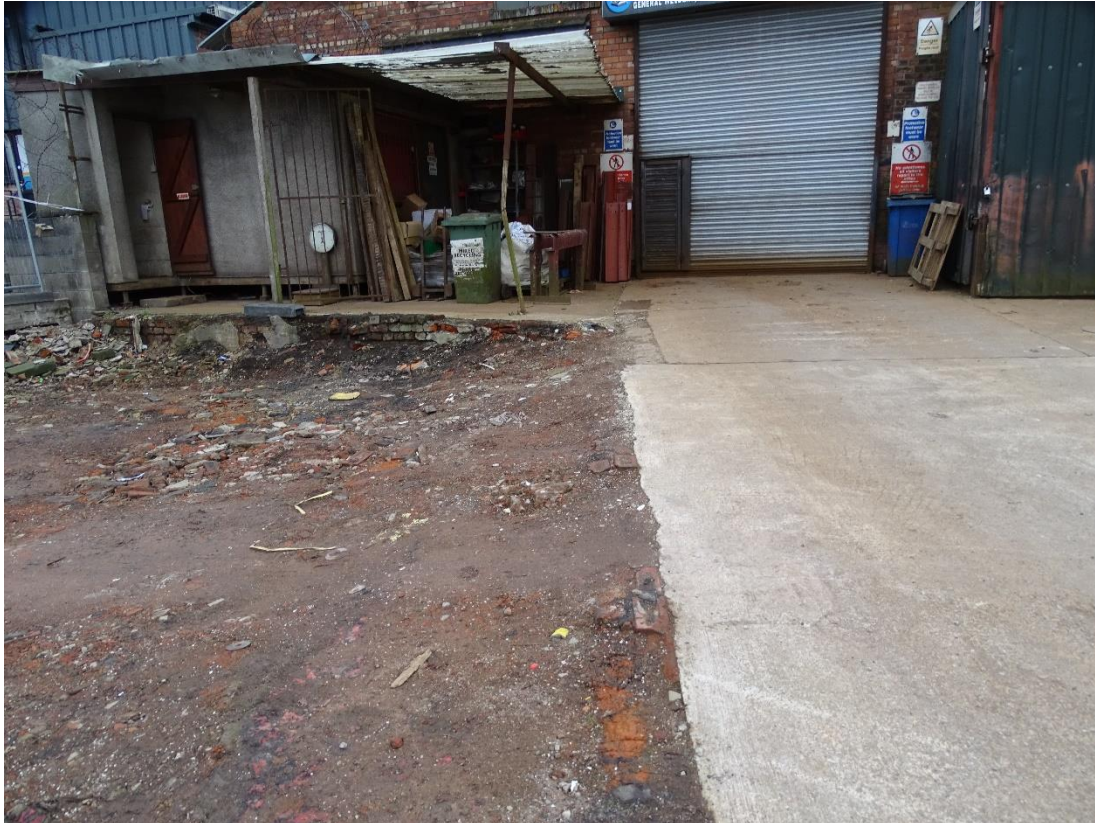
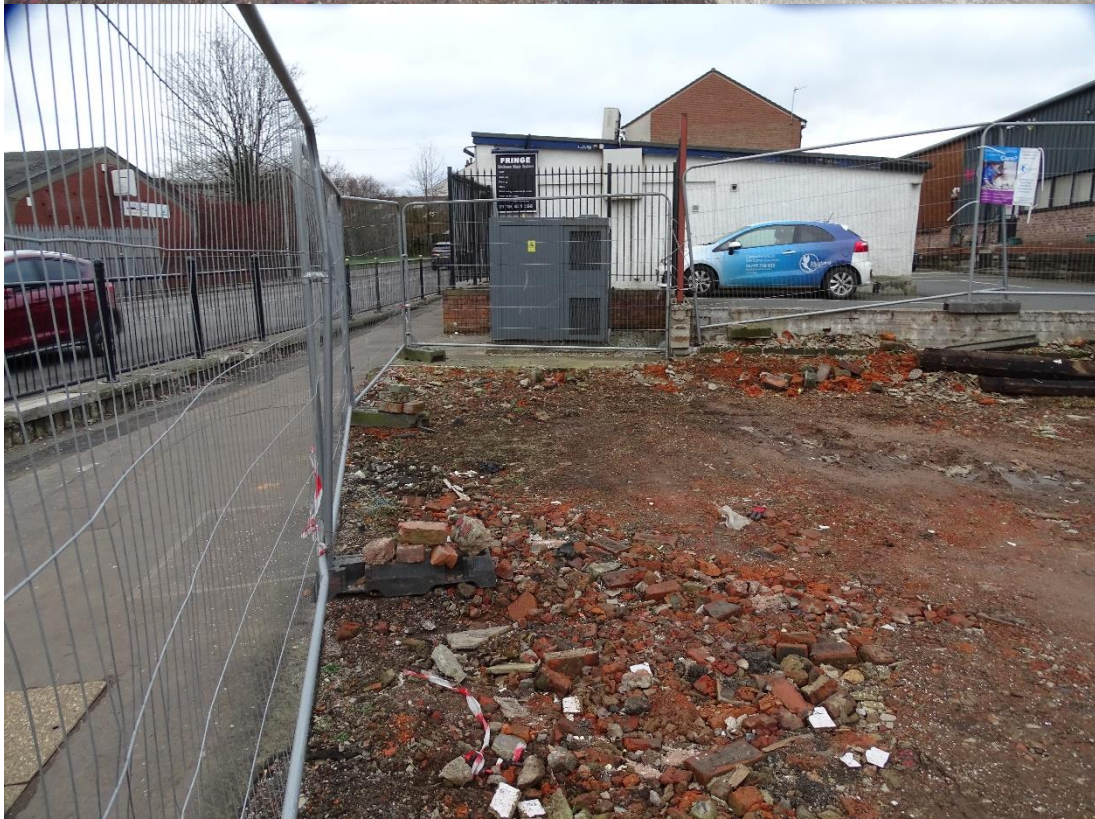
Northeast corner looking west and then south

No signs of contamination, discoloration or olfactory evidence, dead or dying vegetation were seen during the walkover.
