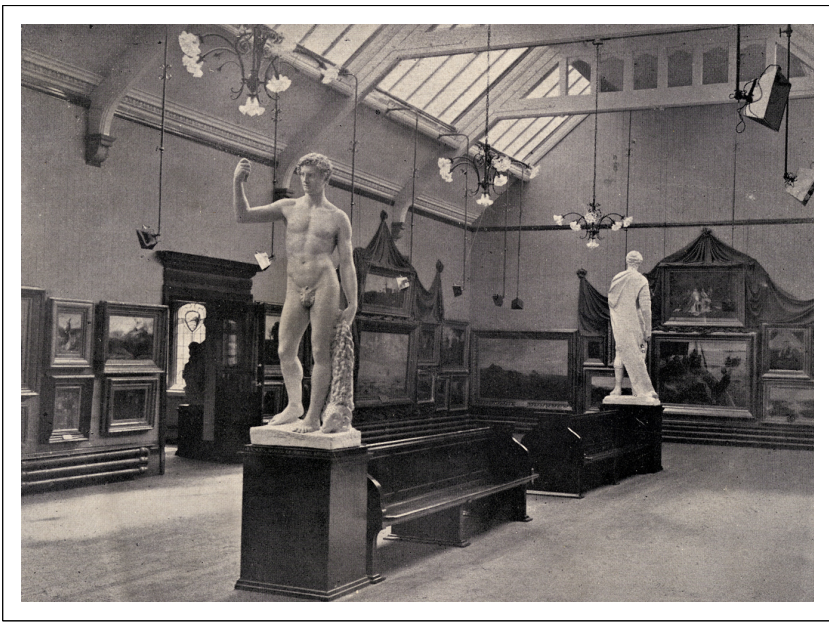
**Image 01 - Gallery 02**  
Photograph c.1903

**Notes:**  
Gallery 02 original exposed pipes heating system visible to walls at floor level. Image also shows the original entrance from the stair lobby.

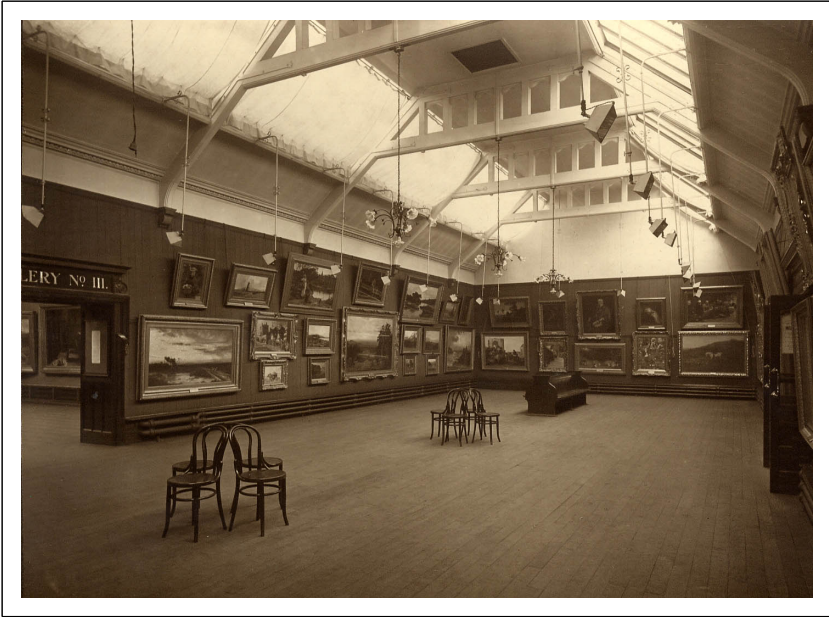
**Image 02 - Gallery 02**  
Photograph c.1915

**Notes:**  
Gallery 02 original exposed pipes heating system visible to walls at floor level + extract at roof level. Image also shows the rear partition in it's original position, further back and in line with the end skylight.

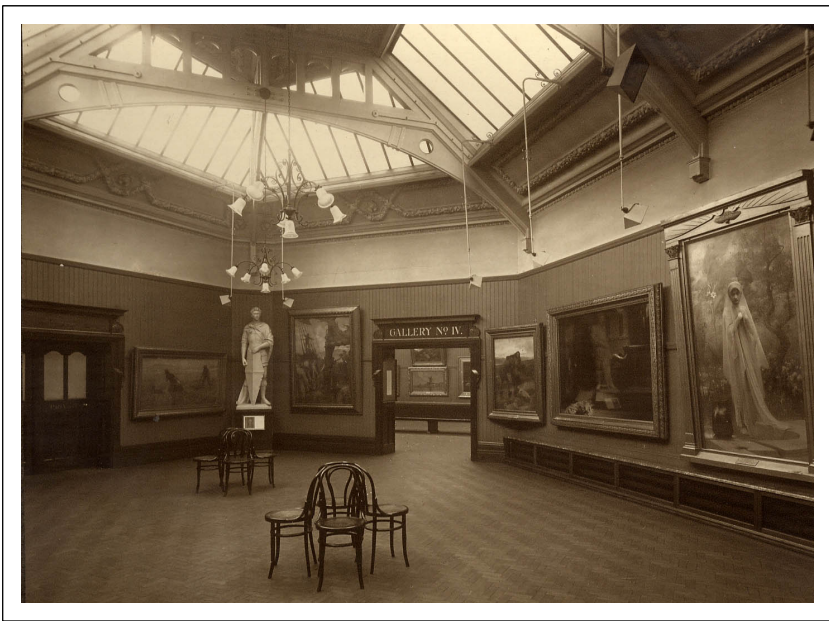
**Image 03 - Gallery 03**  
Photograph c.1915

**Notes:**  
Gallery 03 original heating system - pipes covered by panelled 'shelf' to floor/ lower level forming consistent datum for exhibition wall space.

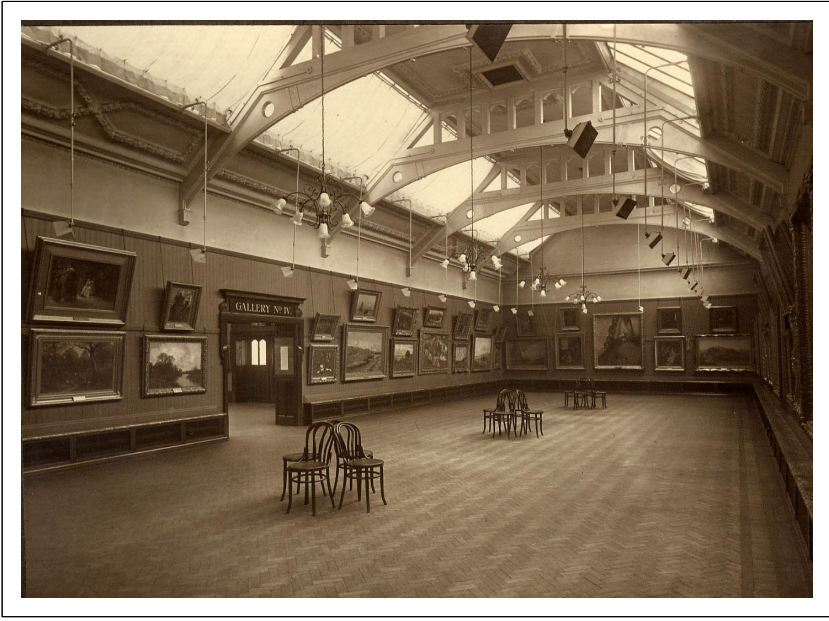
**Image 04 - Gallery 04**  
Photograph c.1915

**Notes:**  
Gallery 04 original heating system - pipes covered by panelled 'shelf' to floor/ lower level forming consistent datum for exhibition wall space. Ceiling extract visible at roof level.
