01 F15b - North Elevation  
3548 1:50 @ A3

02 F15b - South Elevation  
3548 1:50 @ A3

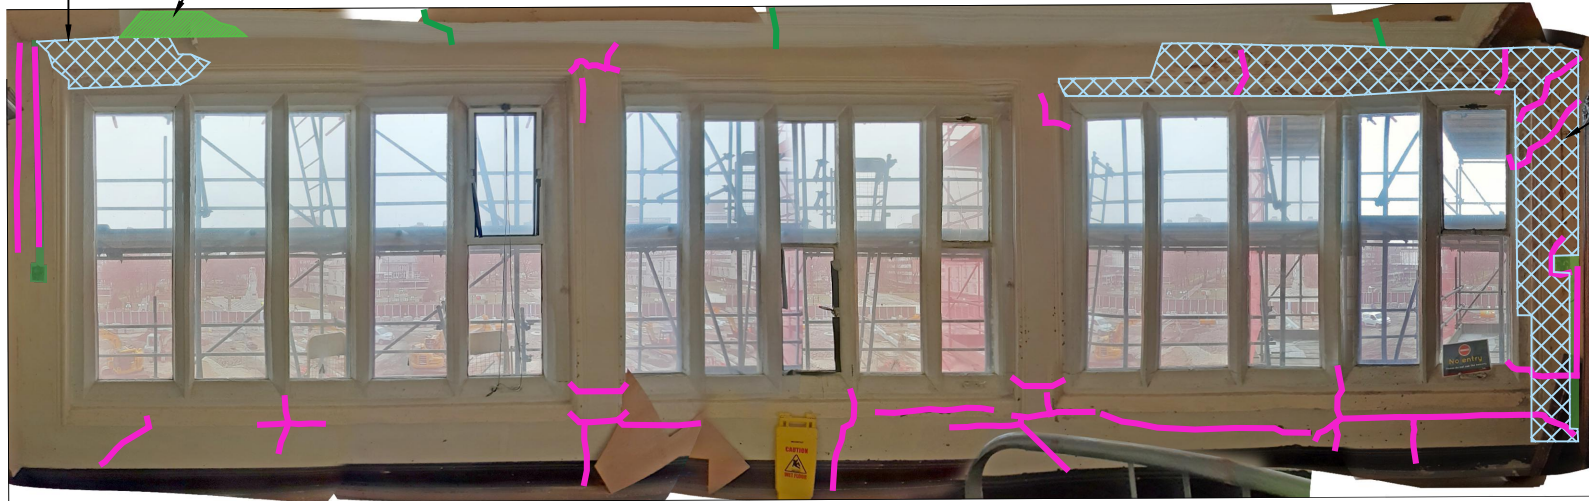
Water Damage:  
Allow for new plaster including window reveal roll mould. Plaster appears friable and possibly 'live' - TBC following high level access inspection.

Spalled surface to cornice from water damage. Allow new run insitu section to match existing.  
NBS M20/ 693

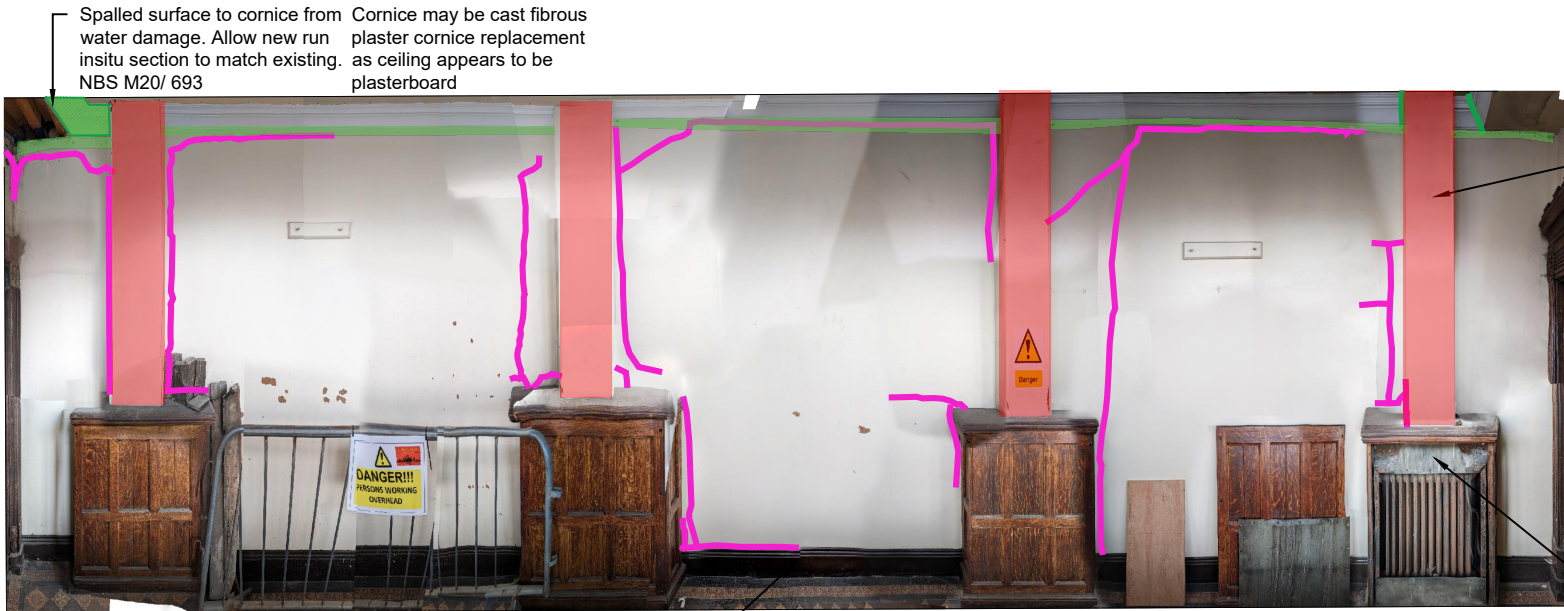
- Vent ducts**
- Vertical vent casings and any associated ductwork to be removed.
  - Allowance to make good plaster/masonry behind. Provide Access to Architect following removal.

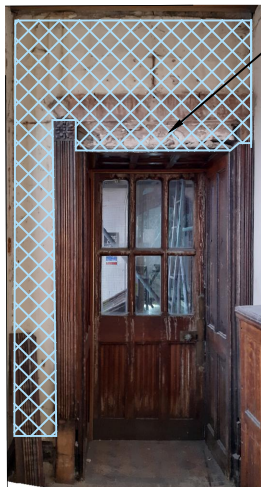
Temporarily removed existing joinery: Door architraves and entablature to be fully reinstated to good order.

Evidence of water staining but plaster appears sound. Allow provisional sum for re-plastering over door.
