Week 4 – W/E 06.09.2024 – Stage Floor lifted to reveal oriel window support frame

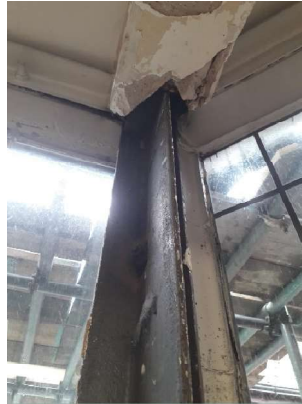
Upper oriel support frame exposed for inspection
