# **GEO-ENVIRONMENTAL AUDIT**

## **PHASE 2 Site Investigation & Risk Assessment**

## **PHASE 3 Remediation Statement**

**Proposed Residential Development**  
**Former Sladen Mill**  
**Littleborough**  
**Rochdale**

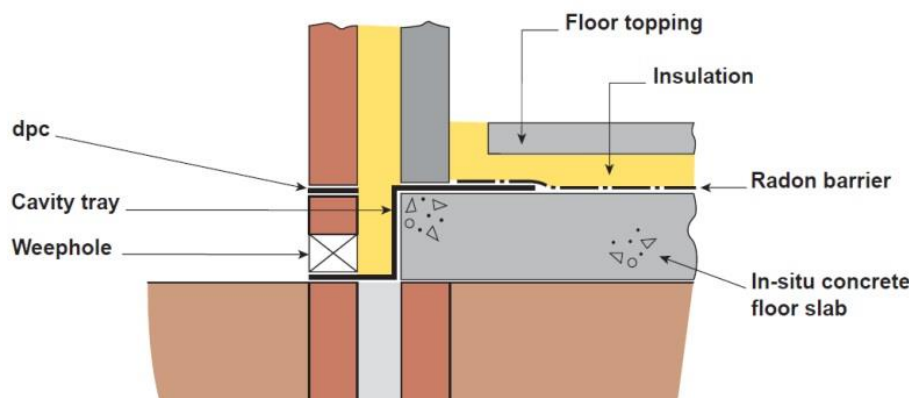
A radon membrane should be included in all building foundations. The membrane will need to comprise a robust construction, suitably lapped and sealed as per manufacturers guidance, with proprietary top hat seals to all incoming slab penetrations. Refer to typical floor slab:

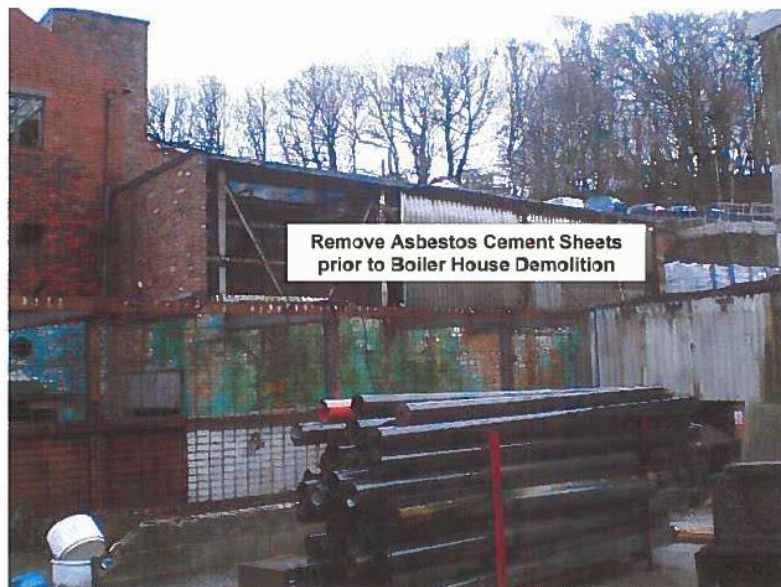
Asbestos Cement Sheets to be removed prior to Boiler House Demolition

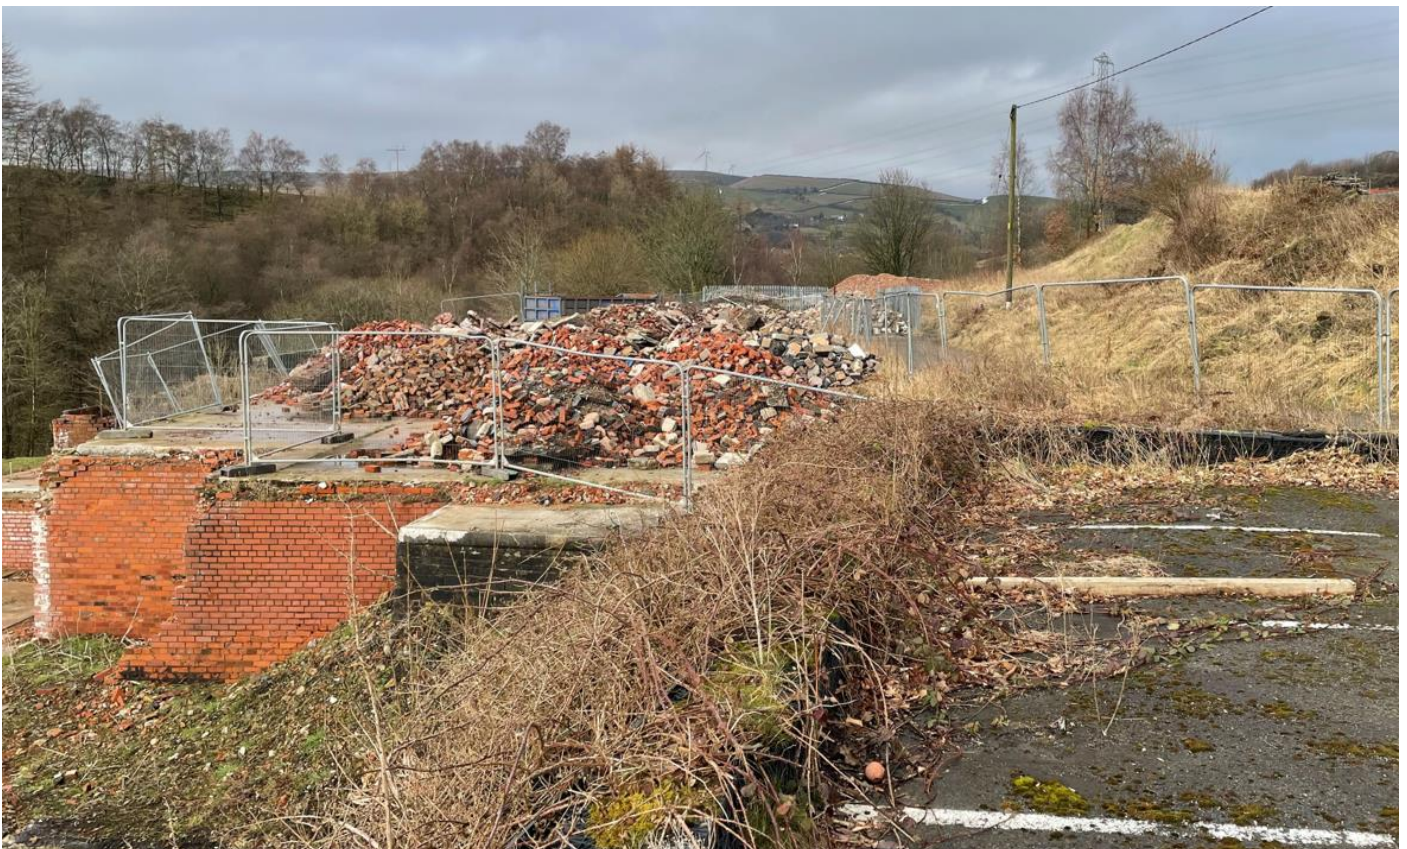
Demolition materials separated for removal.
