Ref: rep-tjba-baxter-buxton st-validation-150623.docx

Subject: **B & L Homes Ltd – Buxton Street, Heywood, Rochdale,  
OL10 1BS.**

**PHASE 4 - SITE VALIDATION.**

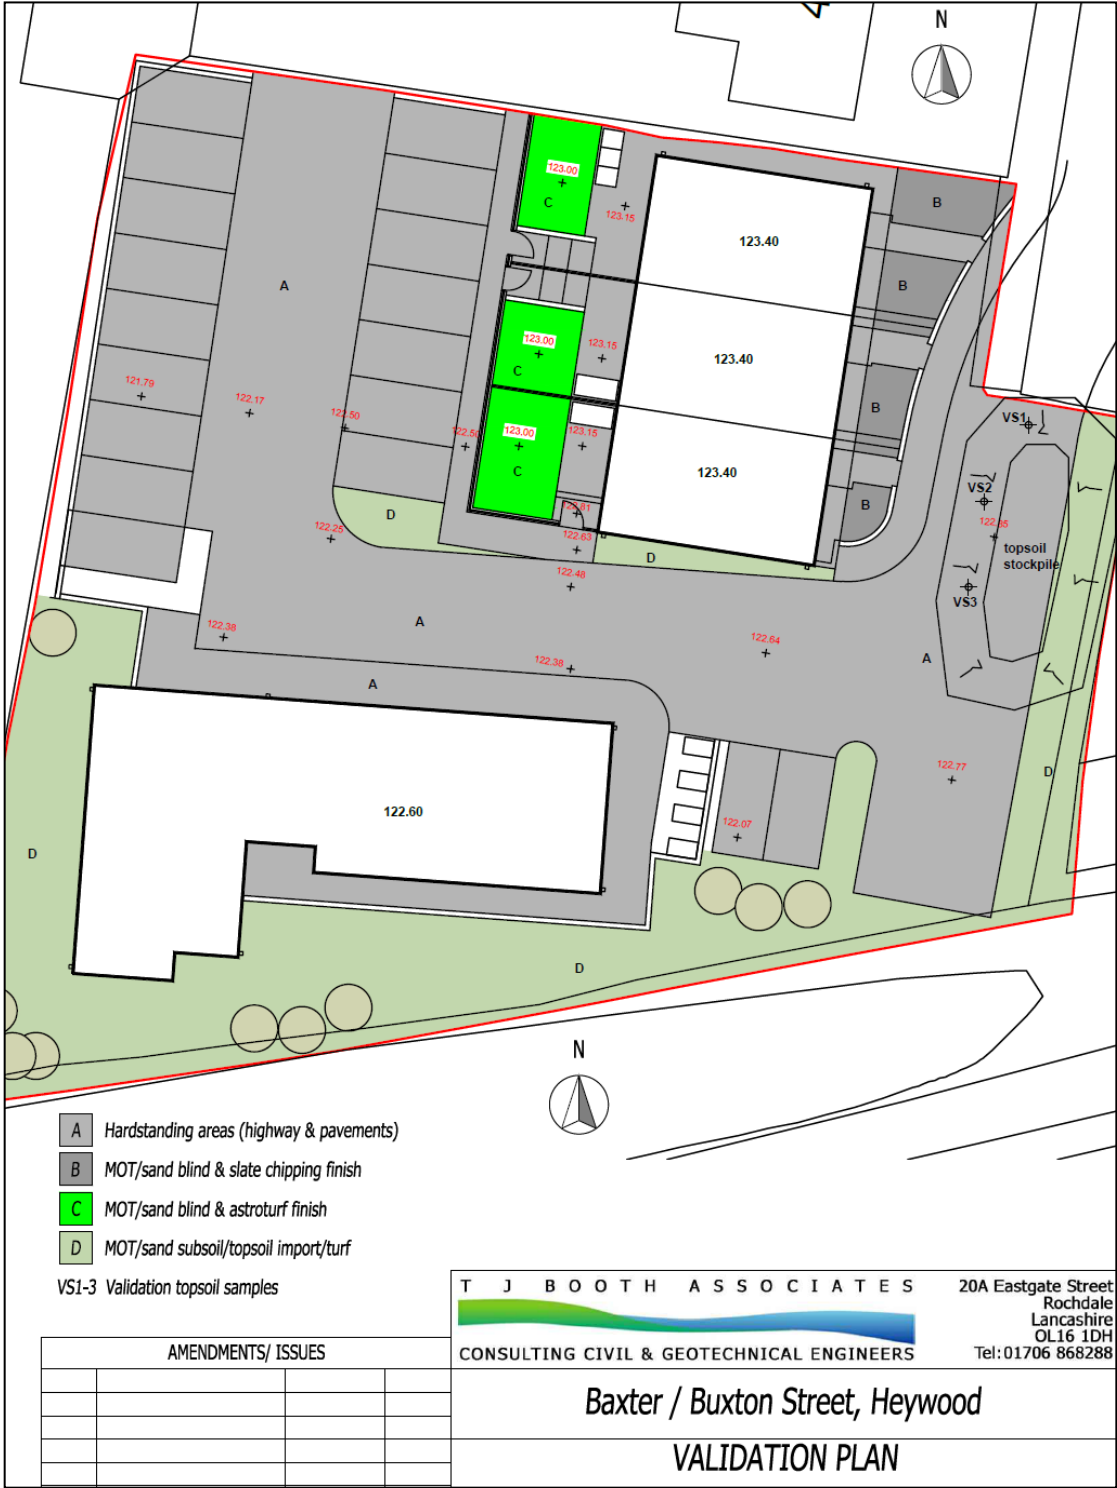
Site Validation Plan.

The only landscaped areas included in the final design were the gardens to the individual plots (areas B & C on the Validation Plan - Appendix), and the POS areas to the rear of the apartment block (area D on Validation Plan) as described below:

Area B individual front gardens: between 500-1000mm MOT, 100 sand blind & slate chipping finish.

Area C individual rear gardens: between 500-1000mm MOT, 100 sand blind & astroturf cover.

Area D communal landscaped area: geotextile, 250 MOT, 250 sand, 100 topsoil.

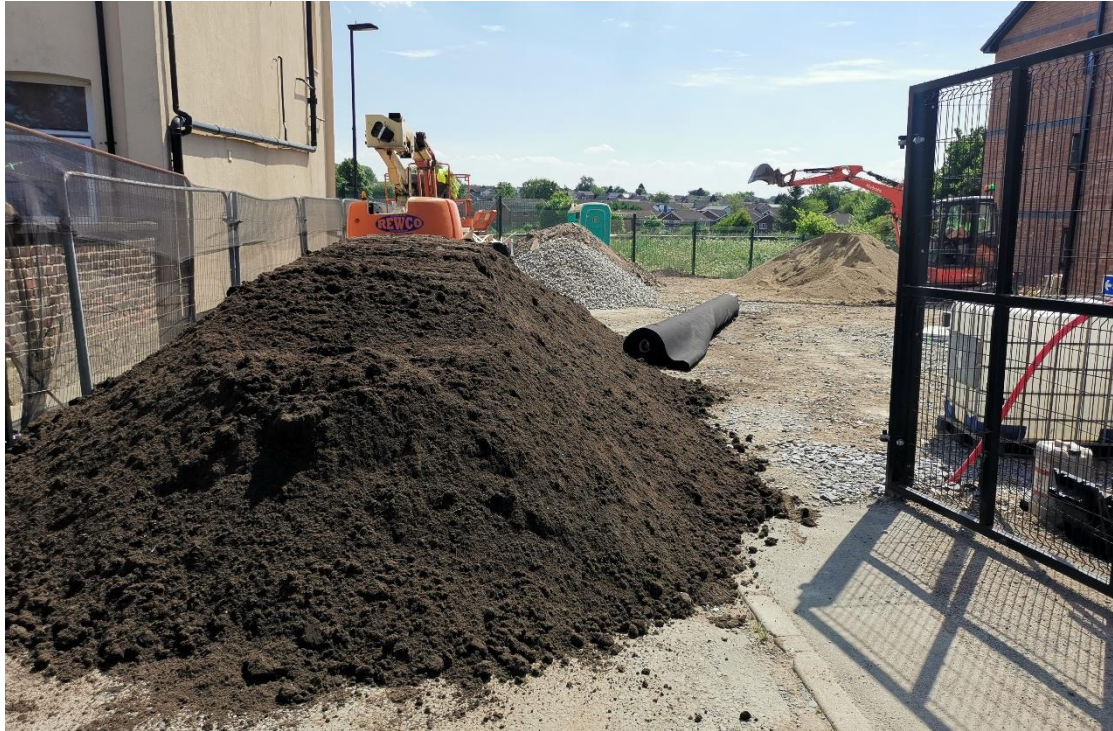
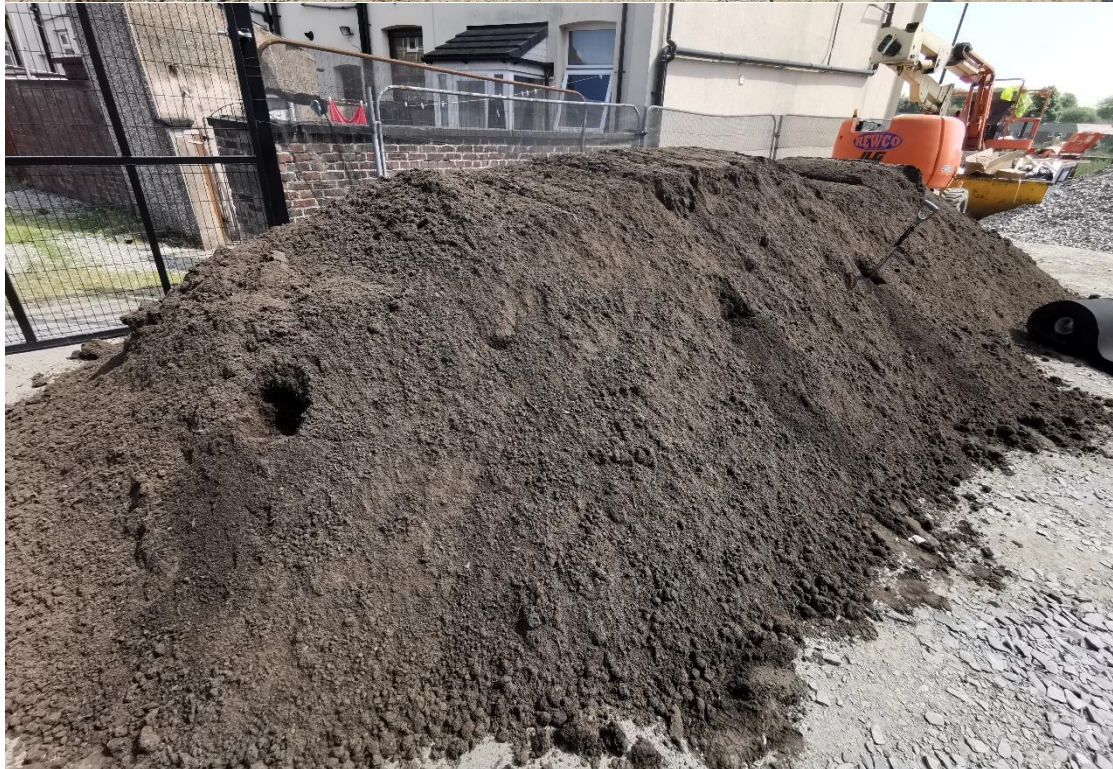
*Topsoil import stockpile, virgin quarried sand & MOT in the b/g*

| Characterisation of material: | <p>A visual screening of the material was undertaken by T J Booth Associates as the material was delivered to the Application Site.</p> <p>The material was immediately stockpiled in a clean hardstanding area within the Site, and was noted to be a dark brown silty loamy fine to coarse SAND topsoil with fine natural organic material.</p> |

| | <p>There was no visual or olfactory evidence of any impurities or potential contaminative material.</p> <p>No evidence of invasive species roots or plant material was noted.</p> <p>There were no signs of asbestos containing materials.</p> <p>Visual inspection of the soil corroborated the provenance of the soil to be a greenfied/manufactured soil, and as such in line with the YALPAG guidance Appendix 1a (Sampling &amp; Testing Matrix) which indicates for such soil, a minimum of 3 samples were required to be tested for standard metals/metaloids, speciated PAH, and asbestos screening.</p> <p>Three samples were taken from the stockpile and sealed in snap top clear plastic containers and amber jars as required by testing laboratories, and sent to Envirolab Ltd to be tested for metals, speciated PAH, inorganics, SOM, and asbestos screen.</p> |
| Stockpiling of material: | <p>The topsoil was stockpiled on Site in a hardstanding area where no contamination could occur &amp; while testing was undertaken.</p> |

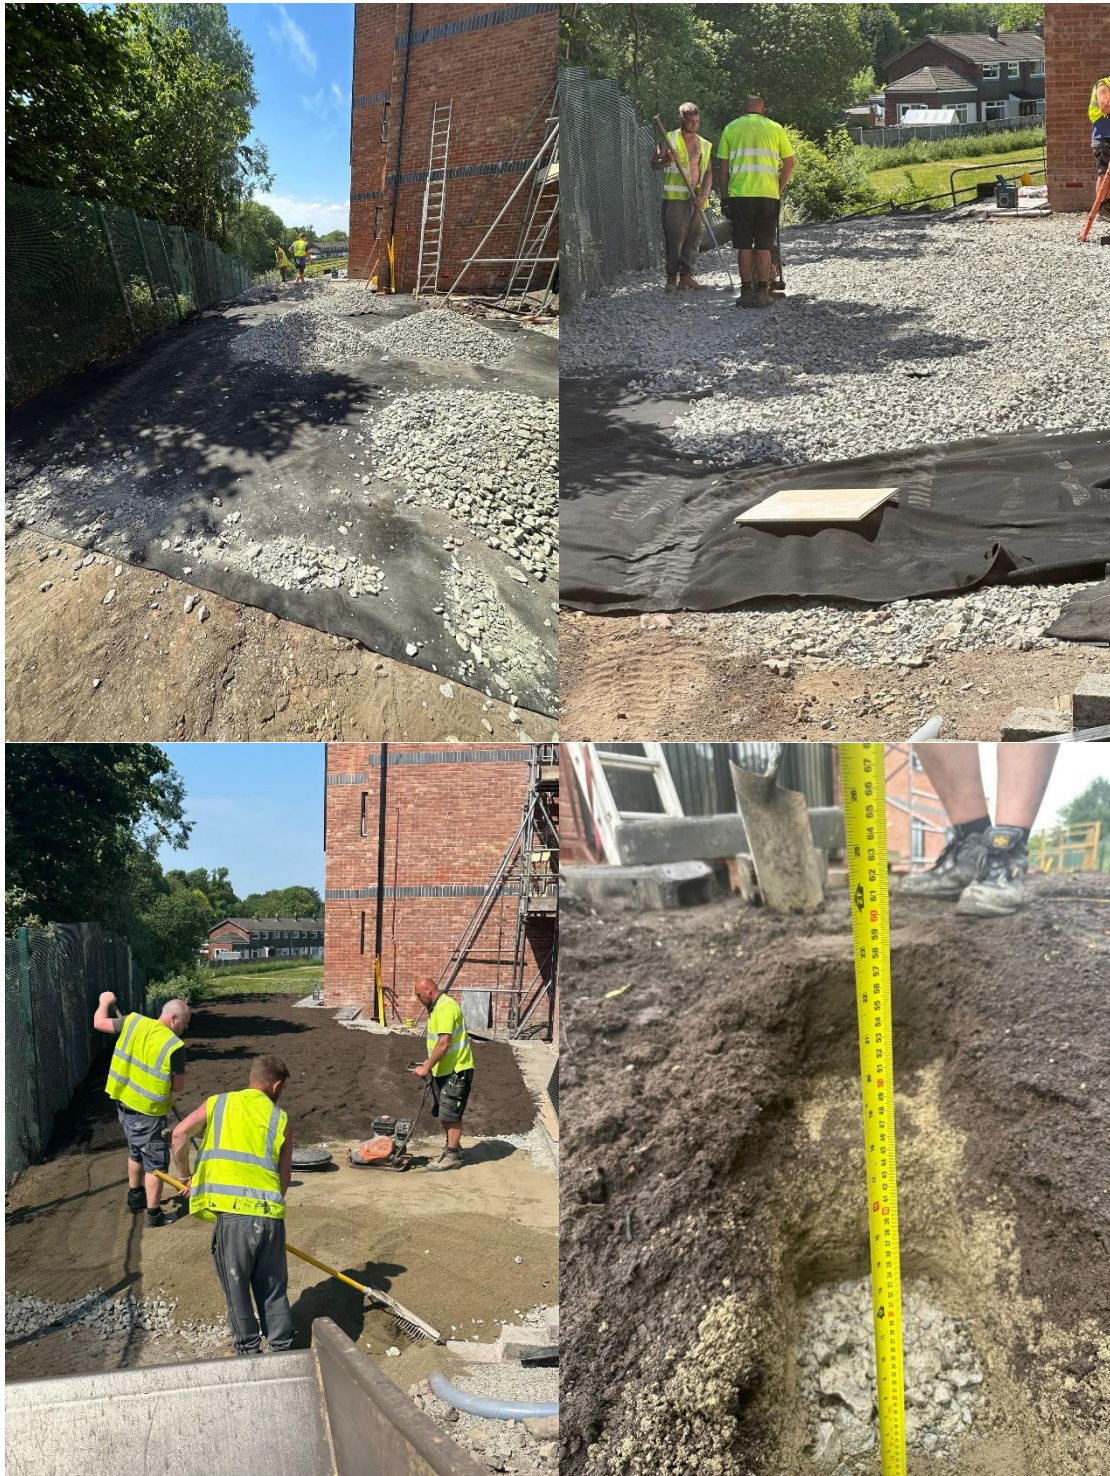
*Buildup of soft landscaping around the apartment block, comprising nominally: geotextile, 250 MOT, 250 sand, 100 topsoil.*

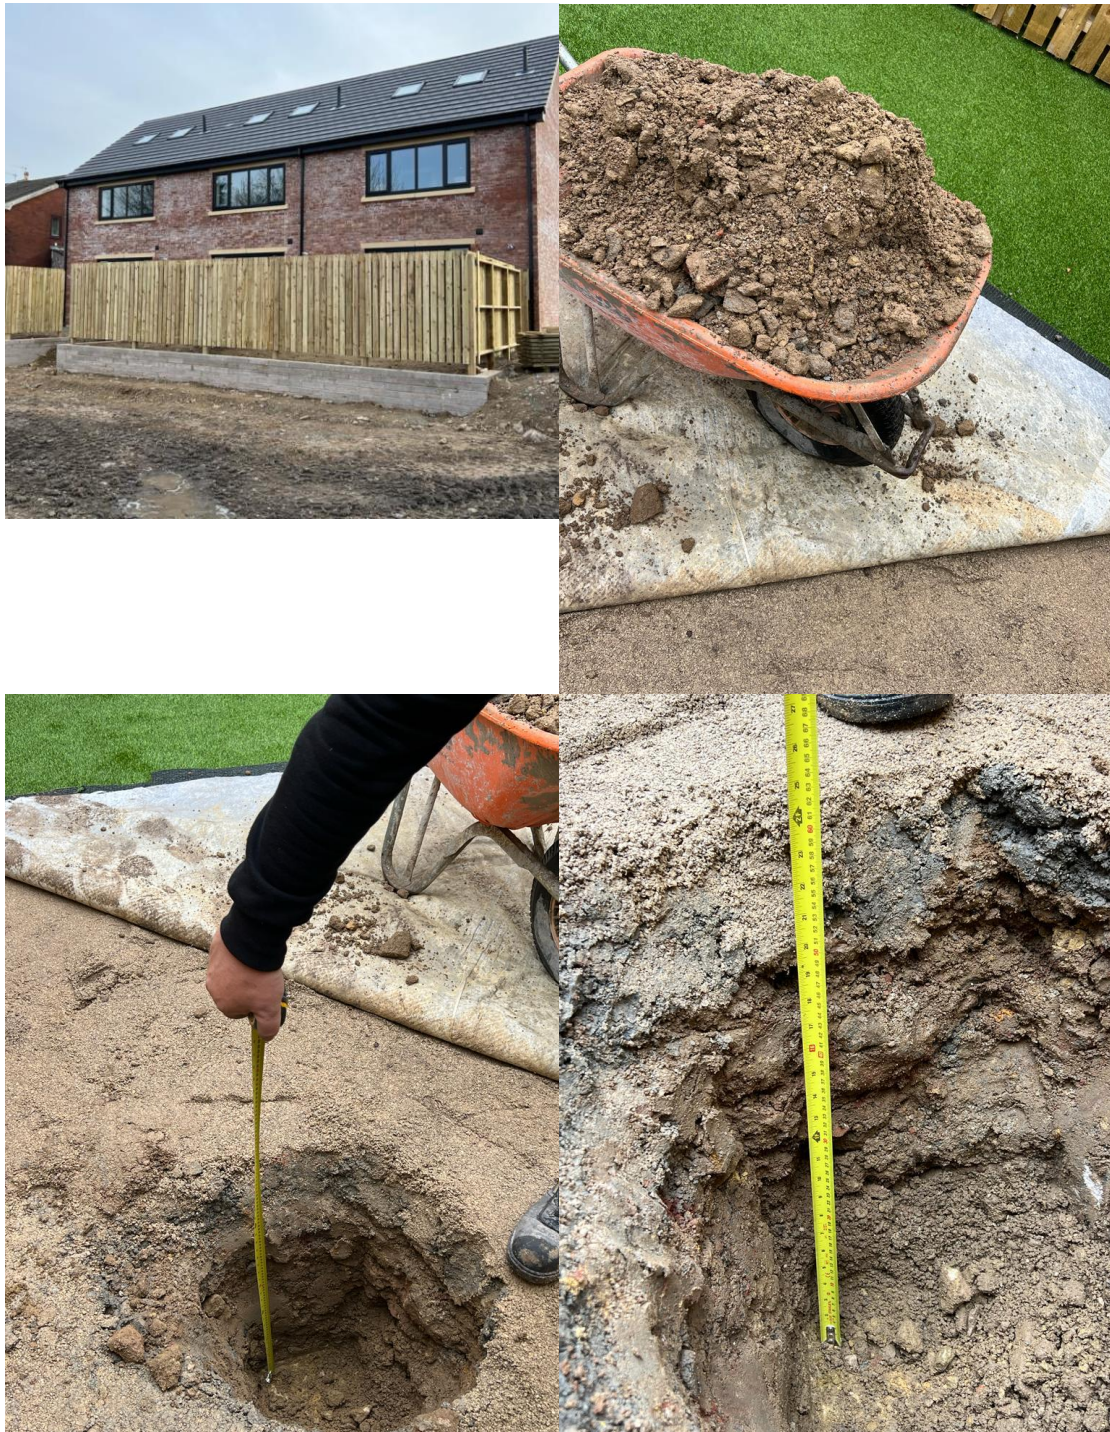
*Buildup of garden areas to the rear of the individual plots, comprising nominally: up to 1m MOT fill (500mm MOT indicated, 100 sand blind & astroturf cover). Front gardens comprise the same with a slate chipping finish.*
