# Contaminated Land Phase One Desk Study for proposed residential development on land at 418 Bury Road, Rochdale, OL11 5EU.

Building Design Services,  
418 Bury Road,  
Rochdale,  
OL11 5EU.

April 2024

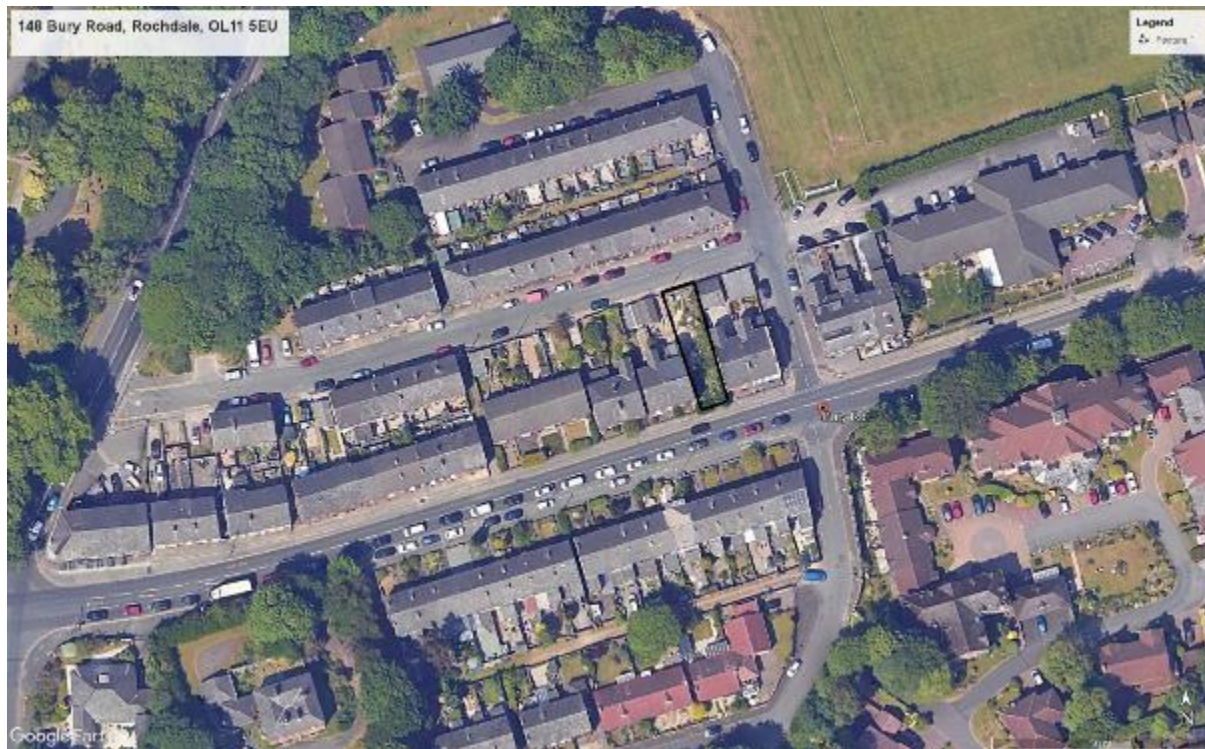
**Figure 1 – Aerial Photograph**

An aerial photograph of the site is included in Figure 1.

The site currently consists of a derelict building plot, formally part of the garden for 418 Bury Road. Residential properties are located to the east and west, and beyond the alleyway to the north. To the south is Bury Road and beyond further residential dwellings.

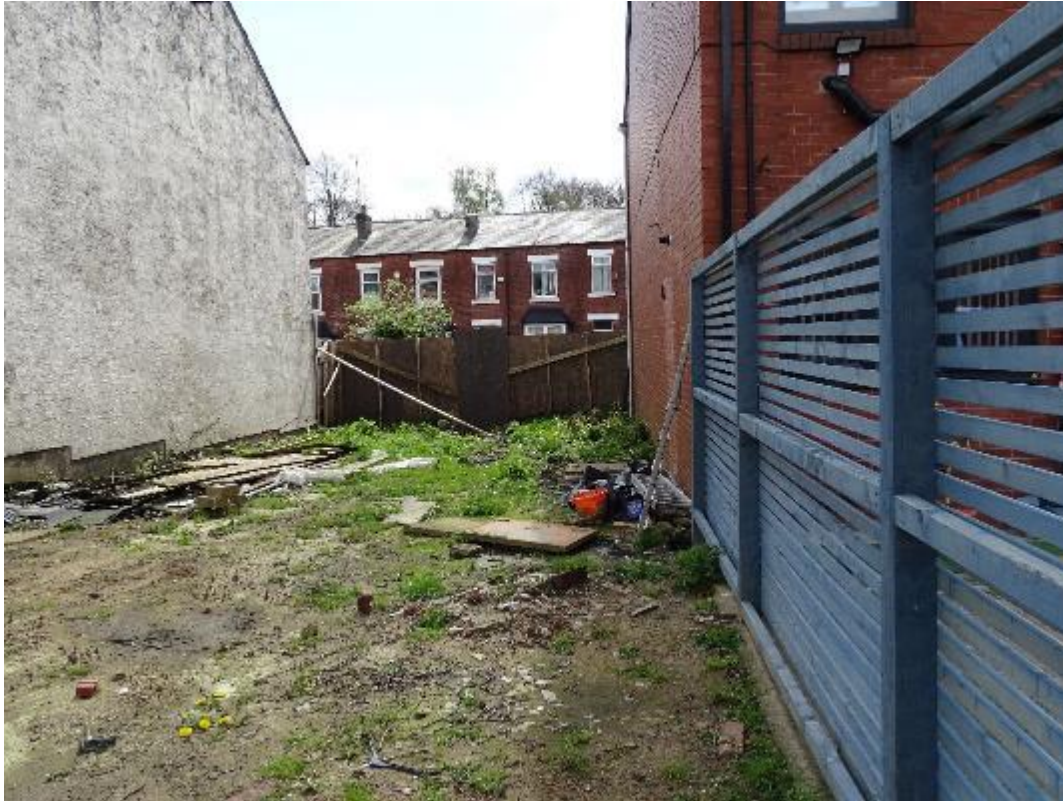
Looking south along the western boundary

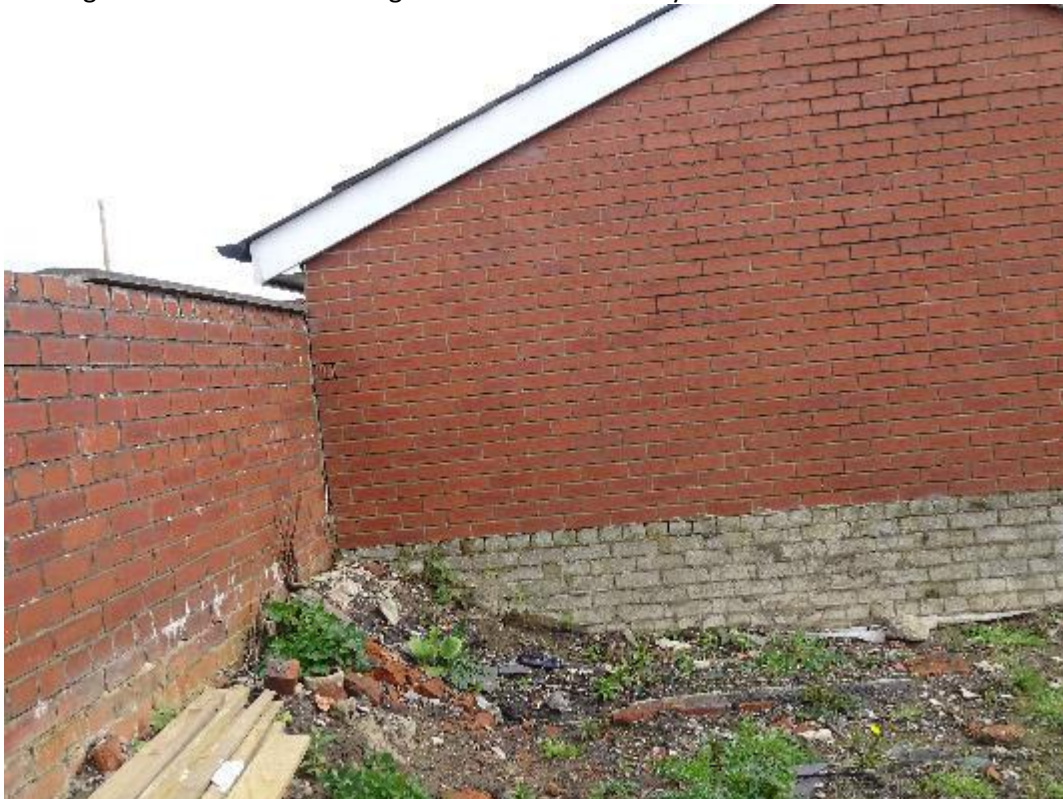
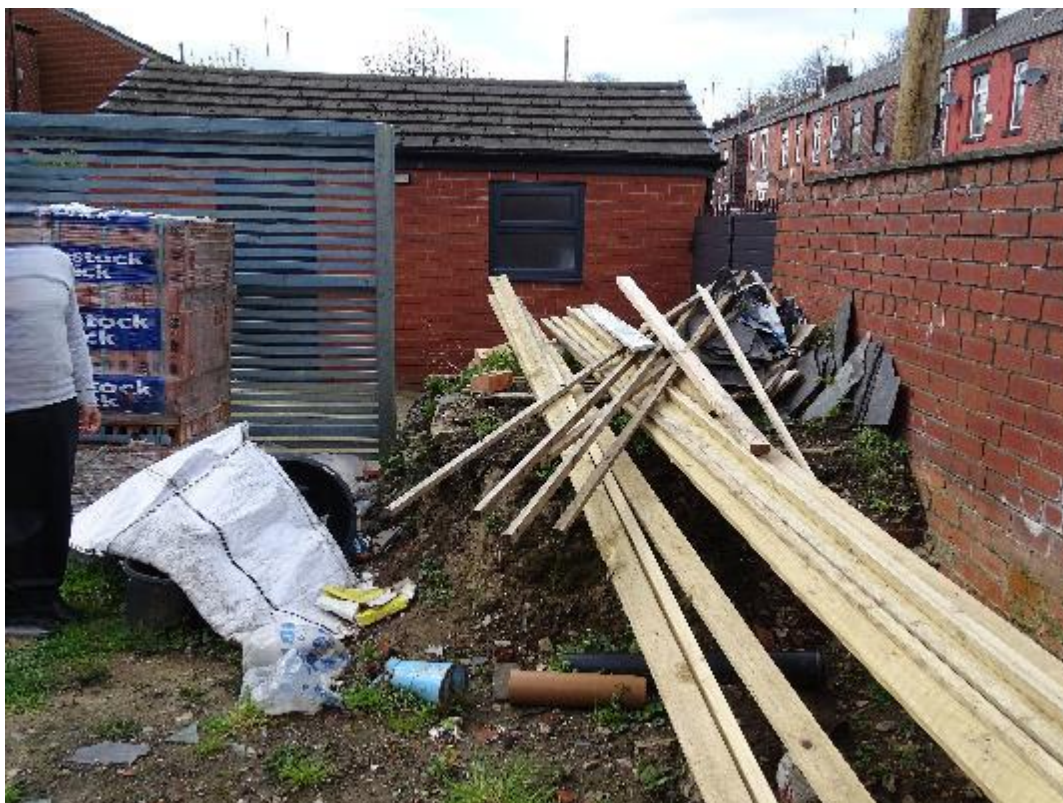
The site has been used as a garden for the adjacent property. Evidence of a single brick wall for a greenhouse were seen to the northern end of the plot.

Looking west and then east along the northern boundary

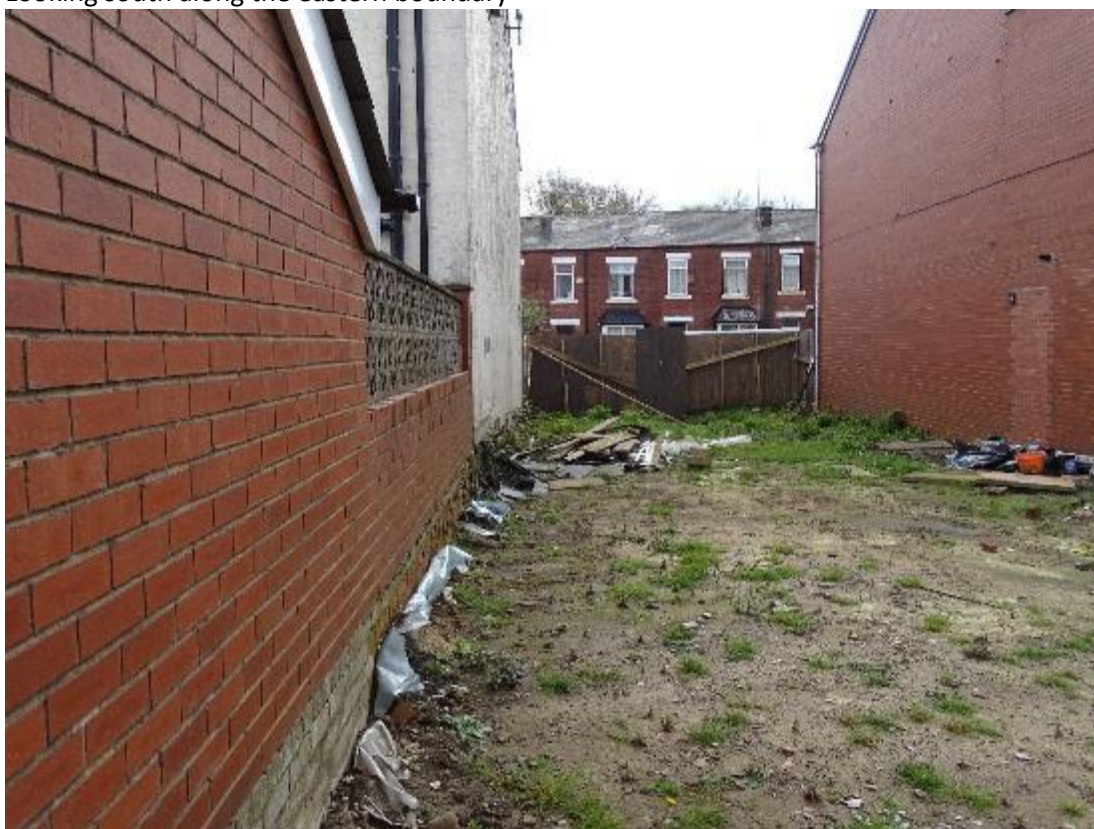
Looking south along the eastern boundary

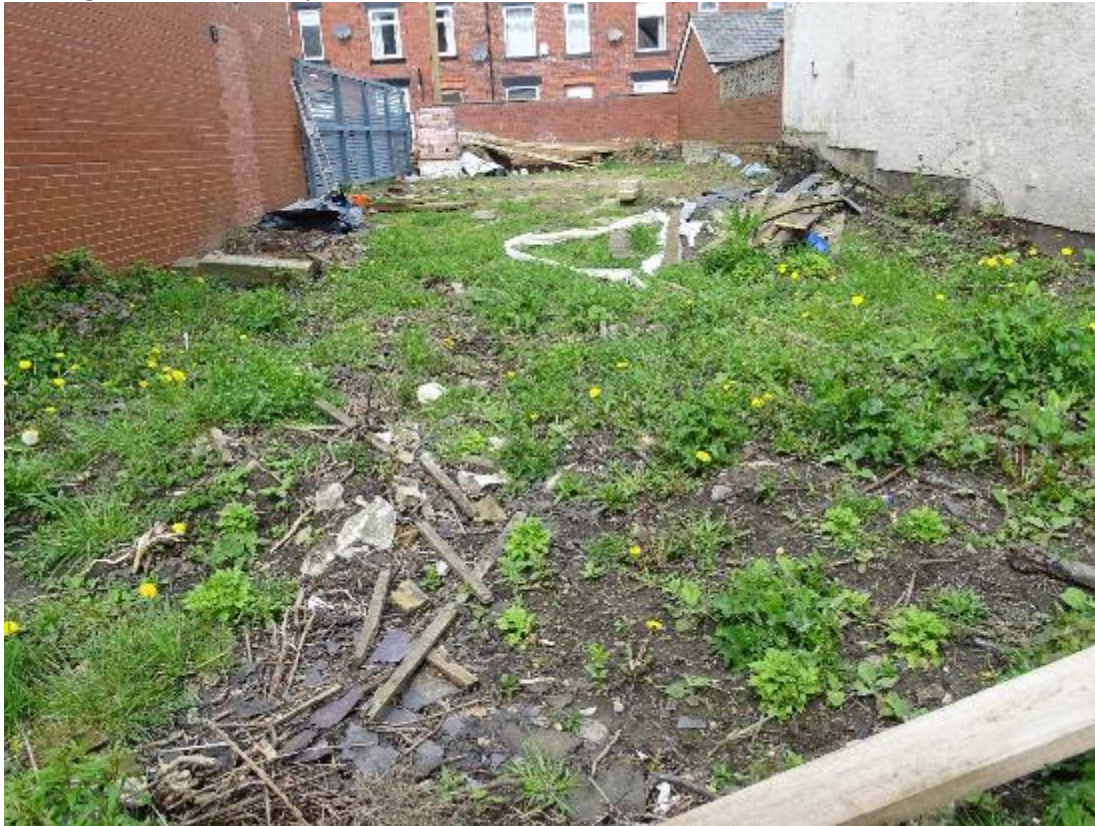
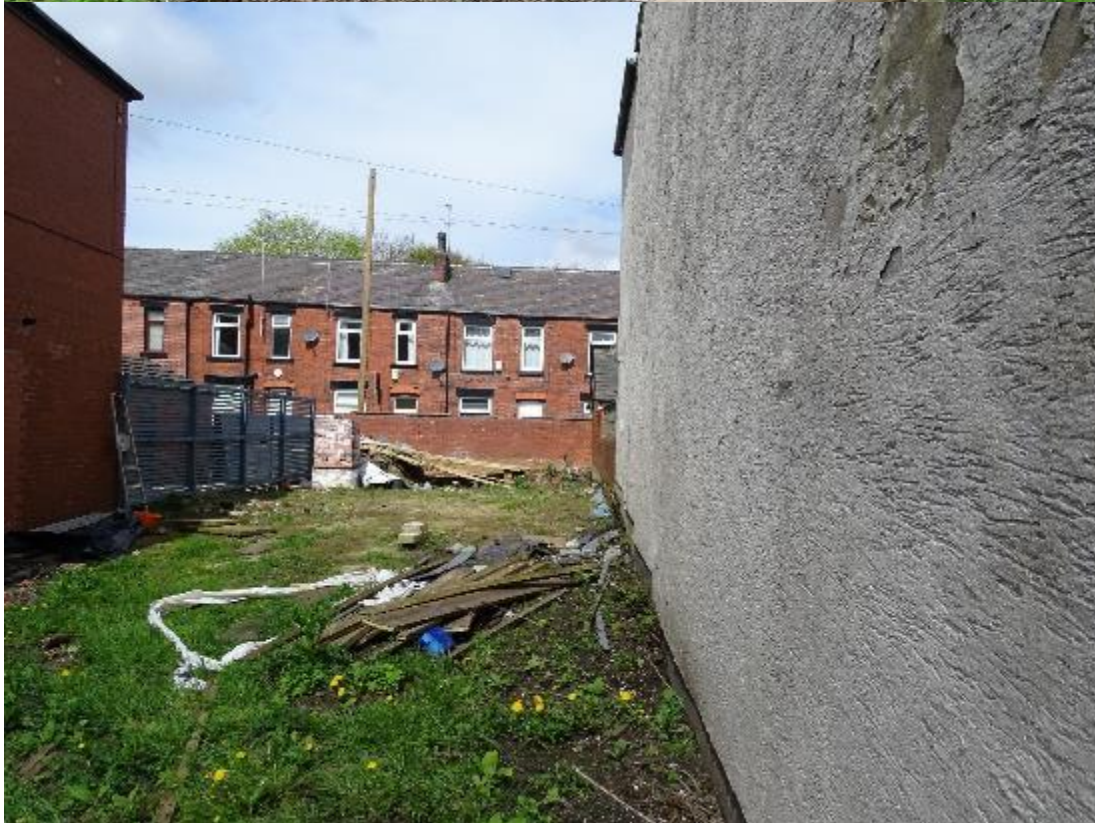
The site is accessed from Bury Road and consists of a rectangular roughly level piece of land between two existing dwellings. A path is located at the entrance to the site which is central and some wood and stone are located across the land which is predominantly covered by soil.

Looking north across the plot

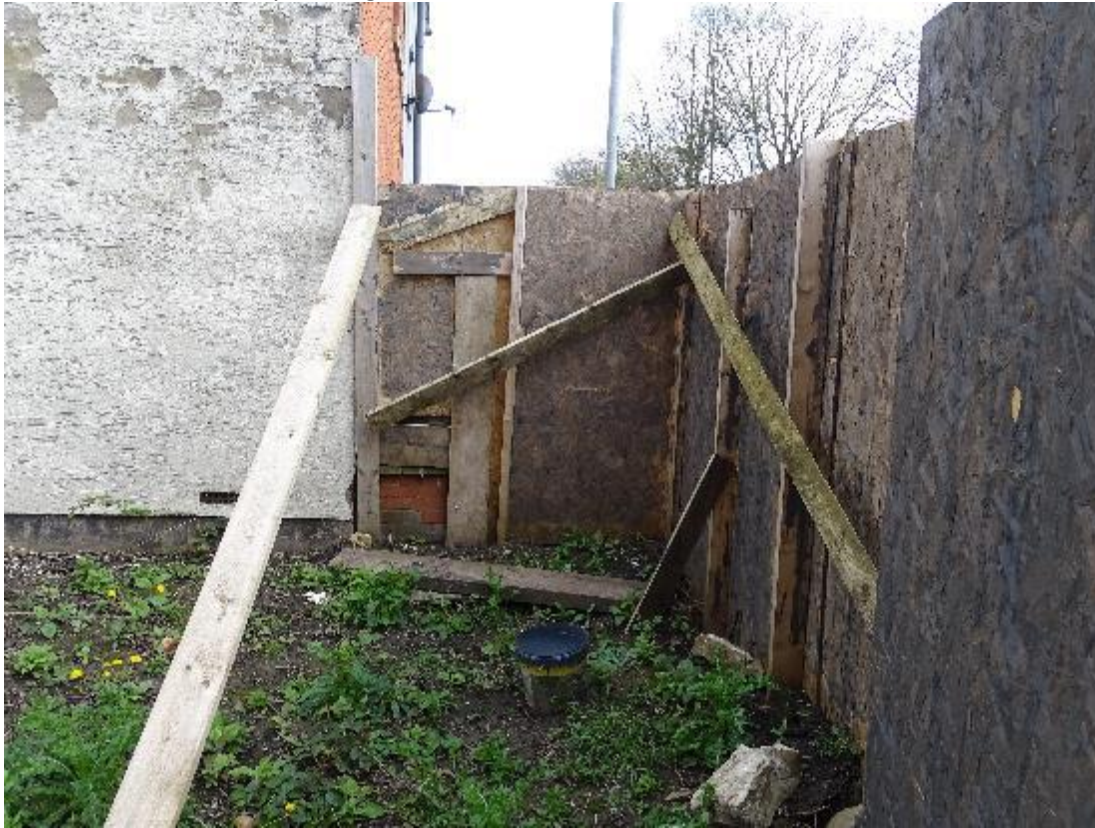
The southern boundary looking east
