Ref: 19-493-LR1-RevB  
Date: 7<sup>th</sup> January 2020

## Land South of Manchester Road, Rochdale

ERGO have been commissioned by HM Property to undertake a Phase II Geo-Environmental Site Investigation for a parcel of land located to the south of Manchester Road in Rochdale. ERGO have based the site investigation works on a brief specification provided by the engineers for the project – Krypton Structure Ltd.

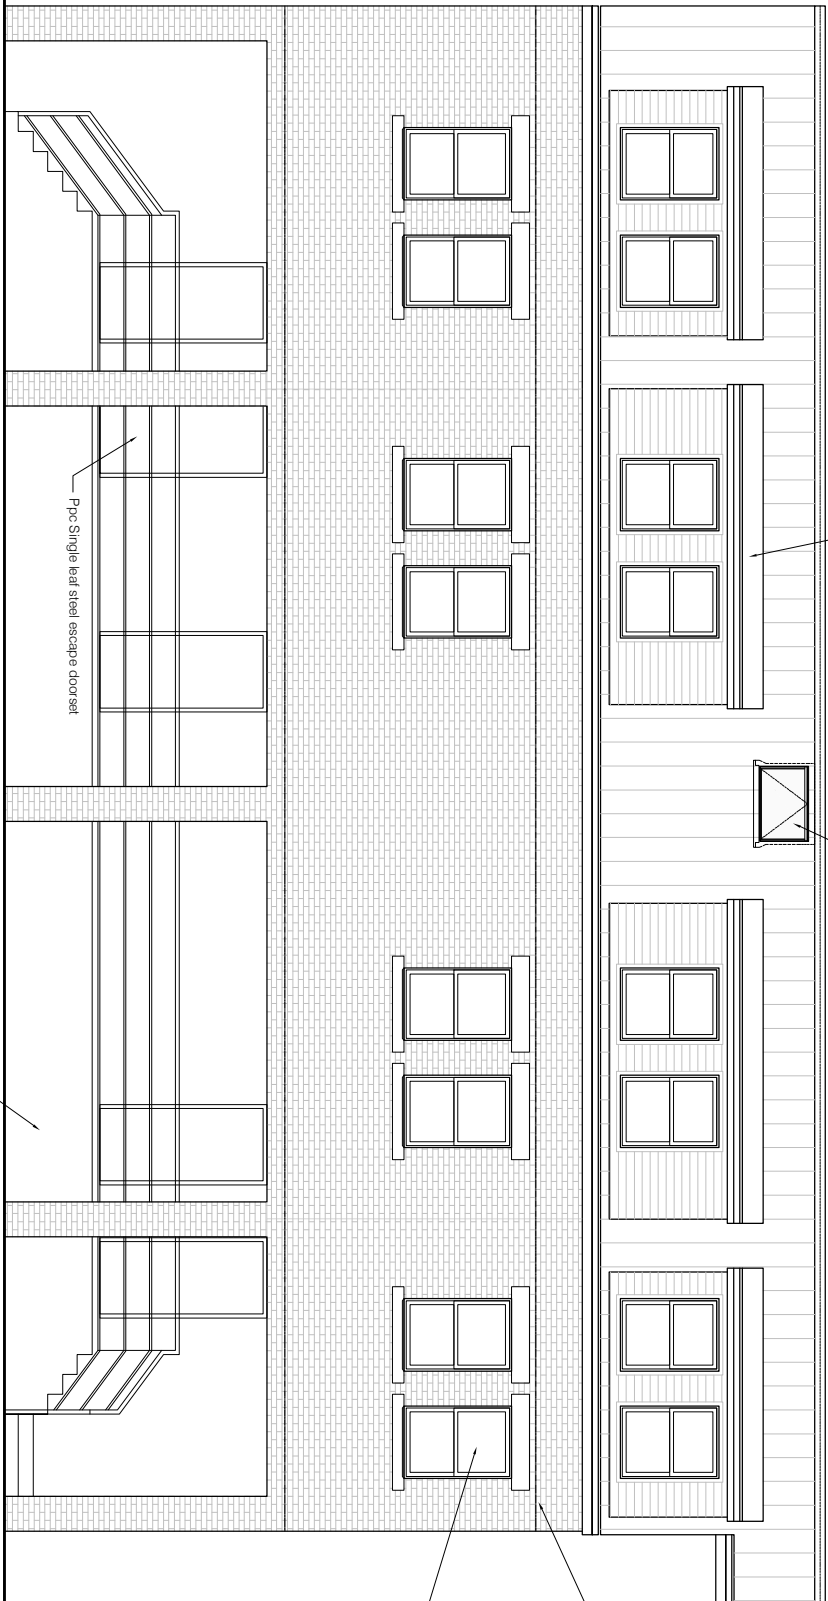
Rear (Western) Elevation 1: 50

External walkway to be in-situ formed concrete slab on brick dwarf wall built up from foundations as SE detail. Walkway to have external stairs as shown with plain fixed galvanised mild handrail at as detailed design

Proprietary dry ridge fixed in line with manufacturer's recommendations
