Report No: C748  
Date: March 2025

**GEOENVIRONMENTAL APPRAISAL**  
of land at  
**CARWOOD COTTAGE, SCHOOL LANE, NORDEN,  
ROCHDALE, LANCASHIRE**

| <b>REPORT NUMBER:</b> | C748 | <b>REPORT STATUS:</b> | Final |
| <b>REPORT TYPE:</b> | Geoenvironmental Appraisal | | |

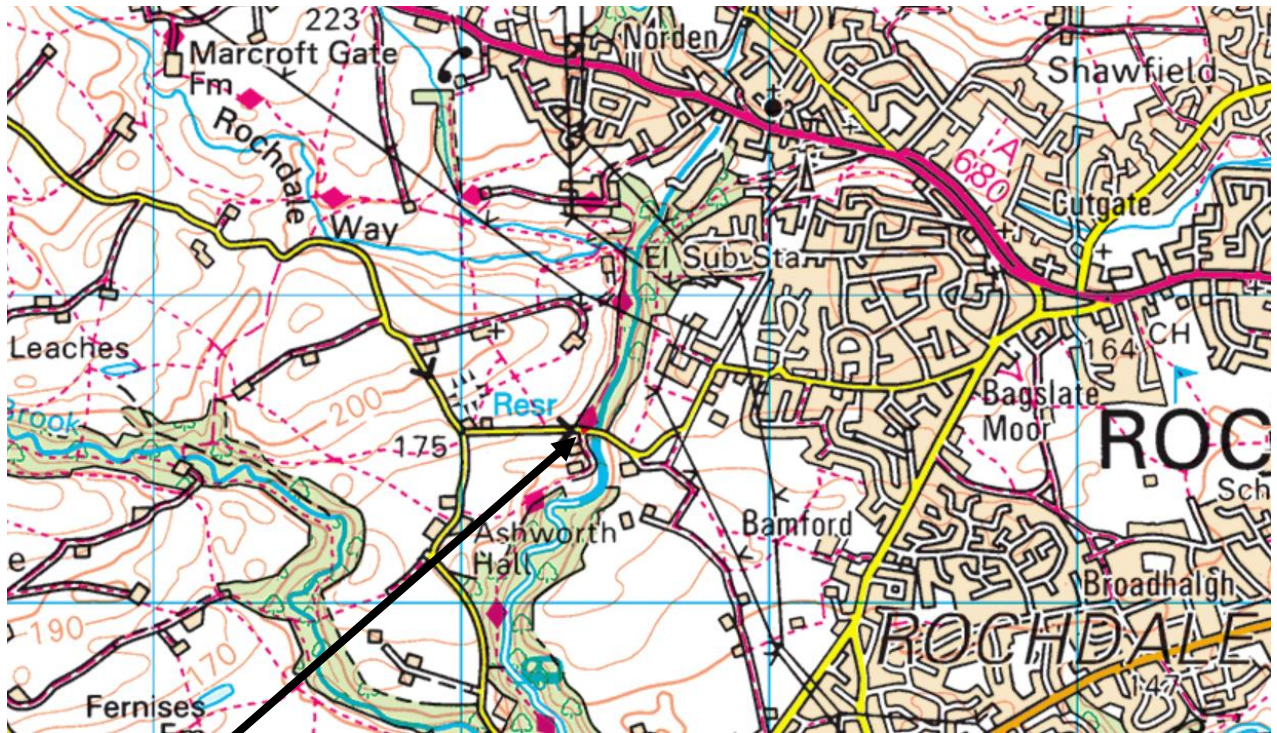
**Drawing No C748/1**

**The Site**

## **Site Location Plan**

The location of the site is shown on Drawing No C748/1, presented in Appendix A of this report.

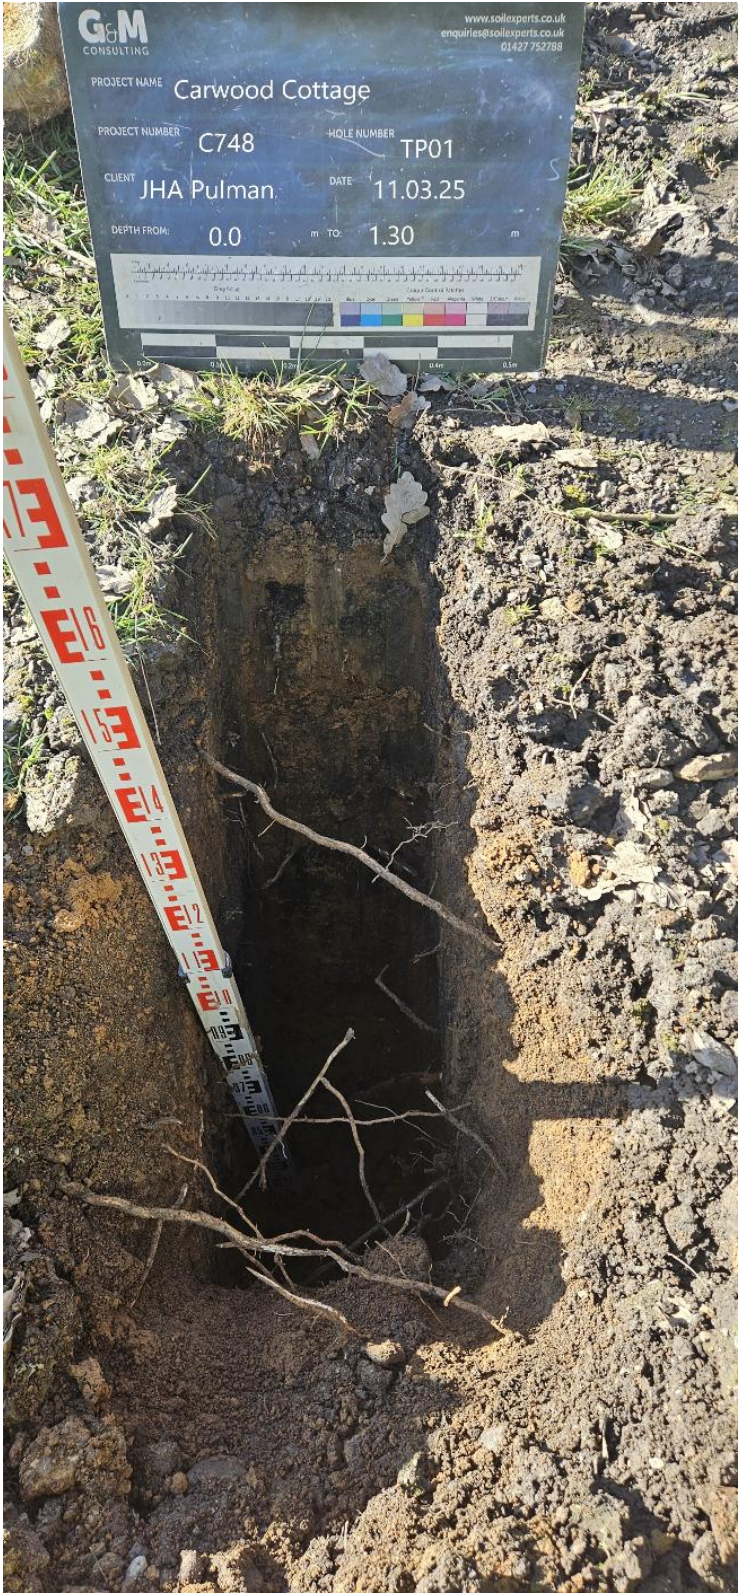
| Remarks<br>Trial Pit Complete | Method, Plant, Stability, Dimensions<br>0.00 - 1.30m TP Volvo EC18<br>Stable<br>Inclination: 90°<br>L = 1.20m<br>W = 0.45m | Logger<br>A Swinbourne |

A photographic record of the trial pits is presented on the respective logs presented in Appendix B of this report.

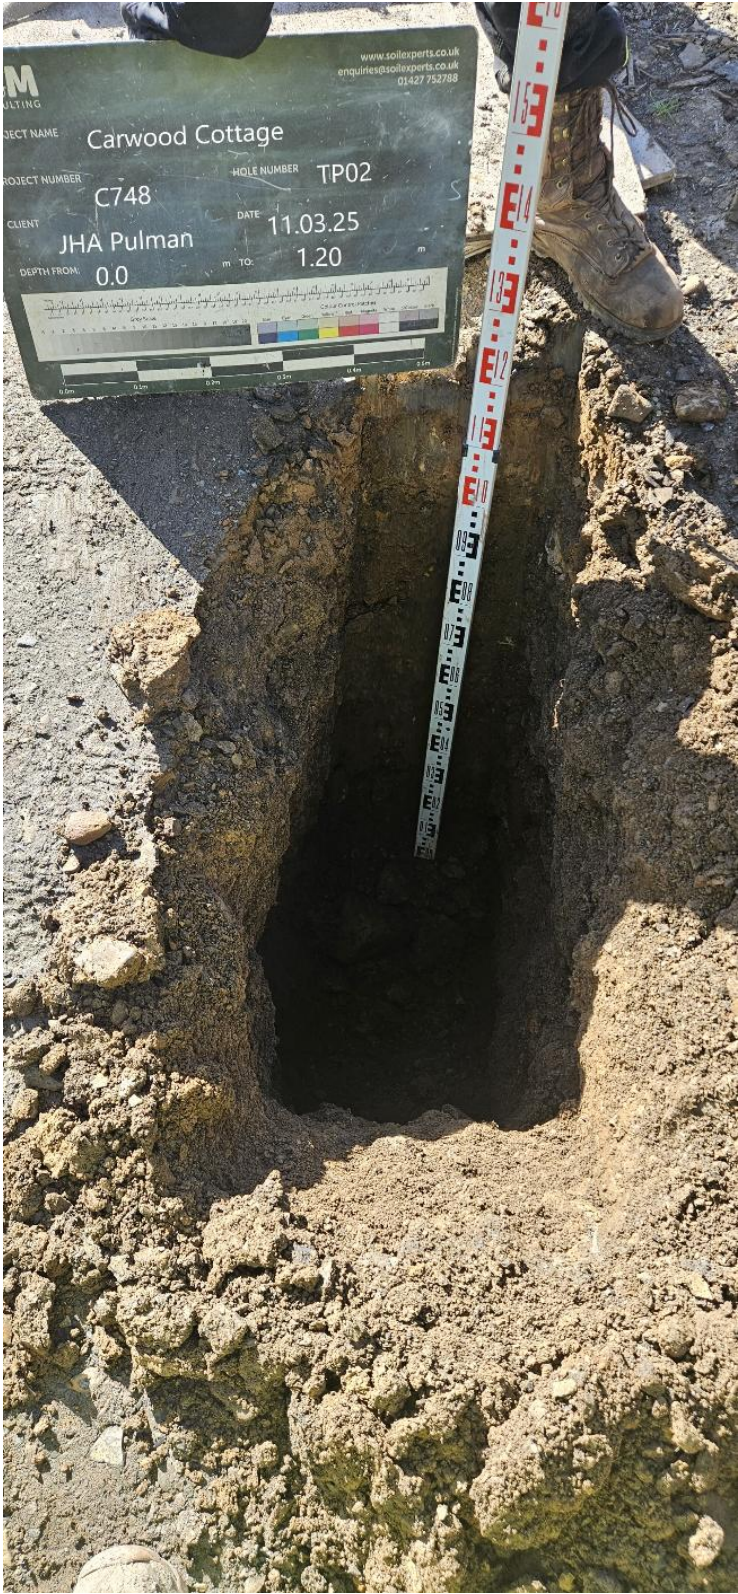
| Remarks<br>Trial Pit Complete | Method, Plant, Stability, Dimensions<br>0.00 - 1.20m TP Volvo EC19<br>Stable<br>Inclination: 90°<br>L = 1.20m<br><div><div></div>W = 0.45m</div> | Logger<br>A Swinbourne |

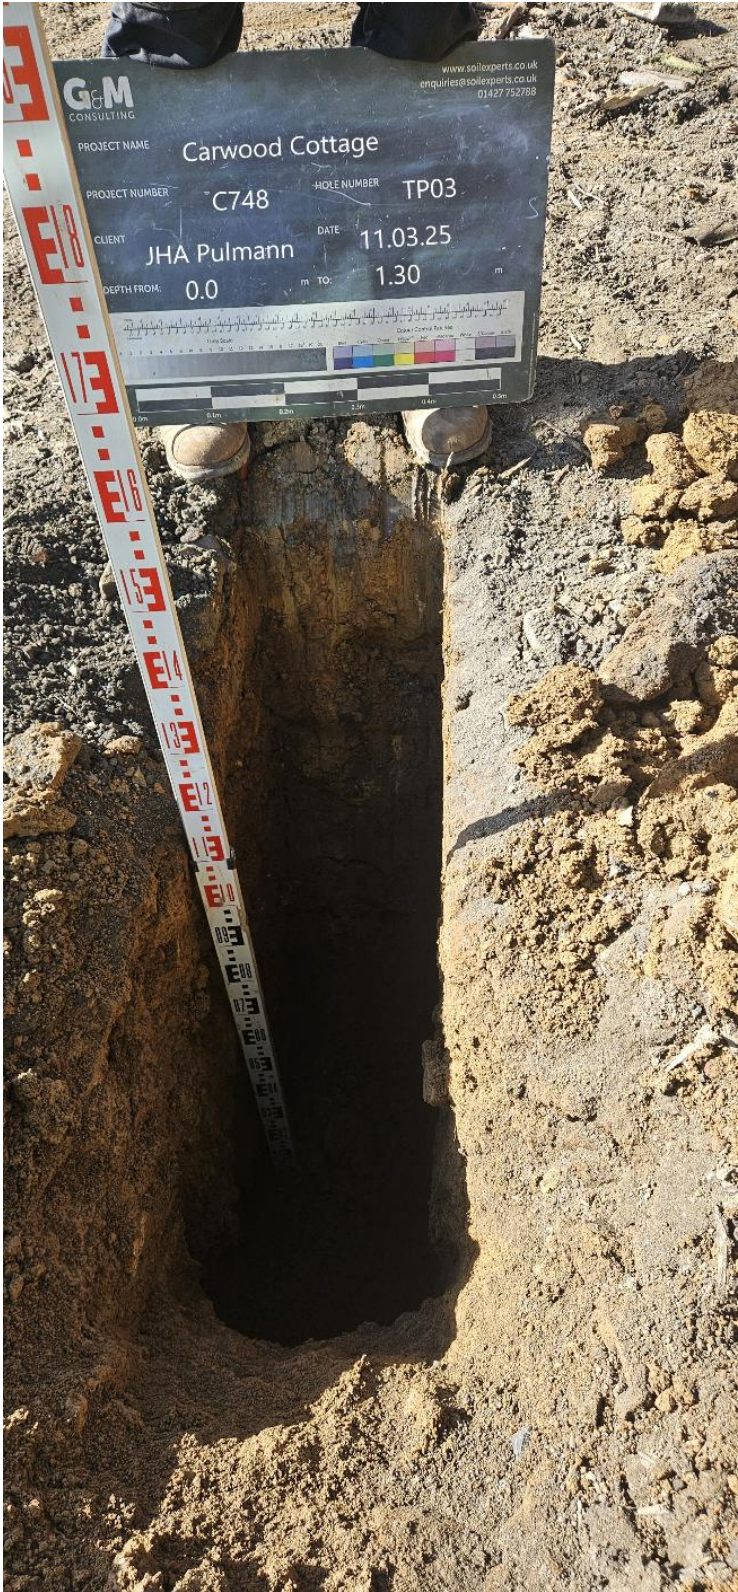
| Remarks<br>Trial Pit Complete | Method, Plant, Stability, Dimensions<br>0.00 - 1.30m TP Volvo EC20<br>Stable<br>Inclination: 90°<br>L = 1.20m<br>W = 0.45m | Logger<br>A Swinbourne |

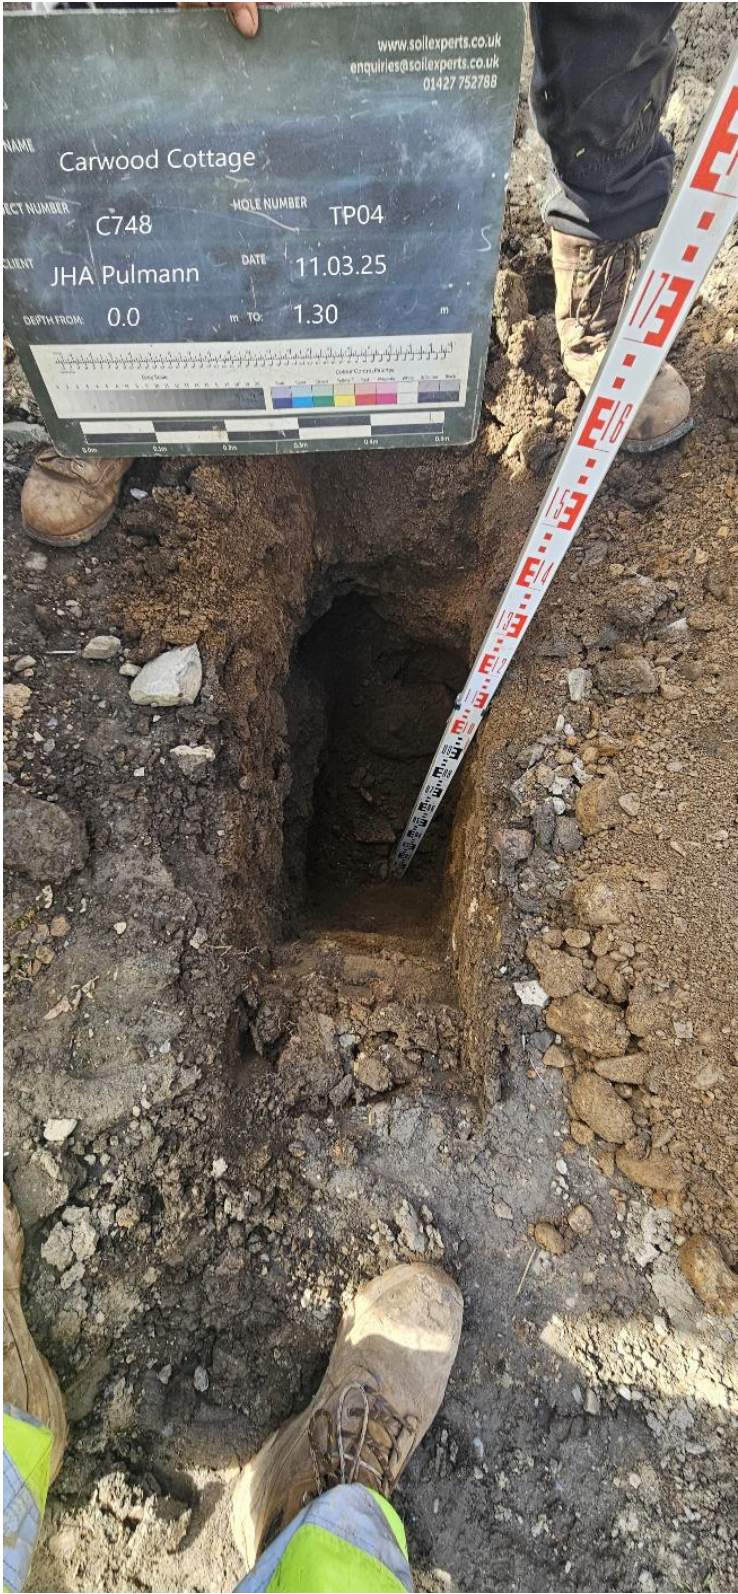
| Remarks<br>Trial Pit Complete | Method, Plant, Stability, Dimensions<br>0.00 - 1.30m TP Volvo EC21<br>Stable<br>Inclination: 90°<br>L = 1.20m<br>W = 0.45m | Logger<br>A Swinbourne |

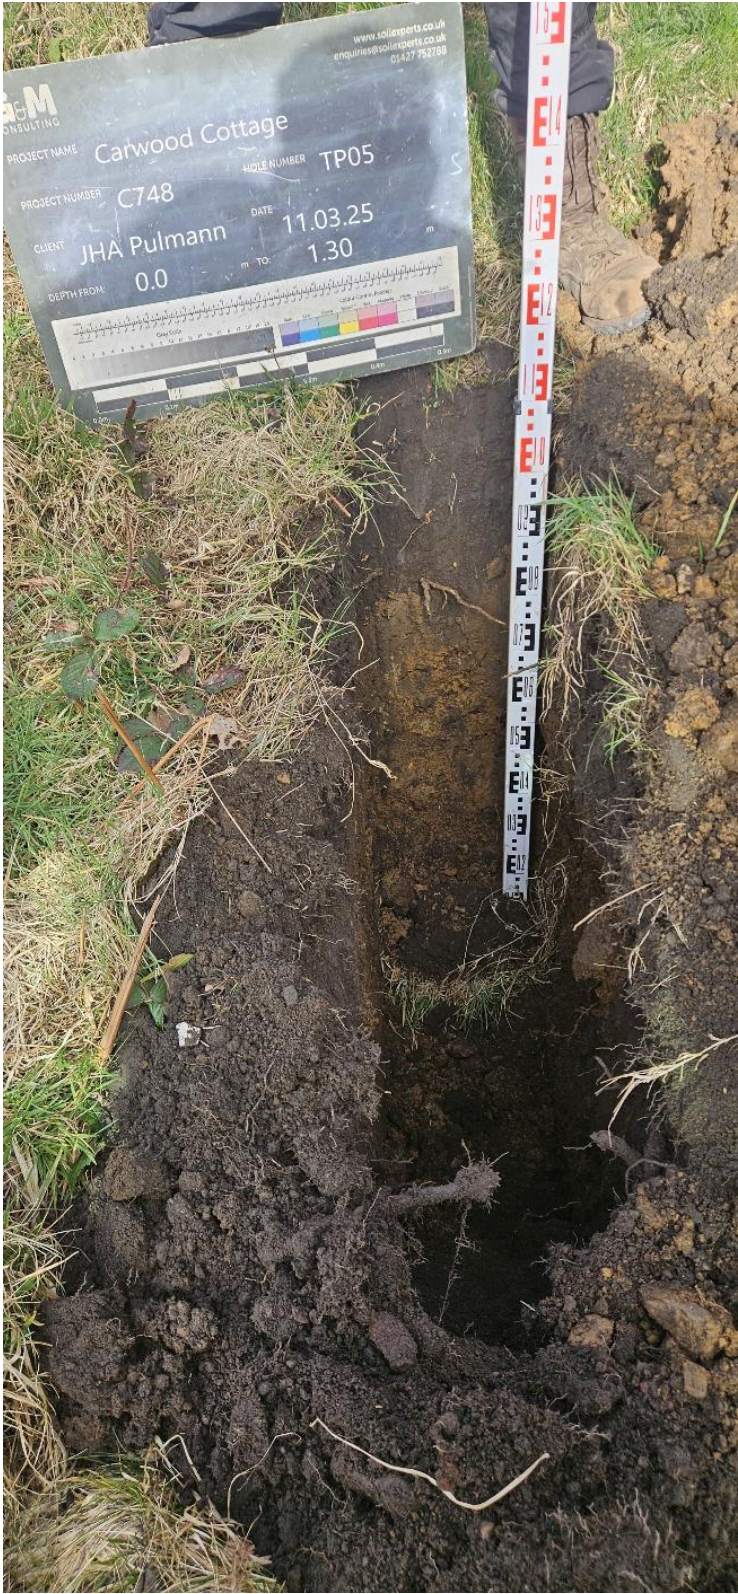
| Remarks<br>Trial Pit Complete | Method, Plant, Stability, Dimensions<br>0.00 - 1.30m TP Volvo EC22<br>Stable<br>Inclination: 90°<br>L = 1.20m<br>W = 0.45m | Logger<br>A Swinbourne |

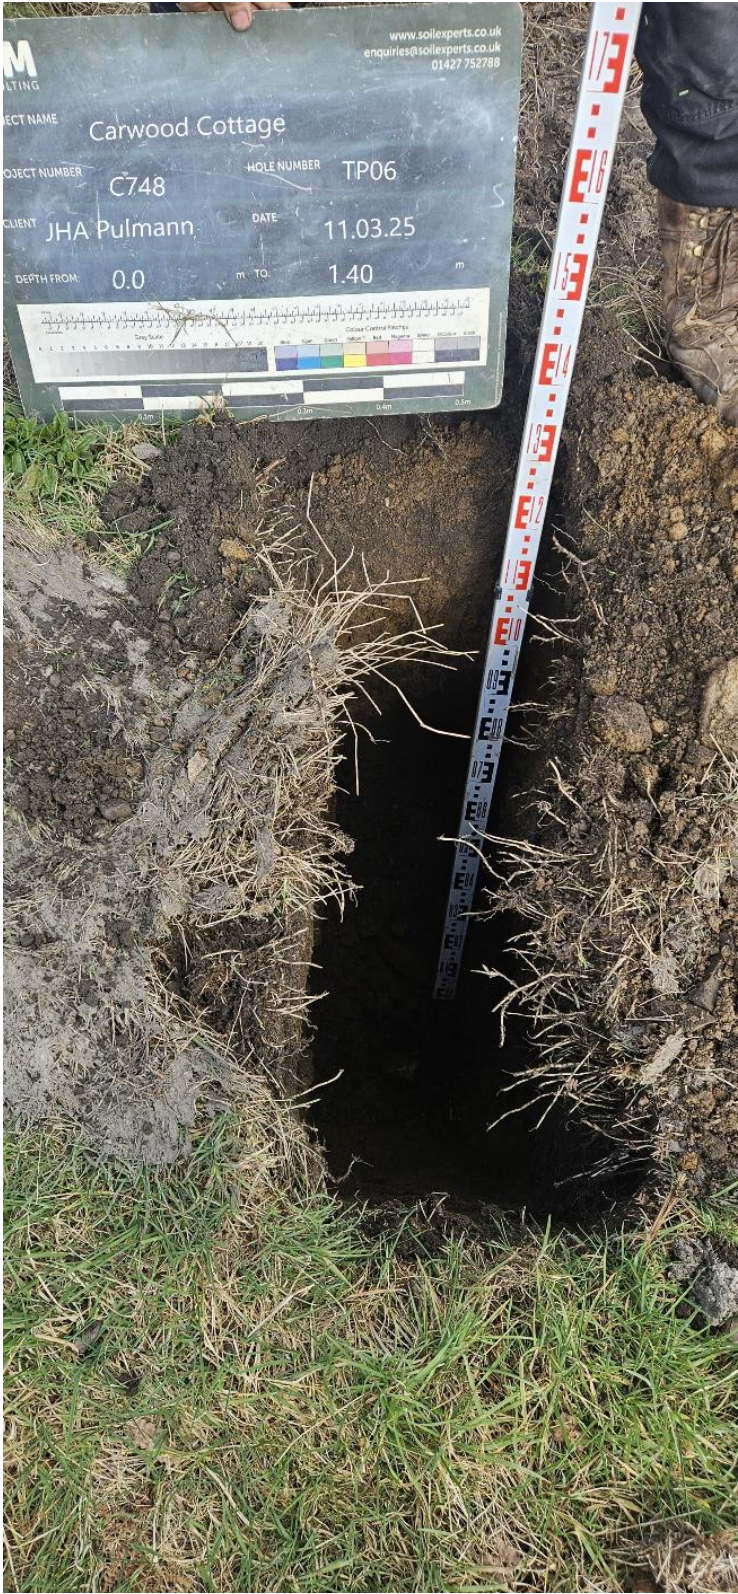
| Remarks<br>Trial Pit Complete | Method, Plant, Stability, Dimensions<br>0.00 - 1.40m TP Volvo EC23<br>Stable<br>Inclination: 90°<br>L = 1.20m<br>W = 0.45m | Logger<br>A Swinbourne |
