Phase II Geoenvironmental Site Assessment  
Land at Greenbooth Road and Edenfield Road, Norden

Reference: 16-465-R2-3  
Date: August 2023

## **PHASE II GEOENVIRONMENTAL SITE ASSESSMENT**

Land at Greenbooth Road and Edenfield Road  
Norden  
Rochdale  
OL12 7TD

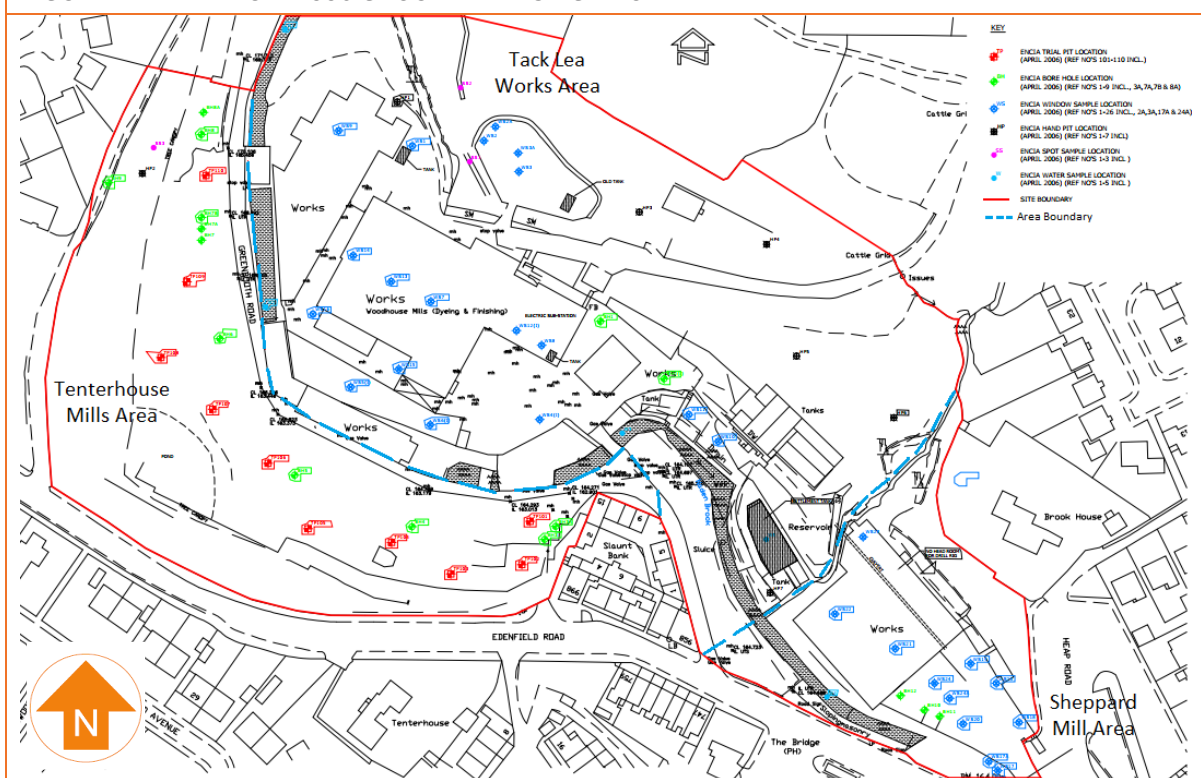
FIGURE 2.1 ENCIA 2006 GROUND INVESTIGATION

Hardstanding was found to be from 0.20 m to 0.30 m thick apart from beneath the main Tack Lea works building (Woodhouse Mills), with thicknesses of 0.70 m to 1.10 m of concrete slabs.

Made Ground was encountered in all exploratory hole locations reaching a maximum depth of 5.00 m bgl in BH2 (centre of the Tack Lea Works area) and 5.10 m bgl in WS17A (south-eastern section of the Sheppard Mill area). The base of the Made Ground could not be determined in a number of positions due to the presence of obstructions (e.g., concrete hardstanding, sandstone boulders). Made Ground was generally shallowest (< 1.00 m) in elevated locations above the valley floor (i.e., the north-western section of the Tack Lea Works area).

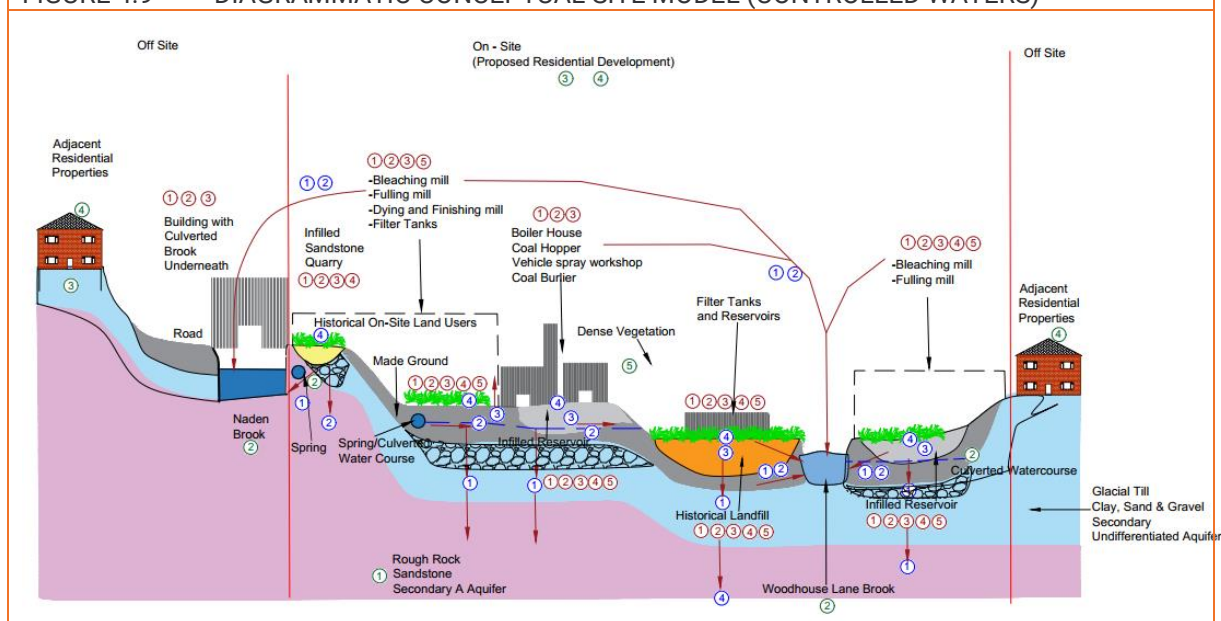
FIGURE 4.9 DIAGRAMMATIC CONCEPTUAL SITE MODEL (CONTROLLED WATERS)

To ensure a robust appraisal of the identified risk to controlled waters, E3P has identified the sources of potential contamination that represent a risk to controlled waters from the initial CSM, we have then assessed the availability of ground investigation data in the form of analysis of the solid phase (soil) and dissolved phase within the perched groundwater or aquifer. The results of this assessment are presented in Table 4.4.

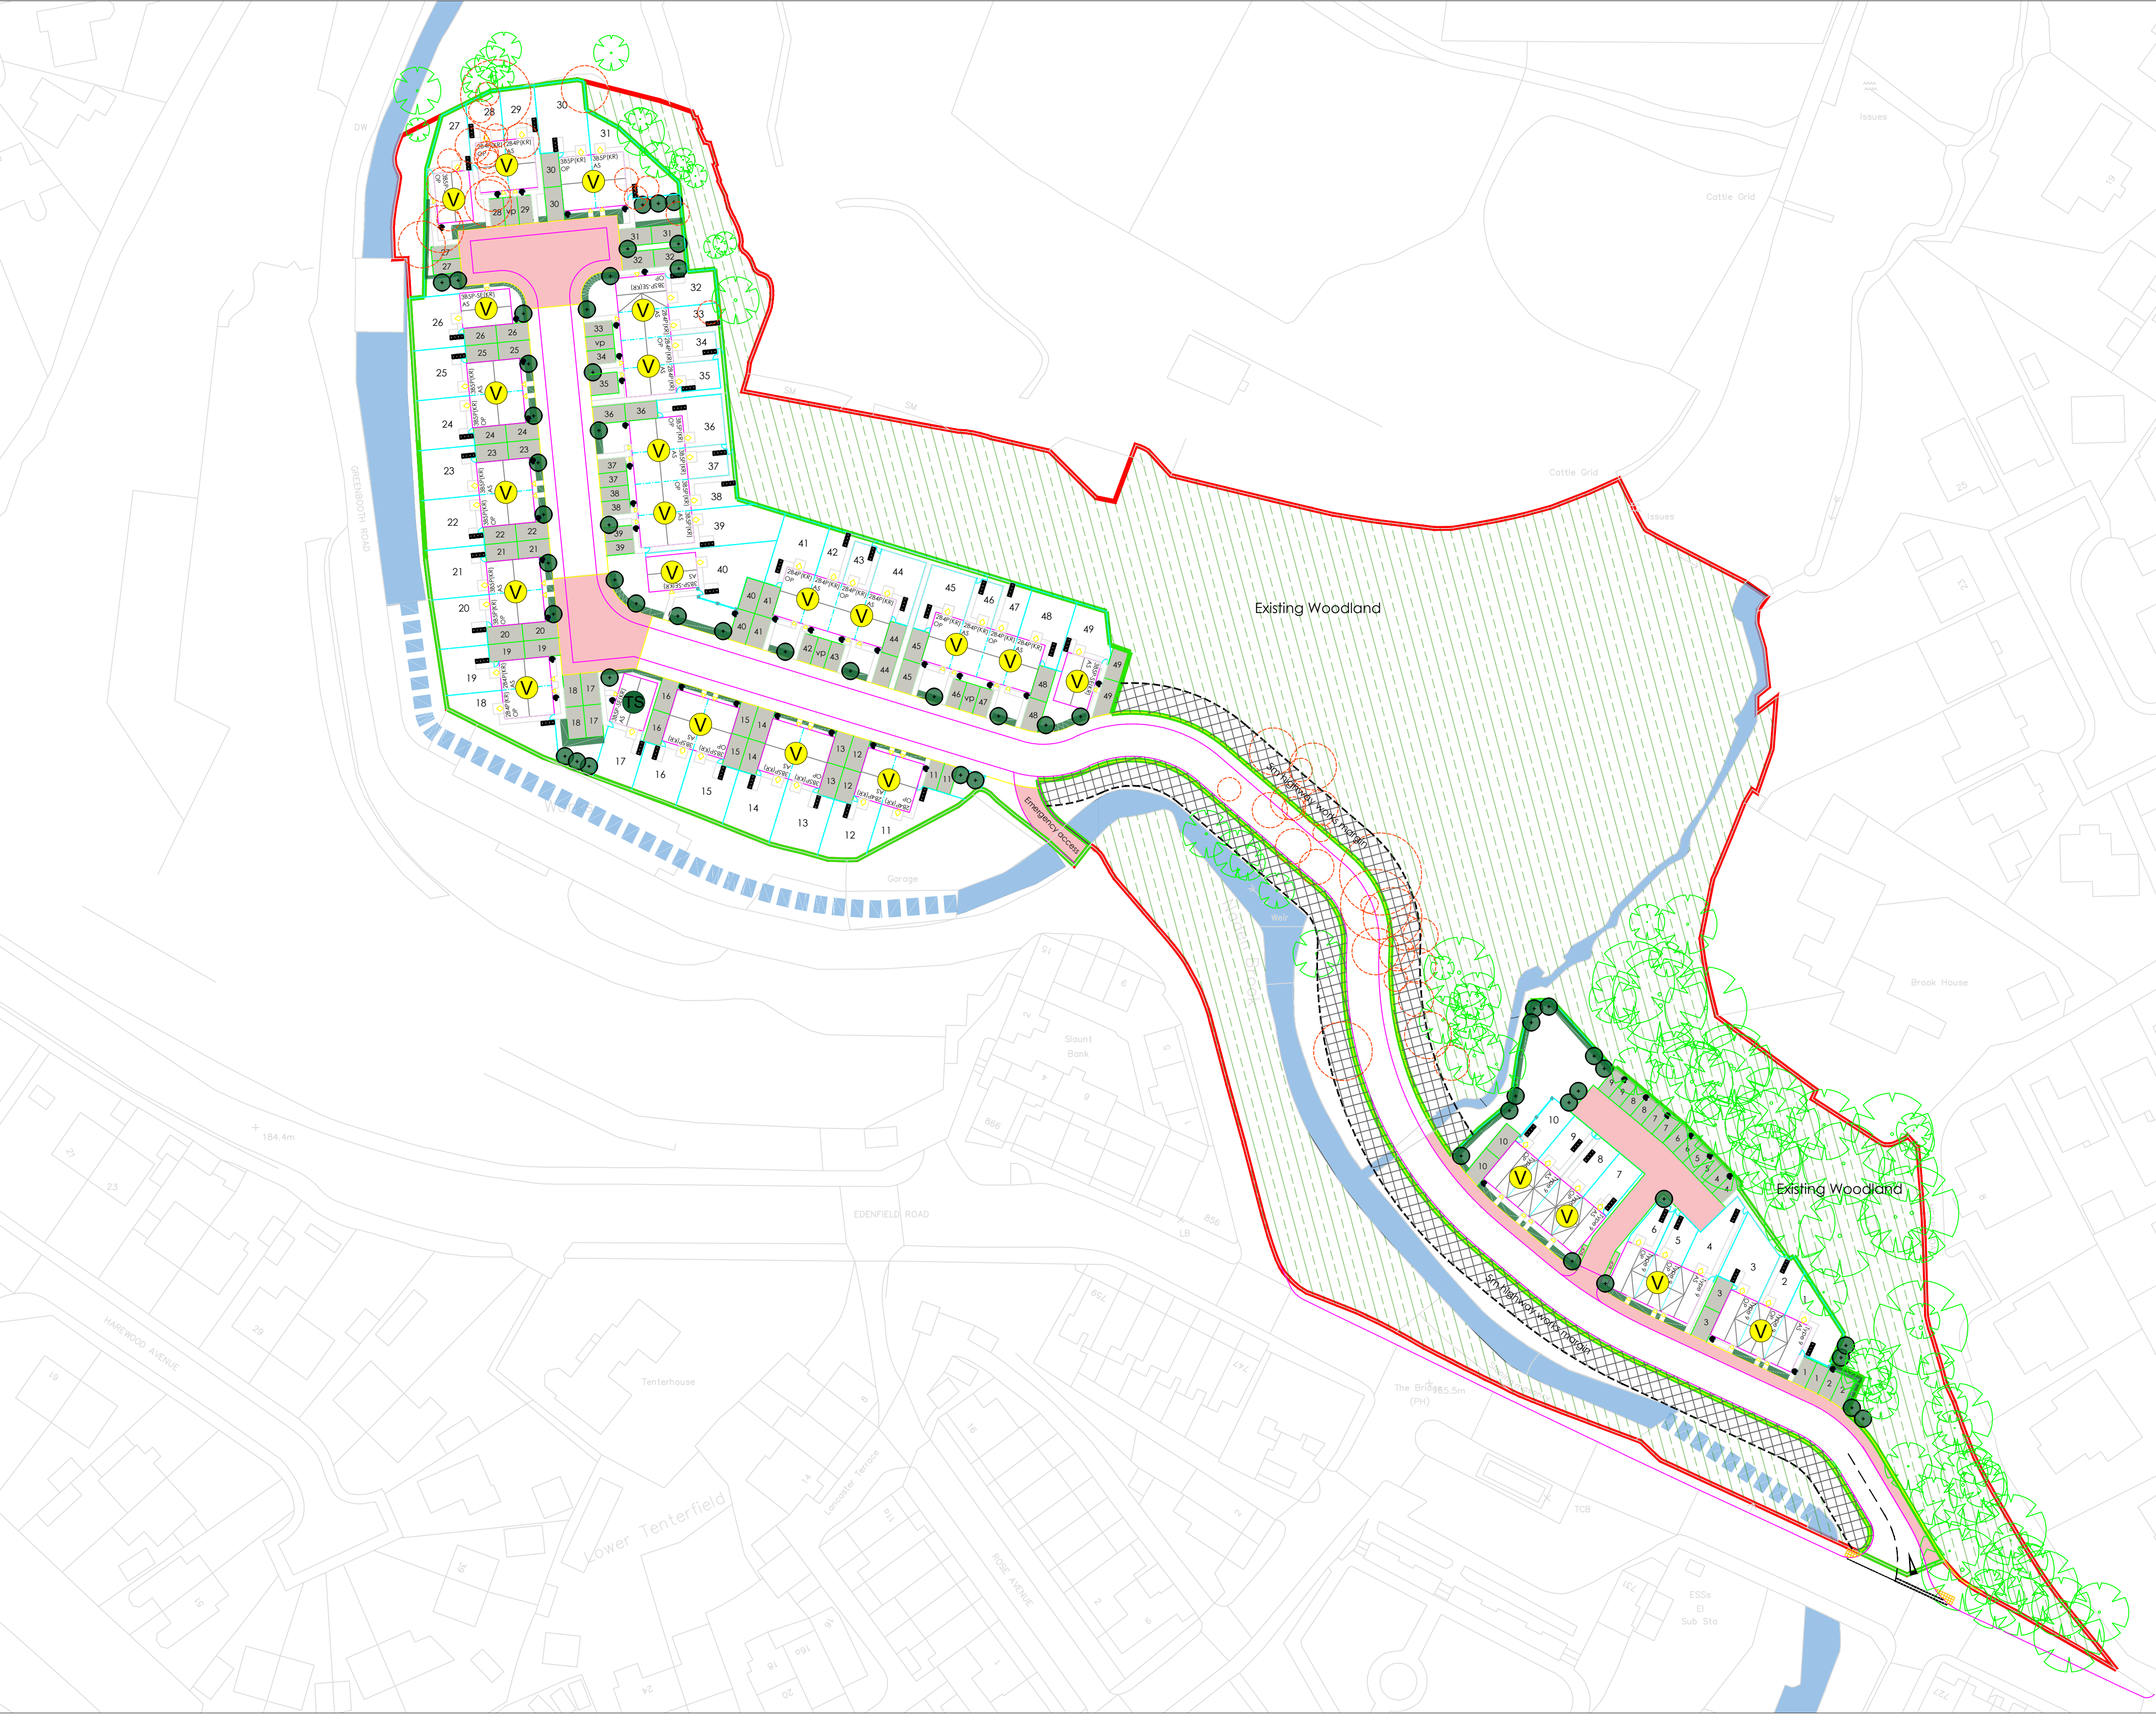
Where foundations are located over treated shallow workings spread and trench fill foundations (strips and rafts) are required to be suitably reinforced to span soft spots (3m span and 1.5m cantilever). It is desirable to maintain bearing pressures below 160kNm/m2 at the grouted horizons - Piles are not generally suitable unless founded below the grouted horizons (typically, this cannot be achieved with driven piles) and would require further detailed assessment. There is also a potential for pile installation to disturb workings or shafts Refer to CIRIA SP32 and C758 for details. Foundations, which encounter coal, should be brought below the coal. The sides of foundations should be protected when they are in contact with coal.

- TS** Traditional Strip Foundations  
Minimum depth 900mm below proposed First Finished Level.  
Maximum safe bearing pressure limited to 100kN/m2.
- MT** Mass Trench Fill Foundations  
Minimum depth 1200mm below proposed First Finished Level.  
Maximum safe bearing pressure limited to 100kN/m2.

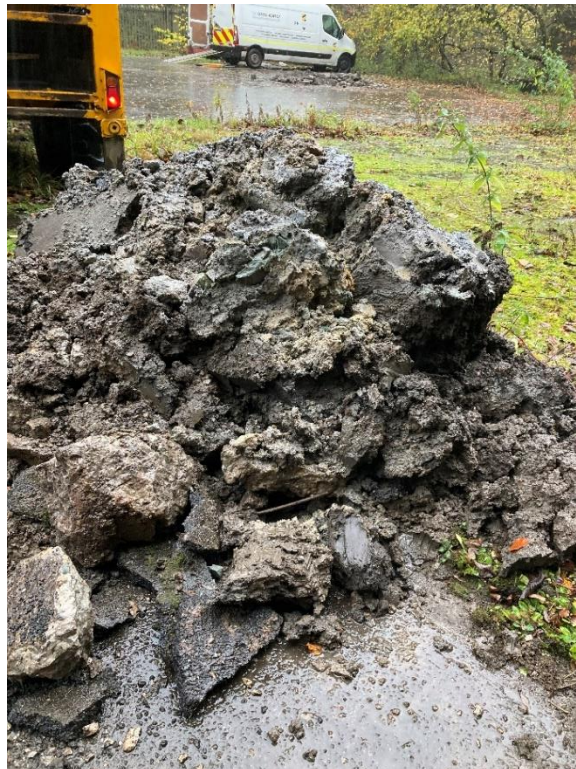
PLATE 3      TP124 ARISINGS

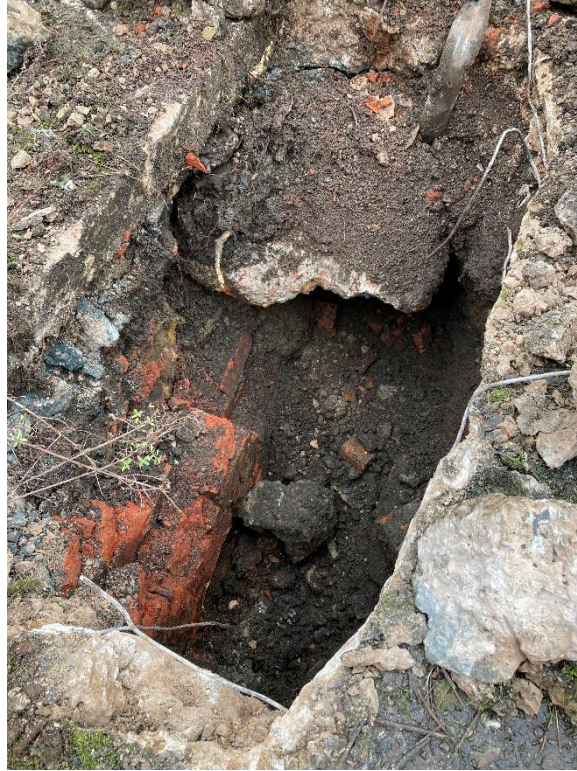
PLATE 4 TP116 EXCAVATION WITH OBSTRUCTIONS

| <p><b>Underground Obstructions</b></p> | <p>Significant concrete and brick obstructions and basement features, which are indicative of relict foundations from former buildings, were identified across the site. As such, the full thickness of the Made Ground could not be fully proven in localised areas within the northern and central parts of the Tack Lea Works area and the southeastern part of the Sheppard Mill area.</p> <p>During a phase of cut-and-fill enabling works to create a developable platform, all below-ground obstructions will require grubbing out to the base of the Made Ground to enable the construction of proposed plots.</p> |

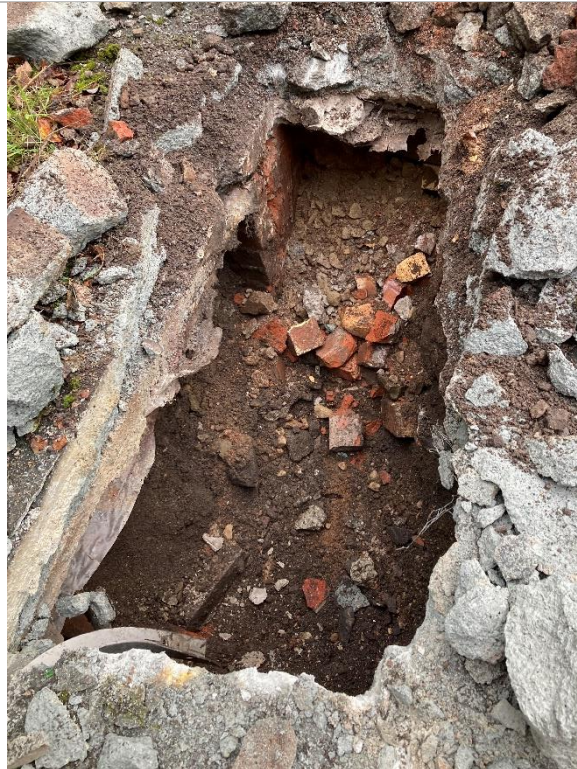
PLATE 5 TP107 EXCAVATION WITH OBSTRUCTIONS

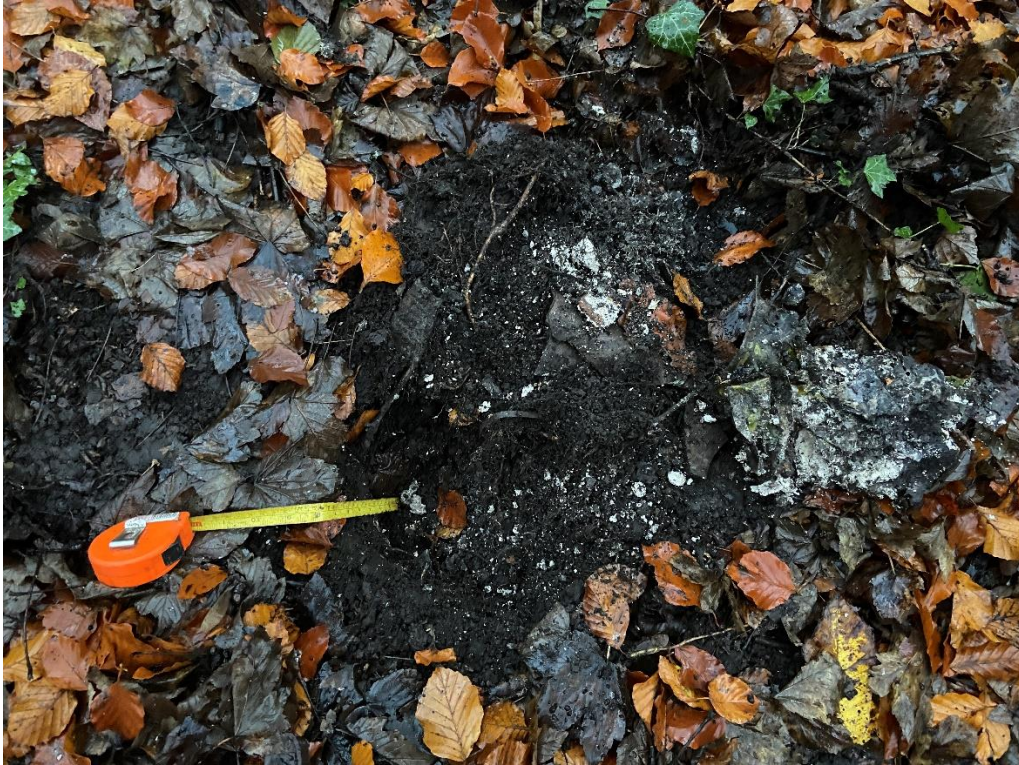
PLATE 6      HP105 EXCAVATION WITH VISIBLE ASBESTOS FRAGMENTS
