# DAYTIME BAT SURVEY

## BARN AT LEACHES FARM, ASHWORTH ROAD, ROCHDALE

FEBRUARY 2023

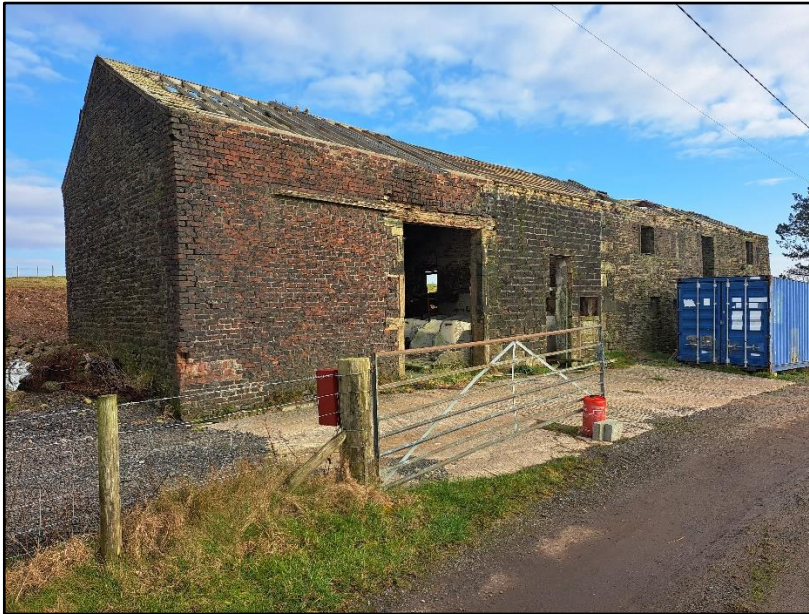
- 3.1 The site is a two-storey traditional barn building constructed of brick and stone (see Photograph 1). The roof is pitched and is almost entirely uncovered (see Photograph 2).

*Photograph 1 showing the front of the site (southwest aspect)*

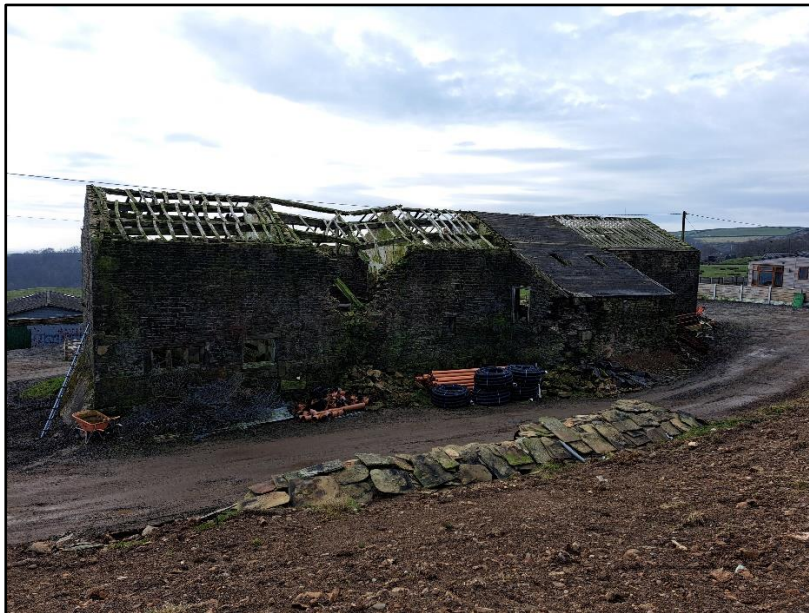
*Photograph 2 showing the rear of the site (north aspect)*

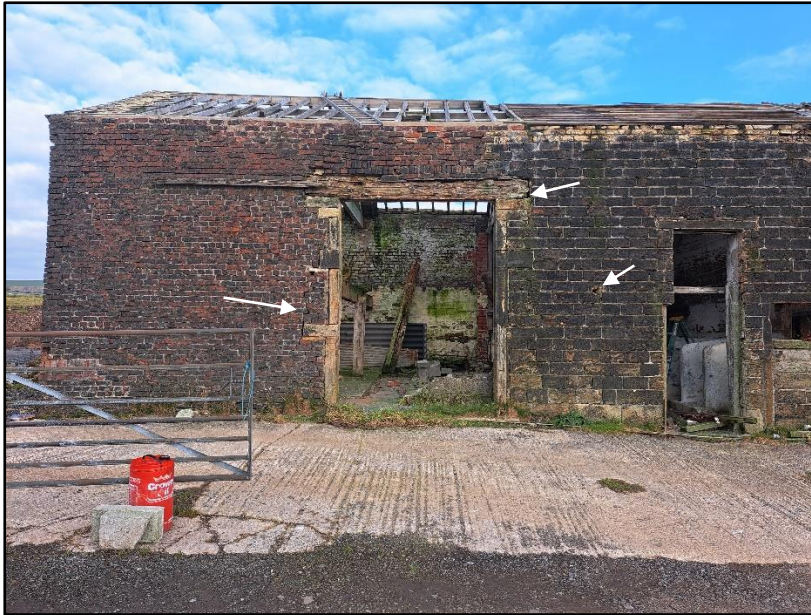
- 3.2 The masonry is in a dilapidated condition with numerous crevices (see Photographs 3 and 4).

*Photograph 3 showing crevices in the masonry (south elevation)*

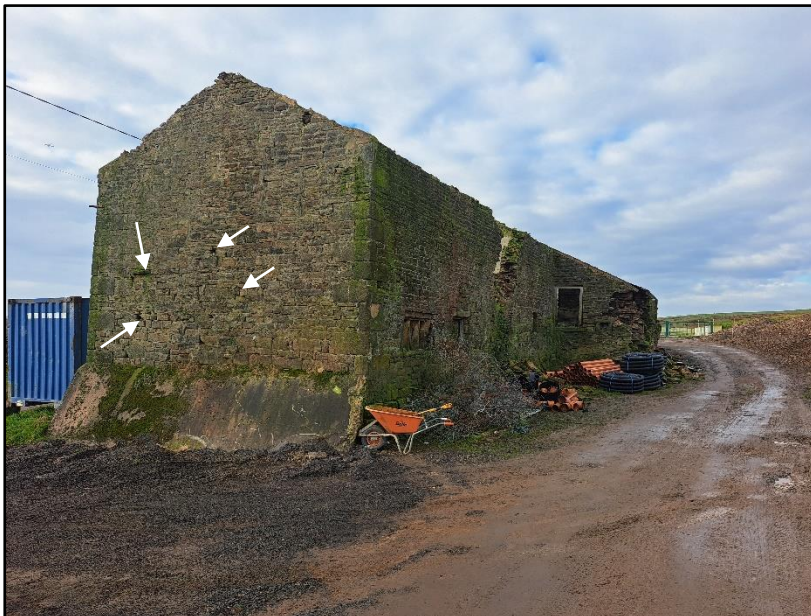
*Photograph 4 showing crevices in the masonry (east elevation)*

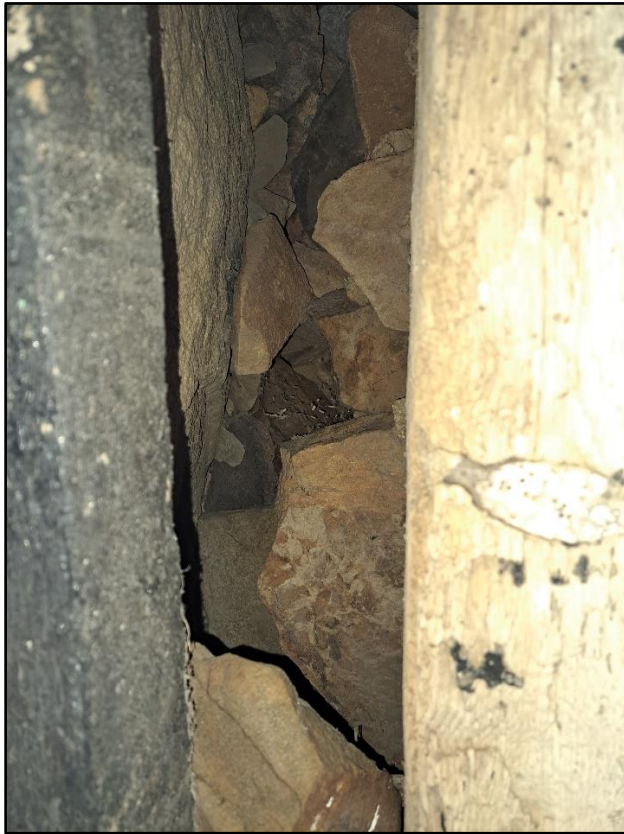
- 3.3 Several of the crevices extended beyond 100mm into the rubble-filled walls (see Photograph 5).

*Photograph 5 showing a deep crevice in the masonry*
