# Newhouse Academy, Heywood

## Phase 2 Ground Investigation Report

Document Ref: SRP1019-CUR-XX-XX-RP-G-0001

Issue Date: 25 November 2022

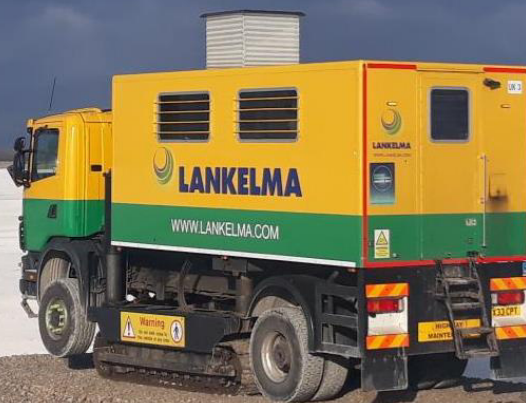
# UK3 Track-truck

| Rig weight | 20.5 T |

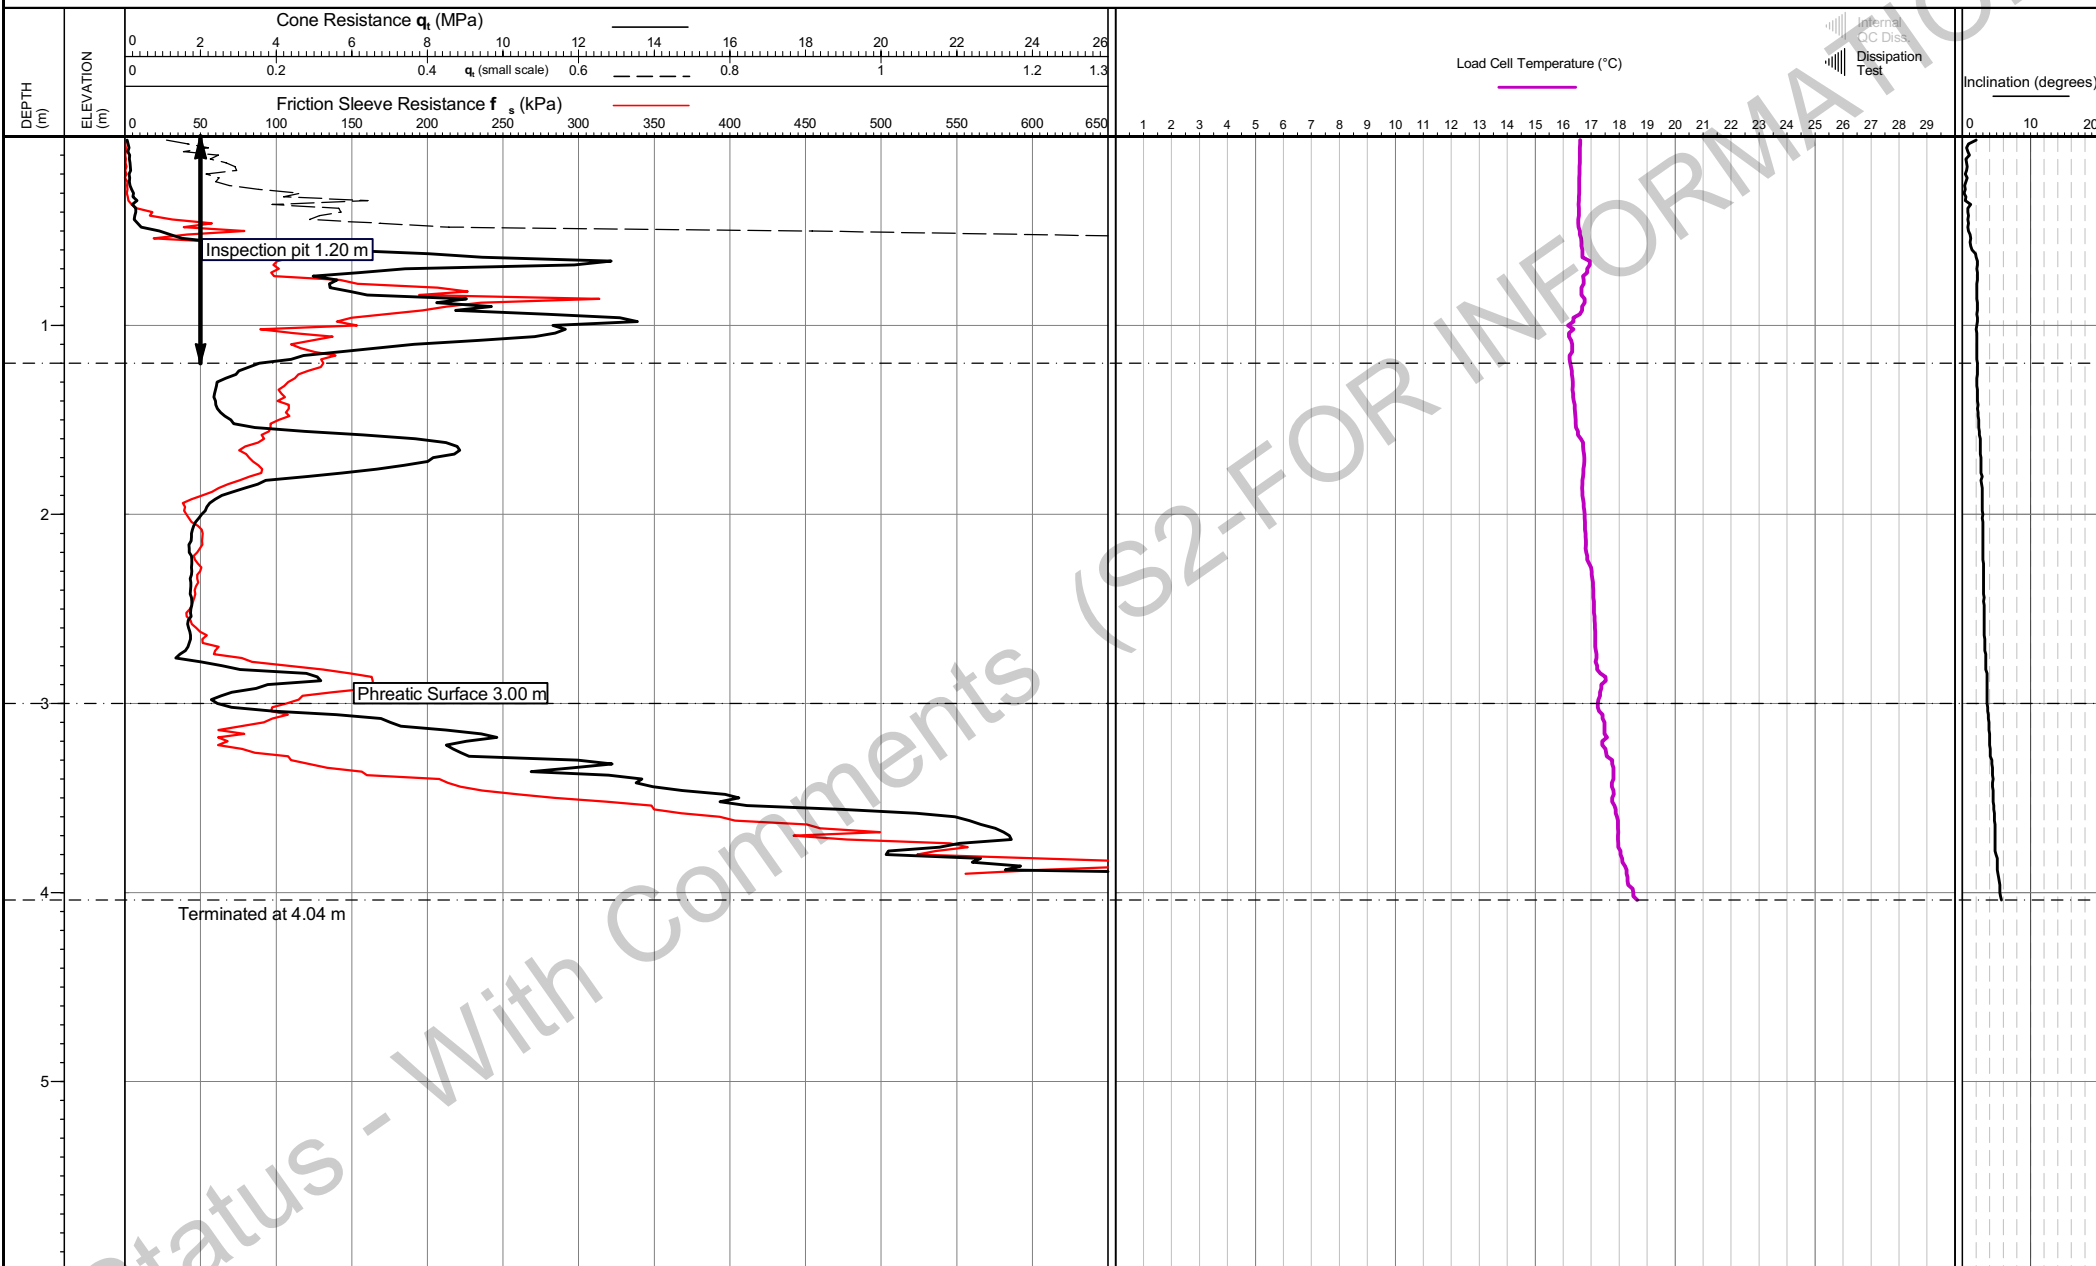
Cone area (mm<sup>2</sup>):  
Cone ID: S15-CFIPTT.1993  
Operator: Jamie Butterworth  
Rig Used: UK3  
Date of test: 28/10/2022 08:46:26

Zero drift (Pre/post test)  
 $q_{0i}$  (kPa): 6.2  
 $f_{s0i}$  (kPa): 0.2 ( $f_{s0i} = q_{0i} - u_{2i}$ )  
 $u_{2i}$  (kPa): 0.4

Ground temperature is only represented following a penetration pause of > 11 minutes.

Plots are provided for locations performed with a digital penetrometer measuring internal load cell temperature.
