**26 Falcon Close**

**March 2025**

AMA Project Number: 22833

2.1.1 This infiltration test report has been prepared by Andrew Moseley Associates (AMA) in relation to the drainage design associated with 26 Falcon Close, Rochdale. The purpose of this document is to supplement the AMA Drainage Strategy report for the development and construction of 2 dwellings located at 26 Falcon Close, Rochdale. A site plan can be found in [Appendix A](#). This report will focus on:

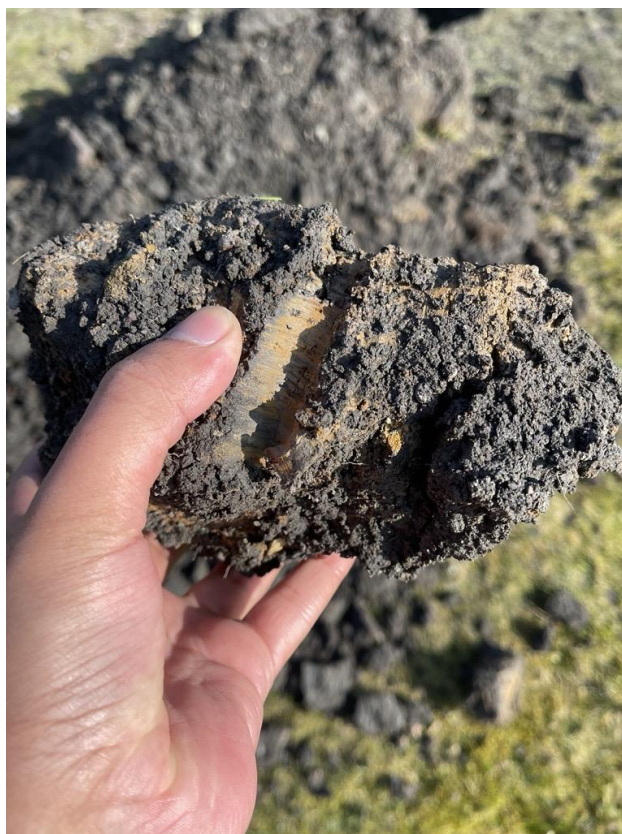
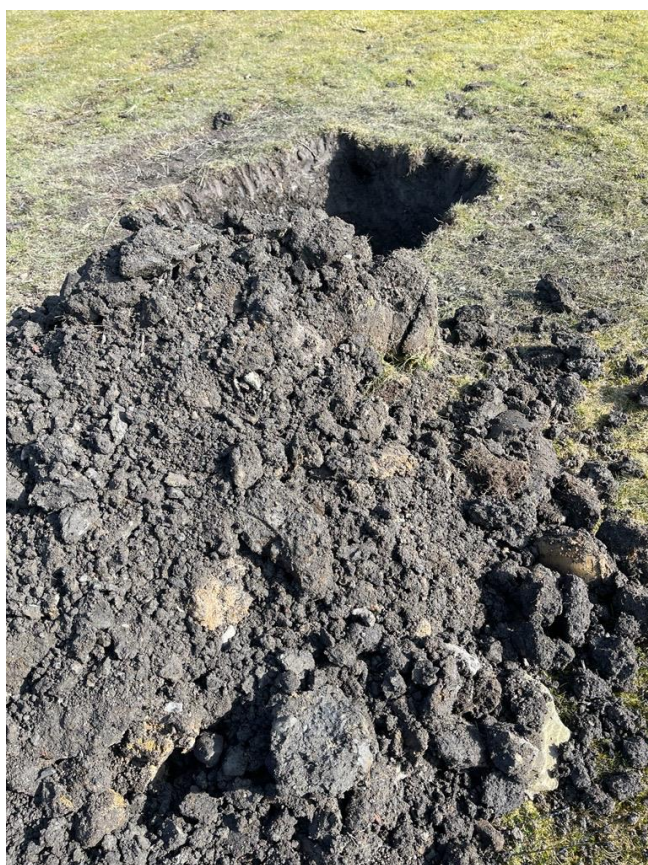
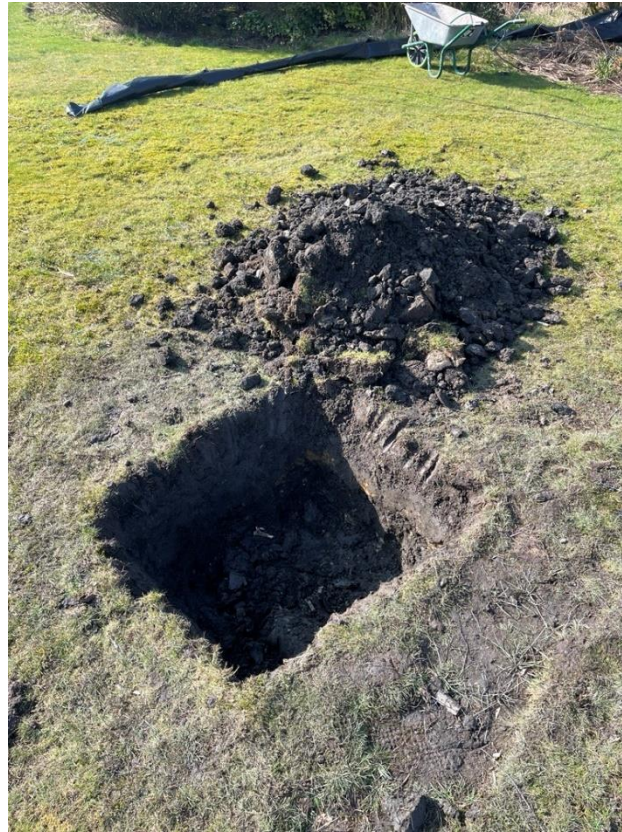
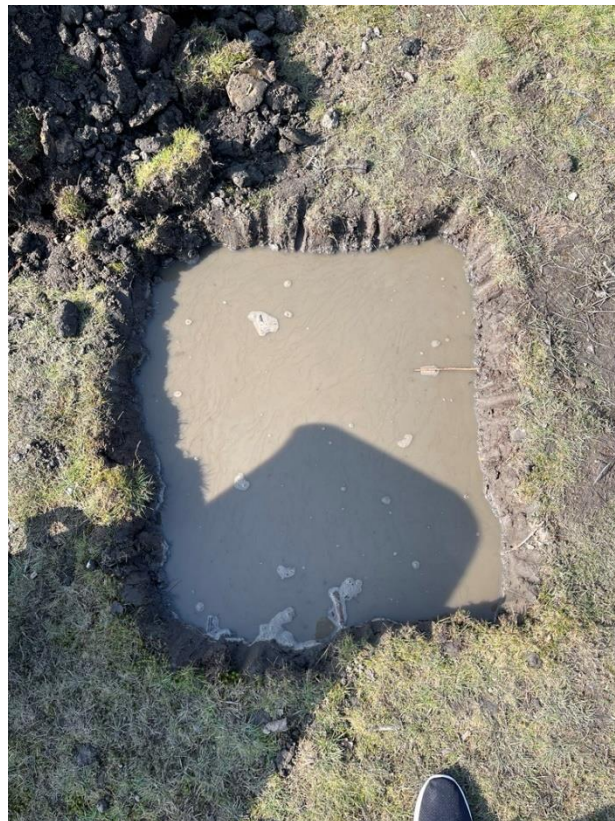
***Appendix B***  
***Test Photographs***

2.6.2 1 trial hole was formed in the center of the site with the following dimensions:

- ▶ Trial Hole 1: 1.0 m x 1.0 m x 0.90 m

2.7.1 For the test completed on Test Pit 1, water was filled to a depth of 0.80m, and the water level dropped to 0.75m over a 90-minute period.

2.8.1 As the water level within the test pit only decreased by 0.05m over a 90-minute period it can be concluded that soakaways would not be viable at the site.
