### **LITTLEBOROUGH SUBSTATION (Asset 8) – Preliminary Roost Assessment**

This letter describes the findings of a Preliminary Roost Assessment (PRA) of the Littleborough Substation (Asset 8), William Street, Littleborough (central grid ref. SD 93233 16112) (see *Figure 1*).

Project  
Littleborough Substation

Title  
Preliminary Roost Assessment

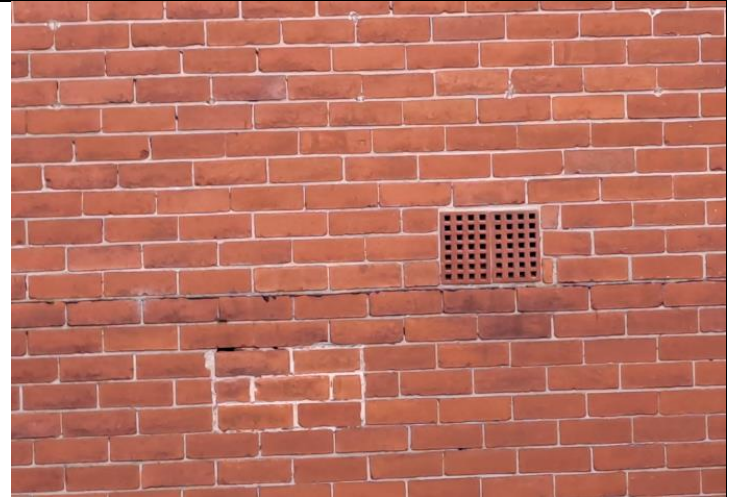
| PRF Reference | Description (roost suitability) | Photograph |
|---|---|---|
| 1 | Vent brick with numerous holes – offers limited suitability for bats, and exposure to elements. Only likely to be used by individuals bats on an opportunistic basis, exposed to elements. ( <b>Low</b> ) | |

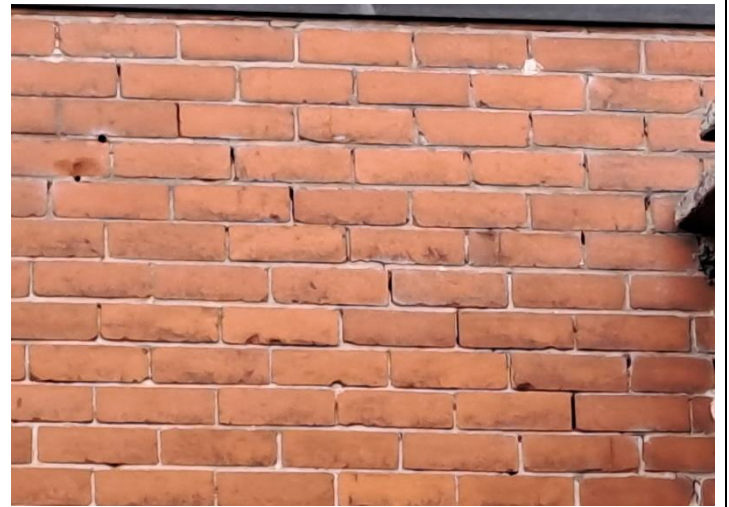
| PRF Reference | Description (roost suitability) | Photograph |
|---|---|---|
| 2 | Mortar gaps which vary in depth, at most these gaps would give opportunistic roosting opportunities during summer months due to variability in weather and exposed nature of feature. ( <b>Low</b> ) | |

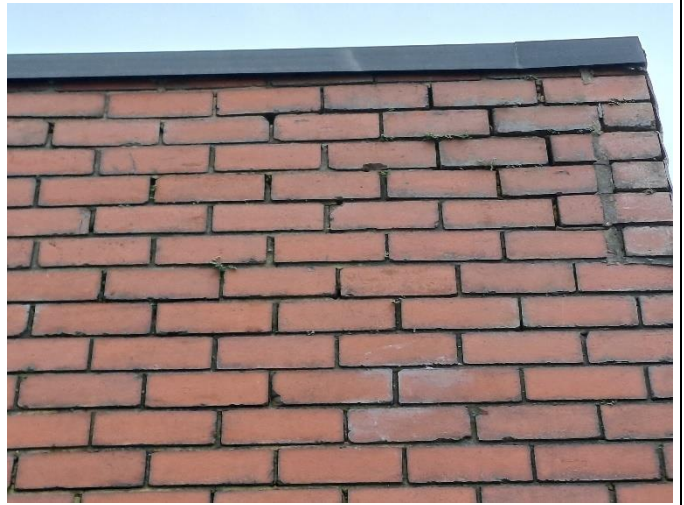
| PRF Reference | Description (roost suitability) | Photograph |
|---|---|---|
| 3 | Led roofing overhang, providing a small crevice of limited depth around all aspects of the building. These would likely be used on an opportunistic basis by individual bats in summer months ( <b>Low</b> ) | |

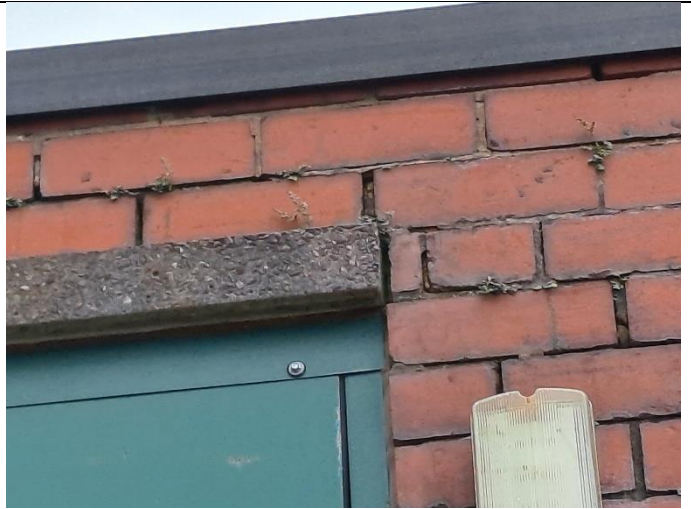
| PRF Reference | Description (roost suitability) | Photograph |
|---|---|---|
| 4 | Mortar gaps around door lintel on eastern aspect. Egress appeared deep and may provide access to cavity wall. This provides roosting opportunities to smaller groups of bats during summer months, but unlikely to support a larger colony ( <b>Moderate</b> ). | |

The building has been assessed to offer moderate suitability for summer-roosting bats and is to be demolished. This will mean the destruction of features that may be used by roosting bats. Further surveys will be required to ascertain the presence or likely-absence of a roost, prior to any demolition taking place. In line with BCT guidance<sup>4</sup> this would take the form of:

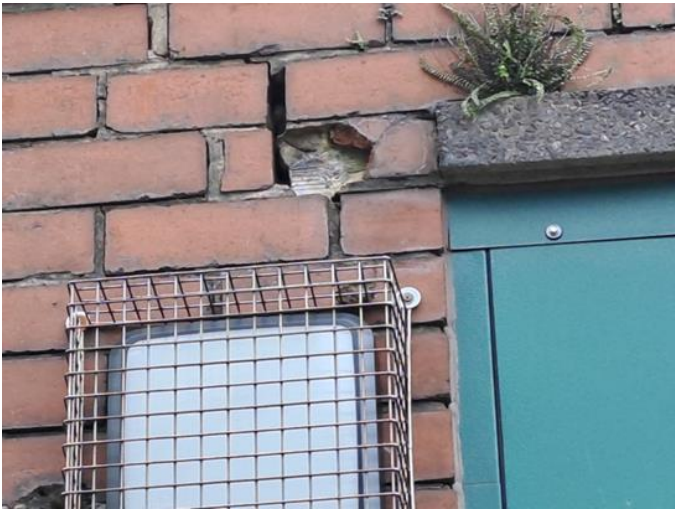
| PRF Reference | Description (roost suitability) | Photograph |
|---|---|---|
| 5 | Large gap in brickwork, which may provide access to cavity wall. Similarly, to feature four this may provide roosting opportunities for smaller groups of bats ( <b>Moderate</b> ). | |

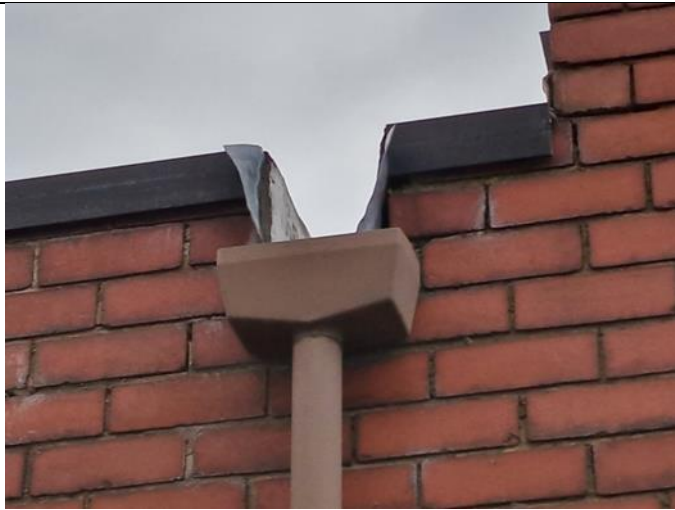
| PRF Reference | Description (roost suitability) | Photograph |
|---|---|---|
| 6 | Gap in led flashing around downpipe, likely to be wet during rainfall and therefore providing opportunistic roosting opportunities for individual bats in summer months ( <b>Low</b> ). | |

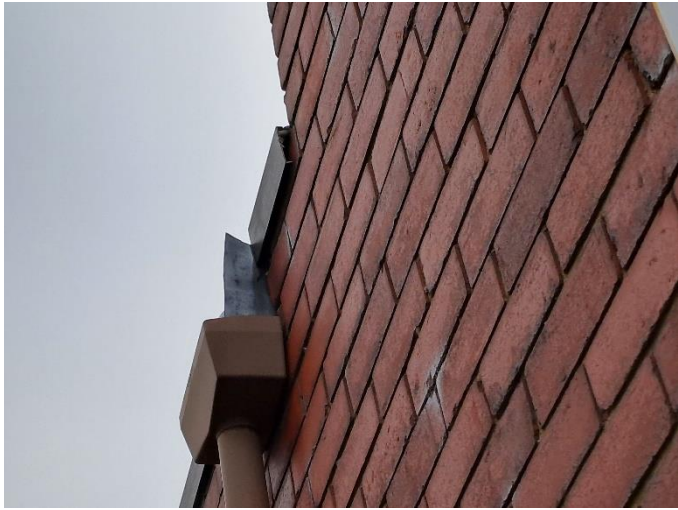
| PRF Reference | Description (roost suitability) | Photograph |
|---|---|---|
| 7 | Missing endcap on roofing overhand, providing access to led flashing overhang, with similar depth to PRF 3. These would like be used on an opportunistic basis by individual bats in summer months. <b>(Low)</b> | |

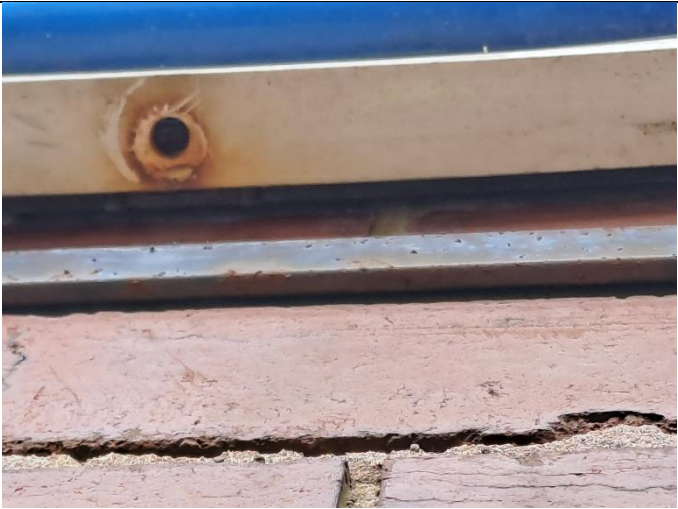
| PRF Reference | Description (roost suitability) | Photograph |
|---|---|---|
| 8 | Gap behind alarm housing providing a degree of shelter, however likely to become waterlogged in periods of rainfall. Feature may be used on an opportunistic basis by individual bats in summer months. <b>(Low)</b> | |

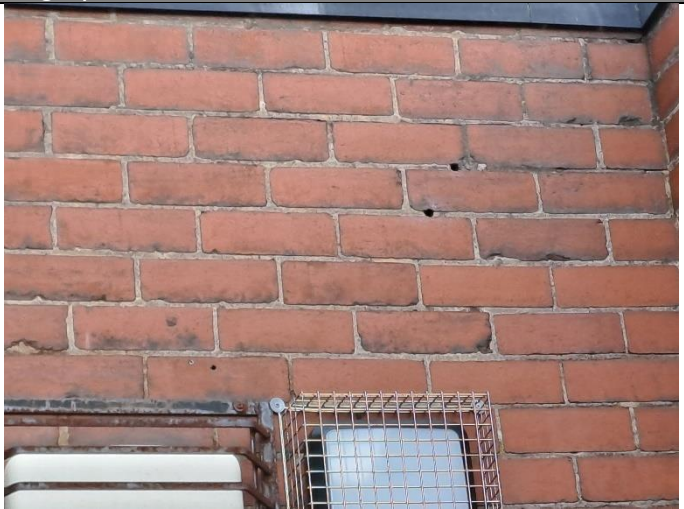
| PRF Reference | Description (roost suitability) | Photograph |
|---|---|---|
| 9 | Service holes, providing access to internal areas. Features are relatively small in diameter and unlikely to be used beyond opportunistic access by individual bats. <b>(Low)</b> | |

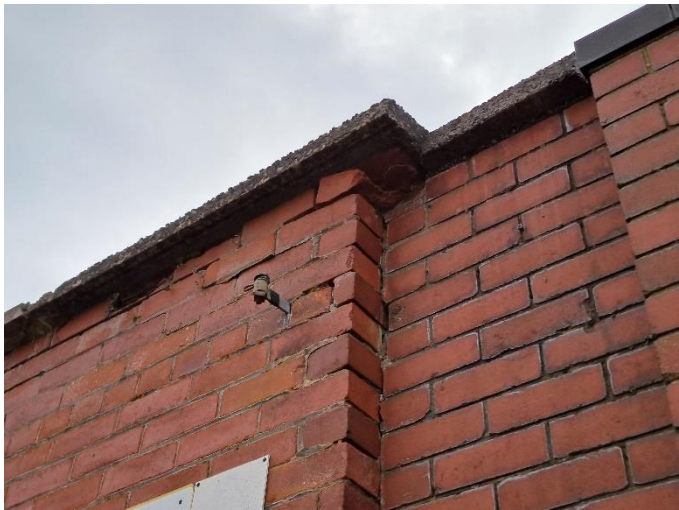
| PRF Reference | Description (roost suitability) | Photograph |
|---|---|---|
| 10 | Portion of brickwork and mortar missing in wall. Relatively deep but would not enter a cavity wall (wall is single skinned). Therefore, as the feature is relatively exposed to the elements, it is likely to be used by individuals opportunistically during summer months <b>(Low)</b> | |
