## GeoEnvironmental Site Investigation Report

Moorgate Farm East

Rochdale

**Report Ref: A5635/23/SI**

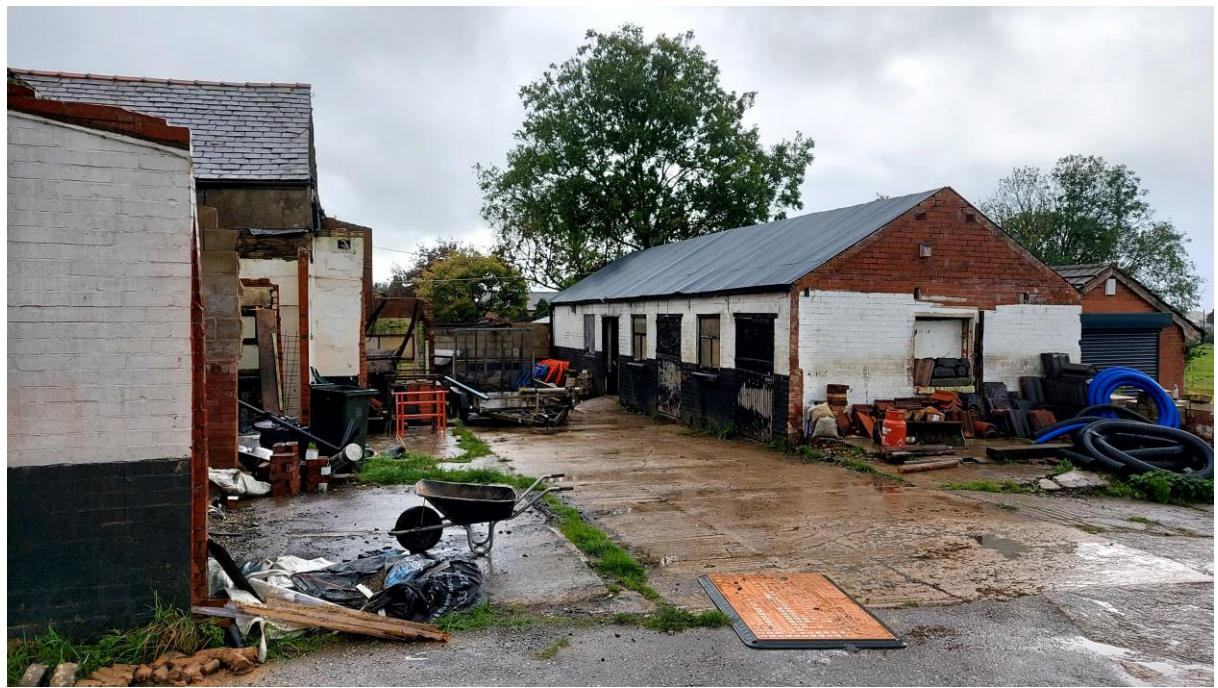
Photograph taken viewing the rear of the existing barn, facing southwest

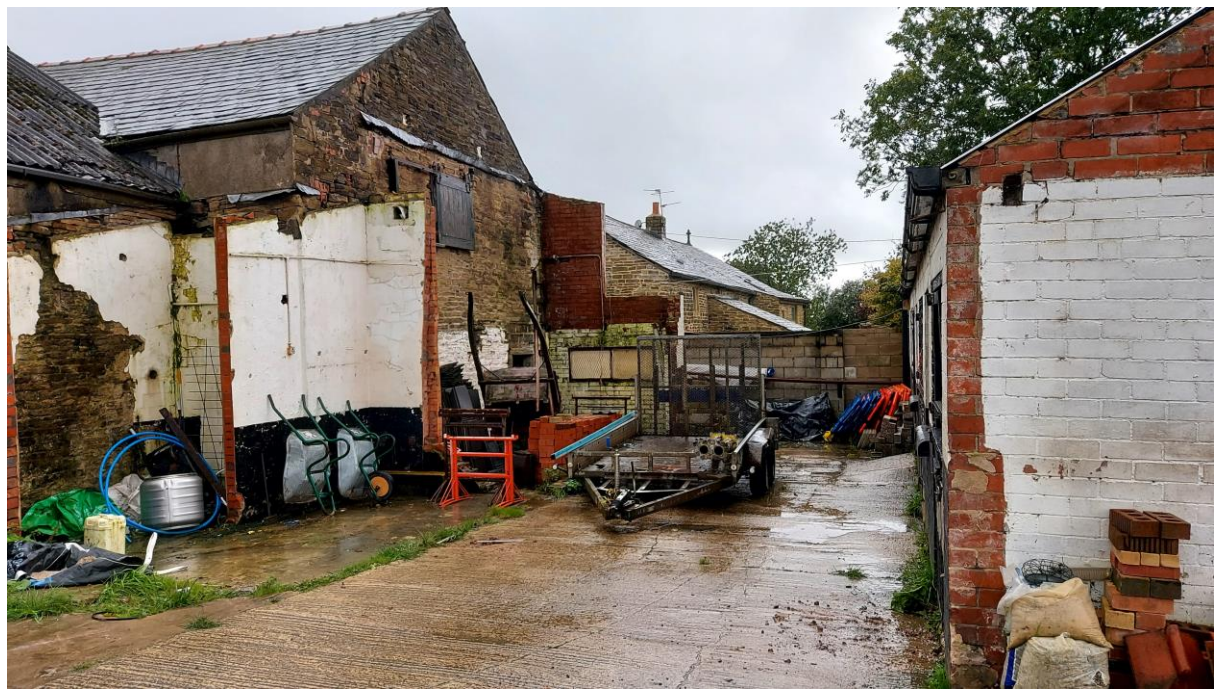
Photograph taken viewing the rear of the existing barn and the partially demolished sections of the barn, facing south

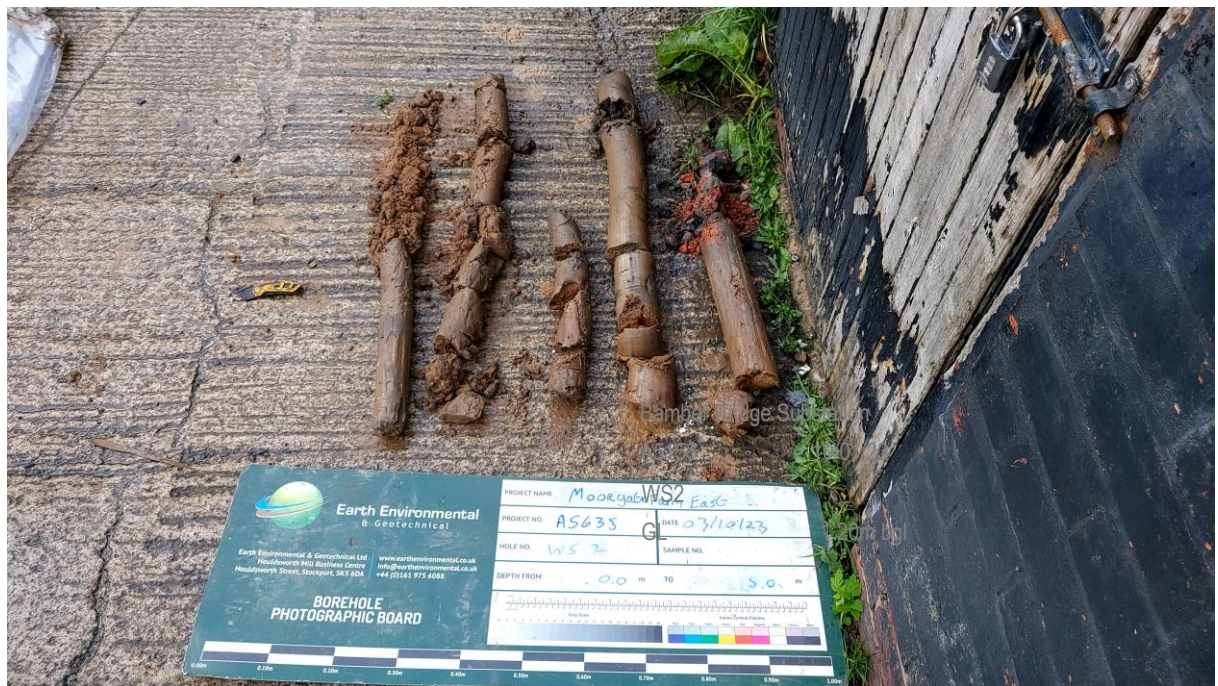
Photograph showing representative superficial soils (WS2)

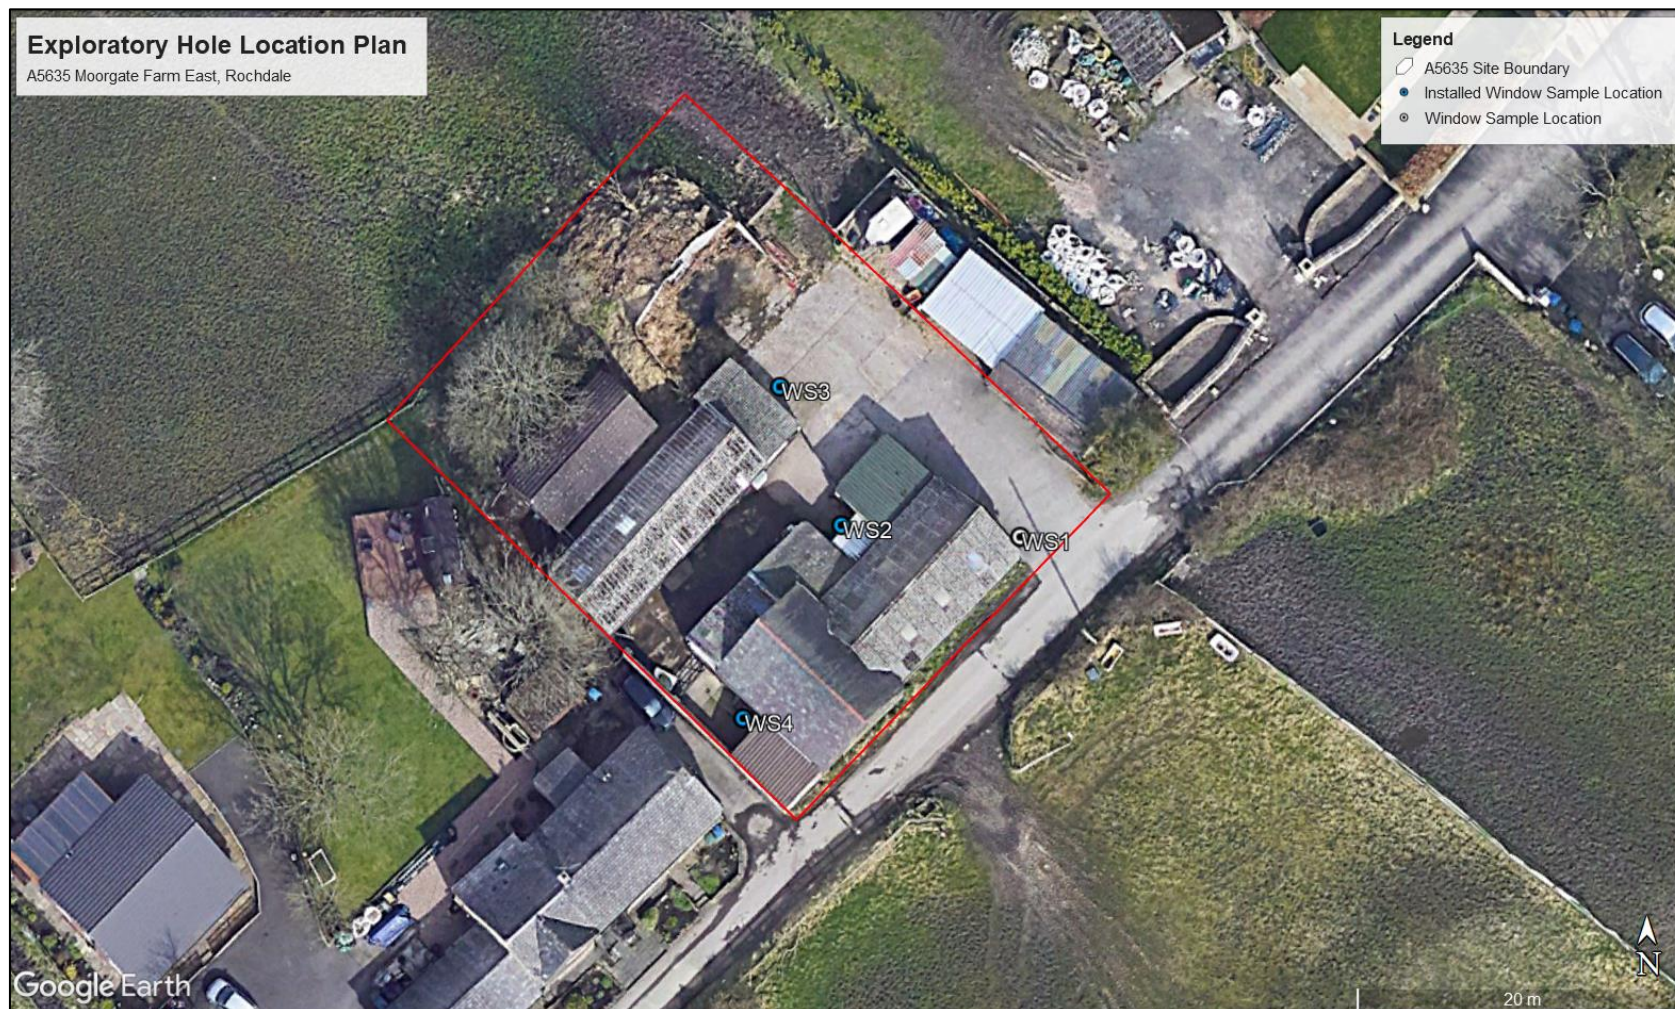
Figure 4: Exploratory Hole Location Plan

An Exploratory Hole Location Plan is presented as Figure 4, overleaf.
