GREATER  
MANCHESTER'S  
PAST REVEALED  
XX

ROCHDALE:  
AN ARCHAEOLOGICAL HISTORY

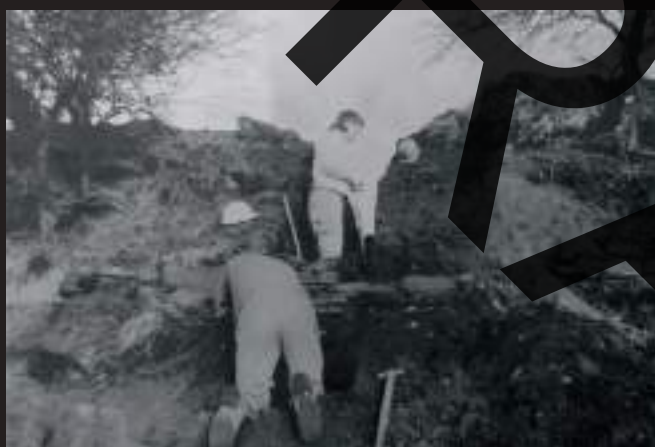
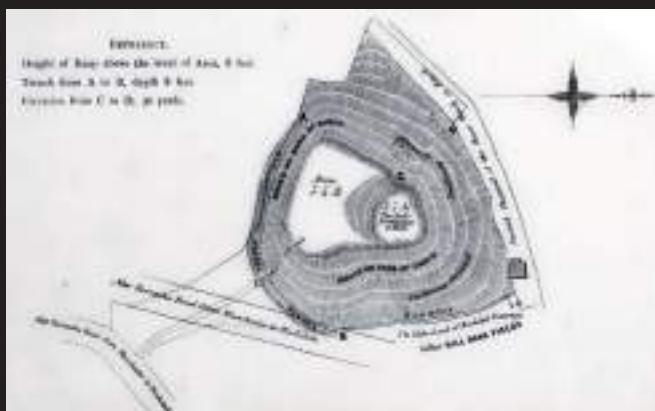
On the plan, it can be seen that the mound, or motte, which gave its name to the township of Castleton, was flat-topped and stood at the apex of the triangular Castle Hill. The bailey was located to the south of the mound and was an irregular square shape. The motte and bailey were then surrounded by an earth rampart and ditch, with a second ditch added to the south and southeast. A timber wall was likely constructed on top of the earthen rampart. The castle features in 12th-century charters but is not mentioned again until the 17th century, suggesting it was abandoned in the early 13th century. Its earthworks were levelled when Castle Hill House was constructed in the 1820s. In 1983, during the construction of new housing at Castle Hill, Greater Manchester Archaeological Unit excavated several trenches on the presumed edge of the outer bailey. Unfortunately, no remains relating to the castle were discovered. However, a sherd of medieval pottery was found during refurbishment works at Castle Hill House in 2001.

**Top:** Rochdale Castle superimposed on modern mapping (GMAU, 2001) **Middle:** The Greater Manchester Archaeological Unit excavation at Castle Hill House in 1983 (courtesy of GMAU) **Bottom:** A detailed plan of Rochdale Castle reproduced in Henry Fishwick's 1889 *History of Rochdale*

Another structure pertaining to Norman settlement in the area was a motte and bailey castle, thought to have stood at the northern end of Castle Hill, half a mile to the southwest of St Chad's. The castle was surveyed and planned in 1823 during the construction of the Manchester to Rochdale turnpike road. In 1889, a reproduction of this plan was published in the book *The History of the Parish of Rochdale in the County of Lancaster* written by local historian and twice Mayor of Rochdale, Henry Fishwick (1835 – 1914).

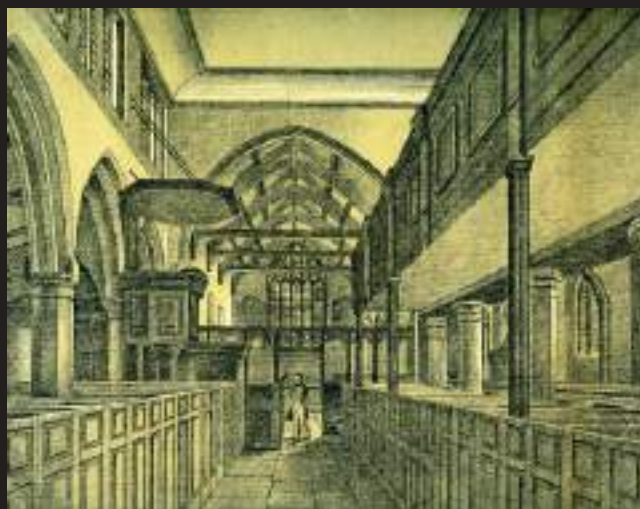
*Above: An illustration showing the nave of St Chad's Church before the renovations of 1853. The 15th-century perpendicular arches of the nave arcade can be seen to the left (courtesy of Touchstones Rochdale)*

In the mid-14th century, the black death greatly reduced the population and destabilised the complex economic and social systems that had developed in the preceding centuries. However, the economy did gradually recover and by the 15th century, Rochdale had become a well-established market centre once again, predominantly dealing in woollen production. The increasing wealth generated by the expanding woollen trade was reflected in investment in the fabric of St Chad's Church. For example, the nave arcade was rebuilt with perpendicular arches and a new chapel, known as Trinity Chapel was constructed.

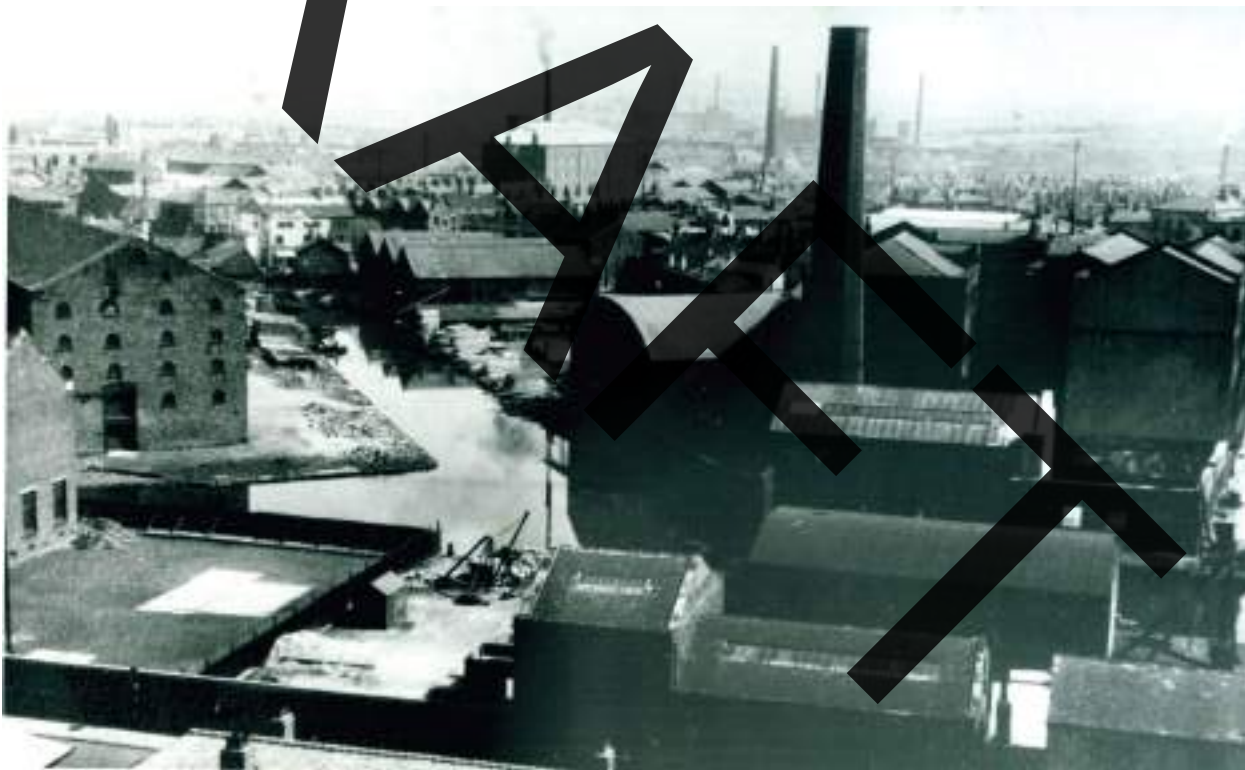
**Right:** An early 20th-century, northeast-looking view of the eastern arm of the canal basin with the wharf warehouse to the left of the basin arm and Vicars Moss Mill to the right (Courtesy of Touchstones Rochdale, Rochdale Arts & Heritage Service)

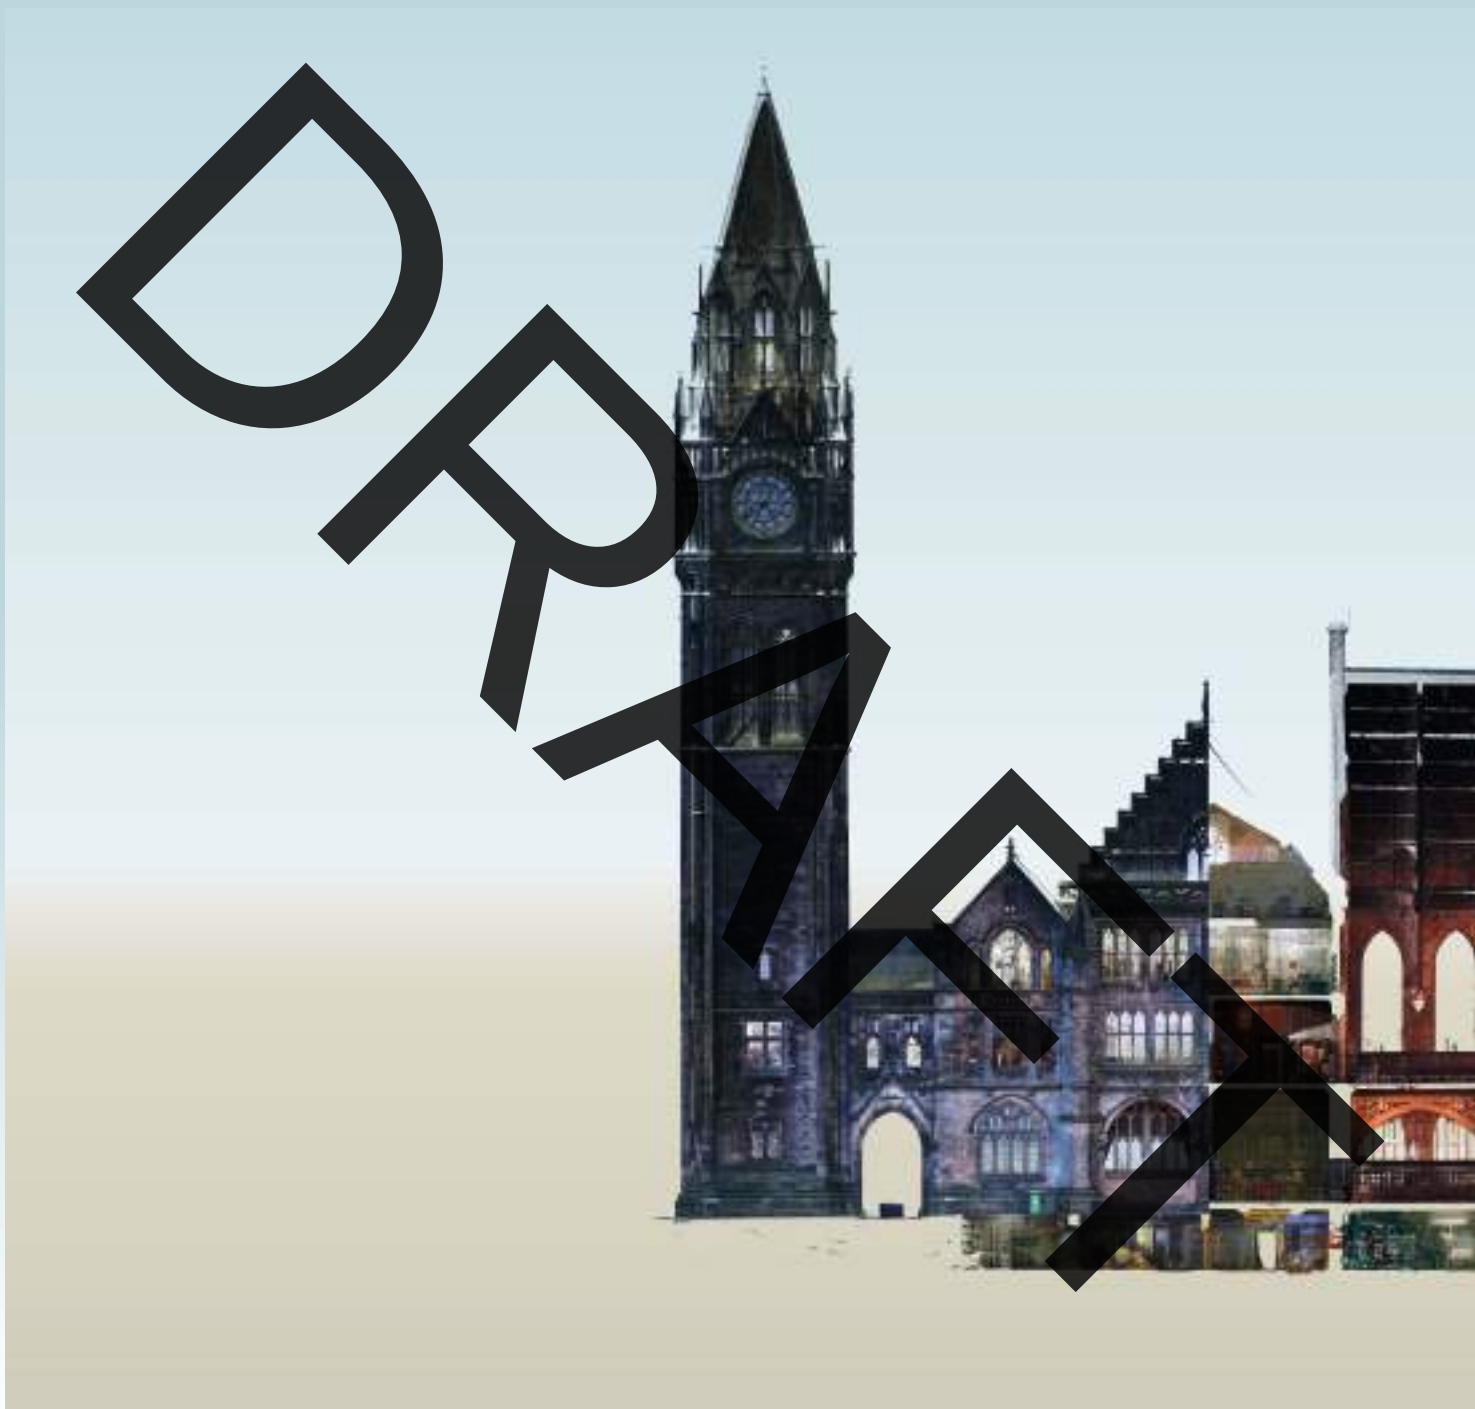
*A section through a point cloud of Rochdale Town Hall, created from a laser scan of the building*

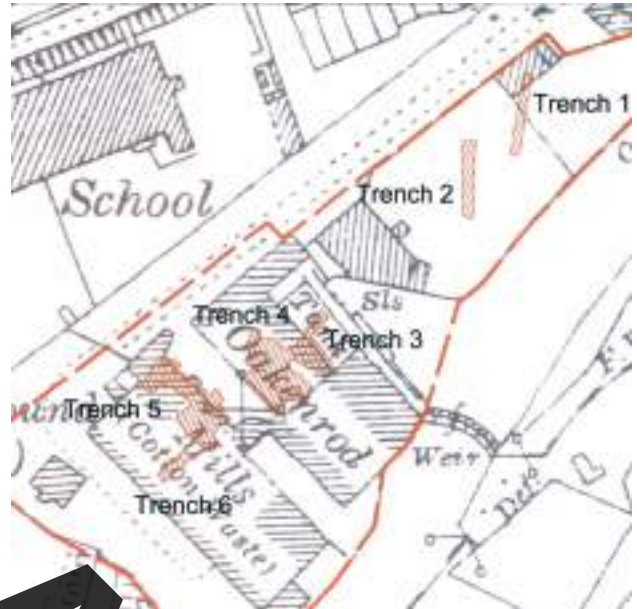
*Above: Location of trenches superimposed on the 1851 OS map (© Oxford Archaeology)*

In 2006 the site of Oakenrod Mill was investigated archaeologically by Oxford Archaeology North with several small trenches excavated across the mill complex. The earliest structures encountered during the evaluation related to the 19th-century iteration of the mill. A trench situated over the footprint of the mill as depicted in 1851 revealed the remains of a waterwheel pit which would have been located in the north-western part of the mill. The wheel pit was large enough to house a waterwheel measuring 14' (4.27m) in diameter by 17 or 17'6" (5.18m, or 5.33m) in width. Although only one waterwheel pit was uncovered, it is likely that both waterwheels were of similar size and style, functioning as high breastshot wheels.

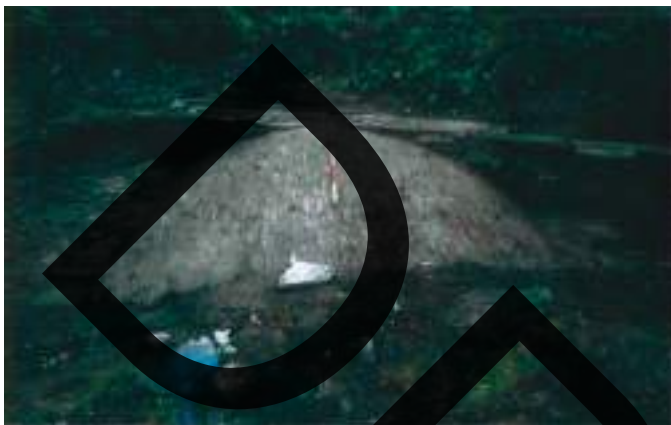
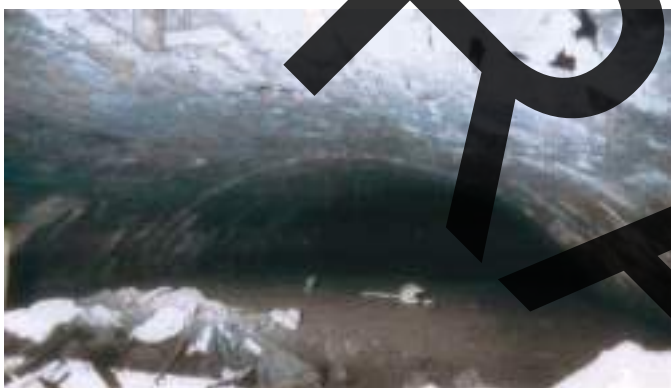
**Top:** Crown of the southeastern head race tunnel (© Oxford Archaeology)

**Bottom:** Internal shot of the northwestern head-race tunnel (© Oxford Archaeology)

A possible suggestion for these changes was that water turbines were installed in the mill by 1890 and this is likely as the investigation exposed evidence for the remodelling of the power system in the earlier block of the mill. It is known that the two waterwheels were replaced with a single 75BHP turbine, supplied by Joseph J Armfield & Co, situated in the northeastern part of the wheel pit of the northeastern wheel pit. Additionally, it could be seen that the head-race tunnel to the southeastern waterwheel pit was blocked at this time.

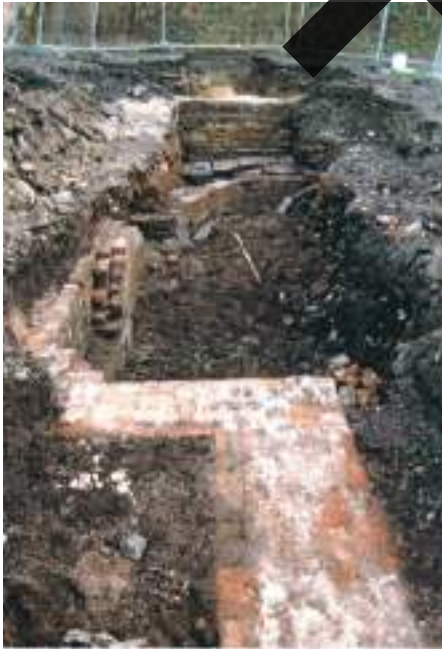
*Left: The mill's boiler house and chimney (© Oxford Archaeology)*

The archaeological investigations revealed vestiges of internal and external surfaces relating to Water Street Mill, built between 1824 and 1831. As some internal partitions were found, the internal layout of the mill could be mapped. Interestingly, elements of the mill's steam-power plant including the boiler house and chimney were discovered.

Additionally, it was found that elements of the engine house also survived within an extant building adjacent to the area of redevelopment. It was notable that no evidence for waterpower was identified, suggesting that the mill had been steam-powered from its inception.

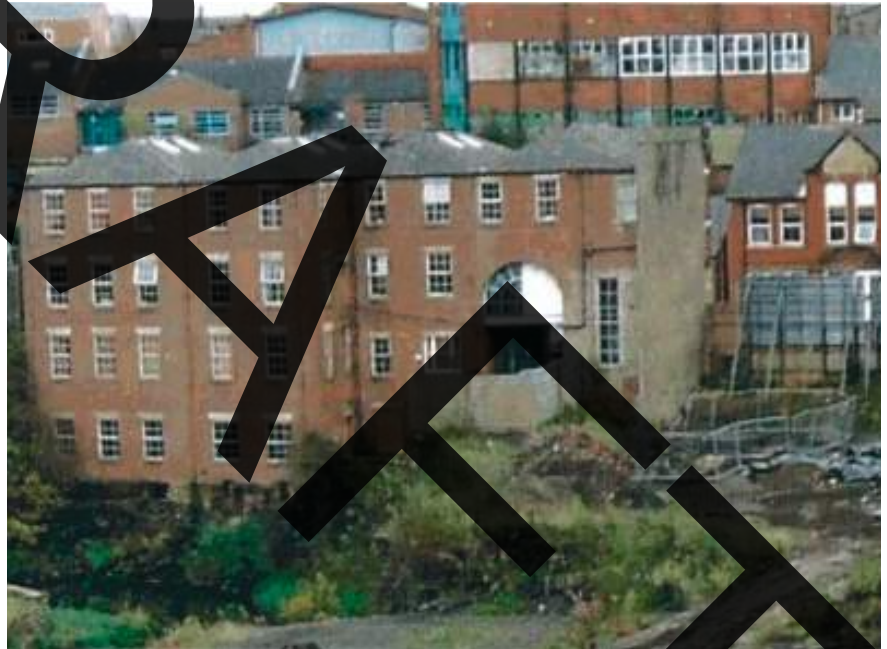
*Right: View of the former engine house and probable warehousing adjacent to Trench 11, which is shown enclosed by fencing (© Oxford Archaeology)*

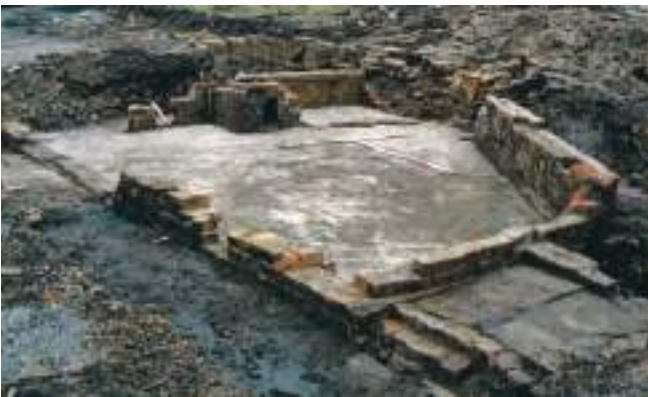
**Top:** Earlier remains of brass foundry  
(© Oxford Archaeology)

**Bottom:** The excavated remains of the  
extension to the brass foundry  
(© Oxford Archaeology)

In the western part of the site the remains of a brass foundry, erected between 1831 and 1851, were discovered. The walls of the earliest phase of the foundry were found to have been formed from two-skins wide hand-made bricks suggesting that the foundry had been a single-storey structure, as the walls did not appear to be of sufficient strength to support the loading of additional floors. The original floor of the foundry had been laid with flagstones within which a series of holes had been made, likely to support fixtures such as a block and tackle, used for lifting crucibles out of a furnace pit.

In the second half of the 19th century, remains of walls and flues indicated that the brass foundry had been extended. The foundry continued to function into the early 20th century, and this was reflected by renovations, such as the laying of a concrete floor, the insertion of walls and ad hoc repairs to the structure of the foundry.

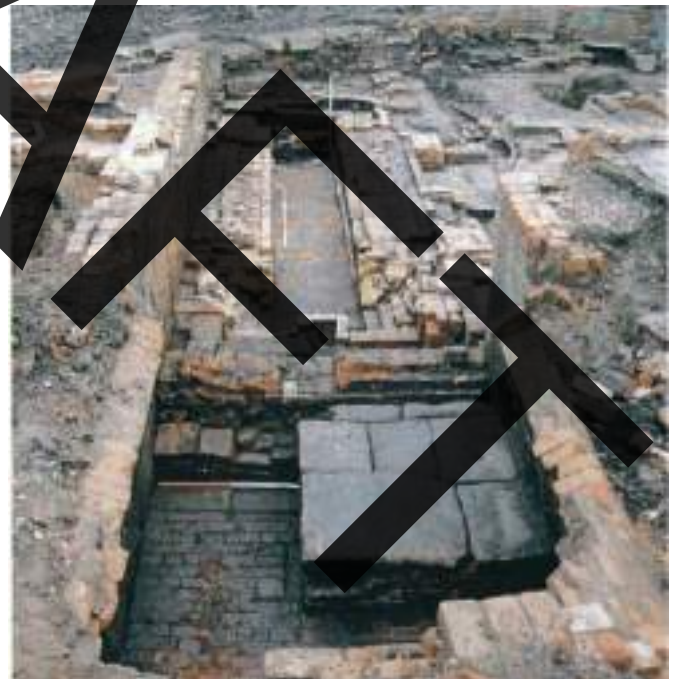
*Right: Looking northeast across the boiler housing,  
with the annexe in the foreground  
(© Oxford Archaeology)*

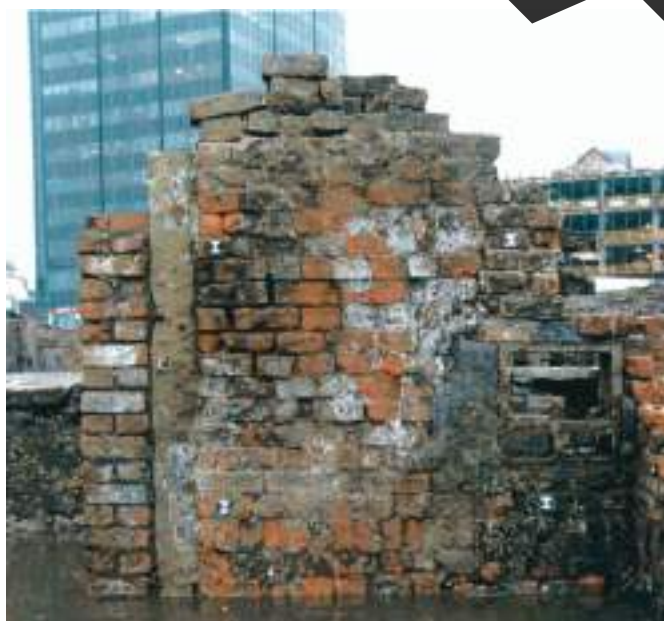
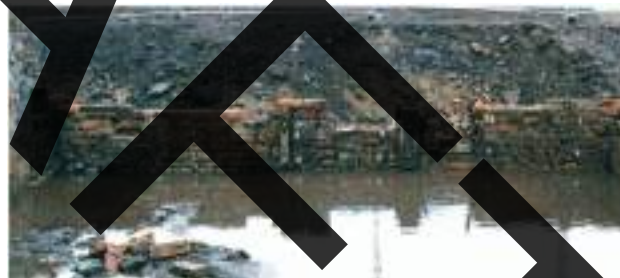
*Above: Possible drive shaft housing in wall  
(© Oxford Archaeology)*

A cast-iron pipe probably used to supply water to the boiler, crossed an internal space with two large, contiguous stone blocks into which iron fixtures had been set. The blocks likely represented machine beds. Four rectangular, brick-built chambers, set into the floor in the south of the building, may have represented casting pits, although firm evidence was lacking. In the southeastern part of the building, there was evidence of power transmission in the form of several housings for bearing blocks. The Ordnance Survey map of 1893 appears to show a direct connection between the southeastern part of the building and the goit immediately to the east. A wood-lined opening found in the eastern wall may have housed a primary motion shaft from a source of, possibly water-driven, motive power located to the east of the wall, although this could not be confirmed.

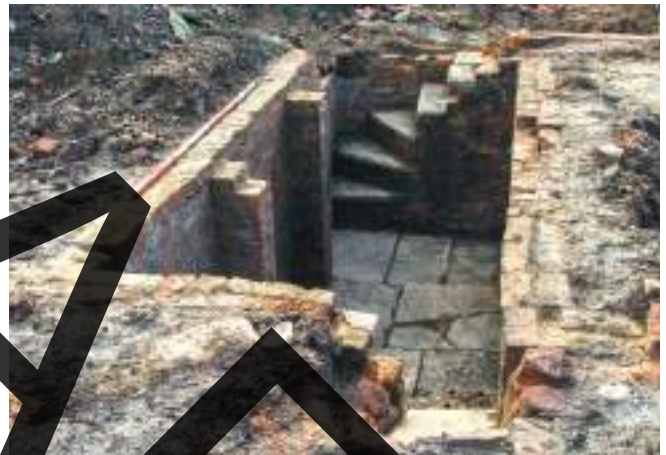
**Middle:** The remains of the cellar within house 9, with the curving staircase, fireplace foundations and coal shoot at the bottom right of the photograph

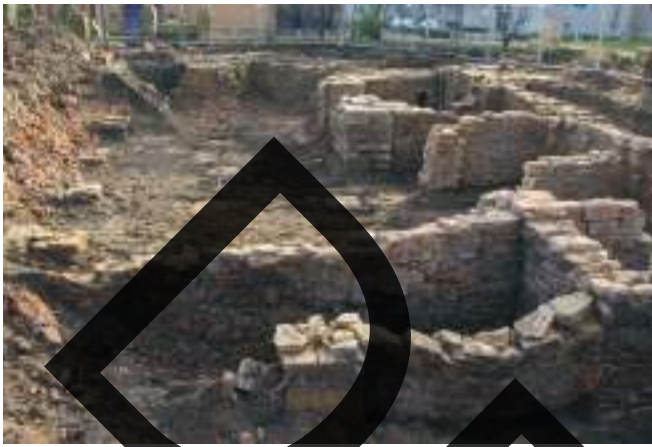
**Bottom:** The remains recorded in the southern part of the northern trench superimposed over the 1892 Ordnance Survey Town Plan

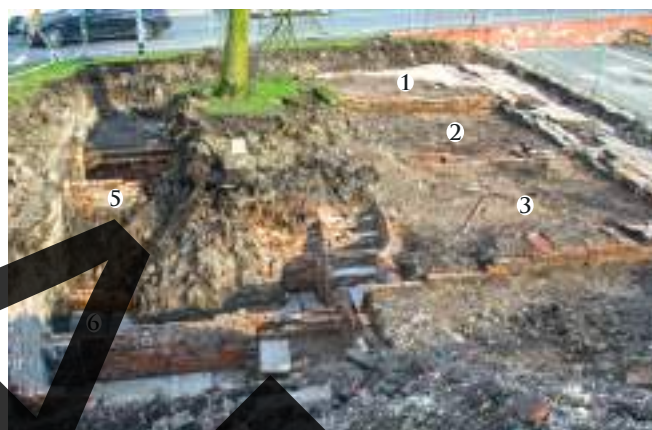
*Middle: Photograph of the eastern trench fully excavated, looking east*

The excavation exposed the pavement of Kelsall Street and the foundations of four houses fronting Kelsall Street (numbered 1, 2 and 3 on the photo) revealing that they were not cellared. Census returns for 1851 suggest that the houses on Kelsall Street were, at that time, occupied by skilled tradesmen associated with the local textile industry, including a machine maker and a foreman in a woollen mill. By the later 19th century the residents' occupations had become more homogenous and perhaps slightly lower status, being exclusively described as skilled mill operatives.

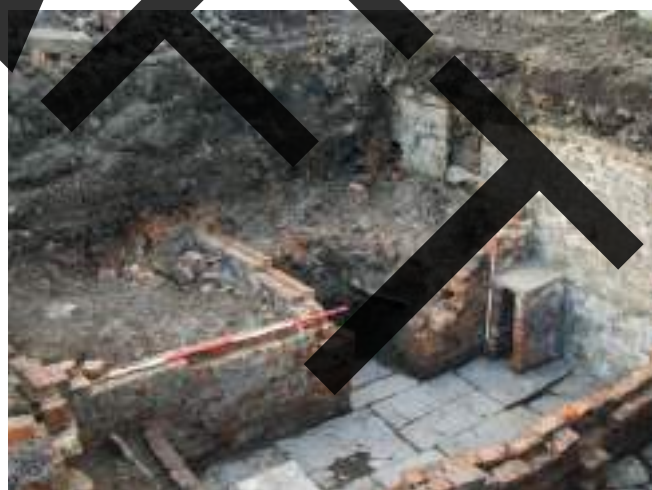
*Bottom: Rooms within the cellar of House 7. Note the remains of a probably 'cold-slab' on the right of the photo*

The larger houses (Houses 5, 6 and 7) that fronted Baillie Street were found to have had cellars split into smaller rooms furnished with coal shutes, fireplaces and stone-flagged floors. Interestingly, The visible brick walls in House 5 and 6 showed evidence of springing points for a brick-built barrel-vaulted ceiling, and the cellar in House 7 had multiple rooms, one of which contained a possible 'cold slab' (a stone slab usually located close to the floor and used to keep cheese, milk and butter cool).

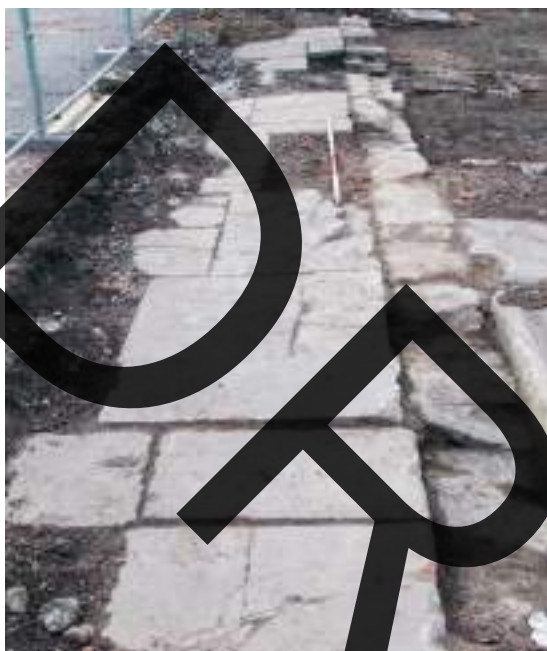
**Top:** The pavement of Kelsall Street (left), front wall of House 1 (middle) and stone drain (right)

The easternmost house had a stone-flagged floor with a stone channel running into a ceramic drain along the interior of the house's front wall, an arrangement that was suggestive of an exterior space. The historic mapping suggests that between 1893 and 1910 the two easternmost houses along Kelsall Street, including House 1, had been incorporated into the Talbot Inn public house to their immediate east, which was located outside the excavation area. Therefore, it appeared that House 1 had been converted into a yard or storage area connected to the Talbot Inn.

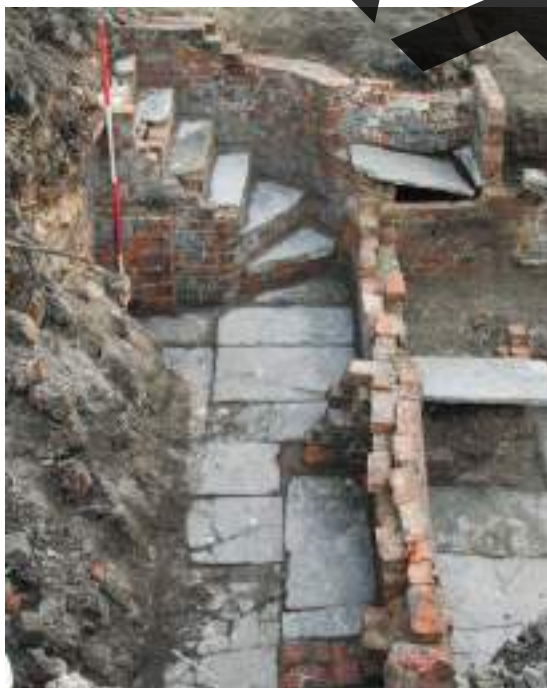
**Bottom:** Staircase, flagged floor, and fireplace foundations in house (6). Springing point for a barrel-vaulted ceiling visible at the left of the scale.

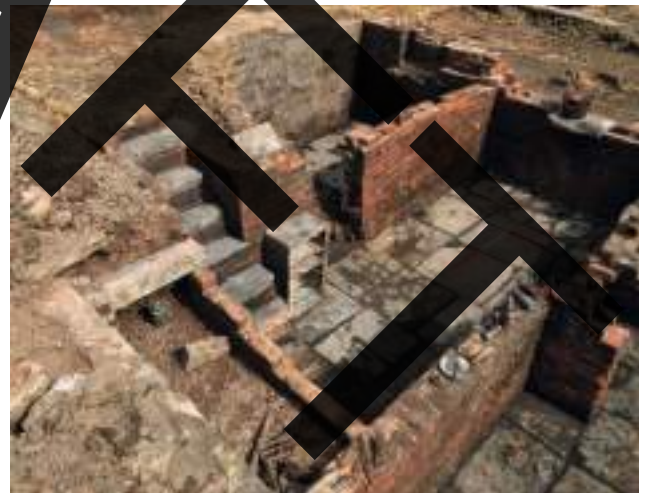
*Below: Knocked-through doorway between Room 1 and 2, staircase for Room 1, looking south-east.*

In the eastern cellar, the partition wall that separated the two cellar rooms showed evidence of alteration, with a small section being knocked through to create a doorway between the two rooms. It is likely, although could not be proven, that the entire cellar became accessible to one property, rather than a space which was split between two. This alteration was probably made in the early 20th century.

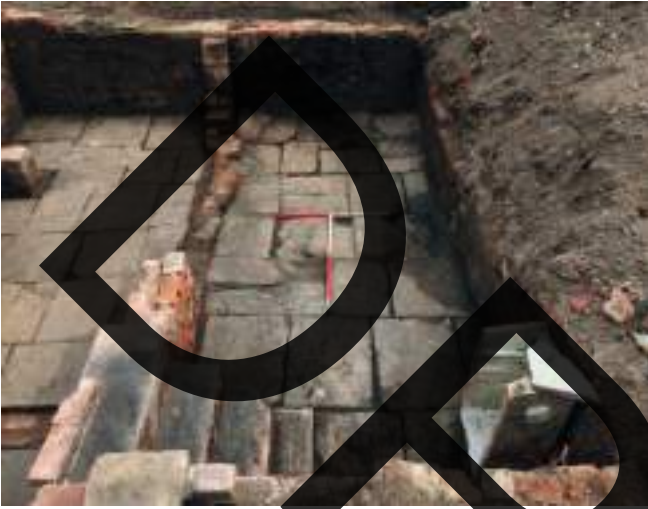
**Above:** 'THE FRIDGE LARDER' in the cellar below No 7 Maude Terrace. It is not clear when the fridge dates from although it was during the 1950s that they started to become affordable in British homes

An object found during the excavation that connects the homes of those who lived in early to mid-20th century Maude Terrace to most of us today is the fridge, two almost identical examples of which were discovered in the cellars below Nos. 6 and 7. These early fridges consisted of a large white glazed ceramic 'box' with internal ribs which would have supported metal shelves. The maker's mark reveals that 'THE "FRIDGE" LARDER' was 'made only by J. Duckett & Son Ltd, Burnley.' The rather curious construction material, ceramic – rather than enamel, metal and plastic – can probably be explained by the 1913 catalogue published by J. Duckett & Son. The company specialised in sanitary wares such as ceramic water closets, urinals, and basins, some with aspirational names such as the 'Kensington' or the 'Victoria,' while others named in an advert from 1898 were less appealing, such as 'The Clencher'.

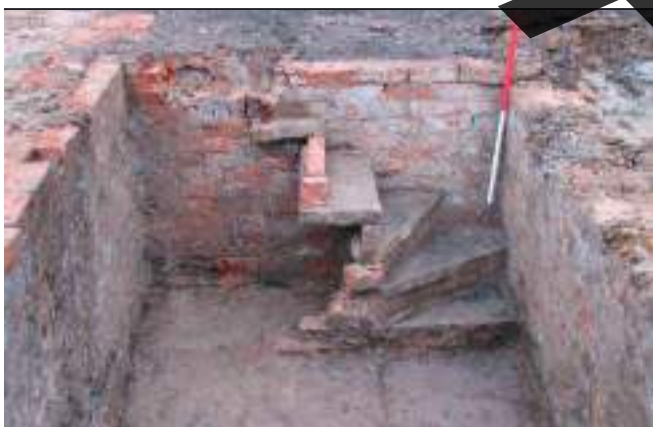
*Below: Excavated cellar and staircase. Black coal dust is visible on the whitewashed walls*

One key indicator that helped the archaeologists recognise that these were cellars was the presence of several sets of winding stone steps. These steps were constructed out of dressed stone flags with some structural elements constructed out of handmade bricks. Both stone staircases were partly enclosed by a brick structure or stairwell. The positioning of the steps suggested to the archaeologists that these cellars were accessed from inside the house rather than through a separate doorway indicating that the cellars were not used as separate cellar dwellings.

Each of the cellar rooms had flagstone floors with some black staining thought to be coal dust. The cellar walls also showed evidence of being painted or whitewashed with the black staining also identified on the whitewash of the walls. This black staining suggested that the cellars were used to store coal – needed to fuel domestic fires for heating and cooking. A lack of internal features such as light fittings and fireplaces also gave clues that these rooms were for storage and not for living in. The fact that the cellars were at the rear of the houses and accessed from within also indicated that they were not used for anything other than private storage, suggesting that overcrowding was not a problem in the area at this time, in stark contrast to the densely populated districts of the regions burgeoning urban centres of Manchester and Salford.

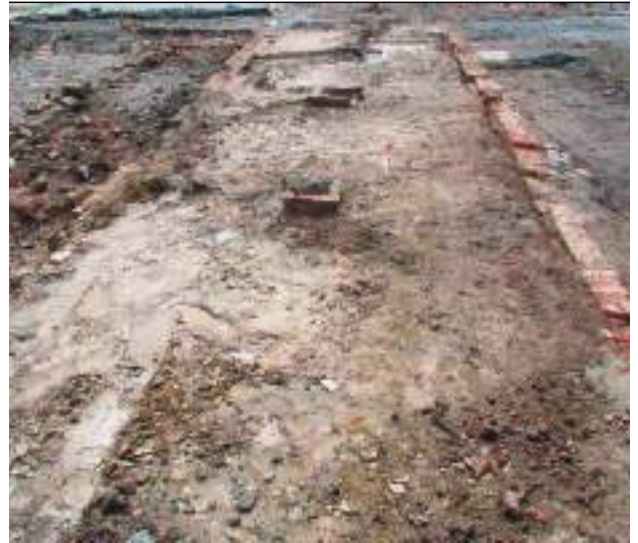
*Above: Remains of front room with fireplace. The back deposit is burnt coal and cinders deposit pictured*

On the western side of the main central cellar wall in the front rooms of the terraced houses were the remains of three intriguing square brick features. Each of them will have originally belonged to an individual property. They were constructed from a single course of handmade bricks with a lime mortar. Each had a square internal opening filled with a coarse black gritty deposit made up of burnt coal, charcoal, and cinders. It was thought that these features were the remains of fireplaces in the front rooms. The leftover ash and burnt material within them would seem to support this interpretation.

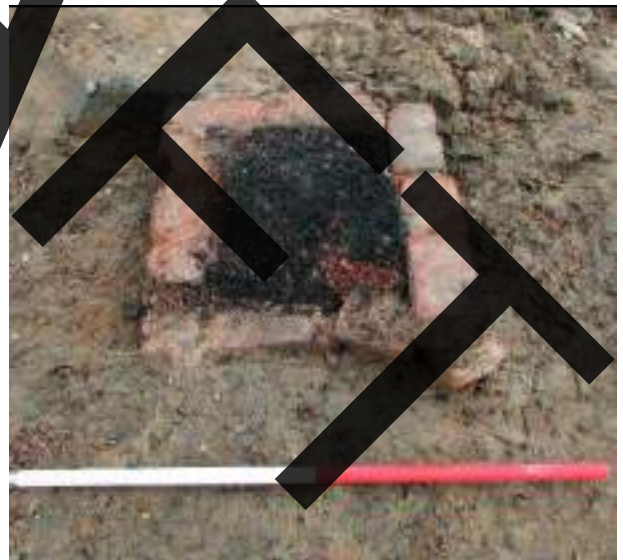
*Below: Close-up of brick fireplace*

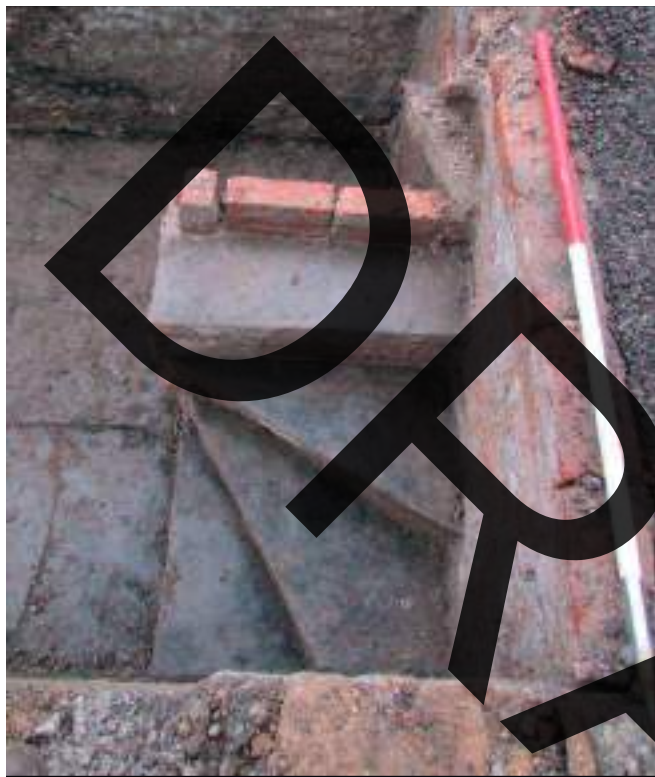
*Close-up of cellar steps constructed out of flag stones and brick fireplace*

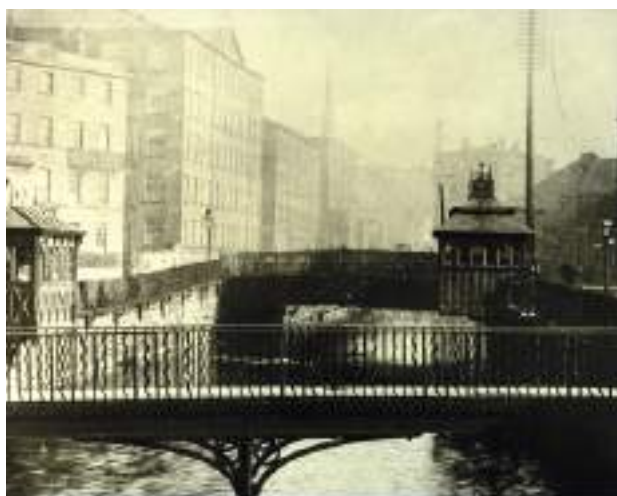
*Far left: The feeder bridge to the west of the 1821 bridge (courtesy of Touchstones Rochdale)*

Following the linking together of the old Rochdale Bridge and the 1821 bridge, in the 1860s, the retaining wall on either side of the river channel was rebuilt along with a flat-decked, curved feeder bridge, to the west of the 1821 bridge. Interestingly, the supports facing the cutwaters of the feeder bridge were designed by Sir Horace Jones, the London City Architect in 1884, and are identical to those in Tower Bridge in London.

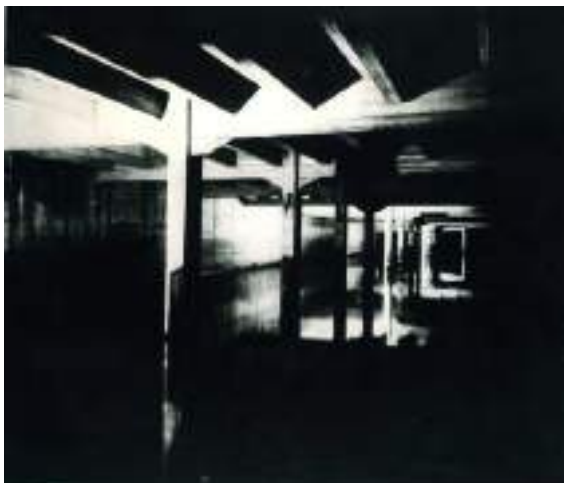
**Left:** Beneath the 1904 reinforced concrete bridge  
(courtesy of Touchstones Rochdale, Rochdale Arts & Heritage Service)

Additions to Rochdale Bridge in the early 20th century essentially led to the culverting of the river beneath the town. New technology and engineering practices utilising reinforced concrete were introduced at the start of the 20th century. All the reinforced concrete beam and slab sections used to construct new parts of the bridge were cast on-site and designed by LG Mouchel and Partners using the Hennebique system.

The first section of the reinforced concrete bridge was built in 1904, filling the gap between the Rochdale and Wellington bridges. It was one of the earliest examples of the use of reinforced concrete in girder bridge construction in Britain, and as such, it is of architectural significance. The Esplanade Bridge was constructed shortly after, to create a 50m wide extension on the western side of Rochdale Bridge forming a road junction with Newgate. The Esplanade Bridge, however, was completely destroyed by bridge renewal works in 1996.

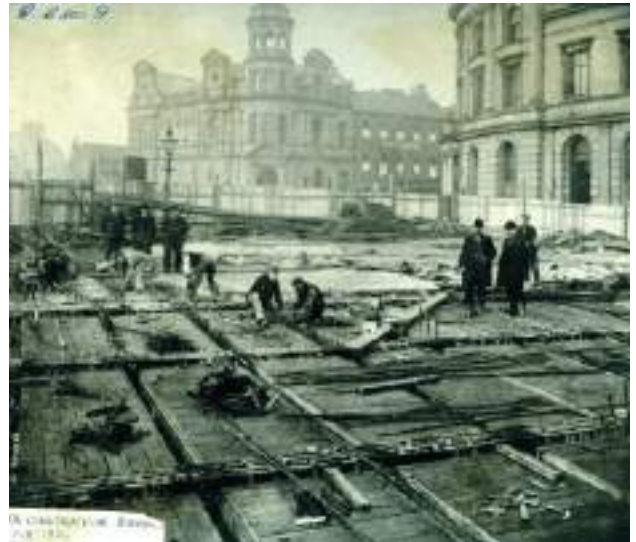
**Top:** Building the reinforced concrete bridge between Rochdale and Wellington bridges, 1904  
(courtesy of Touchstones Rochdale, Rochdale Arts & Heritage Service)

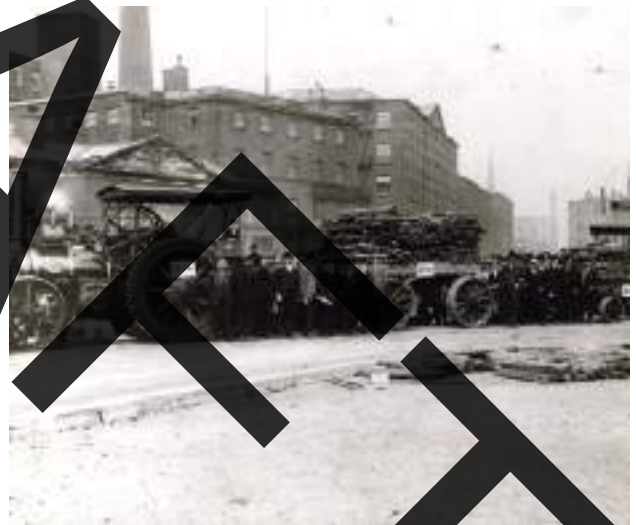
**Bottom:** Testing the 1904 reinforced concrete river crossing, c 1904  
(courtesy of Touchstones Rochdale, Rochdale Arts & Heritage Service)

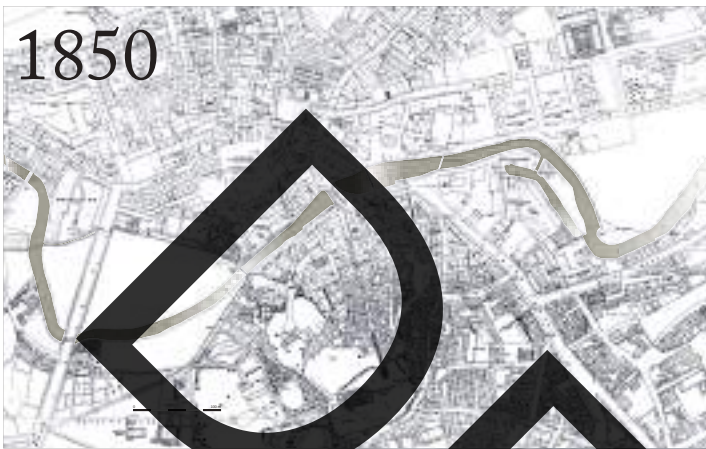
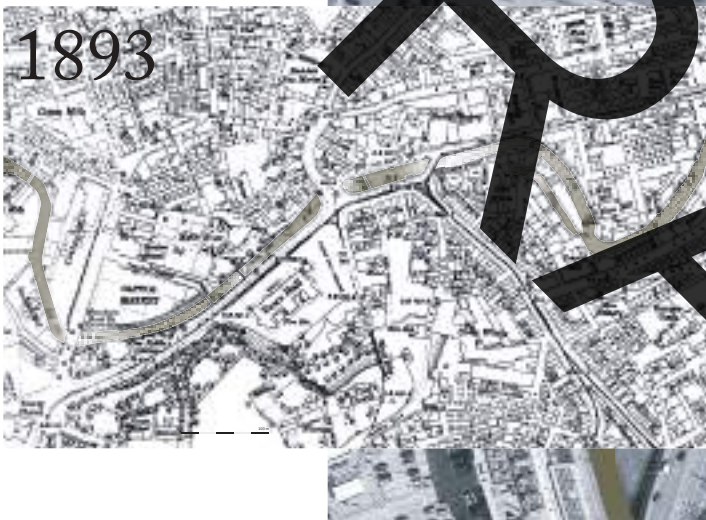
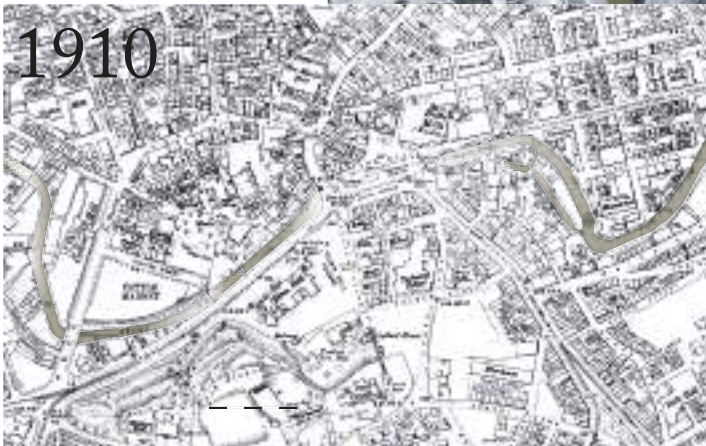
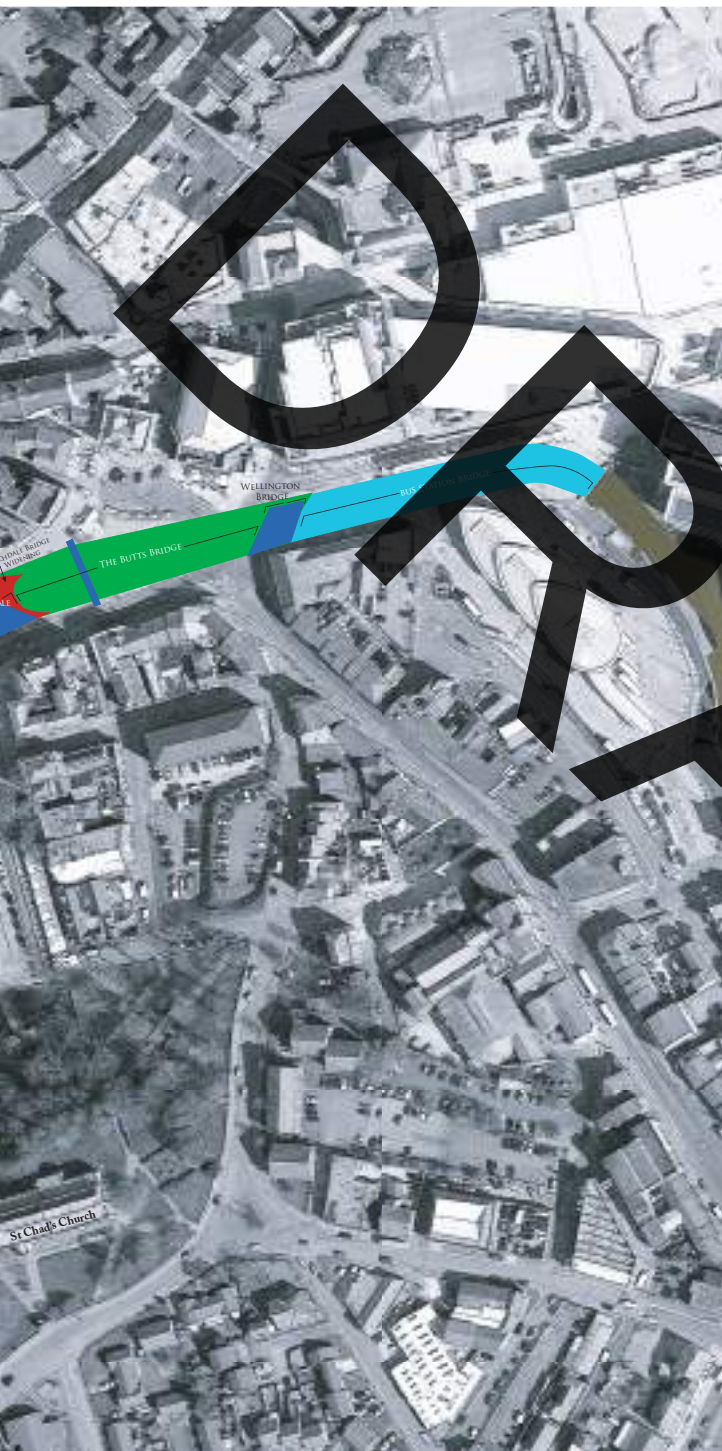
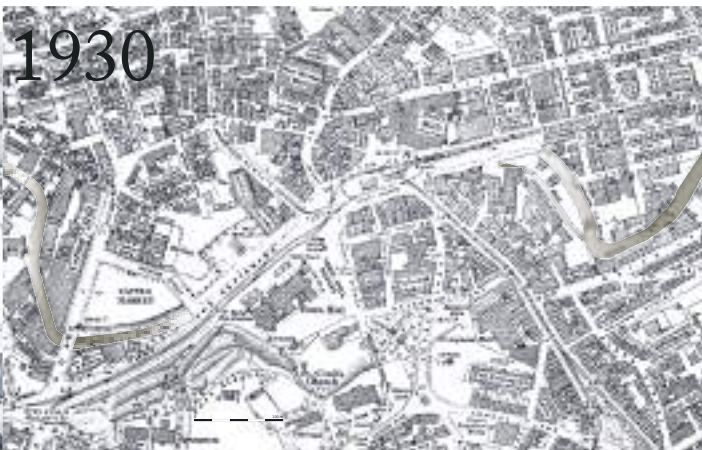
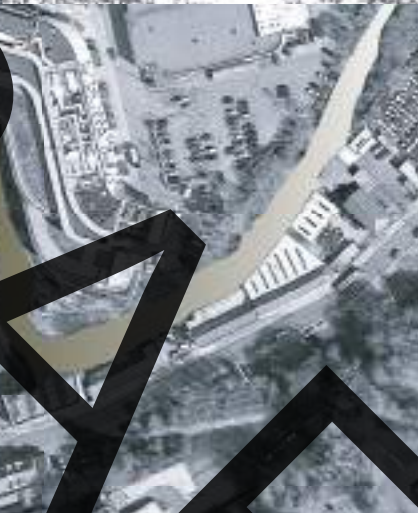
*The evolution of Rochdale Bridge superimposed on modern satellite imagery (©Google) and the subsequent concealment of the River Roch illustrated in the historical, Ordnance Survey, mapping of the area*
