**SITE 3**  
**THE STRAND PHASE 2**  
**ROCHDALE**  
**OL11 2JG**

**VALIDATION REPORT**

**LOVELL PARTNERSHIPS LTD**

Ref: 18-B-12322/The Strand Site 3

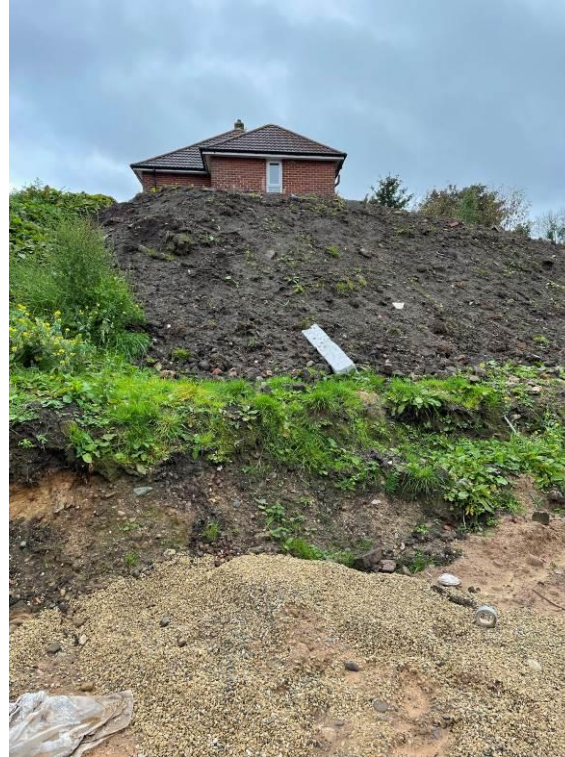
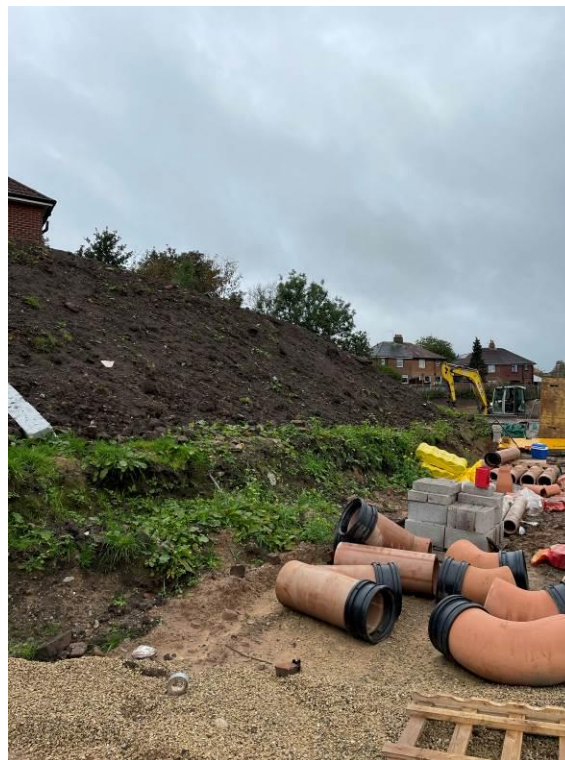
Photographs of Stockpile

It should be noted that excavations into the stockpile were not undertaken, details of stockpile composition are taken from surface only. Should any material other than topsoil be encountered, additional physical assessment by an engineer is required.

No visual or olfactory evidence of contamination was noted within any of the samples.
