# BANK TOP FARM, HOLLINGWORTH ROAD, LITTLEBOROUGH

## Phase 1 - Preliminary Risk Assessment

Report Ref: BEK-22019-1 Rev A

August 2022

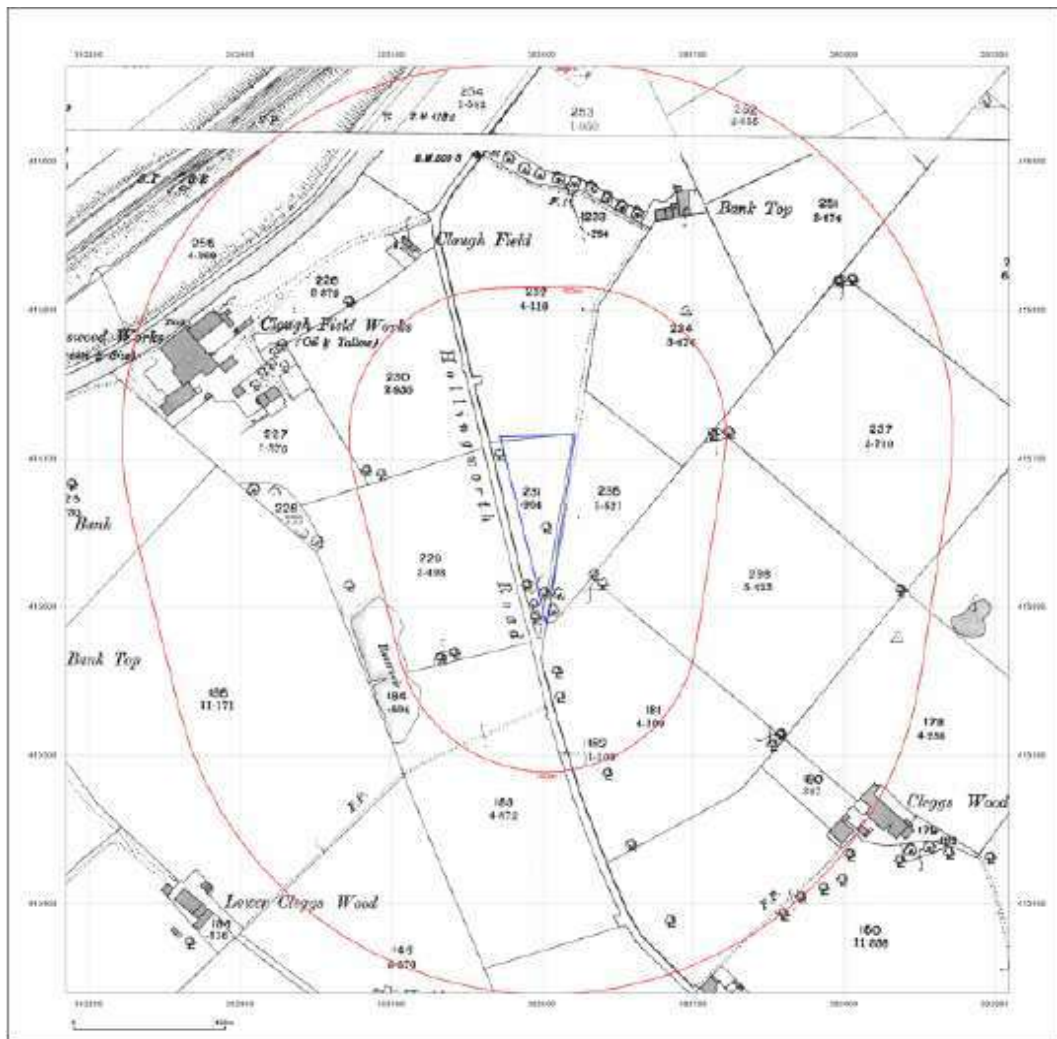
**Figure 2:** OS Map of the Bank Top Farm Site and Surrounding Area in 1891

- 3.1 The history of the site has been established using historical OS maps supplied by Groundsure. A selection of the maps reviewed is presented in Appendix A.
- 3.2 The site has remained virtually unchanged since the earliest OS maps were produced back in 1891 (Figure 2) and 1910. Hollingworth Road runs north-south adjacent to the site up to clough field. A farm track runs along the east side of the site boundary. A reservoir is approximately 100 m south-west of the site and Clough Field Oil and Tallow Works is north-west approximately 200 m away.

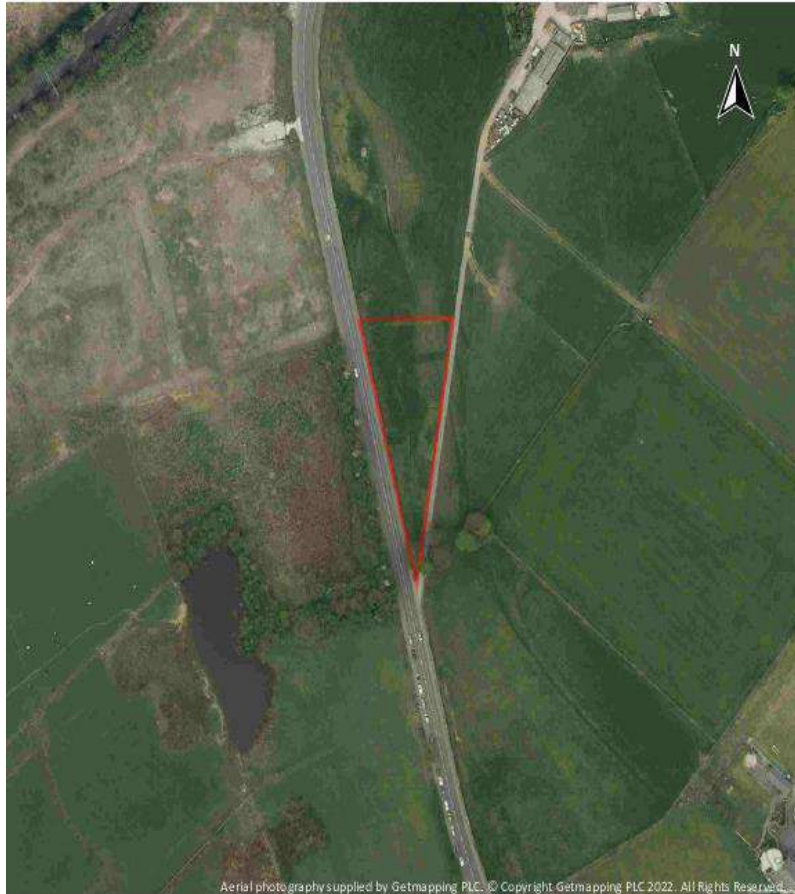
**Figure 4:** Satellite Aerial Imagery of the Bank Top Farm site and the Surrounding Area in 2019

- 3.7 The most recent aerial satellite image (Figure 4), very little change occurred since 2012. The site no longer has a trail leading from the access gate or excavation feature. It is likely the feature seen in 2012 was a lime pile and has subsequently been removed.

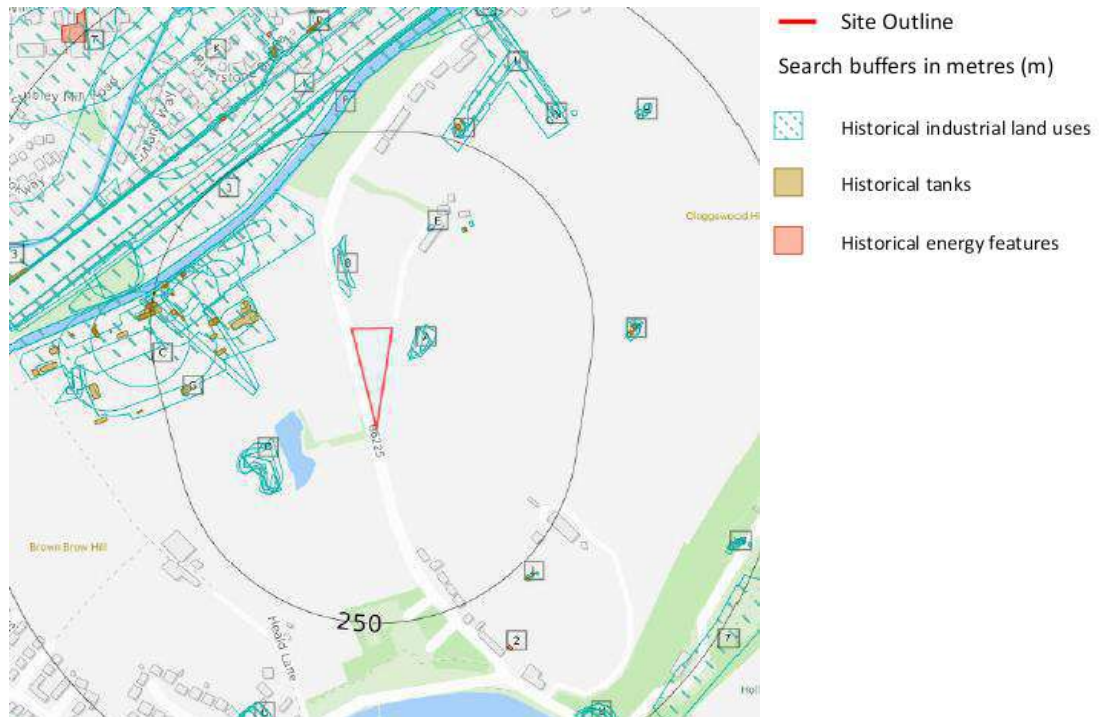
**Figure 5:** Potentially Contaminative Land Use Features Digitized from Historical OS Maps Around the Site Boundary

- 4.5.8 There are no electricity substations located within 250 m of the site noted by Groundsure.
- 4.5.9 There were no historical petrol stations or historical garages located within 250 m of the site.
- 4.5.10 There are 38 potentially contaminative historical industrial sites located within 250 m of the site according to the Enviro+GeoInsight report, with the sites dating from 1851 (Figure 5). There are four unspecified ground workings/pits within 50 m of the site boundary; the closest of which is 25 m east (dated 1928), 27 m east (dated 1938), 39 m east (dated 1949) and 41 m north (dated 1949). The ground workings are unspecified but are likely to be quarries suggested from satellite observation.
