**PHASE I AND II  
ENVIRONMENTAL  
ASSESSMENT**

**Lake Garage,  
Smithybridge Road,  
Littleborough,  
ROCHDALE,  
OL15 0BQ**

**James Hall & Co (Properties) Ltd**

**20/1080.1.1**

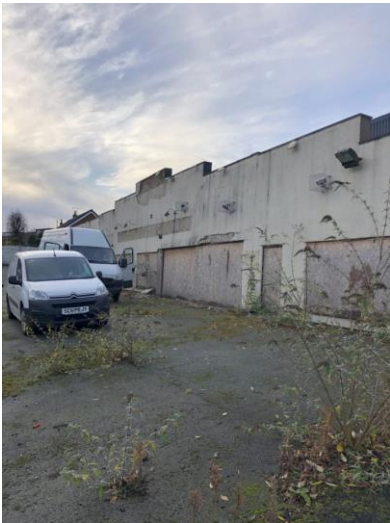
| <p>Image 1: Northern boundary viewed from the north-west.</p> | <p>Image 2: Northern wall of former showroom building.</p> | <p>Image 3: Western boundary of the site..</p> |

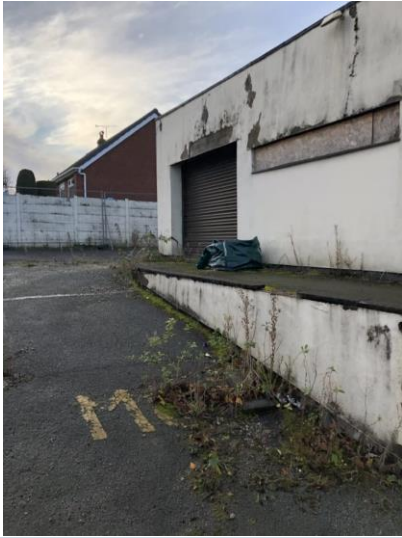
| <p>Image 4: North-eastern corner of the site.</p> | <p>Image 5: Northern entry of former MOT garage.</p> | <p>Image 6: South-eastern boundary viewed from the north.</p> |

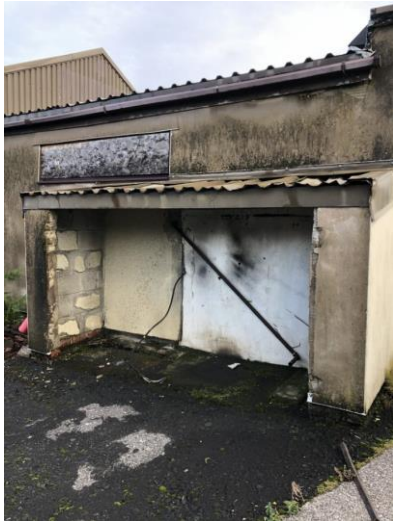
**Image 7:** Potential former AST area, to the rear of MOT garage building.

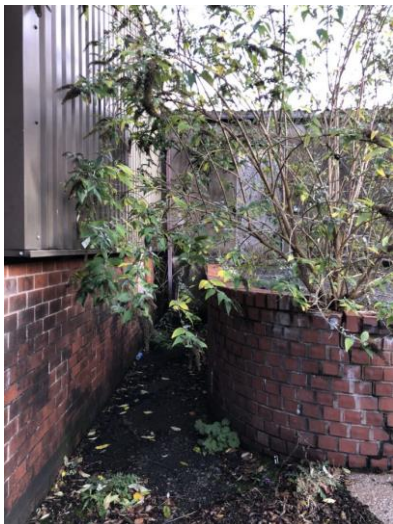
Formerly noted above storage tanks (ASTs), drums, car engines and vehicles were no longer present on the site. The potential area of previously unidentified AST was noted to be located under small shed to the west of the building rear. Black staining was noted along the south-western wall.

**Image 10:** Black staining along the western wall of the rear building.

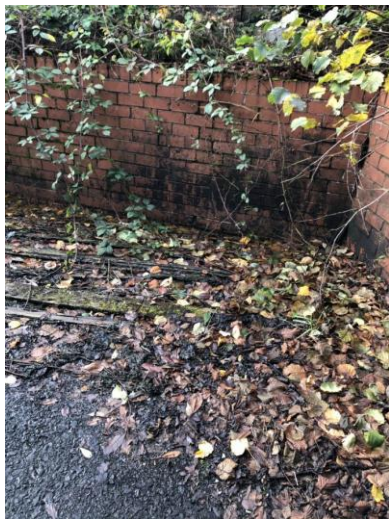
**Image 12:** Black staining on the wall of the south-western corner.
