# Phase 1 Preliminary Risk Assessment Proposed Retirement Living Scheme at Bamford Mews, Rochdale

## Prepared for McCarthy Stone

**August 2024**

**10/2529/001 Rev. 00**

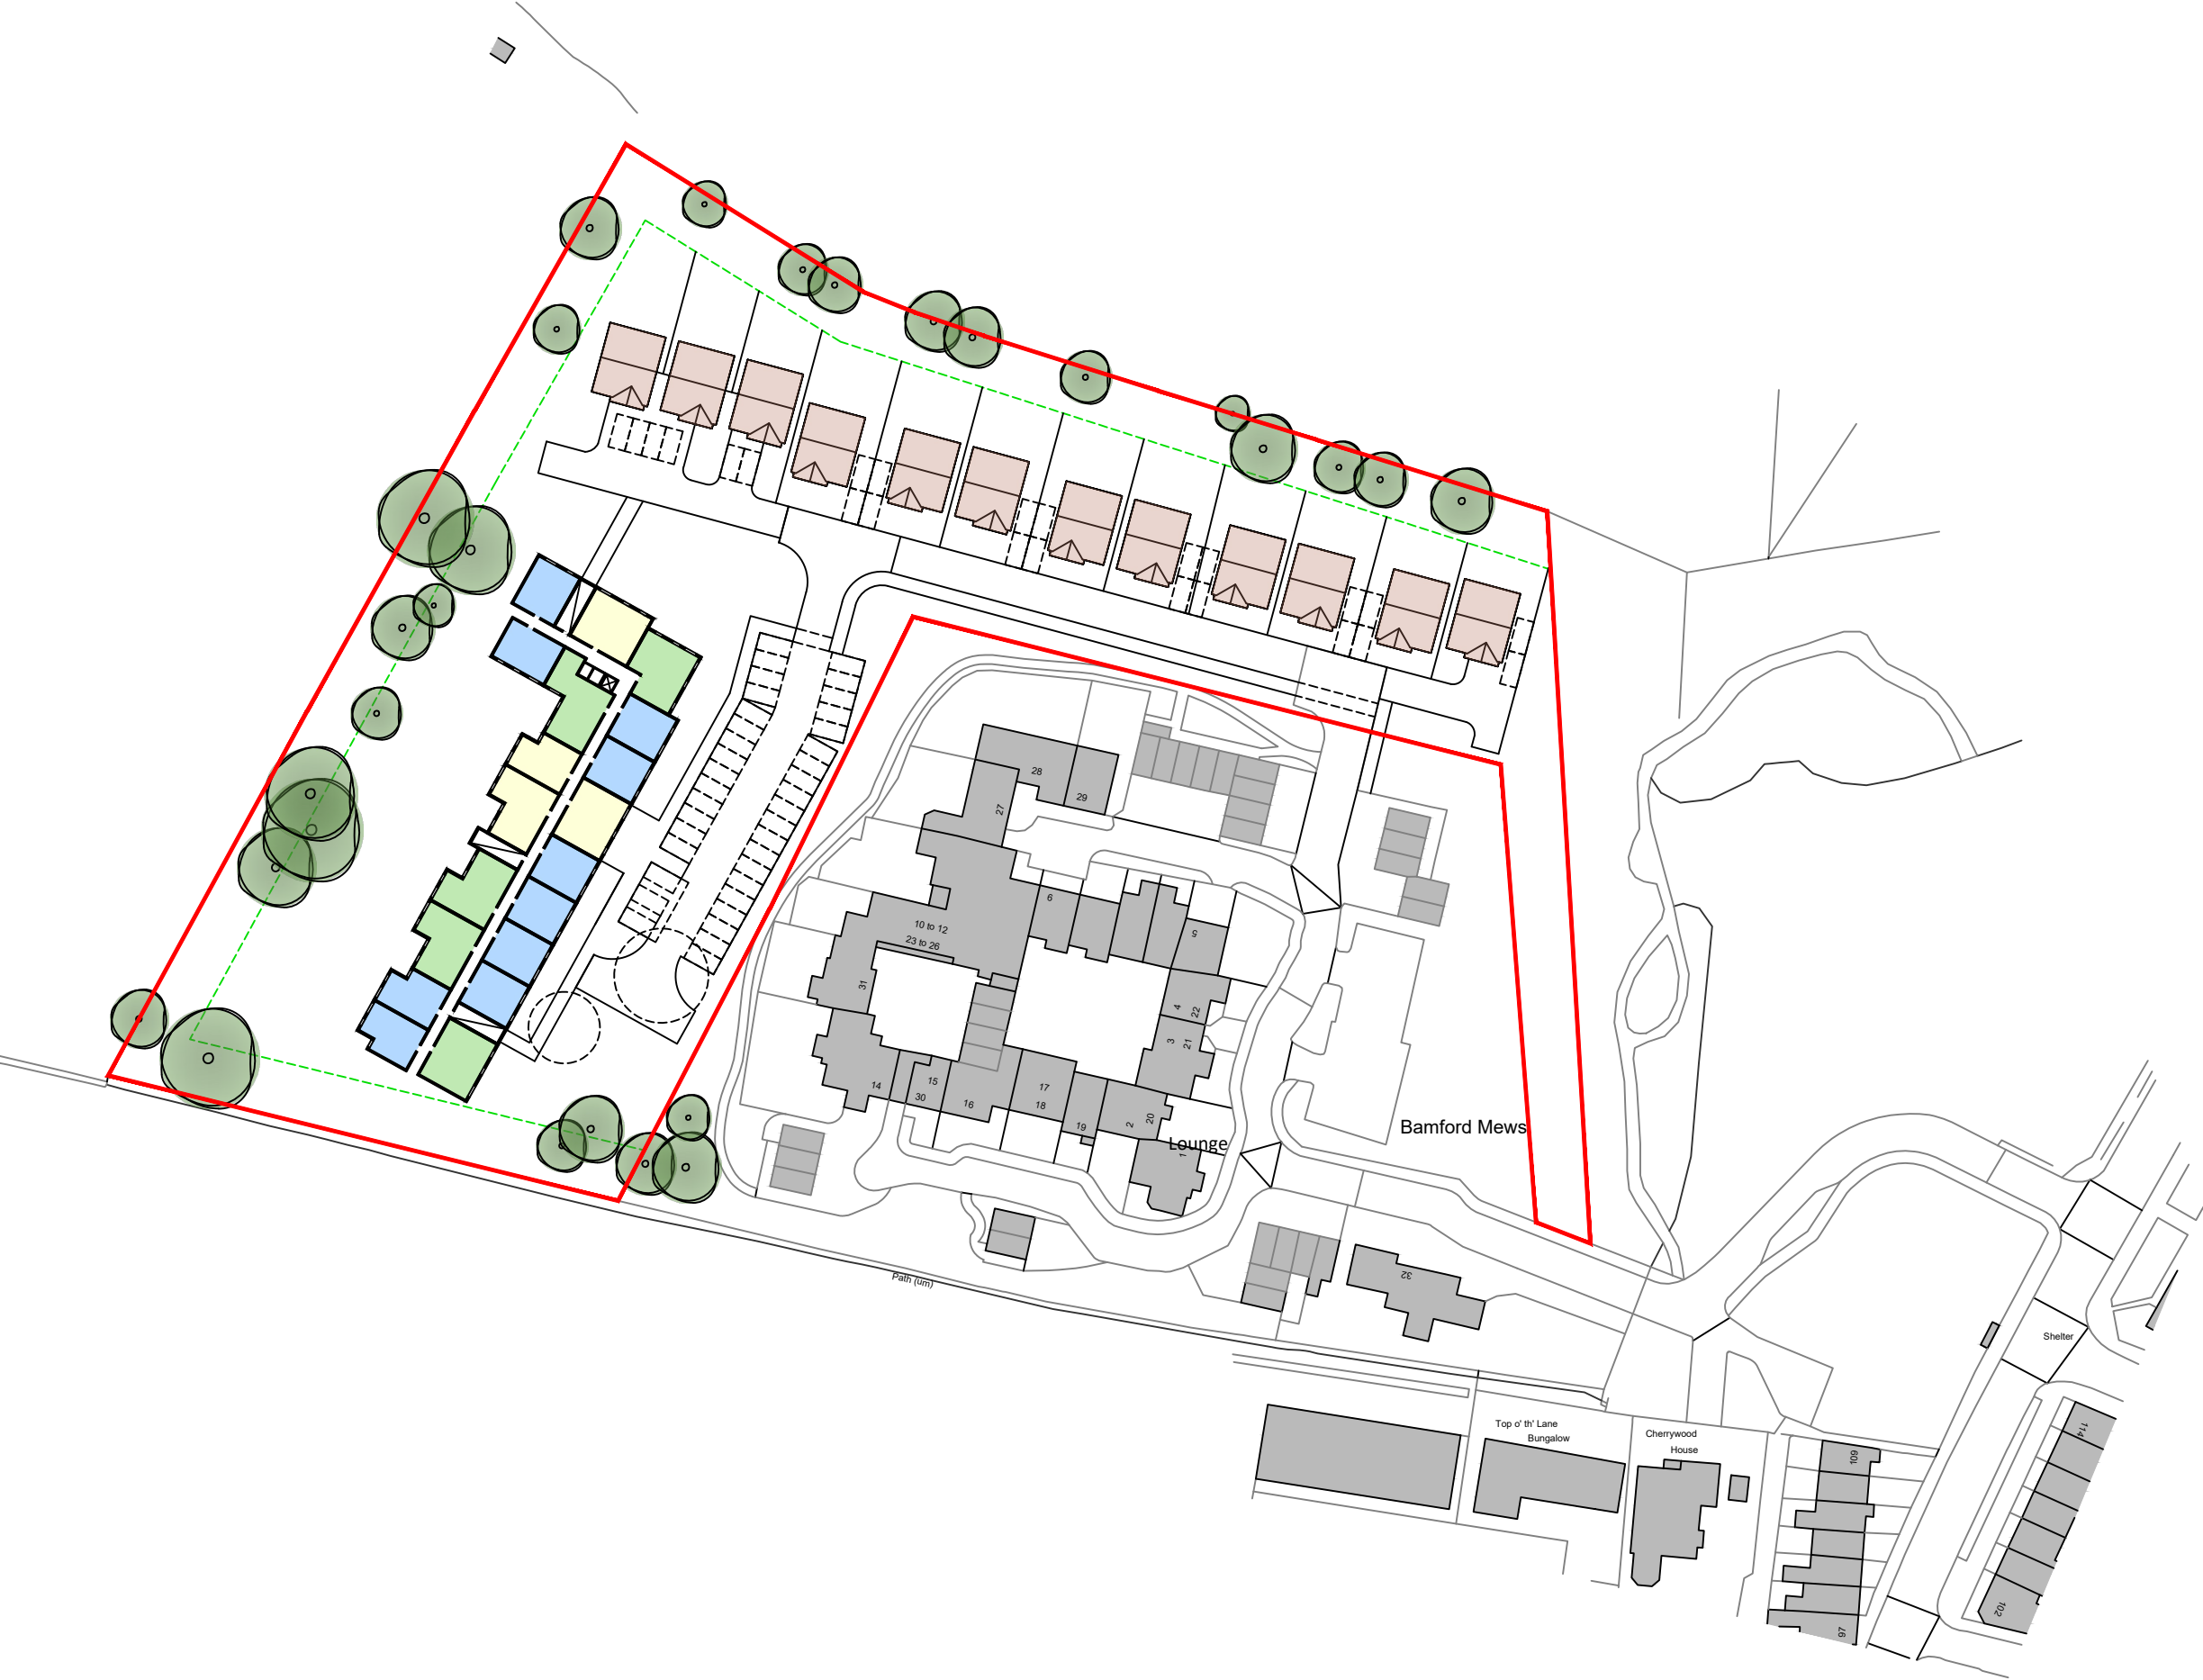
The site is proposed to be developed with a three-storey apartment building, associated parking area and soft landscaping in the west of the site. A series of 12 detached bungalows are proposed in the northern section of the site.

A site location plan and proposed development plan are presented in Appendix I.
