**Paper House Cottage, Norden**

**Bat and Barn Owl Assessment**

**November 2023**

**Project No & Title:** 324. Paper House Cottage, Norden. Bat and Barn Owl Assessment

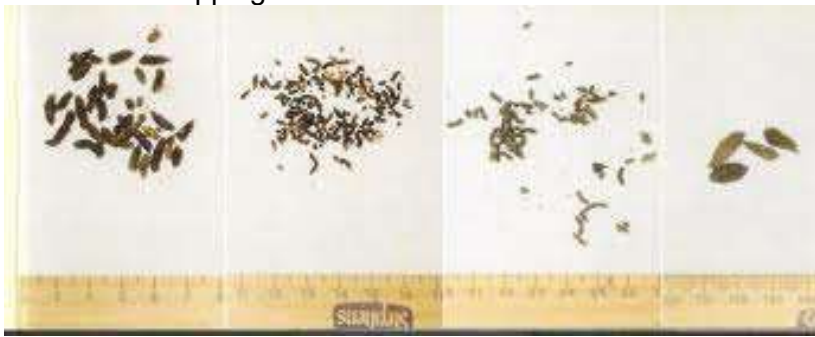
| Action | Method |
|---|---|
| <p><b>5. Evidence of bats</b></p> | <p>The evidence of bats which is most likely to be discovered during the course of any building works is that of droppings. The droppings are small, approximately 5 – 10mm long (refer to Plate 1 below) and crumble into a fine powder when crushed unlike mouse droppings which cannot be crumbled.</p> <p>Plate 1 Bat droppings</p> <p>If bats are discovered during the course of the works, it is likely that they will appear to be huddled behind or within a crevice rather than hanging from the rafters as many people believe. The most likely species to be identified at this property is the Pipistrelle spp. bat as pictured in Plate 2 below. They are tiny bats which are no bigger than an adult's thumb and may appear cold and lifeless if they are in torpor and may take up to half an hour to wake if disturbed.</p> <p>Plate 2 Pipistrelle bats</p> |

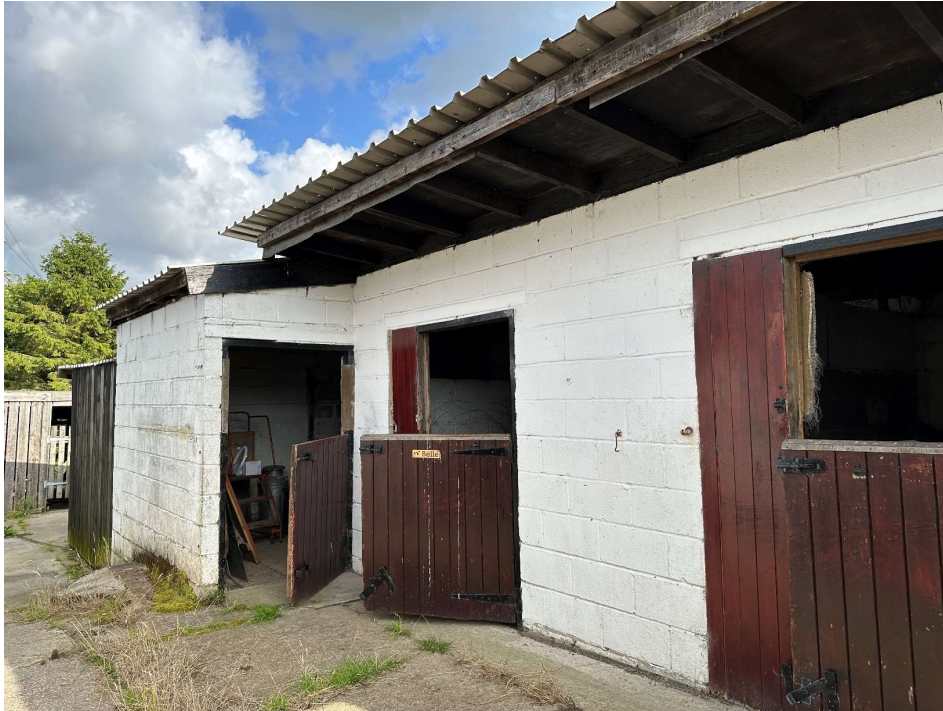
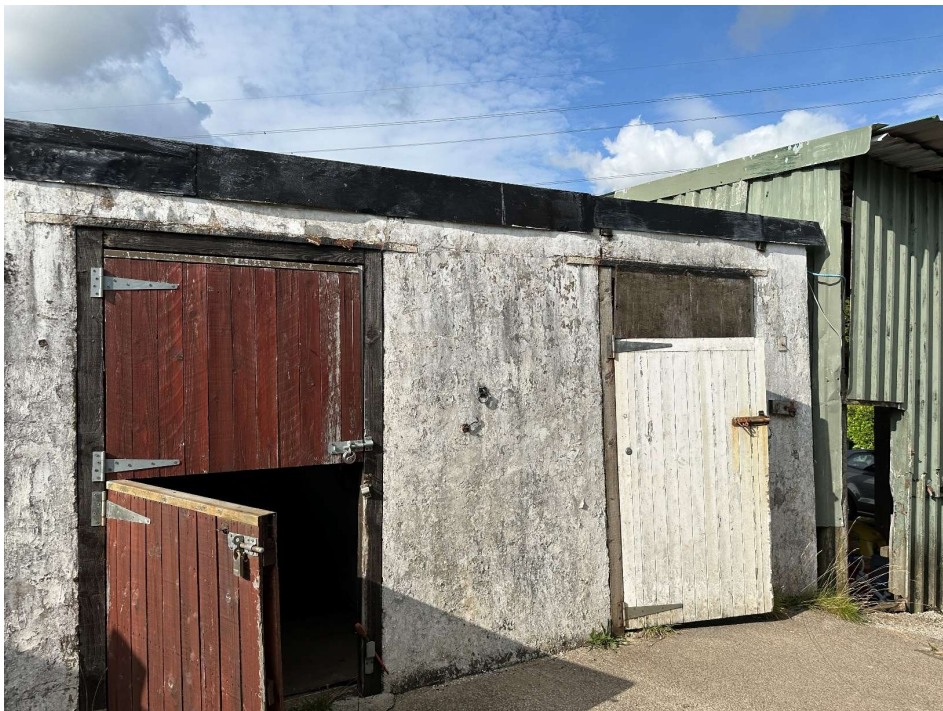
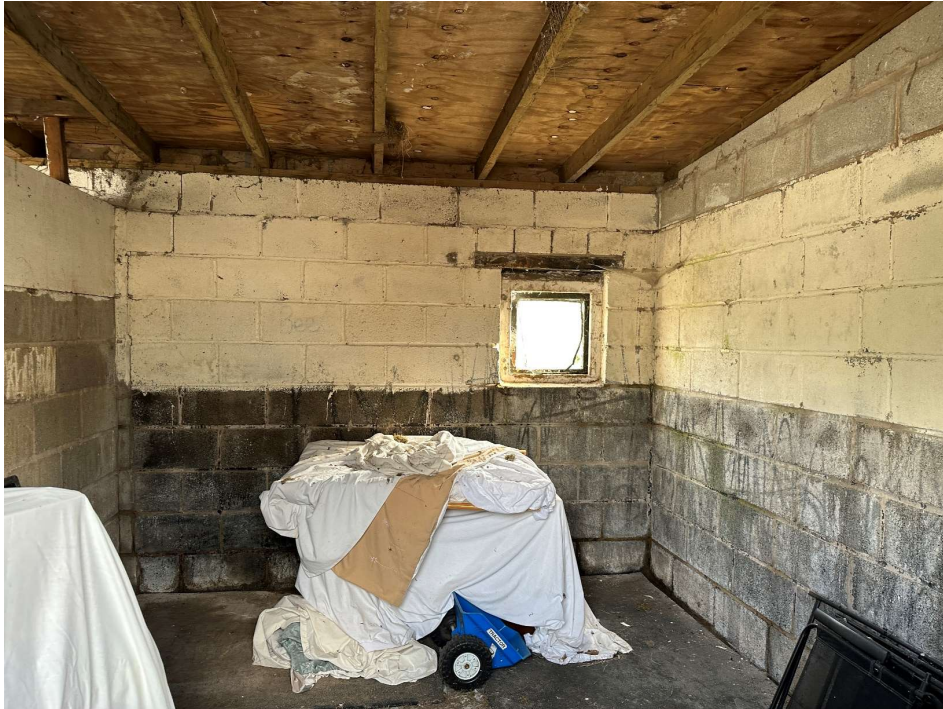
| Building Number | Building Name | Description | Bat Habitat Potential | Photo Number |
|---|---|---|---|---|
| Building 1 | Stable Block 1 | <p>Including a tack room and three loose boxes. Mono pitch roof covered in corrugated metal sheets. Plywood attached to the underside of the roof sheets with no cavity between apart from the cavity beneath corrugations. Wooden fascia board above eastern most stables has degraded and some potential roosting locations have developed. The walls are whitewashed blockwork with no cracks or crevices which may offer suitable crevice roosting habitat.</p> <p>Internally the buildings are no longer used as stables but they are used for storage and are regularly accessed.</p> <p>No evidence of bat activity in the form of droppings, urine marks or staining</p> | Low | 1 - 3 |

| Building Number | Building Name | Description | Bat Habitat Potential | Photo Number |
|---|---|---|---|---|
| | | were noted either internally or externally.<br><br>Swallow nests identified within the interior of the stables. No evidence of barn owl. | | |

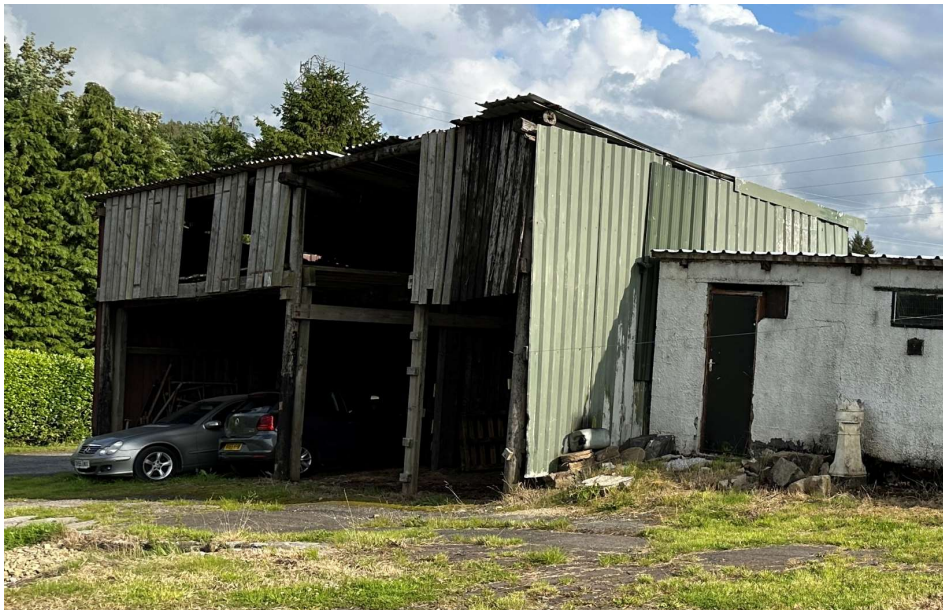
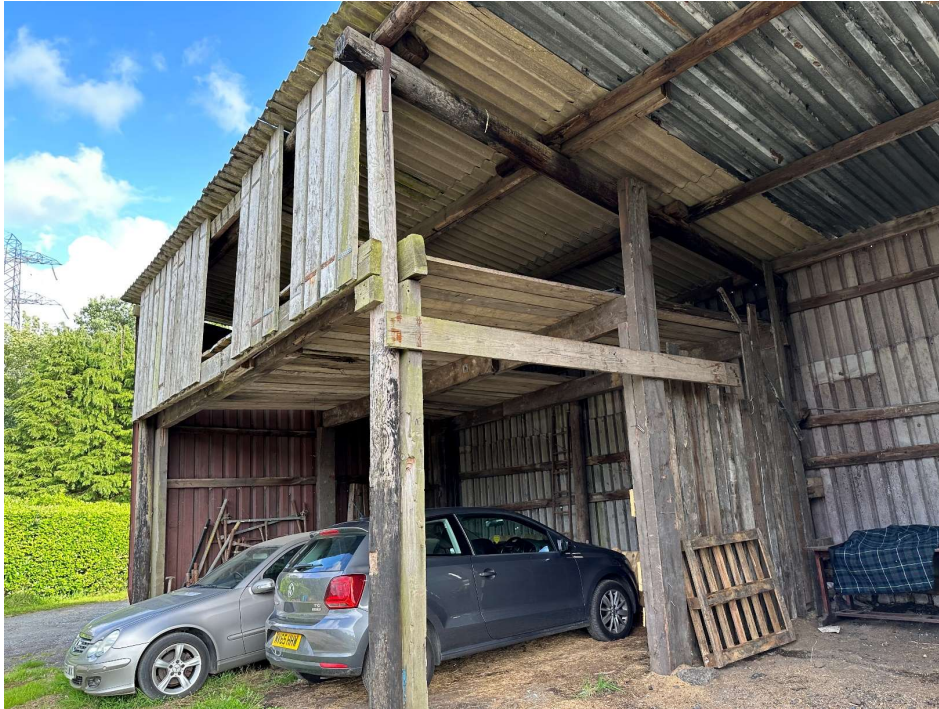
| Building Number | Building Name | Description | Bat Habitat Potential | Photo Number |
|---|---|---|---|---|
| Building 2 | Open high hay store | Timber framed double height barn with a mono pitch roof facing south east and open to the north. Walls and roof constructed of single skin corrugated metal sheets with no cavity between. No suitable roosting cavities within internal timbers.<br><br>Wooden ledge forming mezzanine hay loft assessed for presence of barn owl and none found.<br><br>No evidence of bat activity in the form of droppings, urine marks or staining were noted either internally or externally. | Negligible | 4 & 5 |

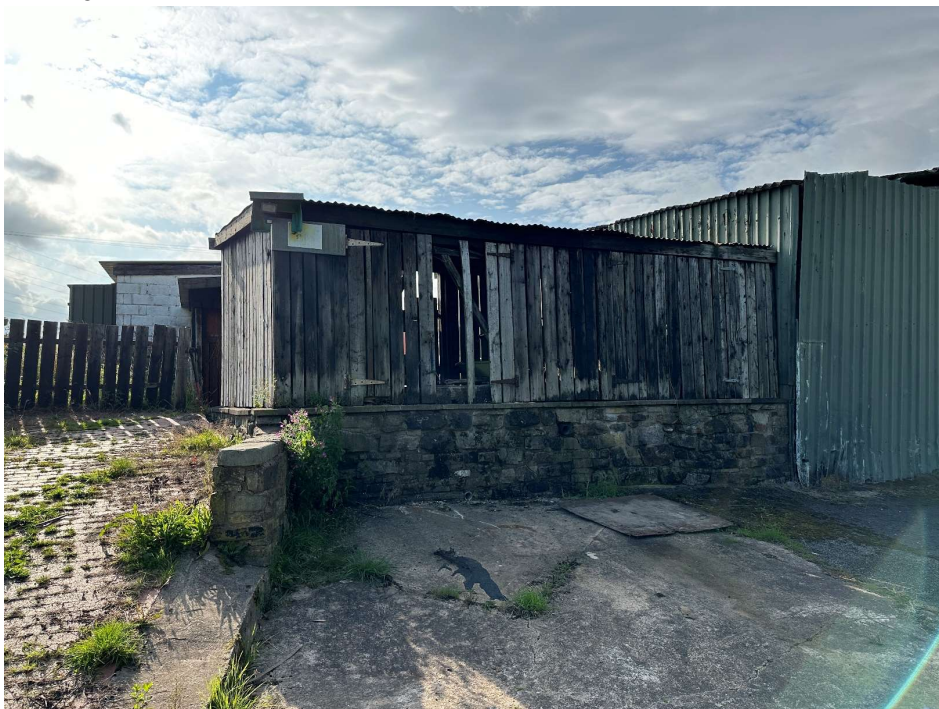
Plate 6

| Building Number | Building Name | Description | Bat Habitat Potential | Photo Number |
|---|---|---|---|---|
| Building 3 | Hay barn | Single height, timber framed with mono pitch roof covered in corrugated metal sheets. Walls formed of timber boards. No suitable crevices in timbers for roosting.<br><br>No evidence of bat activity in the form of droppings, urine marks or staining were noted either internally or externally.<br><br>No evidence of barn owl. | Negligible | 6 |

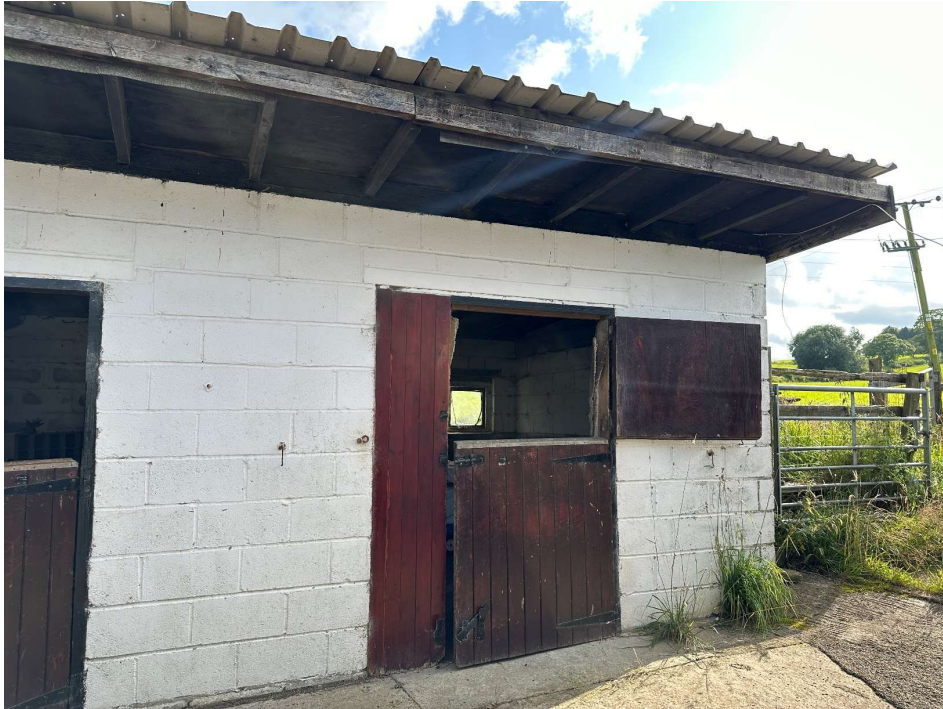
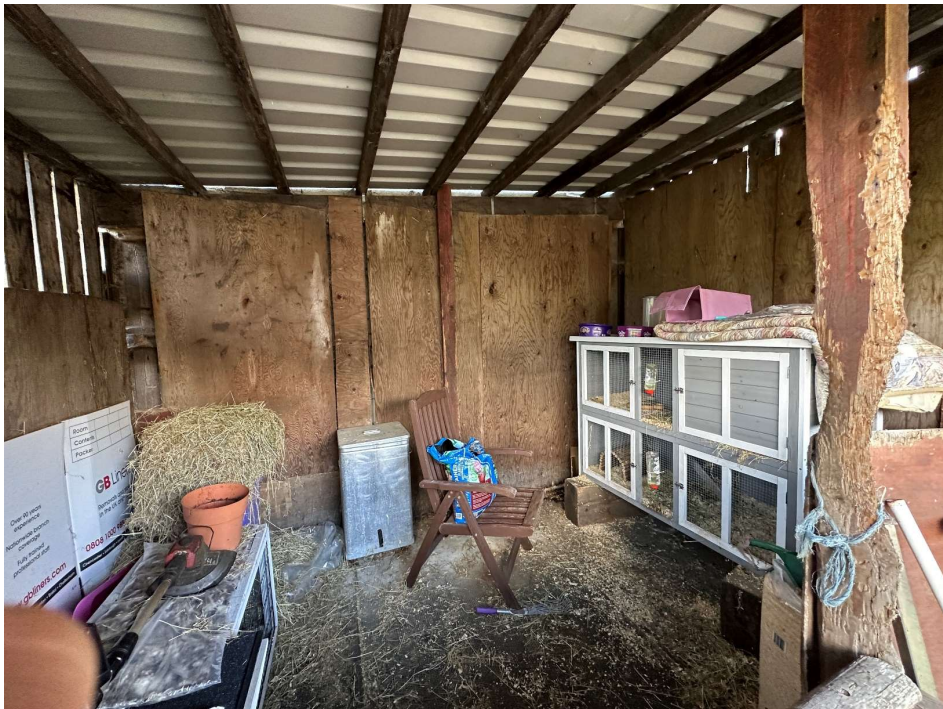
| Building Number | Building Name | Description | Bat Habitat Potential | Photo Number |
|---|---|---|---|---|
| Building 4 | Stables | Including four stables. Mono pitch roof covered in corrugated metal sheets. Plywood attached to the underside of the roof sheets with no cavity between apart from the cavity beneath corrugations. The walls are whitewashed blockwork with no cracks or crevices which may offer suitable crevice roosting habitat.<br><br>Internally the buildings are no longer used as stables but they are used for storage and are regularly accessed.<br><br>No evidence of bat activity in the form of droppings, urine marks or staining | Low | 7 & 8 |

| Building Number | Building Name | Description | Bat Habitat Potential | Photo Number |
|---|---|---|---|---|
| | | were noted either internally or externally.<br><br>Swallow nests identified within the interior of the stables. No evidence of barn owl. | | |
