# GEO-ENVIRONMENTAL AUDIT

PHASE 1 Preliminary Risk Assessment

PHASE 2 Site Investigations

The Red House

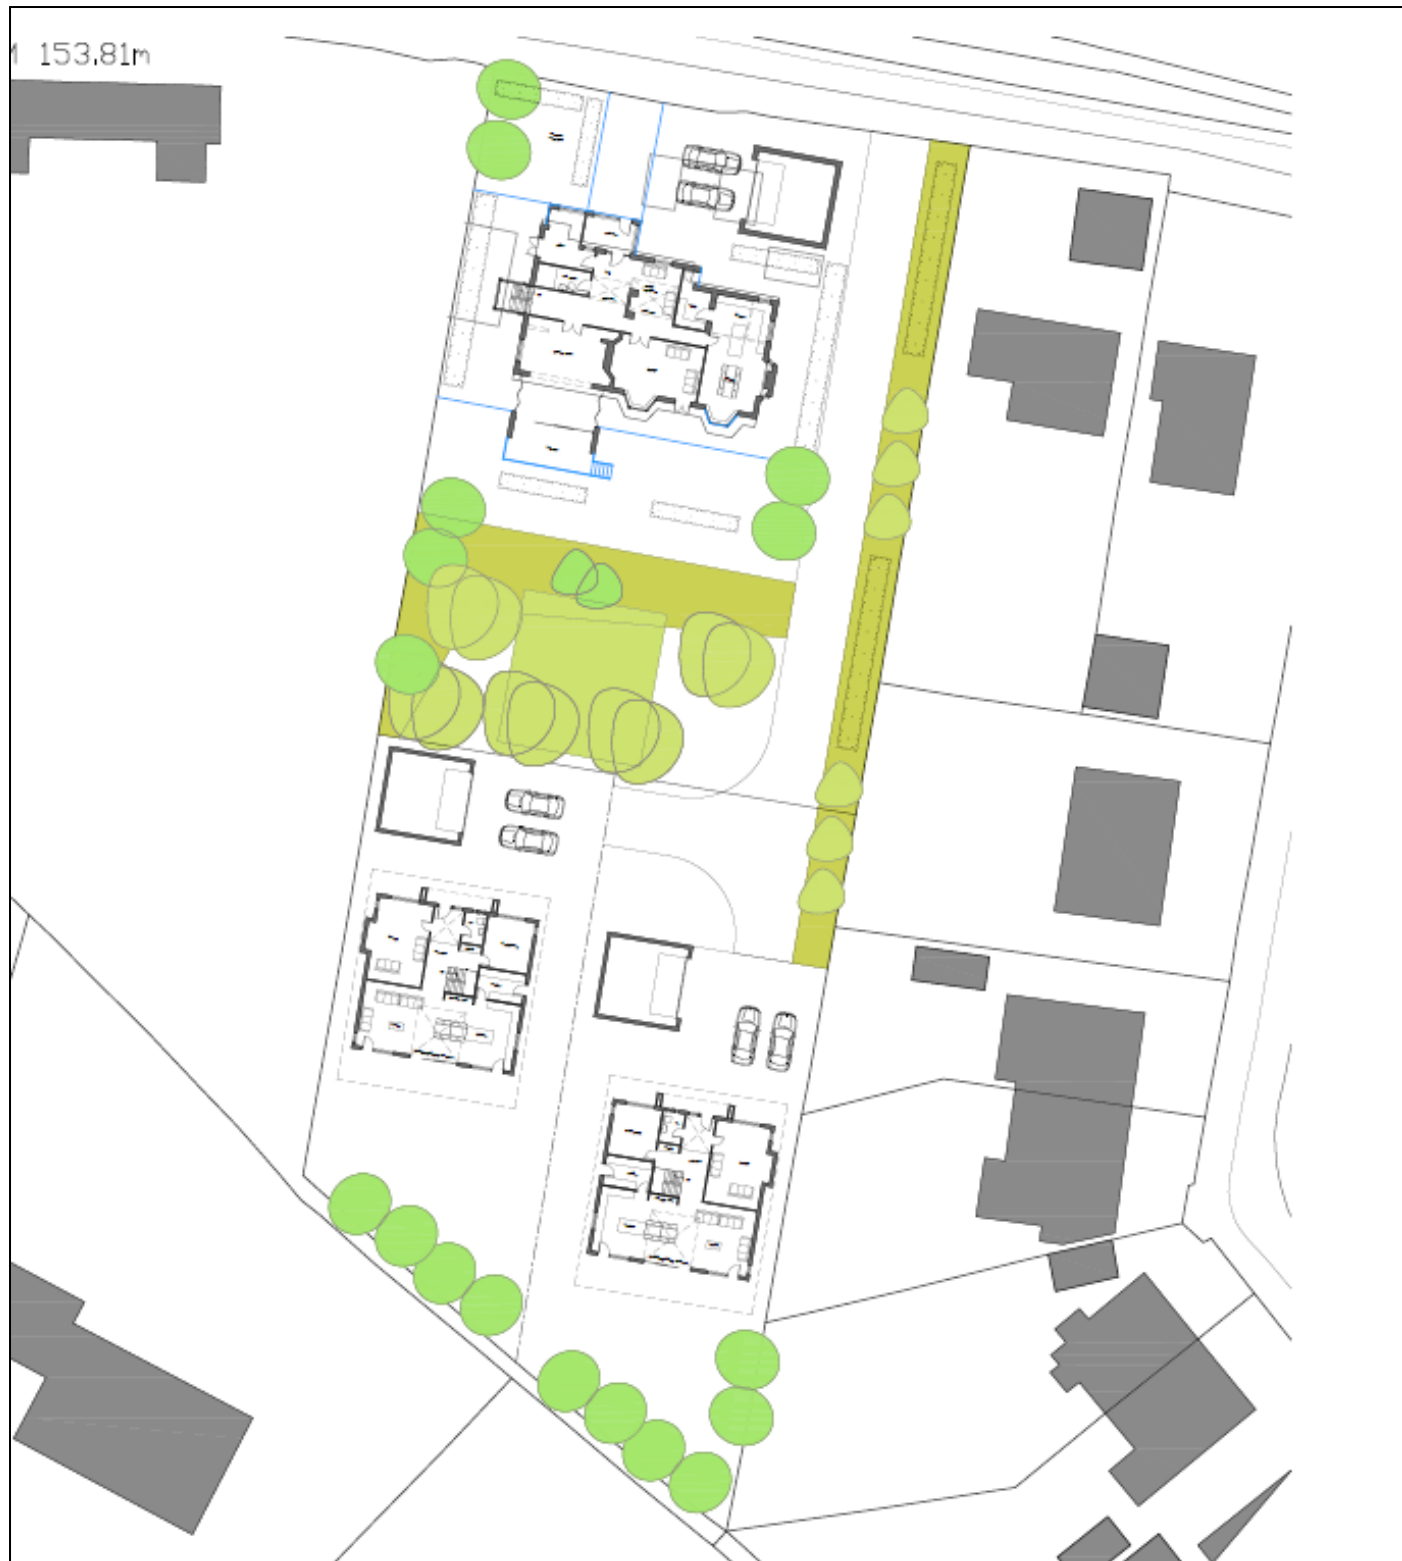
### 5.3. Proposed Development.

The proposed development is for the erection of 2No. two-storey, detached residential dwellings nominally located to the S side of the development. The properties will each have detached garages, driveways, and soft landscaped garden areas.

The dwelling will be accessed via a new access road to the E side of the Site.
