# **GEO-ENVIRONMENTAL AUDIT**

## **PHASE 1 PRELIMINARY RISK ASSESSMENT**

## **PHASE 2 SITE INVESTIGATIONS**

**PROPOSED RESIDENTIAL DEVELOPMENT**  
**PLATTING LANE**  
**ROCHDALE**  
**OL11 2JT**

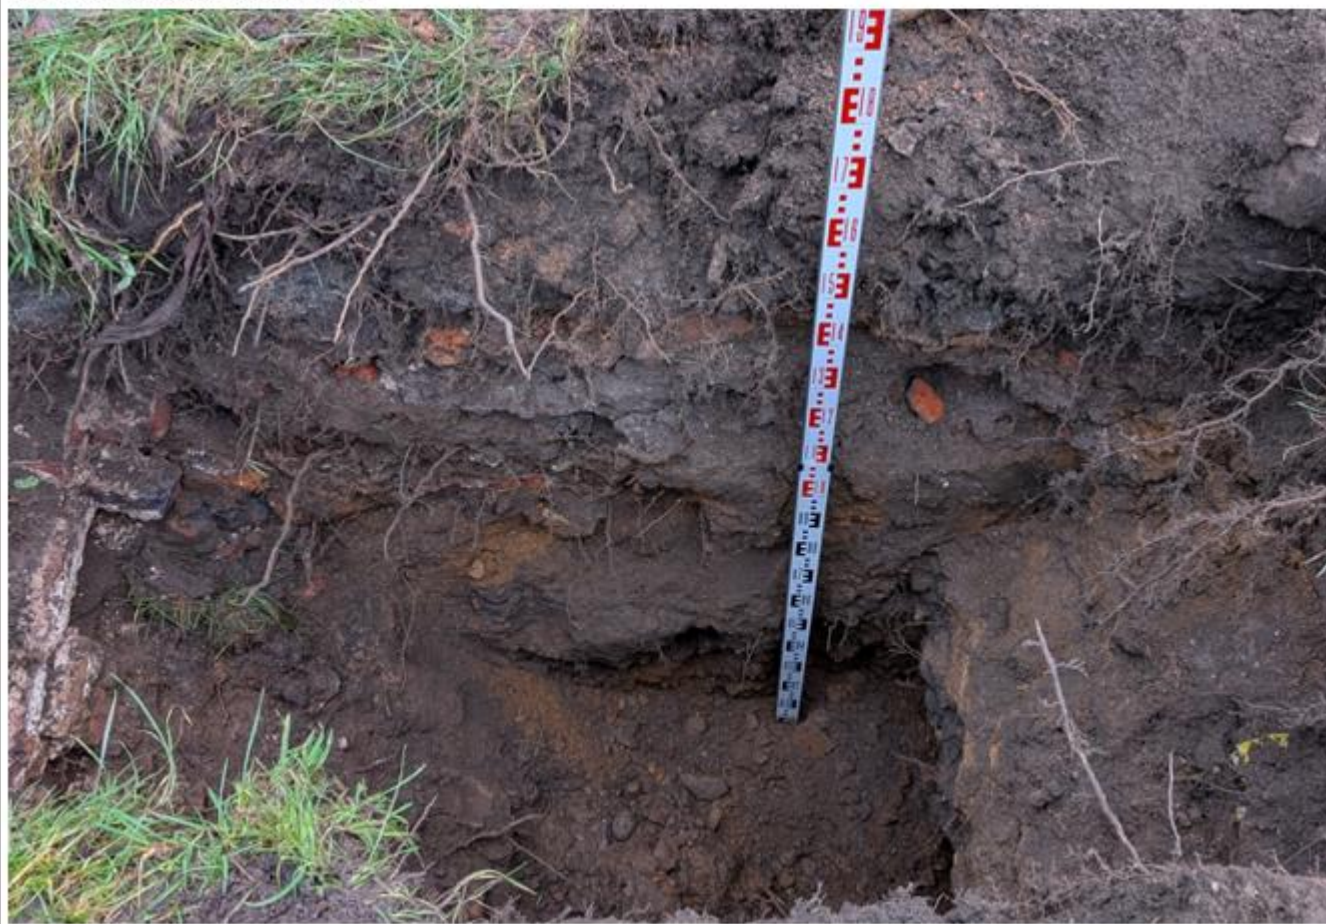
| Trial pit reference TH1 | | | | Sheet 1 of 1 |

| Trial pit reference TH1 | | | | Sheet 1 of 1 |
|---|---|---|---|---|
| | 134.40 | X X<br>X X<br>X X | (0.60)<br>1.10 | Loose brown silty sand & gravel MADE GROUND. Gravel is brick & stone. Former founs noted to N & E sides. |

Additional notes: No groundwater.

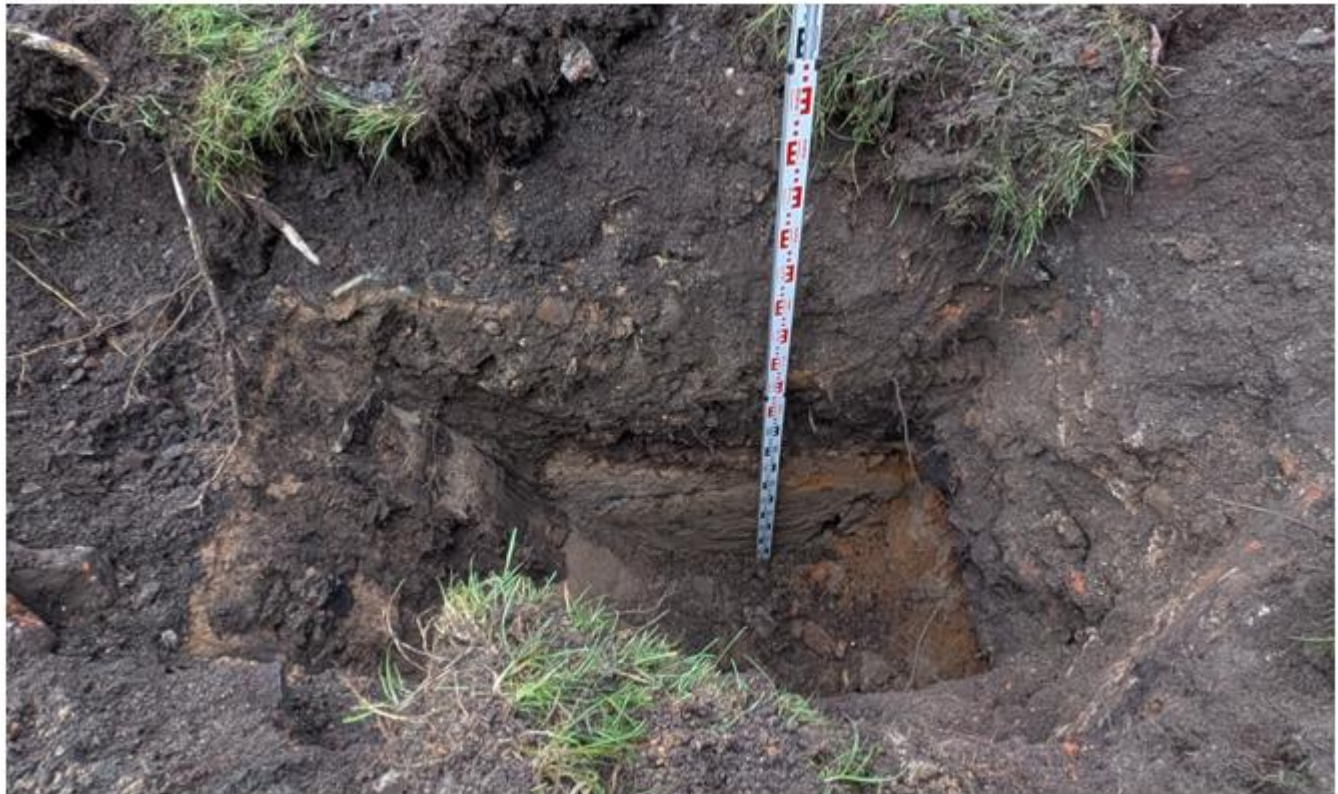
| Trial pit reference TH2 | | | | Sheet 1 of 1 |

| Trial pit reference TH2 | | | | Sheet 1 of 1 |
|---|---|---|---|---|
| | 135.25 | X X<br>X X | (0.40)<br>0.40 | Loose black sand & gravel MADE GROUND. Sand & gravel is brick, stone, slate, glass, ash. (S2) |
| | 134.55 | X X<br>X X<br>X X<br>X X | (0.70)<br><br>1.10 | Loose dark brown/black sand & gravel MADE GROUND Sand & gravel is brick, stone, ash, motar, plaster. |

Additional notes: No groundwater.

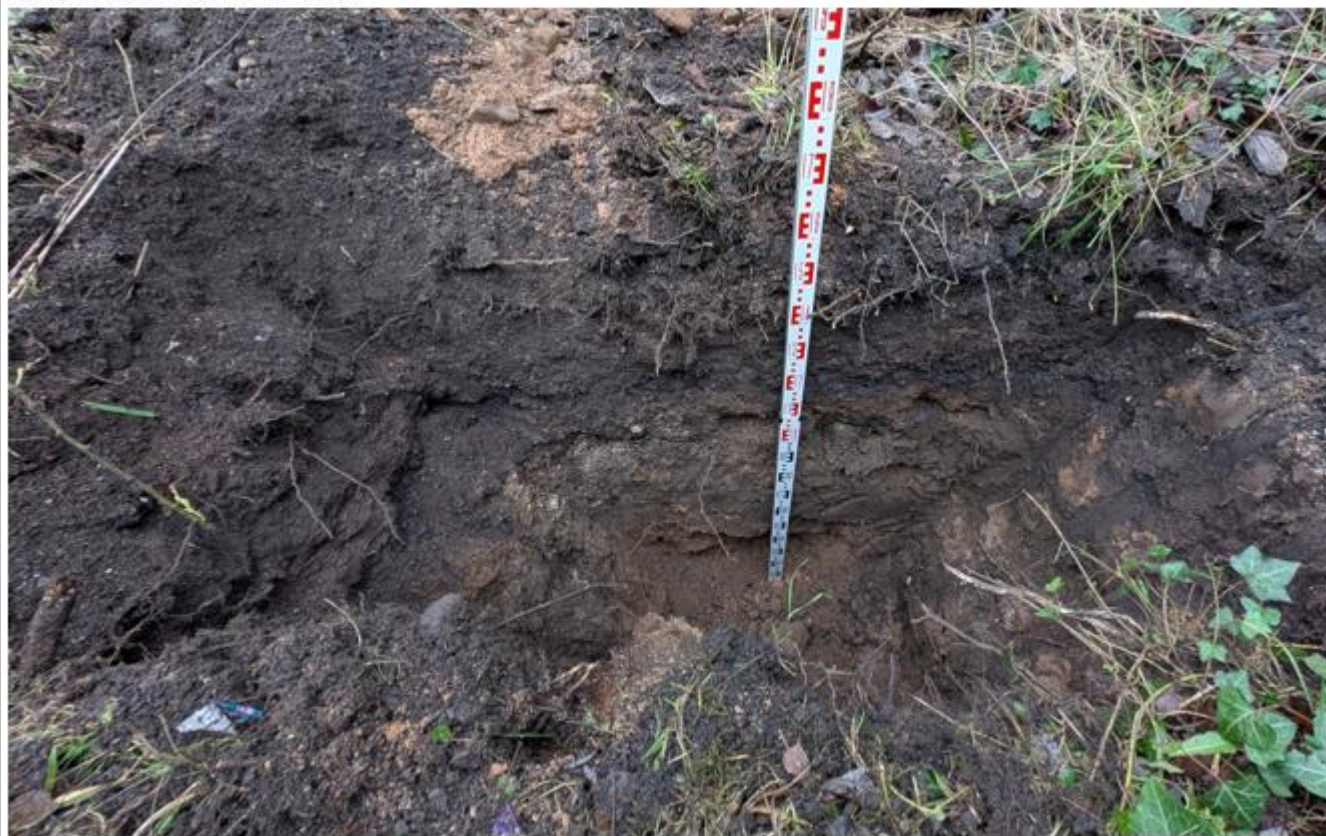
| Trial pit reference TH3 | | | | Sheet 1 of 1 |

| Trial pit reference TH3 | | | | Sheet 1 of 1 |
|---|---|---|---|---|
| | 135.35 | X X<br>X X<br>X X | (0.55)<br>0.55 | Loose dark brown/black sand & gravel MADE GROUND. Sand & gravel is predominantly ash. (S3) |

Additional notes: No groundwater.

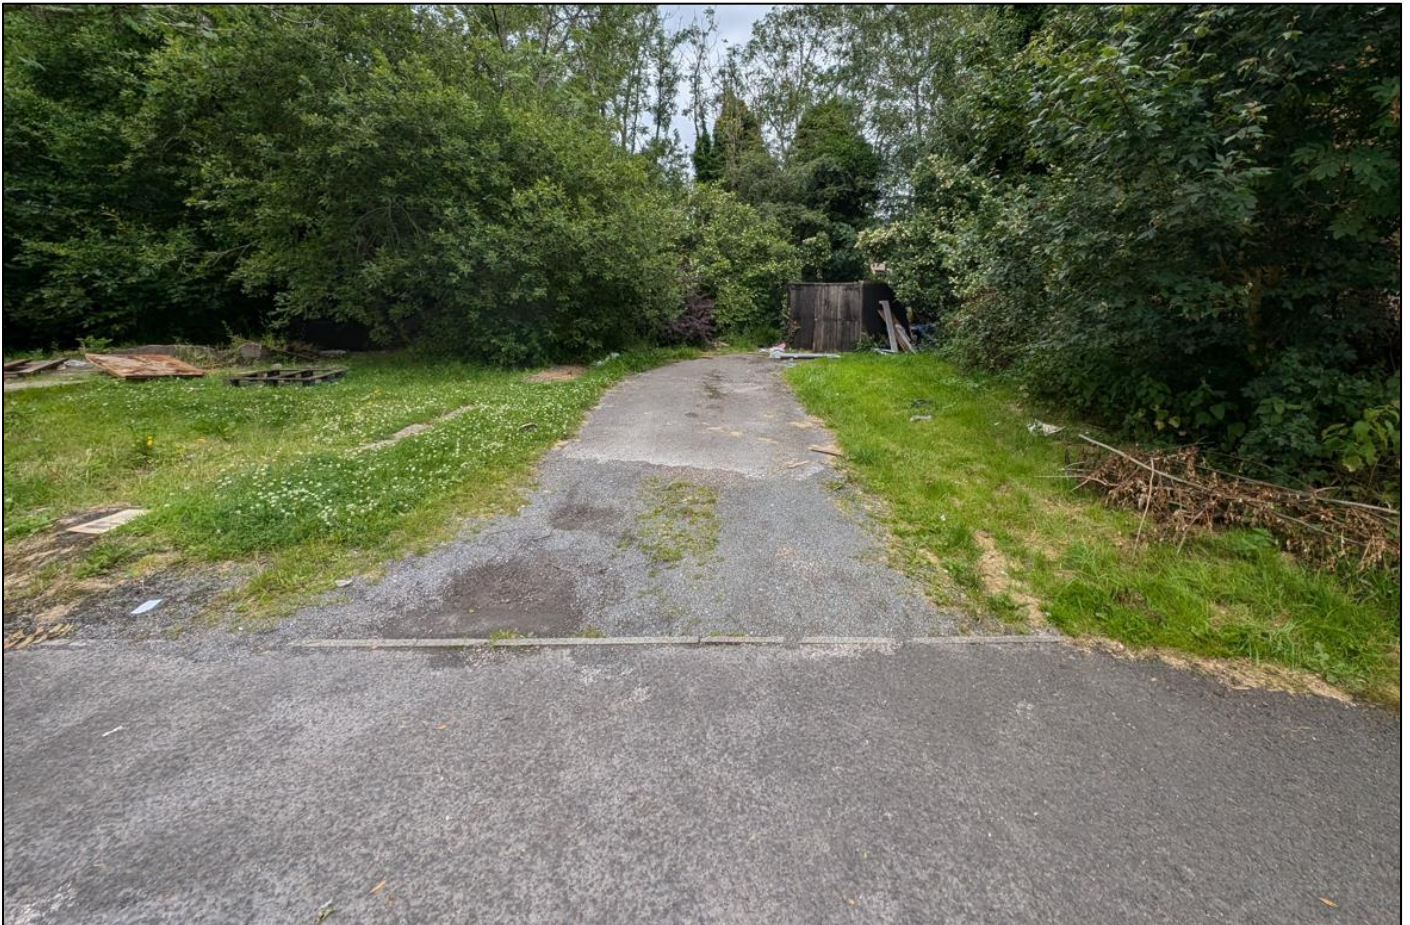
| Details of existing structures: | <p>The Application Site was accessed from Platting Lane.</p> <p>The Site was relatively level with land elevation gently falling to the north.</p> <p>The boundary was open, and the site comprised a grass surface with trees/vegetation along the perimeter with Sudden Brook.</p> <p>The only other structures were a former garage slab nominally central to the site, and a macadam access drive to a dilapidated garage to the southeast corner. The garage to the southeast corner was full of household rubbish/tipping.</p> |

View towards southeast corner, 12.07.2024.
