# Phase I & II Geoenvironmental Site Assessment

Site: Trub Farm, Castleton

Reference: 17-524-R1

Date: June 24

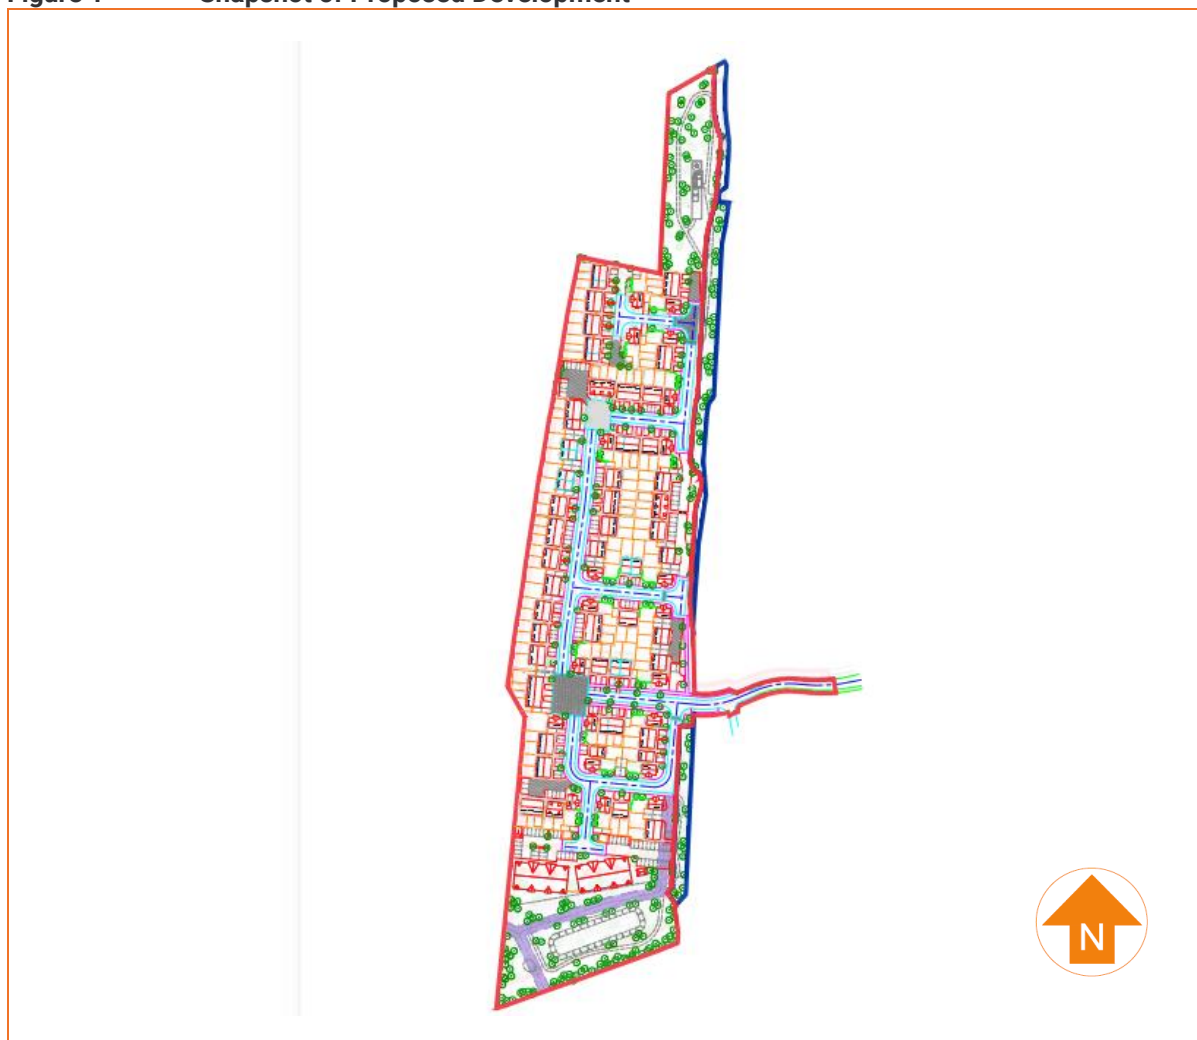
**Figure 1**      **Snapshot of Proposed Development**

| <b>Proposed Development</b> | M.C.I Developments Ltd intend to construct a residential development comprising low rise residential housing and two apartment blocks with associated gardens, estate roads and infrastructure. |

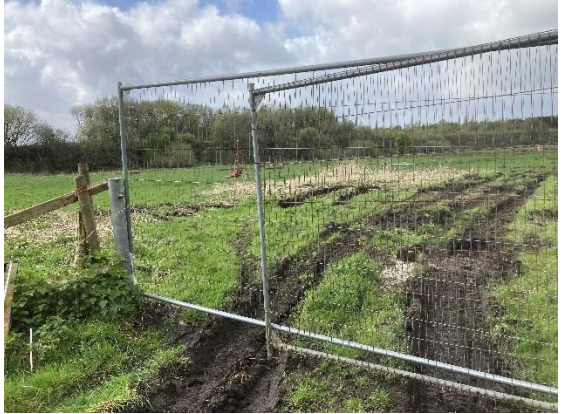
| FEATURE | DESCRIPTION | PHOTOGRAPHIC EVIDENCE |
|---|---|---|
| <b>Access</b> | <p>Pedestrian access and vehicular access to the site can be gained via the gated entrance in the southeast off the hardstanding track. Access to the track is gained via a bridge off Trub Road to the east. No overhead restrictions were noted on the access.</p> | |

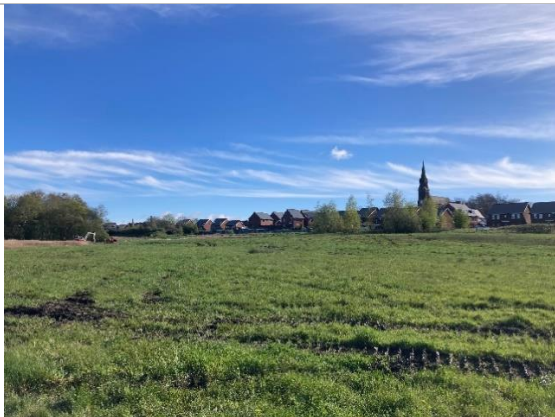
| FEATURE | DESCRIPTION | PHOTOGRAPHIC EVIDENCE |
|---|---|---|
| <b>Slope</b> | <p>The entrance to the site in the southeast is at a higher elevation to the rest of the site. A slope is present along the eastern boundary sloping westward to typical site level. The remainder of the site is relatively flat with a gentle slope upwards to the east.</p> <p>A raised section associated with the combined sewer runs north-south through the centre of the site.</p> <p>Photograph: Slope up to the eastern boundary.</p> | |

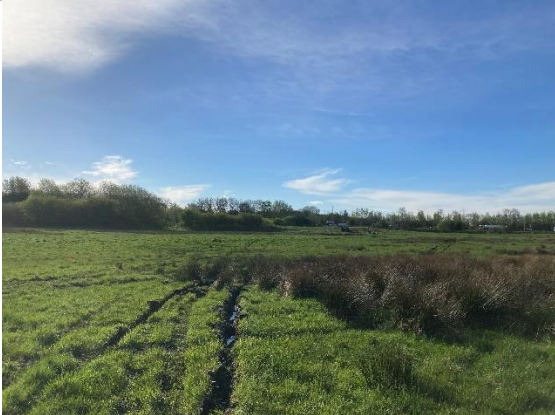
| FEATURE | DESCRIPTION | PHOTOGRAPHIC EVIDENCE |
|---|---|---|
| <b>Vegetation/Ecology</b> | <p>The site is covered by relatively short grass with patches of rough scrub vegetation throughout. Particularly dense rough scrub is present in the northwest and northeast corners.</p> <p>Dense mature trees are present running along the southwest boundary and sporadic mature and semi-mature trees are present along the central eastern boundary.</p> <p>Photograph: Looking south. Short grass, rough scrub vegetation and trees on eastern boundary.</p> | |

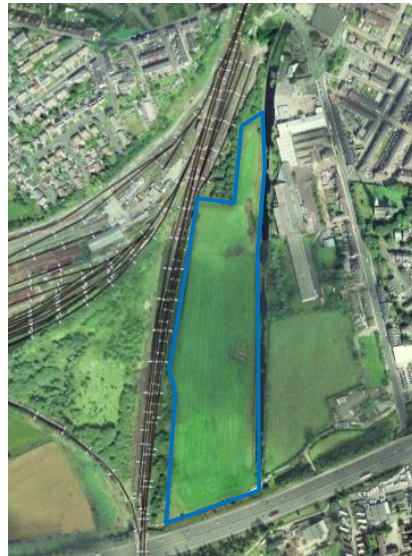
| MAP EDITION | HISTORICAL LAND USE | HISTORICAL MAP EXCERPT |
|---|---|---|
| <p><b>2000</b><br/>Aerial Images<br/>Google Earth</p> | <p>Historical aerial photography from 2000 shows the site to comprise agricultural fields of maintained grassland. No field boundaries, structures or ponds are noted.</p> | |

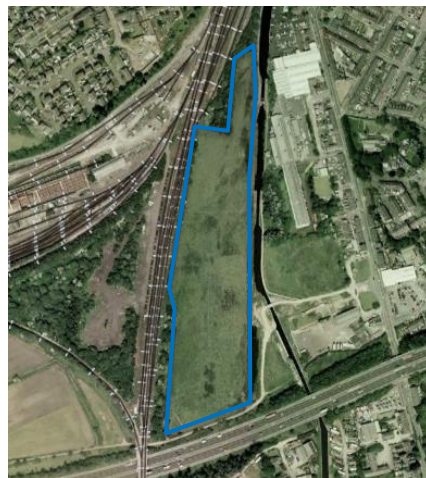
| MAP EDITION | HISTORICAL LAND USE | HISTORICAL MAP EXCERPT |
|---|---|---|
| <p><b>2005</b><br/>Aerial Images<br/>Google Earth</p> | <p>No significant on site changes. The adjacent Rochdale Canal has been diverted with the historic branch of the canal still present along the south eastern boundary.</p> <p>No significant changes have occurred on site since 2005.</p> | |

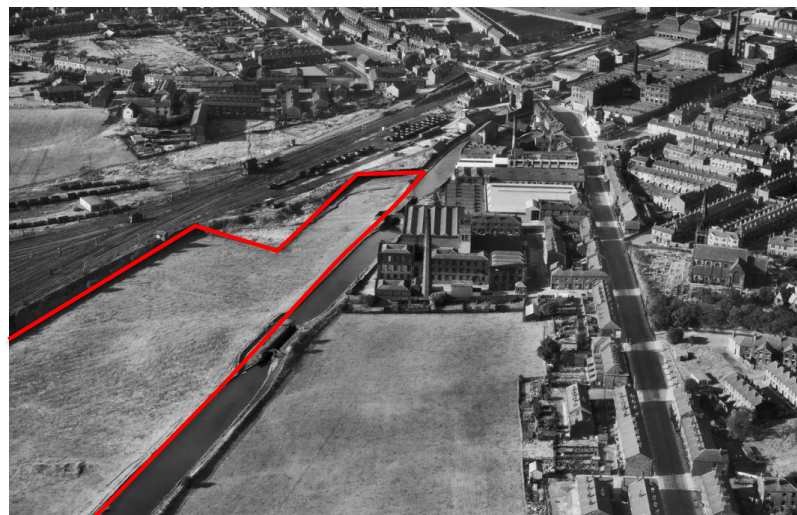
**PLATE 02 – Aerial  
Photo 1947**

North of site in use as agricultural land. No field boundaries, structures, vegetation or trees noted.

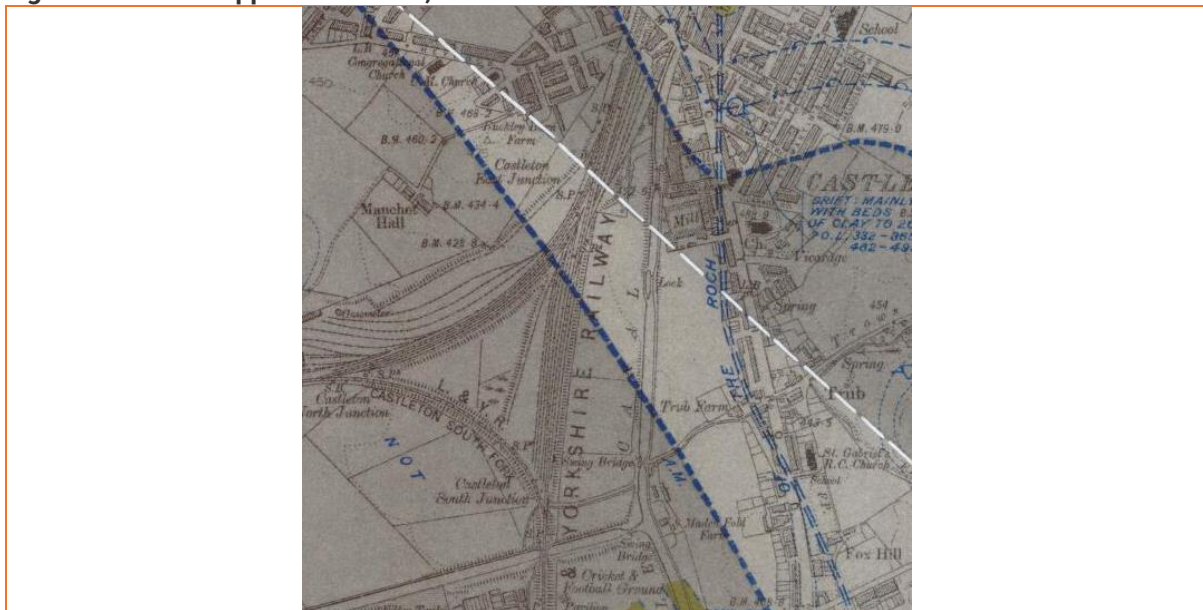
**Figure 7 Snippet of the 1:10,560 Plan for the Site**

Figure 7 is a photograph of the 1:10,560 plan for the site, which shows the Arley seam and faults location on site, however, no dip direction or angle of dip is provided for this seam or the off-site seam to the north.

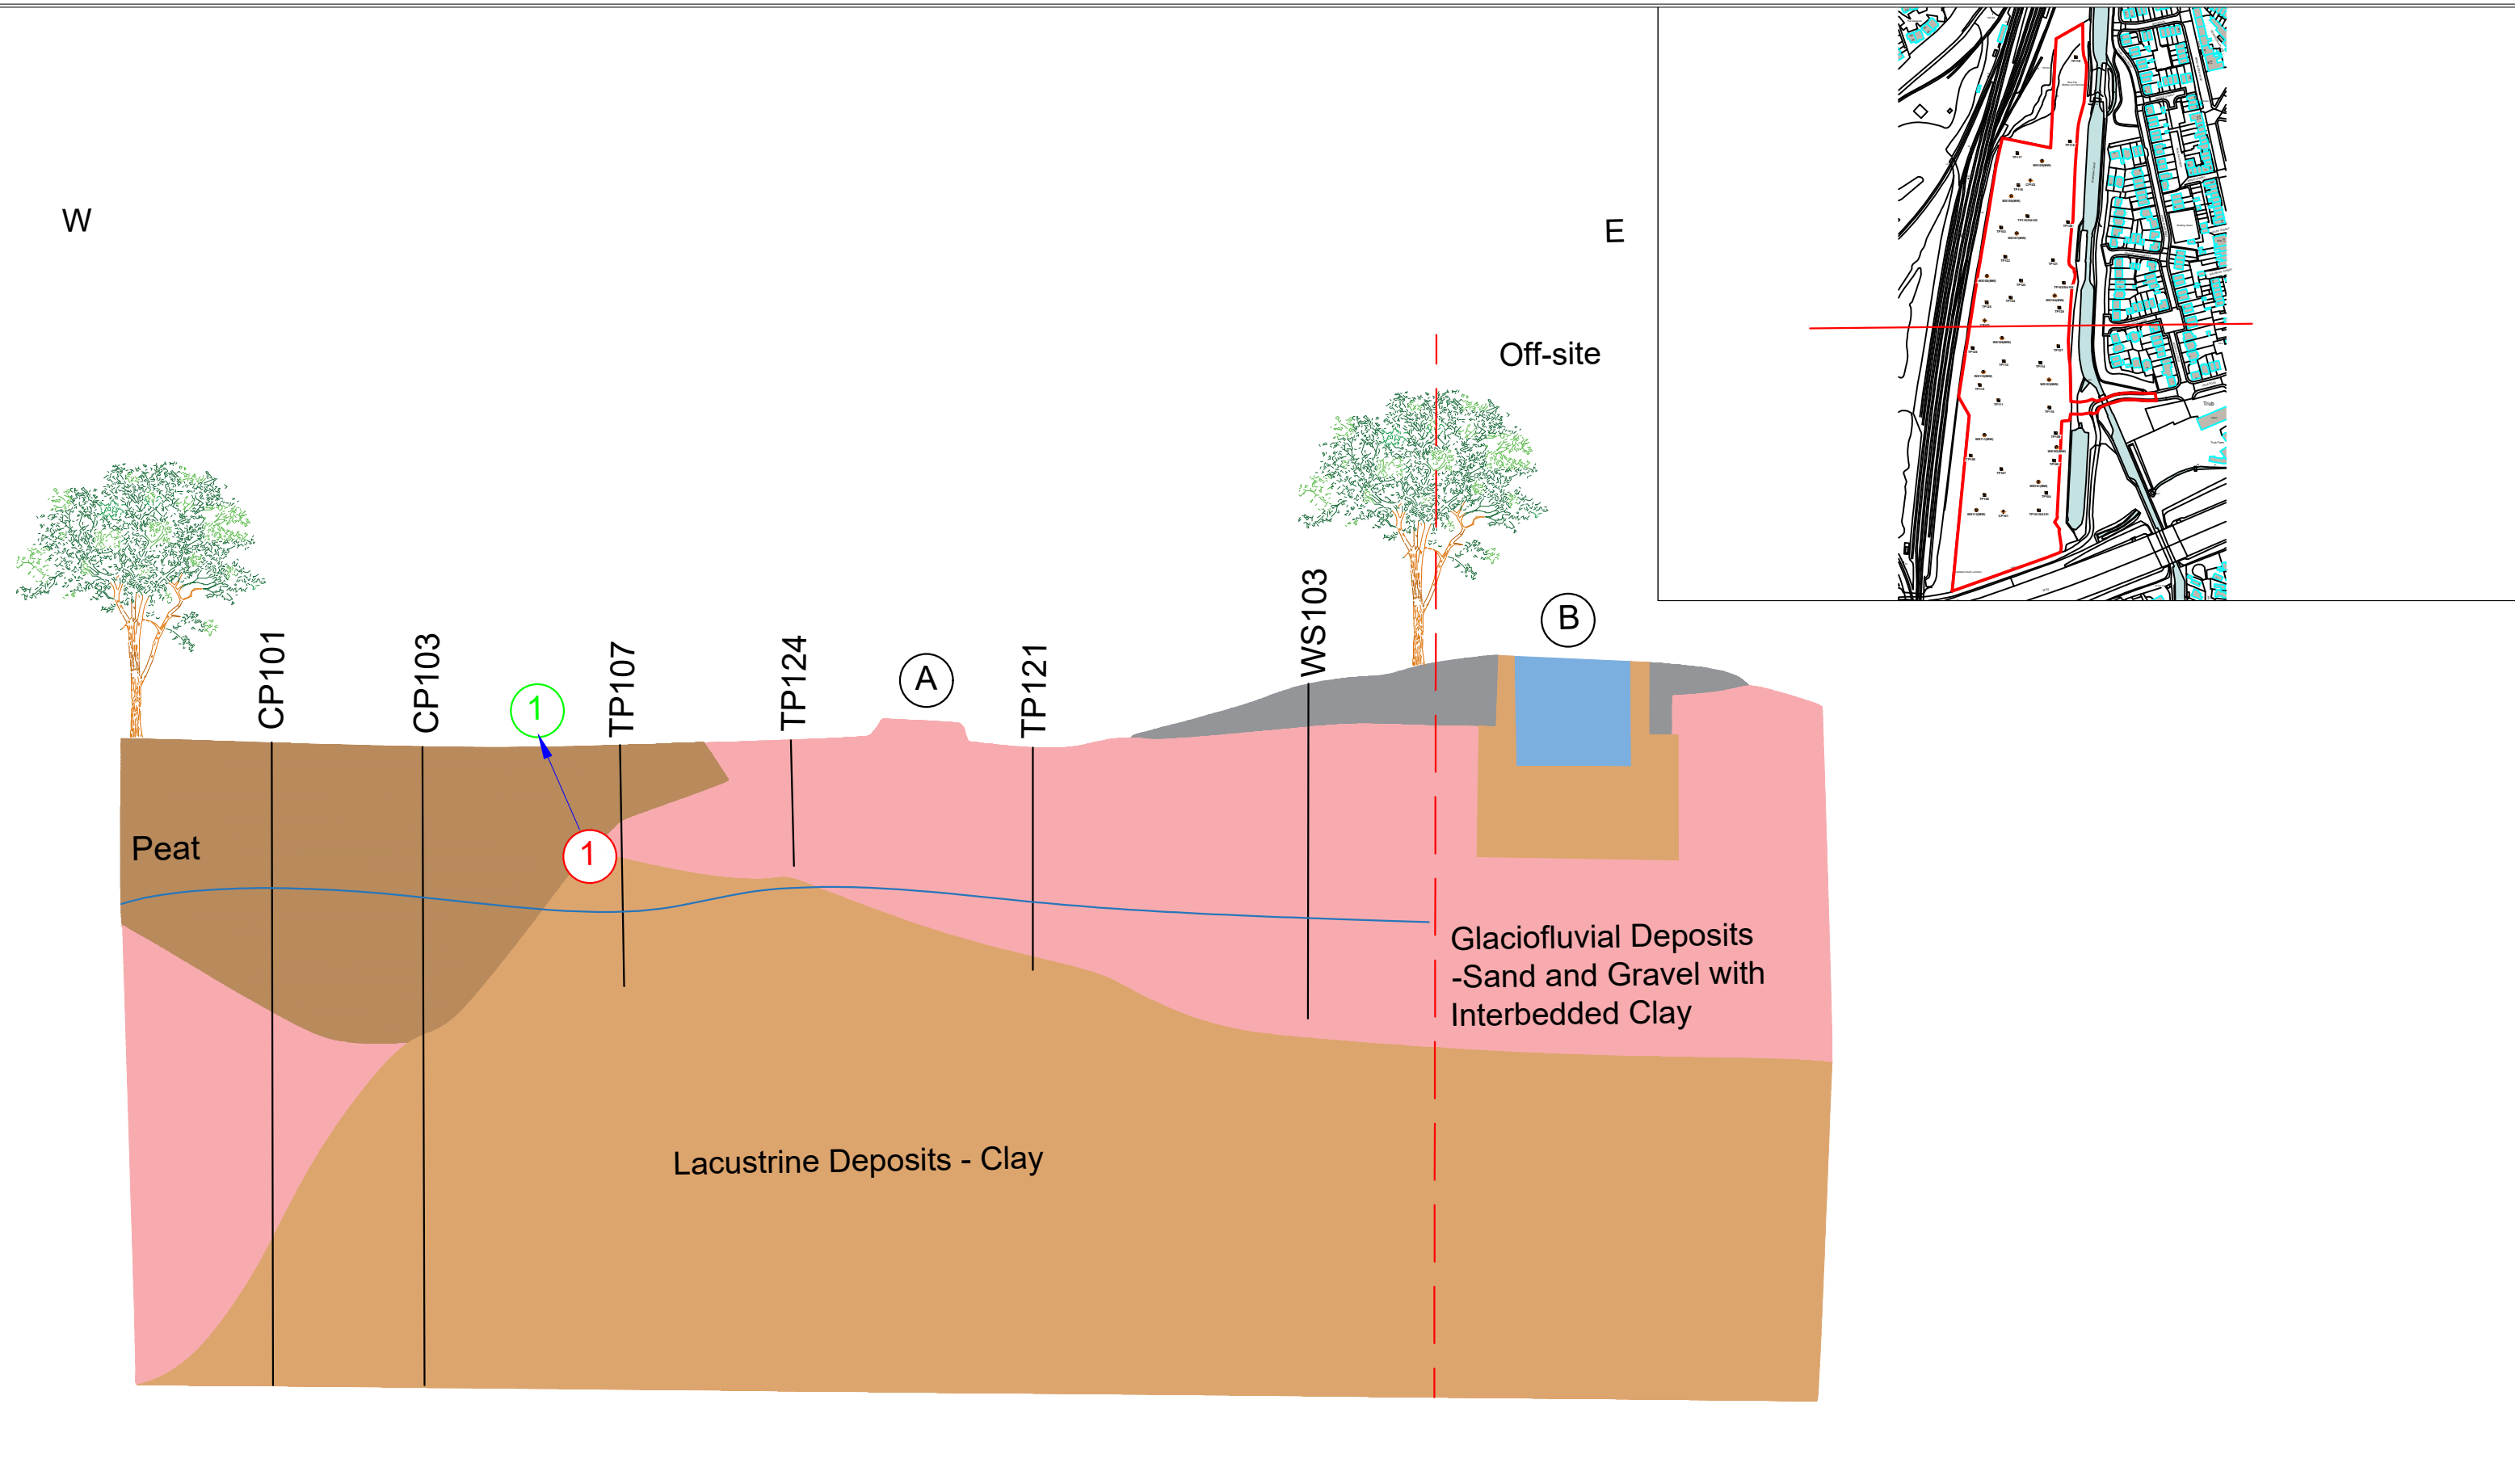
| <p>Geology Key</p> <div><div>Peat</div><div>Glaciofluvial Deposits</div><div>Lacustrine Deposits - Clay</div><div>Shallow Groundwater</div><div>Made Ground</div></div> | | <p>Sources</p> <div><div>1</div>Non Volatile PAH's, Non Volatile (Made Ground)</div> <div><div>2</div>Asbestos</div> <div><div>3</div>Volatile Contaminants</div> <div><div>4</div>Ground Gases</div> <div><div>5</div>Mobile Contaminants</div> <div><div>6</div>Sulphate</div> <div><div>7</div>Phytotoxic Contaminants</div> | | <p>Pathways</p> <div><div>➡</div>Dermal Contact / Ingestion</div> <div><div>➡</div>Vapour Inhalation</div> <div><div>➡</div>Inhalation / Accumulation</div> <div><div>➡</div>Tainting of Water Supplies</div> <div><div>➡</div>Dust Inhalation</div> <div><div>➡</div>Vertical / Lateral Migration</div> <div><div>➡</div>Sulphate Attack on Concrete</div> <div><div>➡</div>Plant Uptake</div> | | <p>Receptors</p> <div><div>1</div>Future End Users</div> <div><div>2</div>Water Pipes</div> <div><div>3</div>Groundwater (Secondary B Aquifer)</div> <div><div>4</div>Surface Water Features</div> <div><div>5</div>Off-site Receptors</div> <div><div>6</div>Building Structure</div> <div><div>7</div>Flora</div> | | <p>Site Features</p> <div><div>A</div>High Pressure Water Main and Sewer</div> <div><div>B</div>Offsite Canal</div> | | <p>Notes:</p> | | | | | | <p>Client:</p> <p>MCI</p> | | <p>Job No:</p> <p>17-524</p> | | <p>Date:</p> <p>31.05.2024</p> | | <div><div><div></div></div><div>e3p</div></div> <p>Environmental Engineering Partnership Ltd<br/>Taylor Road, Trafford Park<br/>Urmston, Manchester, M41 7JQ<br/>Tel: 0161 707 9612<br/>E-mail: info@e3p.co.uk<br/>Website: www.e3p.co.uk</p> | | | |

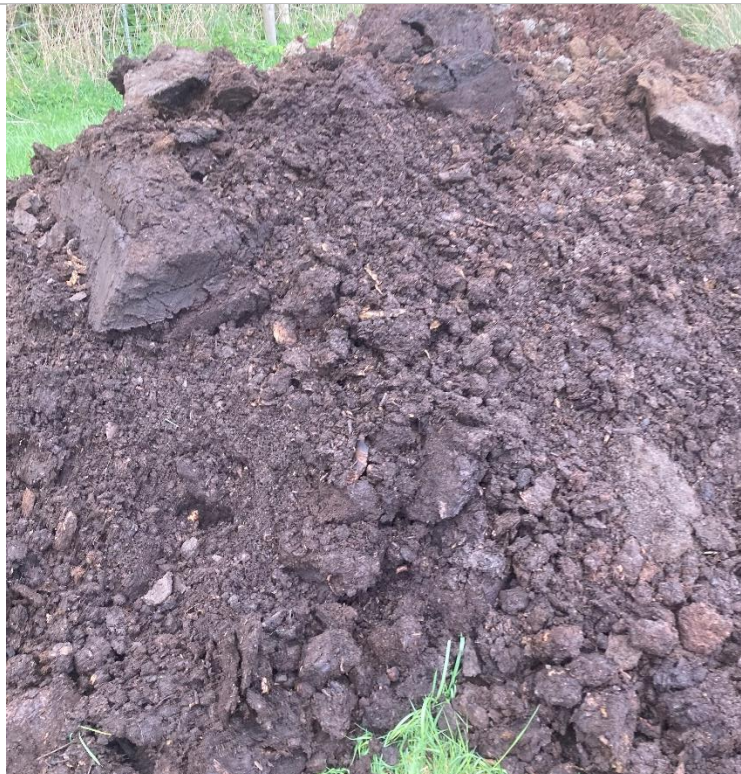
**PLATE 2**      **PEAT DEPOSITS IN TP126**

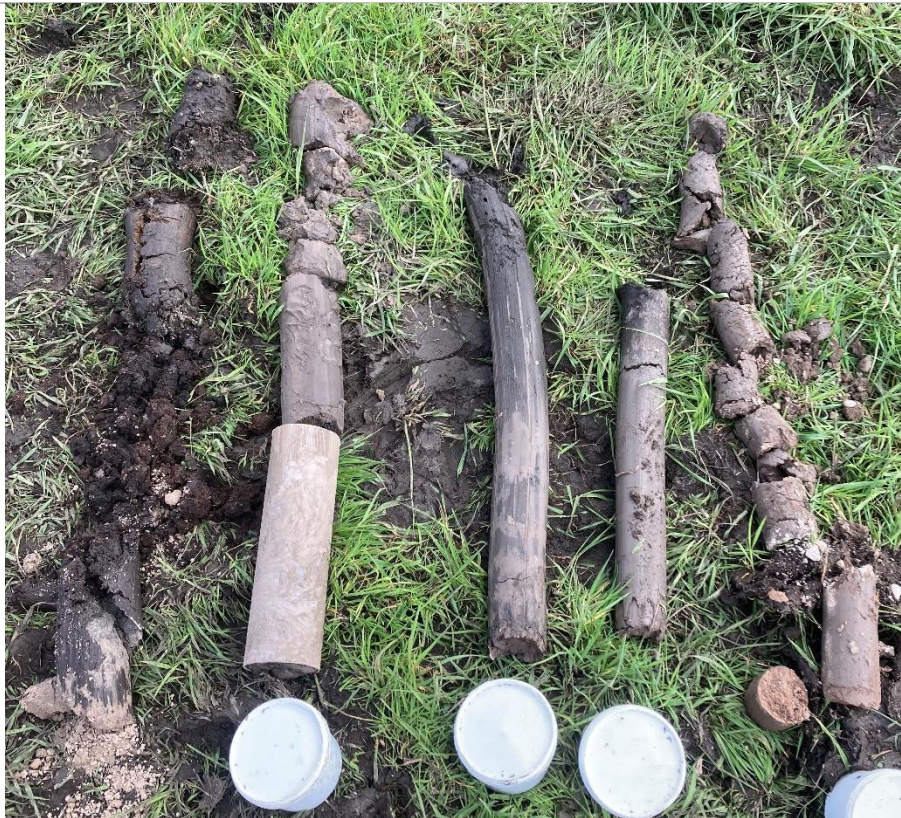
**PLATE 3**      **EXAMPLE OF CORE FROM WS107**

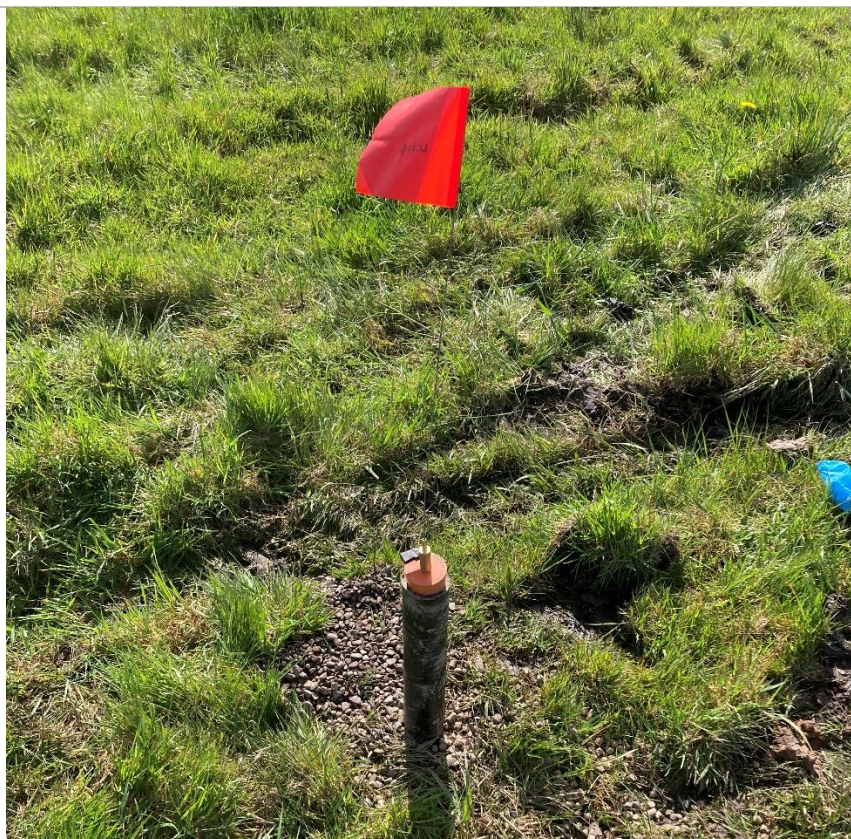
**PLATE 4**      **WINDOW SAMPLE MONITORING WELL**
