# **Pigeon Cote at Springbank Kennels, Birch Hill Lane, Wardle, Rochdale, Greater Manchester. OL12 9LZ**

## **Survey & Assessment in Respect of Bat Species, and Nesting Birds.**

### **Echo Calls Bat Surveys**

**19<sup>th</sup> July 2018**

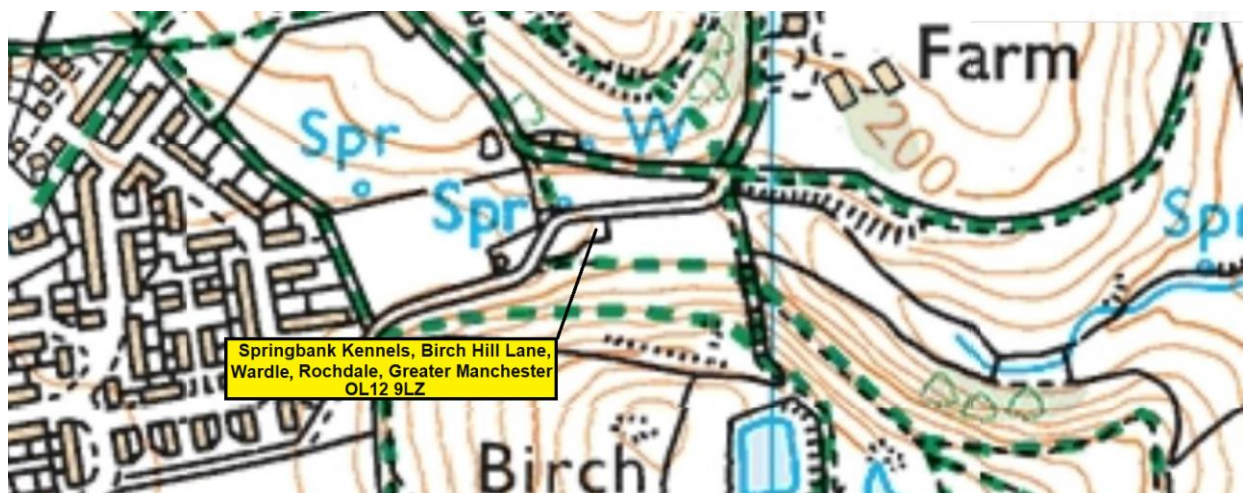
**Fig 1 - The Site Location**

The targeted building was situated along the southern edge of Birch Hill Lane in the Wardle area of Rochdale, and consisted of a pigeon cote, located amongst other buildings within the overall site perimeter. The land and buildings from now on are referred to as the “site”, at OS grid reference: SD 91888 16768, (refer to **Fig 1 - The Site Location**).

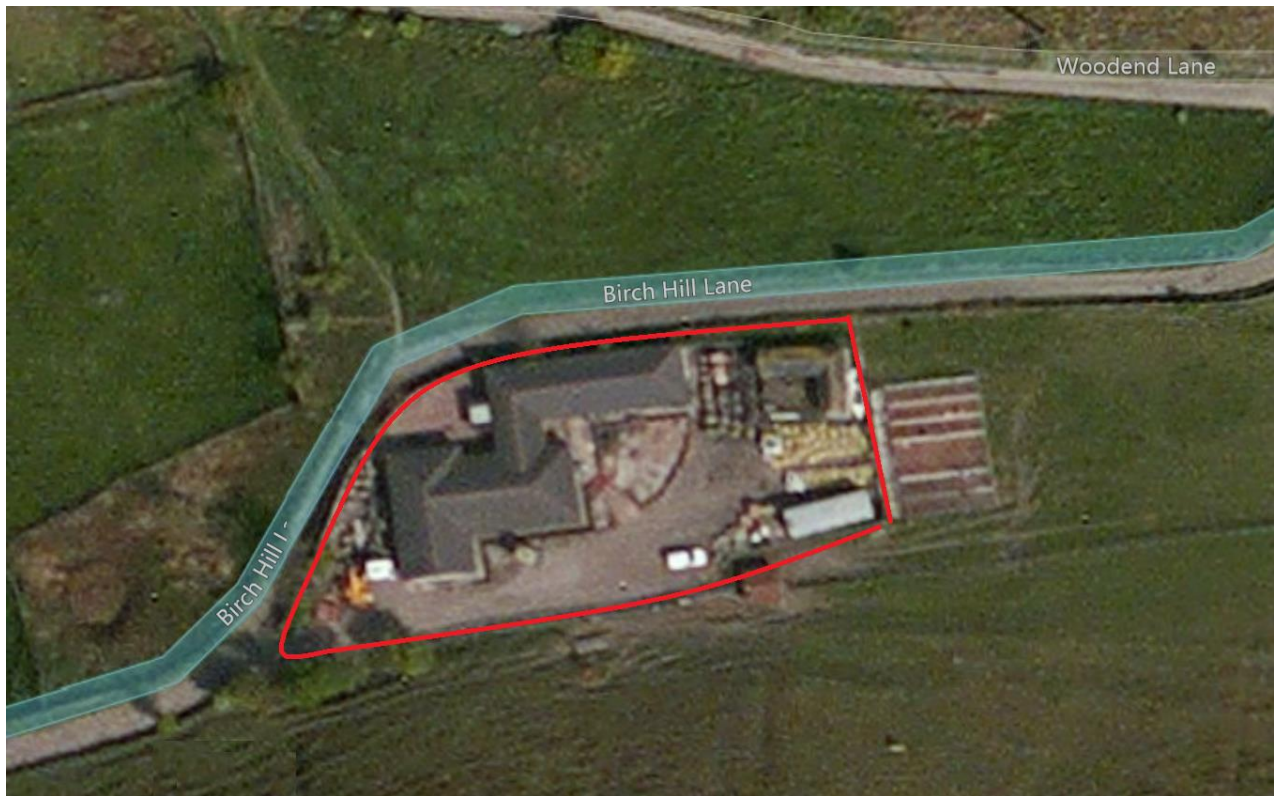
**Fig 2 – Google Plan**

Immediately surrounding the site on all sides, was a mixture of moorland and open rough pasture, containing a few semi mature trees and bordered by either walls, fencing, or by lengths of fragmented hedgerow. 0.22km away to the west, was the town of Wardle containing gardens with some shrubbery and small trees, whilst 0.19km to the south-east was a small reservoir, with a shelterbelt of mature trees, 0.1km to the east, (refer to **Fig 2 – Google Plan**).

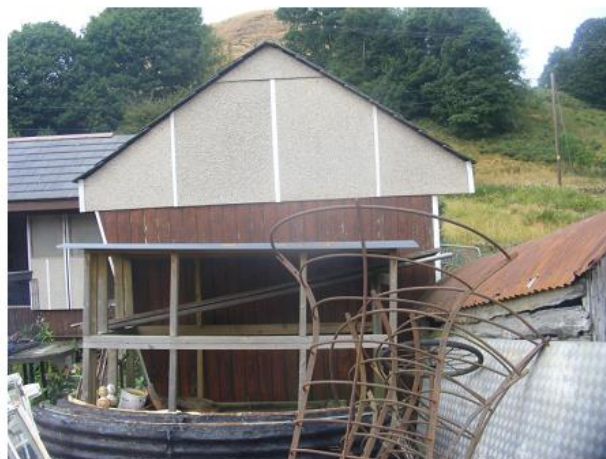
**PHOTO 8**  
**Eastern Gable of Pigeon Cote**

Also, due to the numbers of roosting pigeons, the interior of the cote was dirty, and noisy with birds being a constant disturbance. These things, together with the copious inclusion of light through the open doors and windows, reduced roosting opportunities within the building interior. Therefore, it was concluded the pigeon cote offered negligible potential as any type of bat roost, (refer to **fig 3** and **photos 1 to 11**).

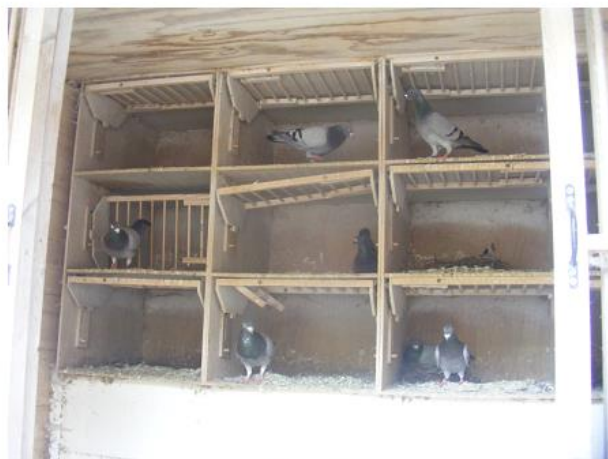
**PHOTO 11**  
**Typical View of Inside of Pigeon Cote**

The pigeon cote was a single storied, hipped building, constructed from a mixture of concrete and wooden panels, mounted on a timber frame. Along both south and western elevations were sliding door panels, which allow both people and pigeons to access into the interior. It had a pitched roof of underlined concrete tiles, but no roof void. The interior was made up of pigeon cages, mounted one upon another, totally filling the inside of the building.
