## Phase 1 GeoEnvironmental Desk Study

Mount Road

Middleton

**Report No. A5865/24**

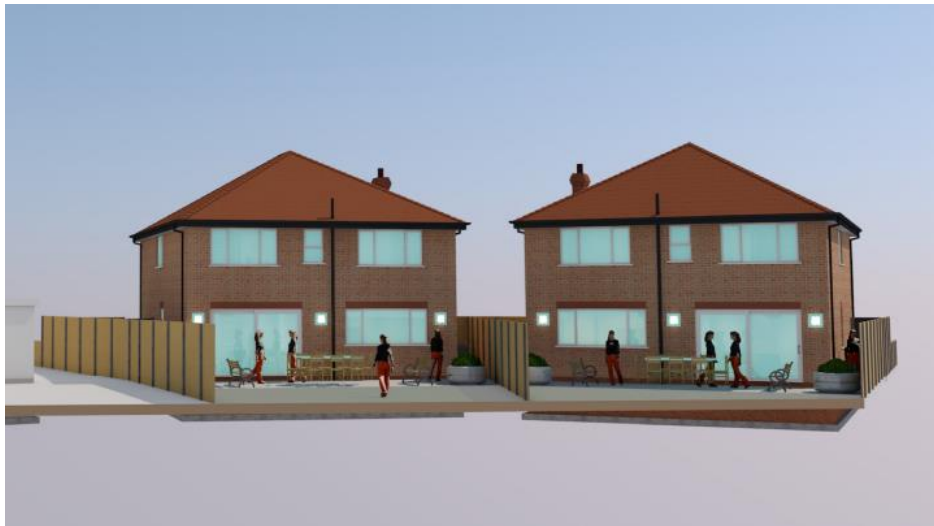
**Figure 1 Proposed Development Model**

- 1.1 Earth Environmental & Geotechnical Ltd has been commissioned by Mrs Margarita Pankovych (the client) to undertake a Phase I GeoEnvironmental Desk Study for the proposed residential development on vacant land on Mount Road, Middleton.
- 1.2 It is understood that the client wishes to construct two new detached residential dwellings with associated soft landscaping, parking, and boundary treatment.
- 1.3 A proposed development model for the site is shown in Figure 1 below.

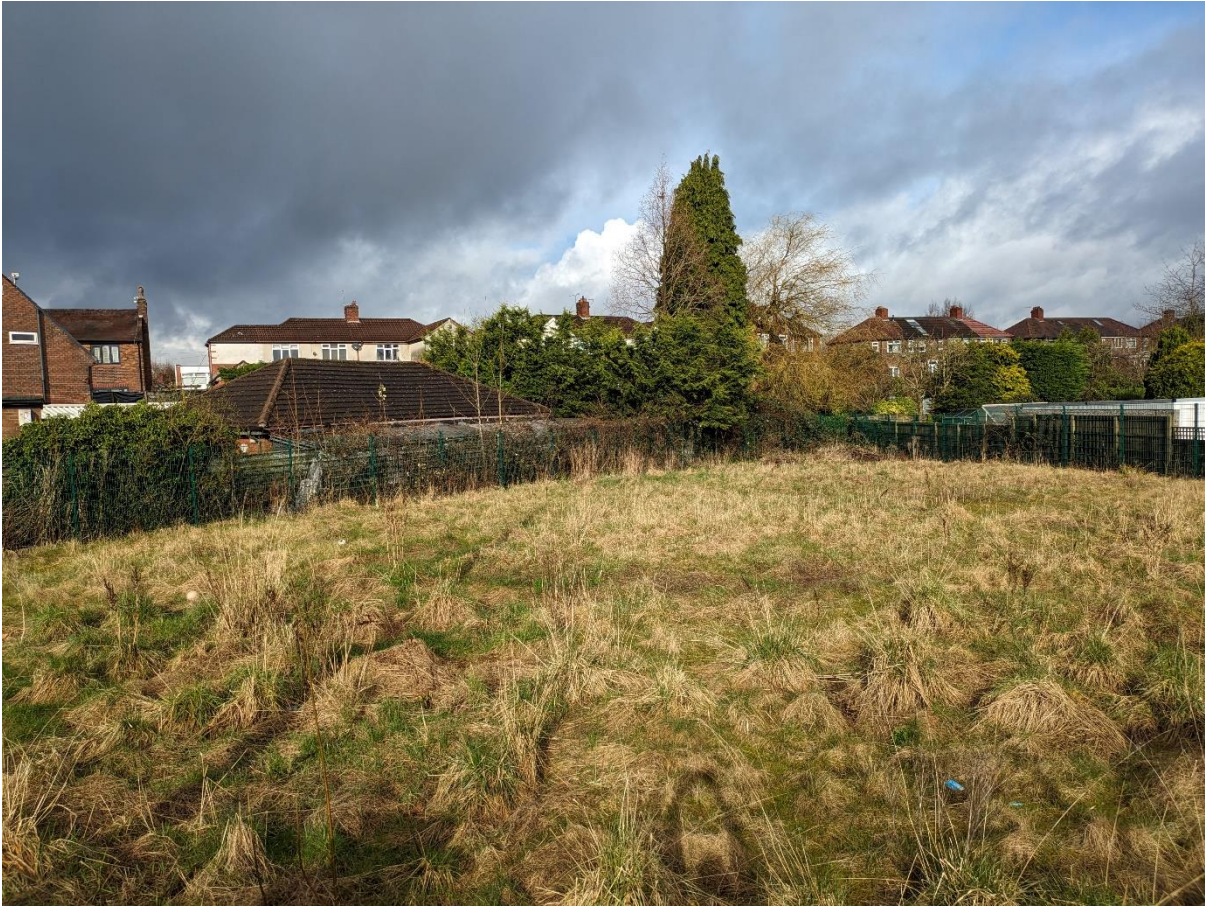
**Figure 3 Site Photograph**

- 2.3 The site is an irregularly shaped triangular parcel of land with current access from Mount Road. Currently the site is accessed through a locked metal gate.

- 2.4 The land is surfaced predominantly in grass vegetation and is generally flat lying but slightly undulating in the southern area. The site is bound by a mixture of metal and wooden fencing with commercial units directly adjacent to the west and a residential dwelling adjacent to the east.

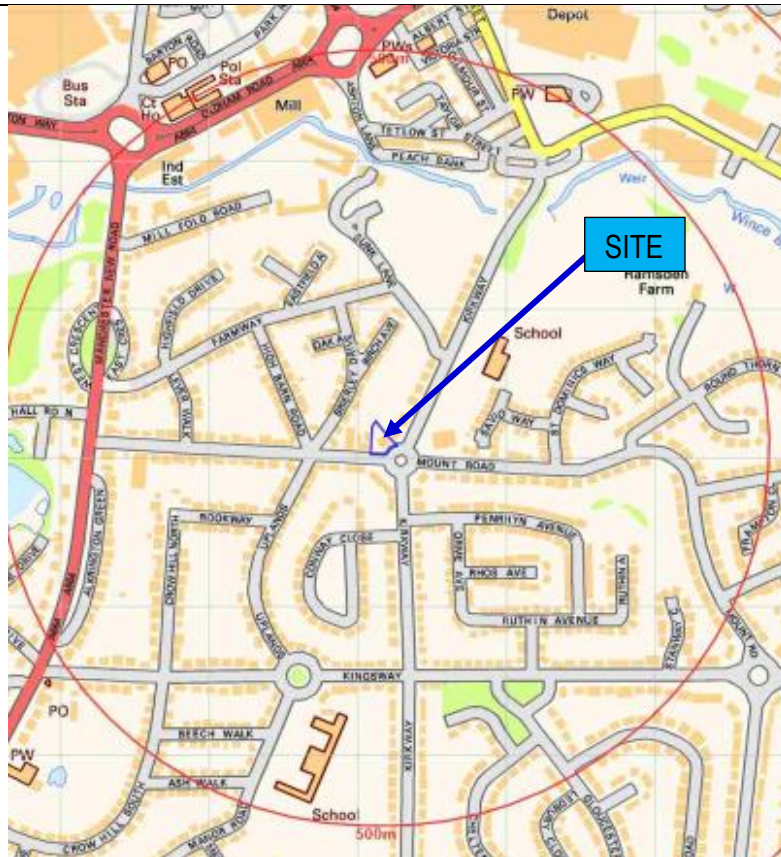
Figure 6 OS Map Extract 2001

| Date | On-Site History | Surrounding Land Use History |
|---|---|---|
| 2001, 2010<br>1:10,000<br><br>1992, 2003<br>1:1,250 | No Significant Change. | Secondary school no longer present on mapping records, replaced by residential property developments. |

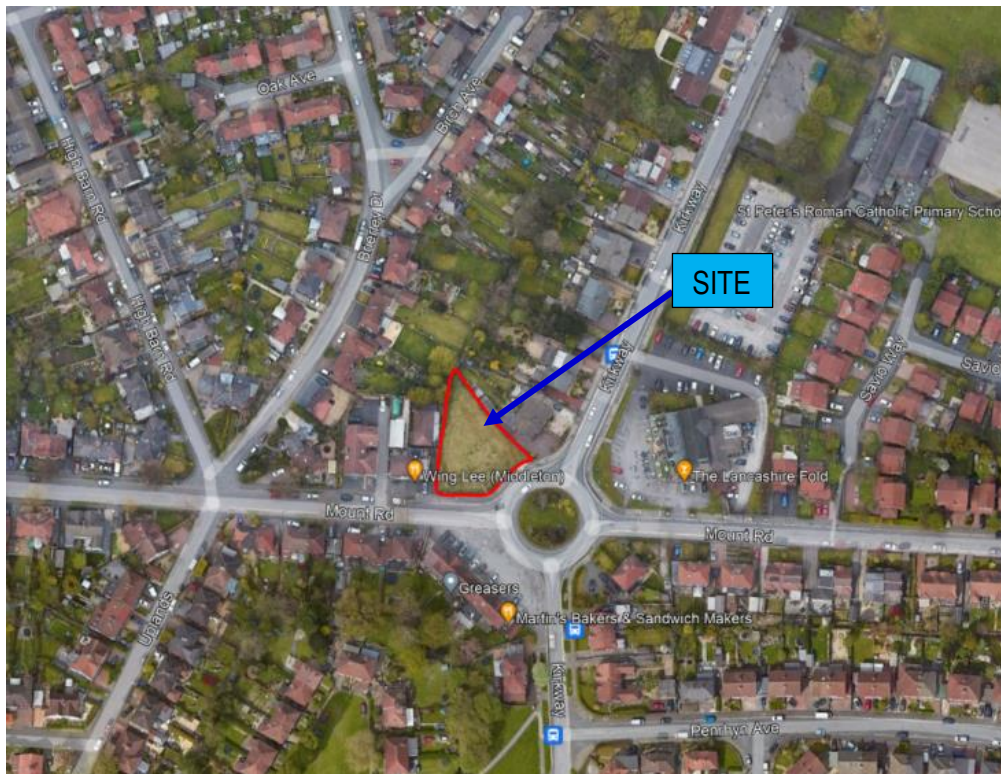
Figure 7 Aerial Photograph 2022

| Date | On-Site History | Surrounding Land Use History |
|---|---|---|
| 2024<br>1:10,000<br><br>2020, 2021.<br>2022, 2023<br>Google Earth<br>Satellite<br>Imagery | Building developments no longer present onsite. | No Significant Change. |

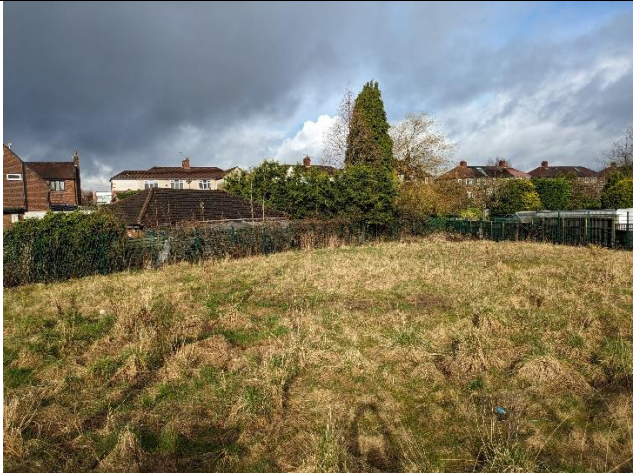
| <p><b>Plate 1 Photo across site viewing north</b></p> | <p><b>Plate 2 Photo across site viewing west.</b></p> |

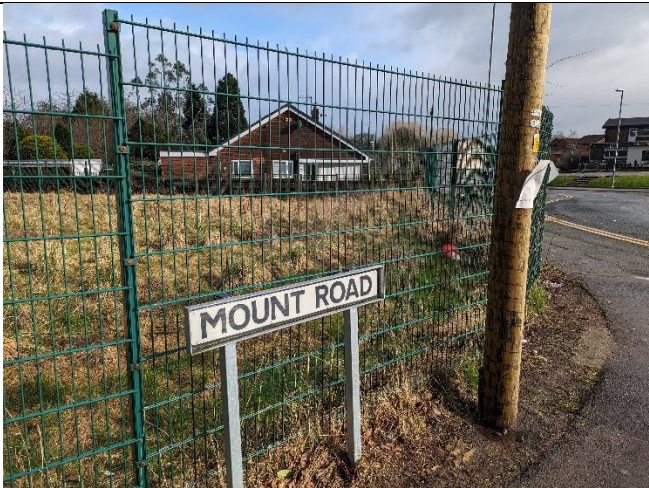
- 5.5 Fly tipped litter was observed along the southern fence of the site, including black bin bags with general household waste.
- 5.6 The site is bound predominantly by metal fencing across all borders, with an access gate along the southern fence line. Immediately adjacent to the site to the east is a residential property and to the west, a commercial unit.

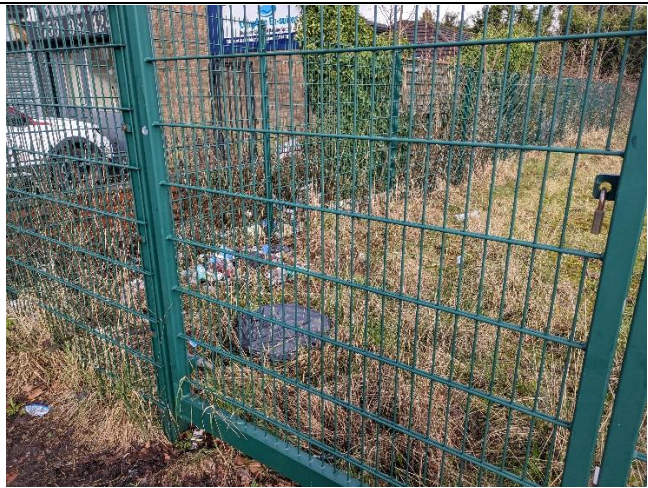
| <p><b>Plate 3 Photo of Mount Road signpost adjacent to the southern fence border</b></p> | <p><b>Plate 4 Photo through access gate of fly tipped litter</b></p> |

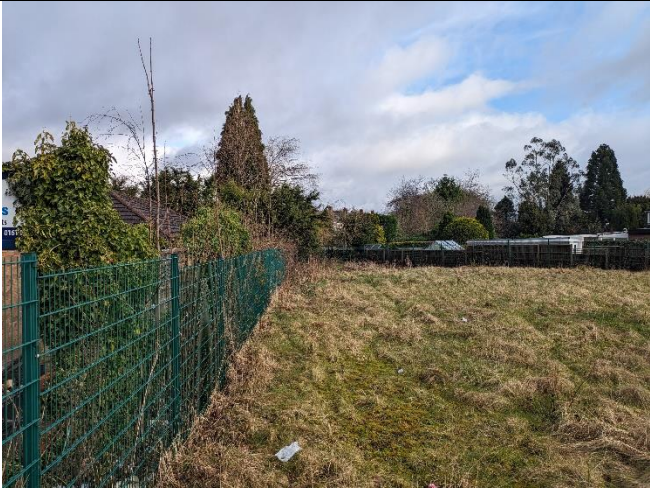
| <p><b>Plate 5 Photo along western border looking north</b></p> | <p><b>Plate 6 Photo of southern boundary fence</b></p> |

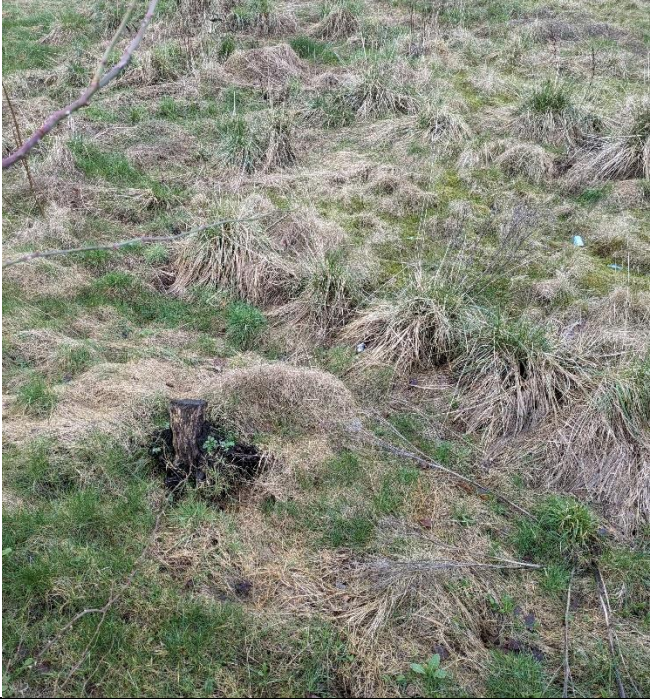
| <p><b>Plate 7 Photo of tree stump in southern area of the site.</b></p> | <p><b>Plate 8 Photo along southern boundary looking east.</b></p> |
