Remediation Strategy & Deployment Plan

Development at Greenhill Road, Middleton

Site Ref: 6127/VGH-RSDP v1.00

Remediation Strategy and Deployment Plan

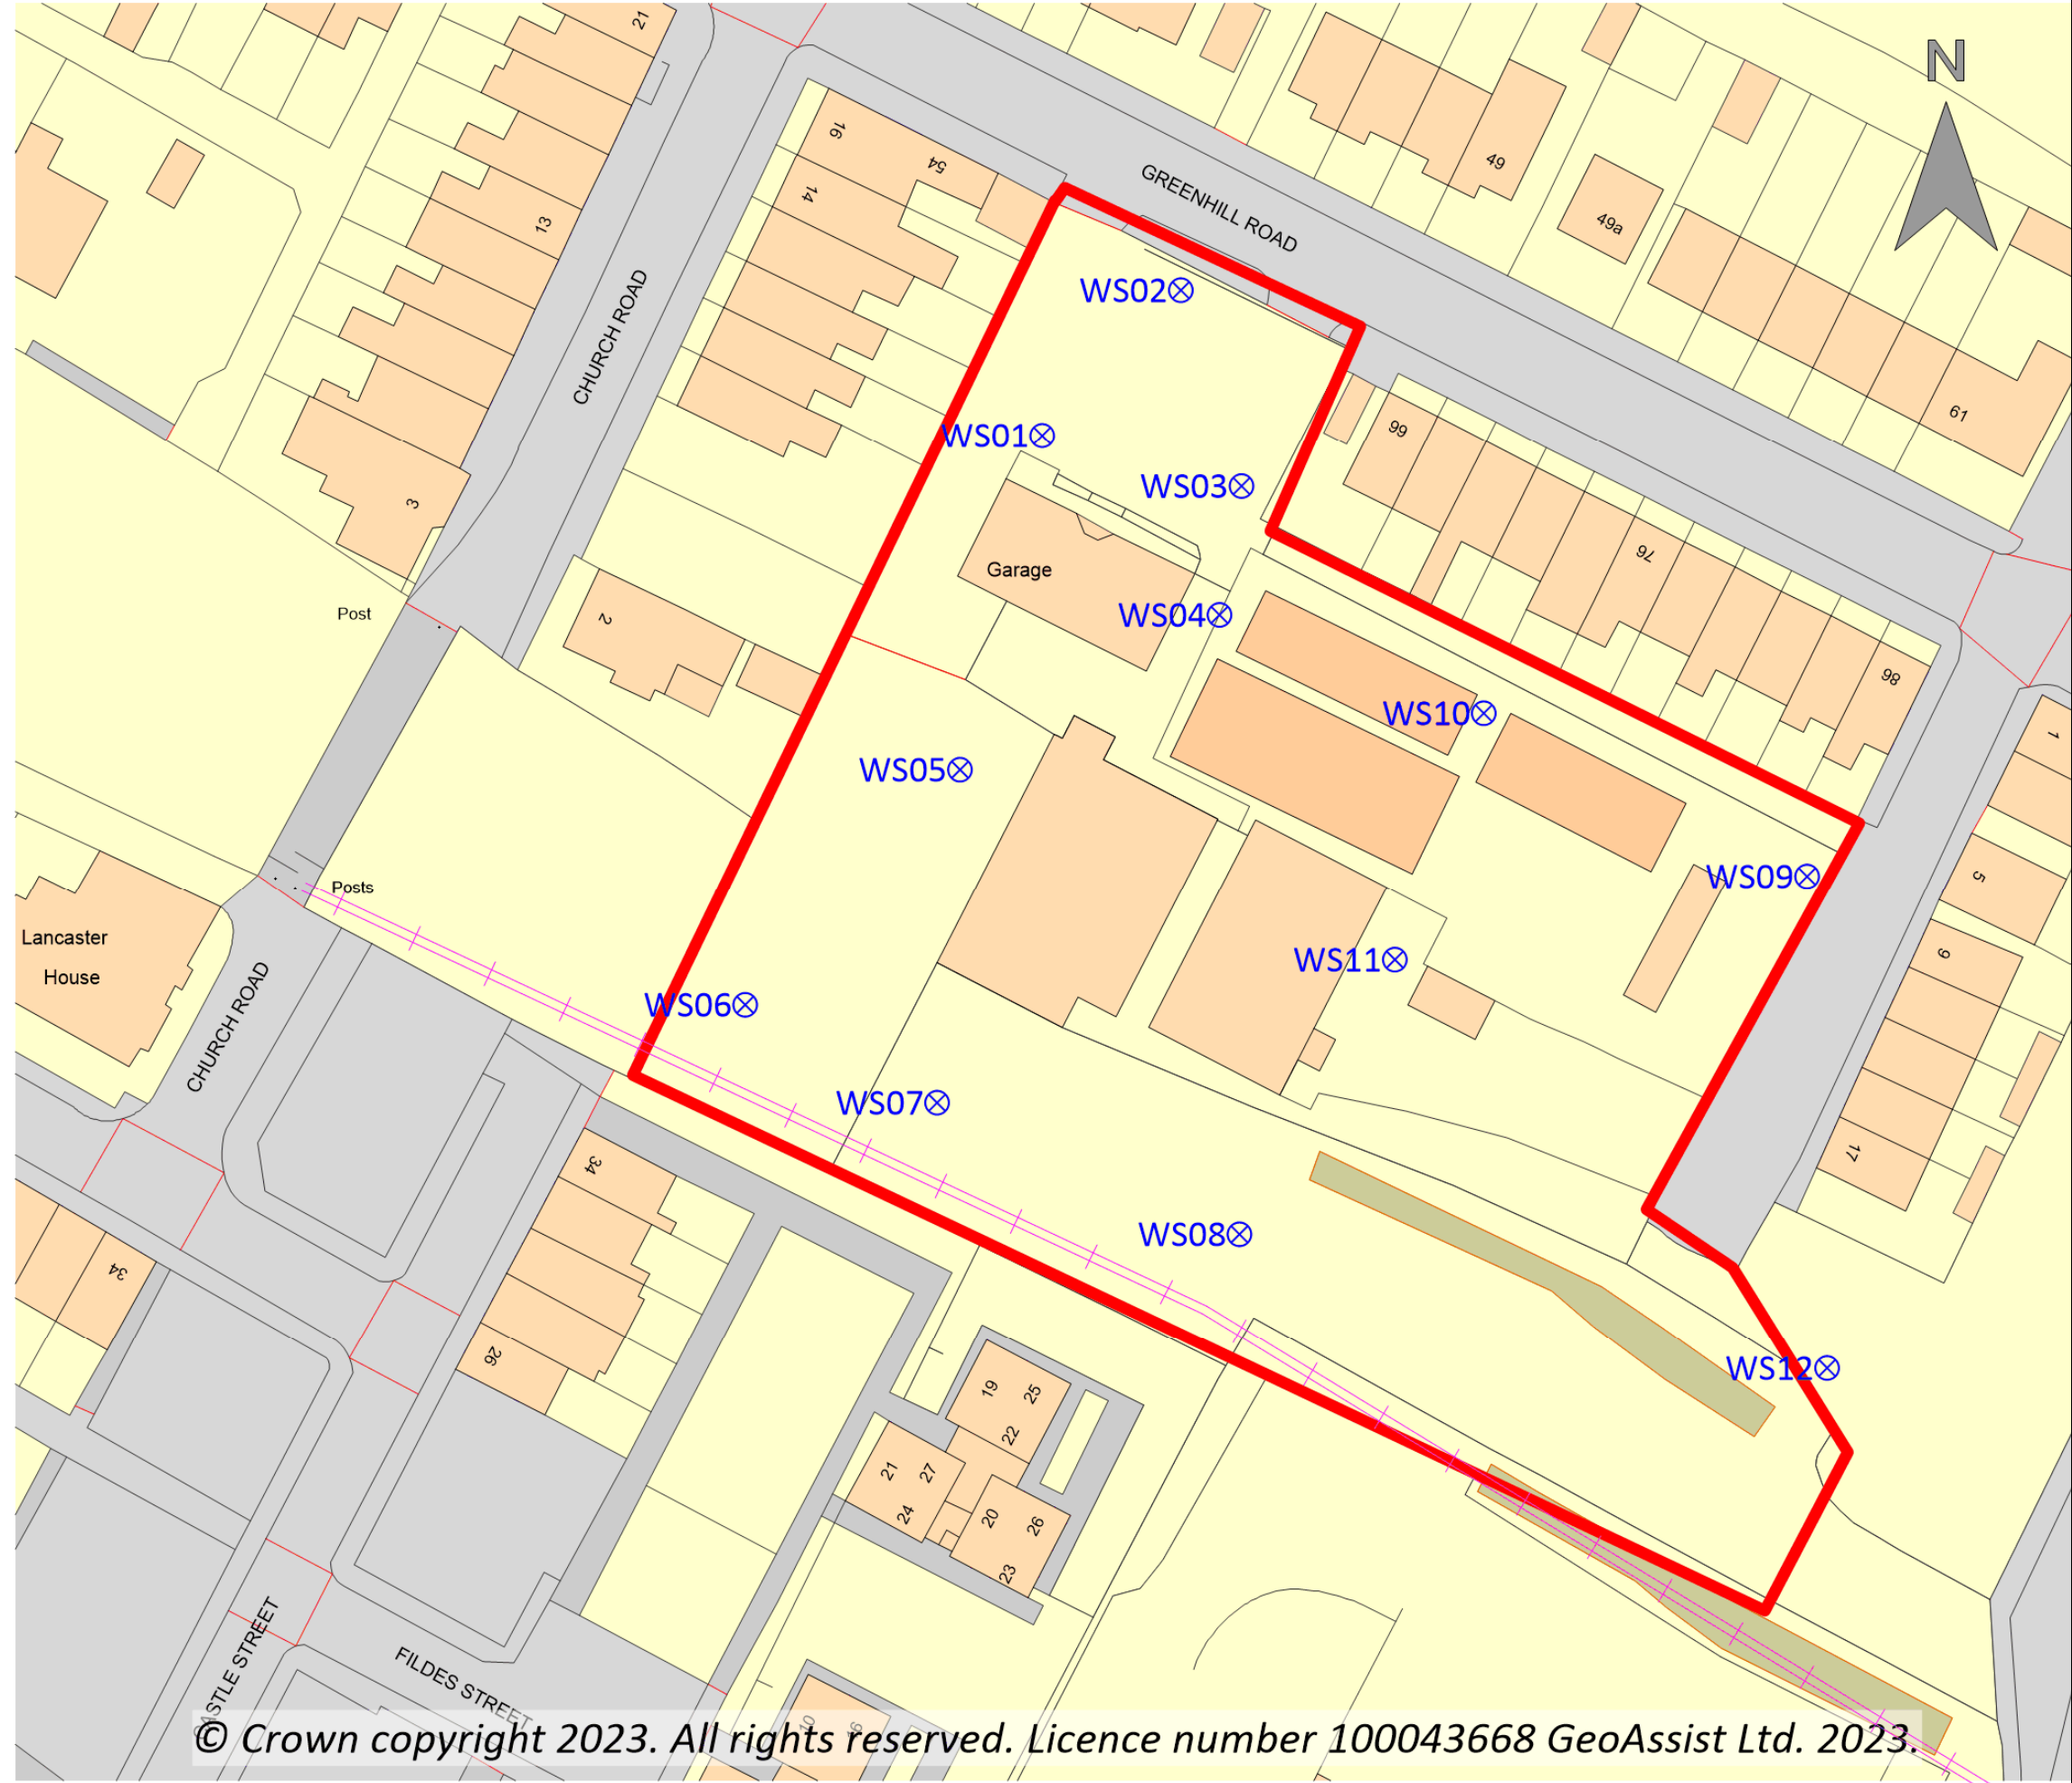
# A1 Site Plan

The approximate grid reference for the centre of the site is 388610, 405180 and the total area of the site is approximately 6,200m<sup>2</sup>. The approximate area of the Site is outlined with a solid red line on the Site plan in Appendix A1. The positions of exploratory holes are also indicated on the plan.
