**TACK LEA WORKS  
BURY**

**PHASE 1 PRELIMINARY  
RISK ASSESSMENT,  
GEO-ENVIRONMENTAL  
INVESTIGATION AND  
RISK ASSESSMENT**

Date: 18<sup>th</sup> August 2022  
Ref: CL-602-LKC 16 1018-02

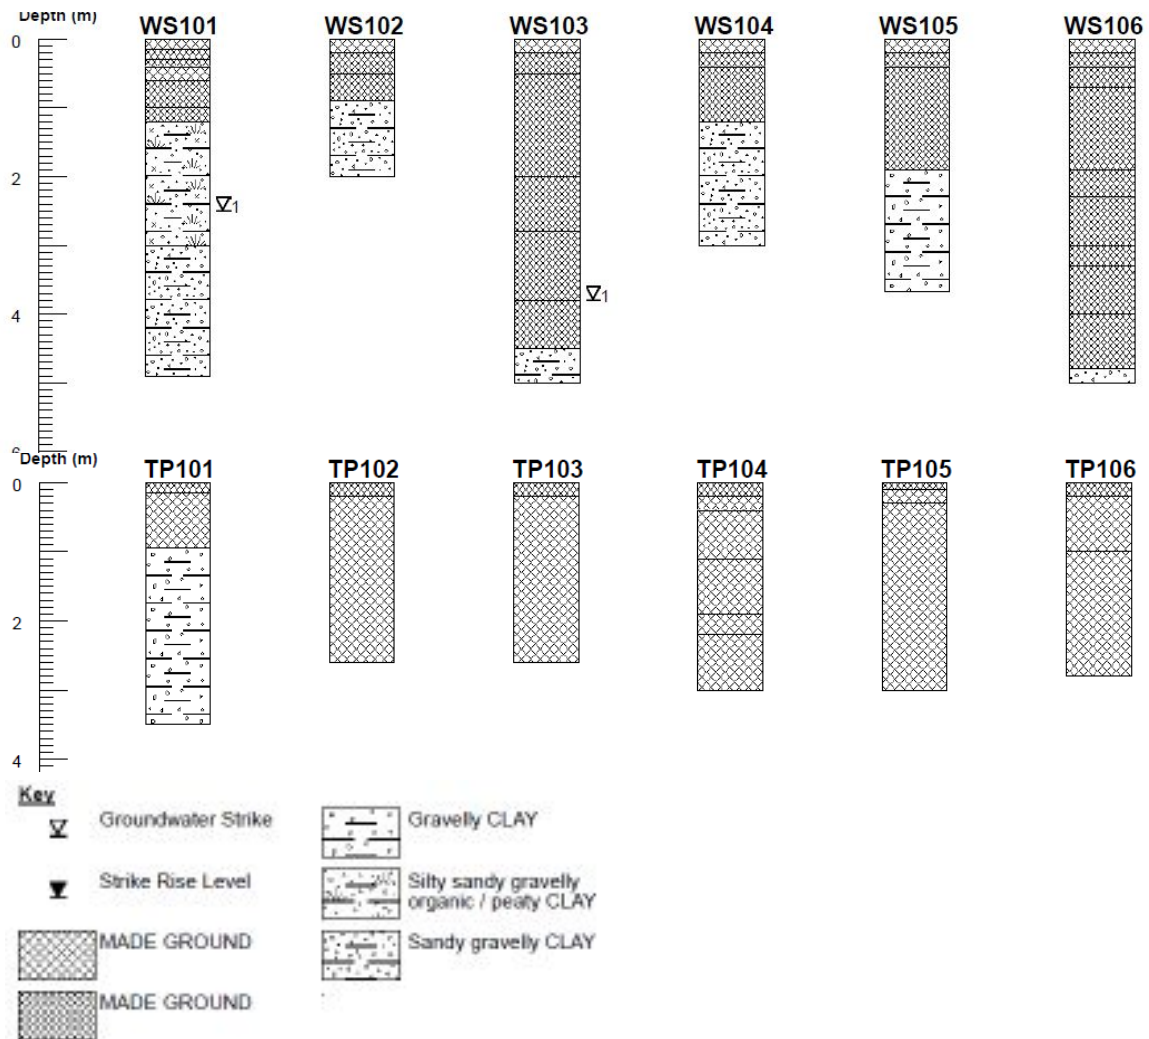
Plate 7-1: Summary of ground conditions.

The ground conditions beneath the site comprised made ground underlain by natural sandy gravelly clay. A summary section of the logs are provided in Plate 7-1, with additional comments below.

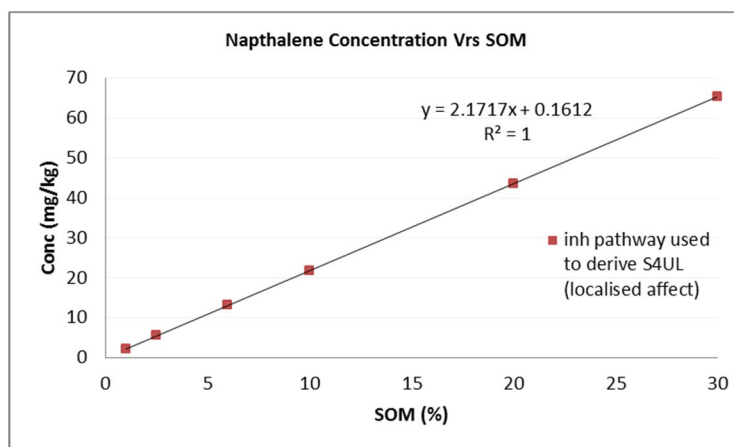
Graph 8-1: Naphthalene vs SOM

There is a linear relation ( $r^2 = 1$ ) between Naphthalene and SOM concentrations (see Graph 8-2).

The modified assessment criterion for naphthalene is calculated as 41mg/kg, when using the above formula.

Naphthalene was elevated in WS103 (2.8 m) at a concentration of 280mg/kg. The SOM value for the sample is 19%.
