# **Wicken Hall Mill, Ogden Lane, Newhey**

## **Phase 1 Geo-Environmental Investigation**

For: Leigh Kelly

Ref: 3865-01  
Job: 3865  
Rev: A  
By: AS

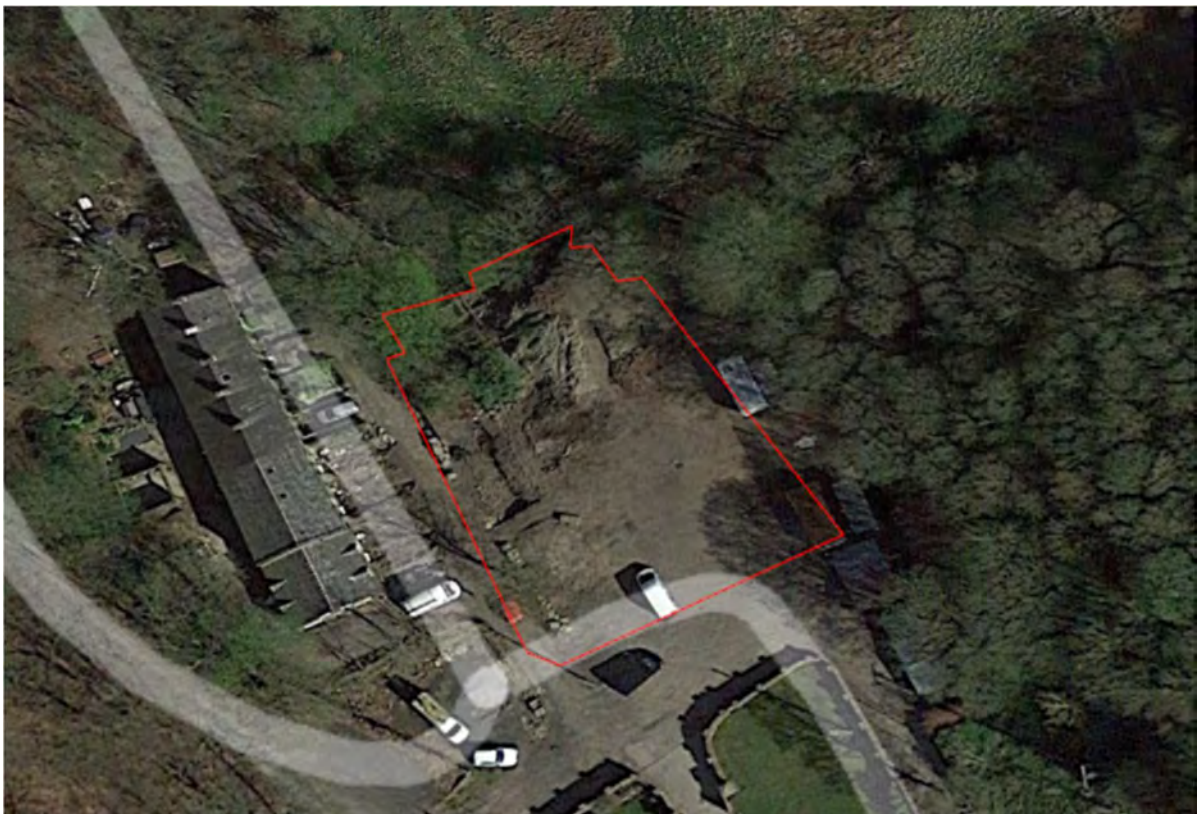
The site currently comprises derelict land, with on-site private cabins and established trees along site boundaries. The site is bound by established trees to the north and east, industrial and agricultural buildings to the southeast and an access road to the west and south. Access to the site is off the local access road in the south of the site. An aerial photo of the site is included below:

*Figure 1: Aerial image of the site dated April 2021.*

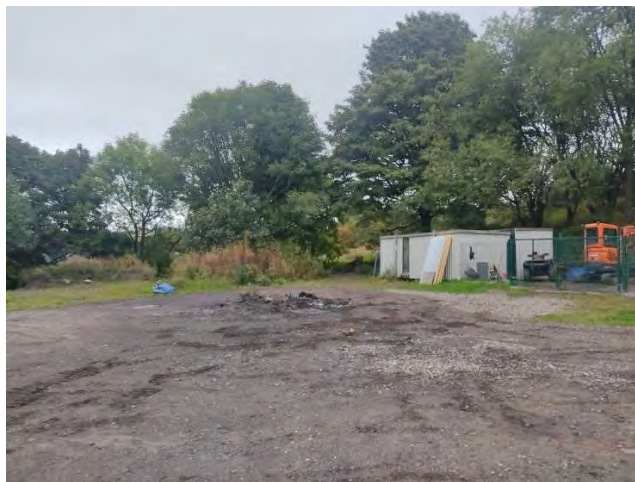
The site currently comprises derelict land, with on-site cabins and established trees along site boundaries. The ground underfoot was noted to be Made Ground across the site, with some areas of grass and shrubbery, mainly in the north and north-east site sections. Established trees are noted along the northern and eastern site boundaries. Numerous portable cabins are present in the eastern and south-eastern site sections, some noted to be used as a dog kennel with an area of palisade fencing noted around the cabins.

*Figure 2: Photograph showing the extent of the site, looking north.*

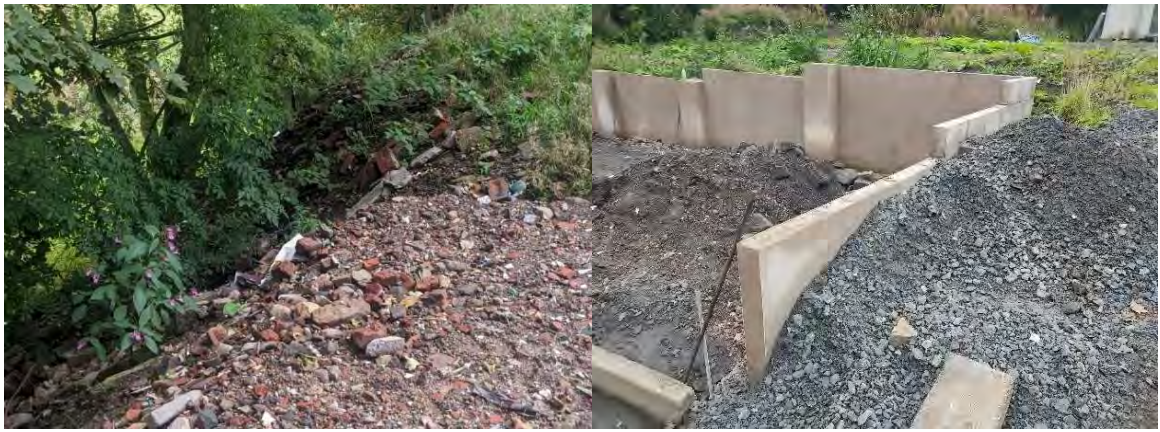
The topography of the site gently falls from c. 232m in the eastern site section to c. 230m AOD in the northern site section, before steeply sloping down towards the northern boundary to c. 223m to the north of the site. A c. 10m tall man-made slope (1:1 gradient) partially formed by a retaining wall is present in the northern site section and along the northern boundary. A densely vegetated natural slope (c. 1:2 - 1-3) is also recorded along the eastern boundary forming the valley wall bearing signs of suspected past landslips and land movement. A second retaining wall approx. 2m tall, was noted along the western site boundary, constructed to form car parking bays along the western site boundary.

Figure 3: Photographs showing the topography of the northern site section dropping off steeply, looking northeast (left photo) and of the 2m retaining wall along the western boundary (right photo)

| <b>Slope Stability</b> | Steep slopes are present on-site, including a 1:1 c. 10m tall man-made slope along the northern boundary. And a natural c. 1:2 - 1:4 slope forming the valley walls along the eastern boundary. | A relatively rapid outward and downward movement of a mass of rock or soil on a slope due to the force of gravity. Typically slope instability is caused by either a decrease in soil strength or an increase in shear stress. Numerous factors are involved but usually loading on or at the crest of the slope, increasing the amount of water entering the slope or cutting at the toe of the slope cause failure. Damage by landslide can occur through the removal of supporting ground from under structures, externals or services or by the movement of material onto property. | <b>High</b> |
| <b>Retaining Walls</b> | There are 2 No. distinct retaining walls along the northern and western site boundaries. The northern wall is approx. 6m tall with a 1:1 slope above and either side. The western wall is approx. 2m tall and appears to be newly constructed and in good condition. | The retaining wall will need to be inspected and remedial measures undertaken prior to development, subject to an assessment of the impact upon Third Party assets. | <b>Moderate</b> |

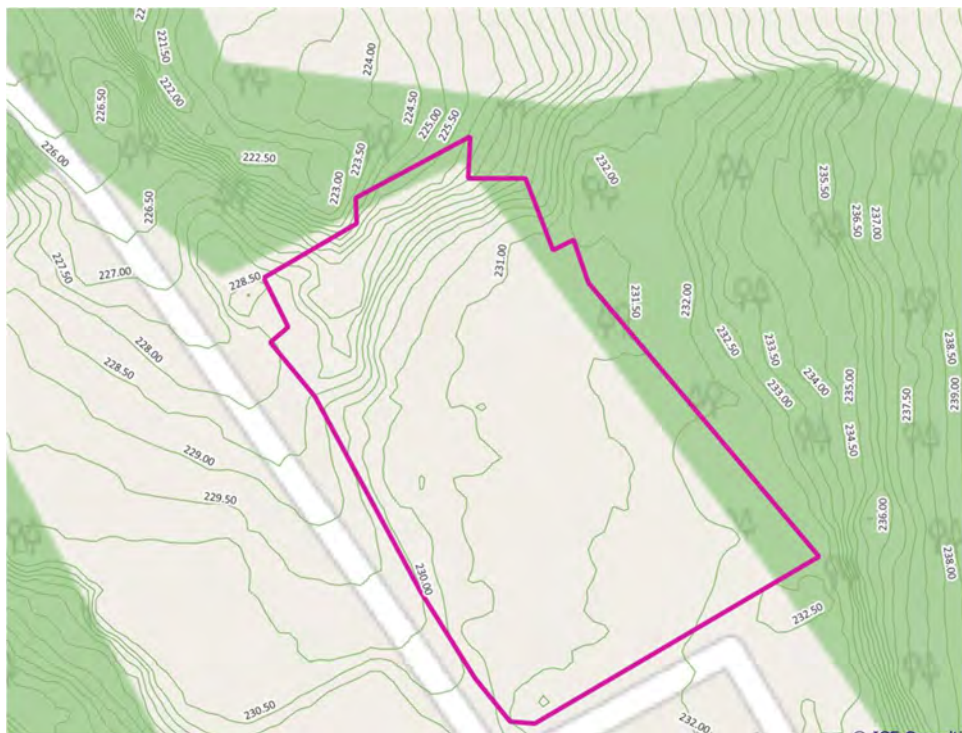
A contour plan based on the 1m DTM LiDAR data is included below for reference, showing the locations of the slopes mentioned above

Figure 4; Extract of the LiDAR Plan showing the site topography and slopes to the north and east of the site.

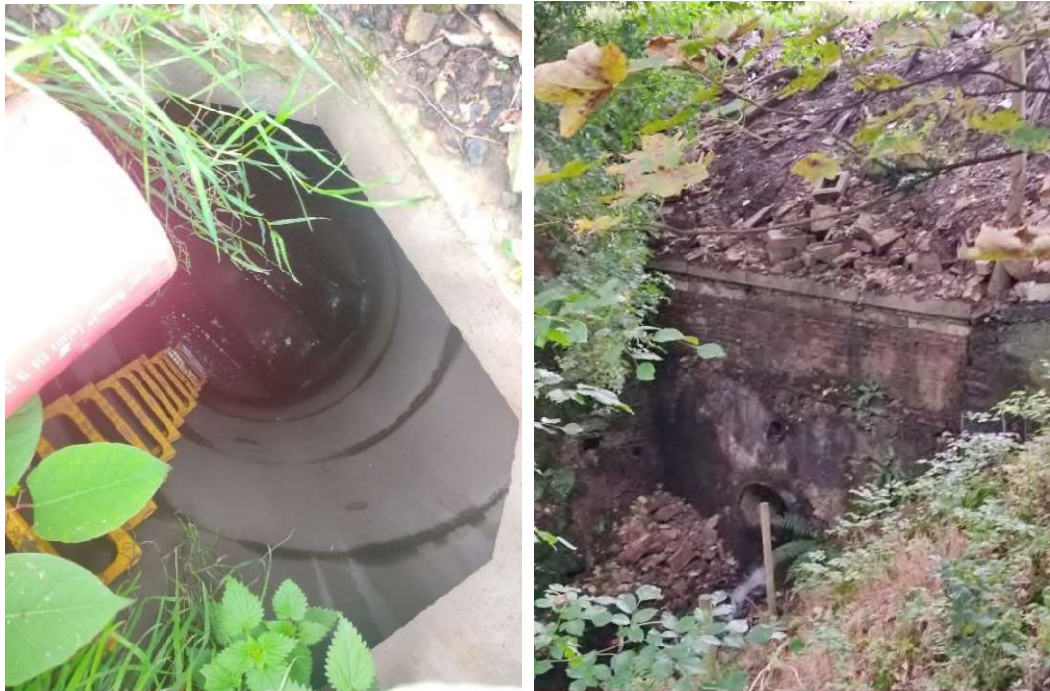
A culverted stream has been noted in the western site section, oriented NW-SE. The water level was recorded at 6.10m below site surface, the base of the culvert could not be determined during site walkover. A retaining wall is present at the northern terminus of the culvert, with a steep slope above it, indicating past significant upfill of the site. Anecdotal evidence suggests that the culvert has been diverted in recent

years to facilitate the development of residential dwellings to the south if of the site, therefore the route in the southern site section may have changed.

Figure 5: Photographs showing the culvert access point on-site in the western site section (left) and the northern retaining wall where the culvert ends (right).

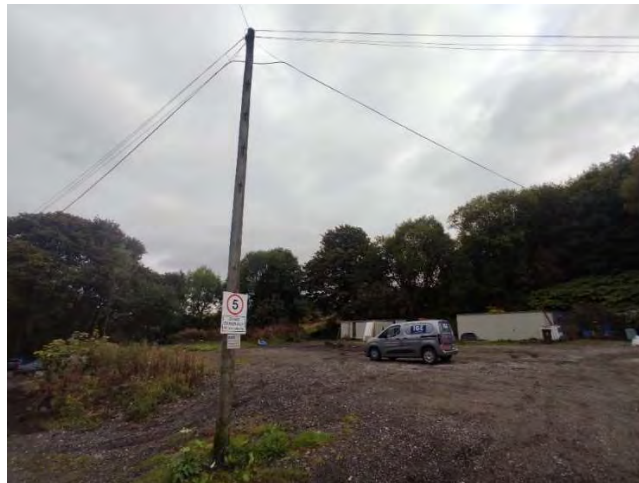
Overhead power cables were noted along the western and southern site boundaries. A few manholes were also recorded, one in the western site section, associated with the culverted stream, as well as in the eastern site section.

Figure 6: Photograph showing the overhead electricity lines in the southwestern site corner, looking northeast.

Overhead power lines were noted along the site boundary in the south-western corner and a deep culvert is present in the western site section, running parallel to the western site boundary, oriented N-S, the approximate locations of both features are noted on the Site Features Plan, contained in Appendix 8, full service plans should be obtained prior to any intrusive works.

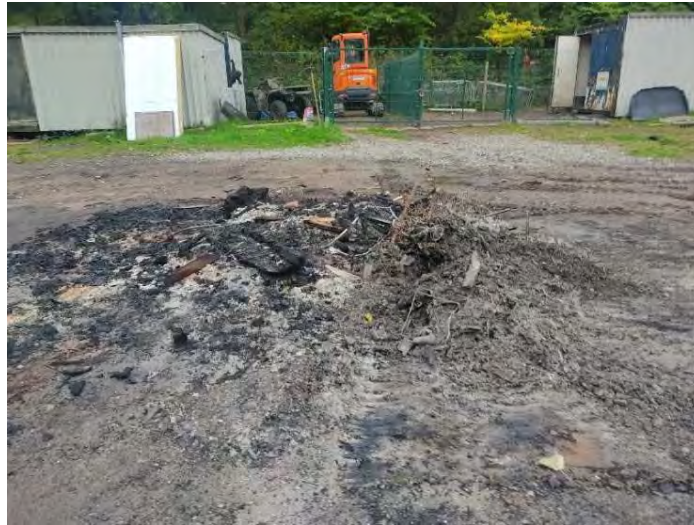
Evidence for the burning of materials was noted on-site, potentially acting as a contaminative hotspot in the centre of the site. The contents of the 2 No cabins found

on-site are unknown, however, one of them was noted to be used as a dog kennel. No other significant contaminative sources were noted on-site (i.e. tanks).

*Figure 7: Photograph showing the possible contaminative hotspot in the centre of the site, looking east.*

| Potentially Contaminative Source | Associated Determinands | Remarks | Risk |
|---|---|---|---|
| <b>On-Site Made Ground Including On-Site Possible Historical Refuse Heap/Site Upfilling (1909 – 1930)</b> | Unknown, anticipated to be metals, semi-metals, PAHs, TPH, asbestos.<br><br>Ground Gas – carbon dioxide, methane, hydrogen sulphide, VOCs | Made Ground is present on-site and is anticipated to be very deep (possibly c. 7m bgl based on culvert depth).<br><br>Historical evidence of raising levels or significant upfill is noted as well as evidence of burning of materials on-site. Therefore, based on the above and the historic al site uses significant contamination may be present.<br><br>A refuse heap has been recorded on-site in the early 20 <sup>th</sup> century, no longer identified on the records following the industrial development of the site, anticipated to be infilling of the site to raise the site levels. Widespread contamination as well as contaminative hotspots may be present within the material. | <b>Moderate to High</b> |

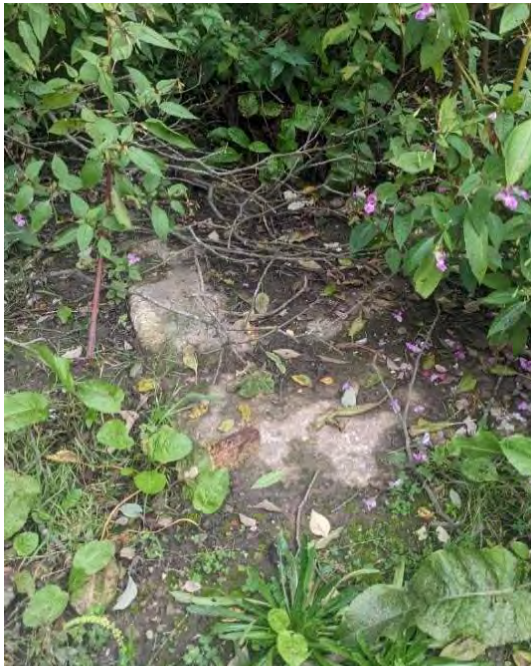
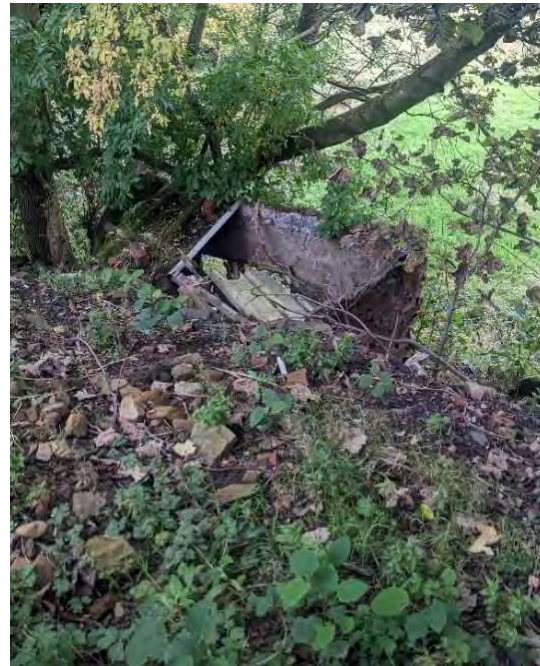
The remnants of the historical industrial buildings are present on site and could potentially influence the future on-site developments. The most notable features are present in the northern site section where a small brick building of unknown use is present. Evidence of possible subterranean concrete construction were also noted, possibly former floor slabs or foundations and walls.

*Figure 8: Photograph showing the remnants of historical structures: a concrete floor slab (left) and an unknown rectangular structure in the northern site section (right).*

| <b>Ground Obstructions</b> | Former building slabs, foundations, tank bases may still be in place, evidence of cobbles and boulders noted during walkover as well as relict masonry buildings. The Wicken Hall Clough stream culvert is known to have been rerouted during development of adjacent houses. | May act as obstructions to excavations and / or the chosen foundation solution or act as 'hard spots' within the ground if left in-situ. | <b>Moderate</b> |

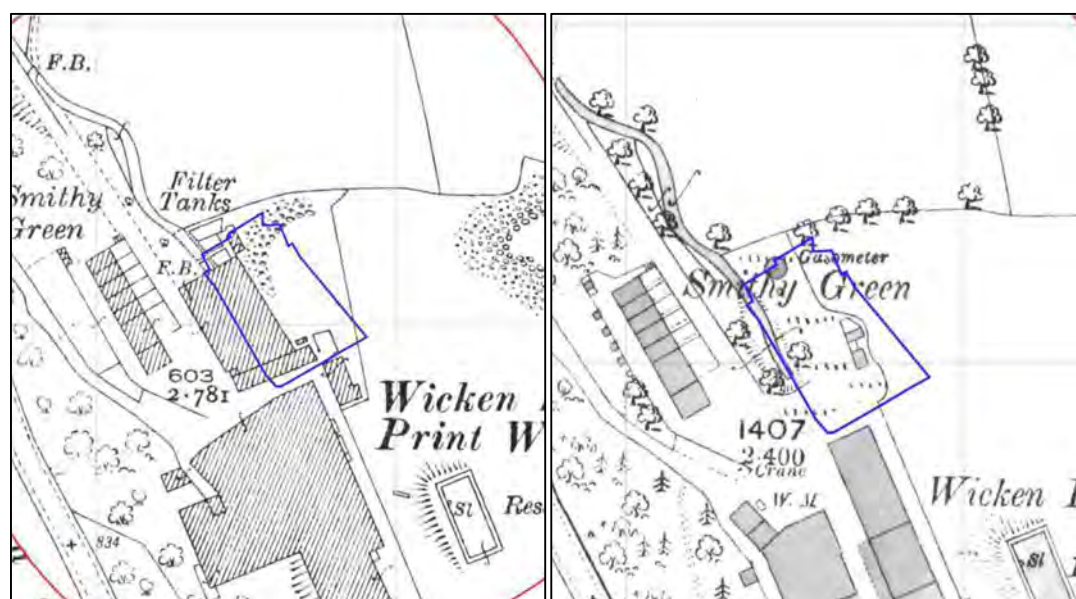
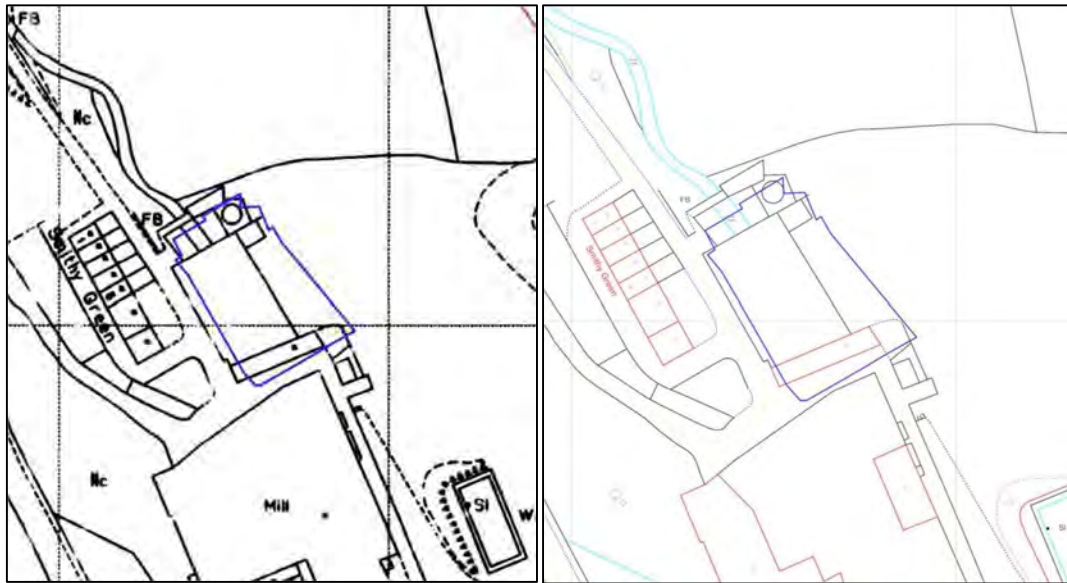
| Date | Site Feature |
|---|---|
| 1851 – 1888 | On the earliest historical map, the site is recorded as a field in the Higher Ogden village with unspecified buildings present in the middle site section, recorded from 1888. An unnamed stream is noted to run along the western site boundary, which appears to be culverted under the site. |
| 1888 - 1909 | A gasometer is recorded in the northern site section, later recorded as a tank. Filter beds and/or tanks are also noted in the northern site section. |
| 1928 – 1992 | A building which is a part of the Wicken Hall Print Works is present on-site from 1928, with the main print works buildings located to the south, recorded as an unspecified Mill since the mid-1960s. Filter tanks are noted in the northern site section near the gasometer. The former gasometer is no longer recorded. The evidence for site uplift/refuse tip is not recorded from 1930 following site development. |
| 1992 – Present | The building associated with the Wicken Hall Print Works is no longer recorded on-site. Unknown buildings are recorded in the southern site section, not noted after 2003. The site appears to have remained relatively unchanged since. |

Figure 9: Extracts of the OS historical maps dated 1892, 1930, 1992 and 2003 from left to right, top to bottom

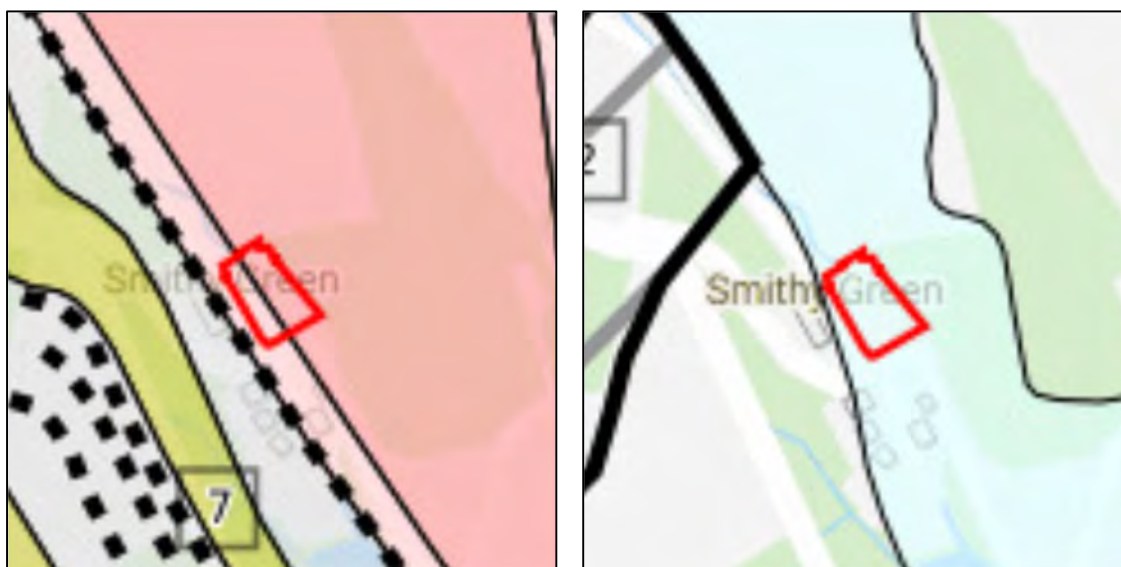
The BGS 1:50,000 Solid and Drift Geological Maps of the area (Sheet No: 76, both dated 2008) indicate that the site is underlain by superficial deposits comprising **Glacial Till** which typically comprises a heterogenous mixture of clays, sands and gravels. The superficial deposits are underlain by variable bedrock. The majority of the site is underlain by bedrock of the **Rough Rock**, comprising coarse, cross-bedded sandstone. The westernmost site section along the western site boundary is underlain by Rossendale Formation, comprising mudstone and siltstone.

Figure 10: Extracts of the BGS 1:50,000 Drift (left) and Solid (right) Geological Maps. Light blue = Glacial Till, Dark Pink = Rough Rock, Light Pink = Rossendale Formation, Black Dotted, Grey and Green = Pennine Lower Coal Measures Formation

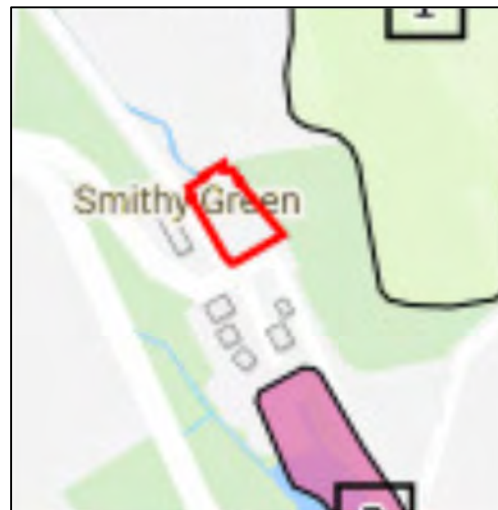
The BGS geological maps record worked ground within 50m of the site (pink on the below extract), anticipated to be associated with the construction of the reservoirs to the south of the site. An area of worked ground / void is also recorded to the north of the site (light green on below extract).

Figure 11: Extract showing the location of the infilled ground (light green) and worked ground (pink)

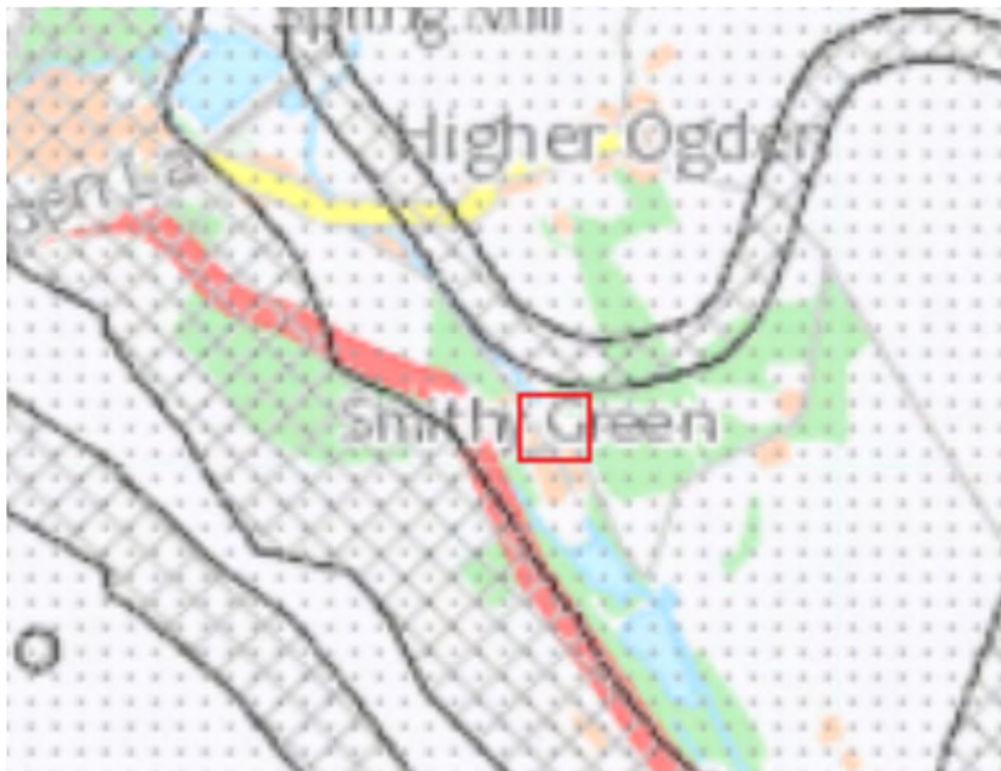
The site lies within a Coal Authority Coal Mining Reporting Area. There are no outcrops, mine entries or development high risk areas recorded on-site, however, a coal seam, suspected to be the Margery Coal, outcrops 70m west from the site, which continuous along the hillside to the south and east of the site, an extract of the BGS 1:50,000 geological map is included below. Development High Risk Areas also exist to the east and west in the vicinity of the site and are associated with the nearby coal outcrops.

Figure 12: Extract showing the location of the near Development High Risk Areas associated with the outcropping coal seams within approx. 80m from site.

Consequently, based on the above information, the Sand Rock Mine may be present beneath the site. Although the coal seam is thin and is not considered to be of significant value in the area, there is potential for the coal to have been worked (i.e. through daypits) if present at shallow depth. It is recommended that intrusive works including rotary open holes are undertaken to determine the presence or absence of coal seams and associated workings at shallow depth beneath the site or

consideration of possible ground instability is factored into the foundation design i.e. use of full stiff rafts.

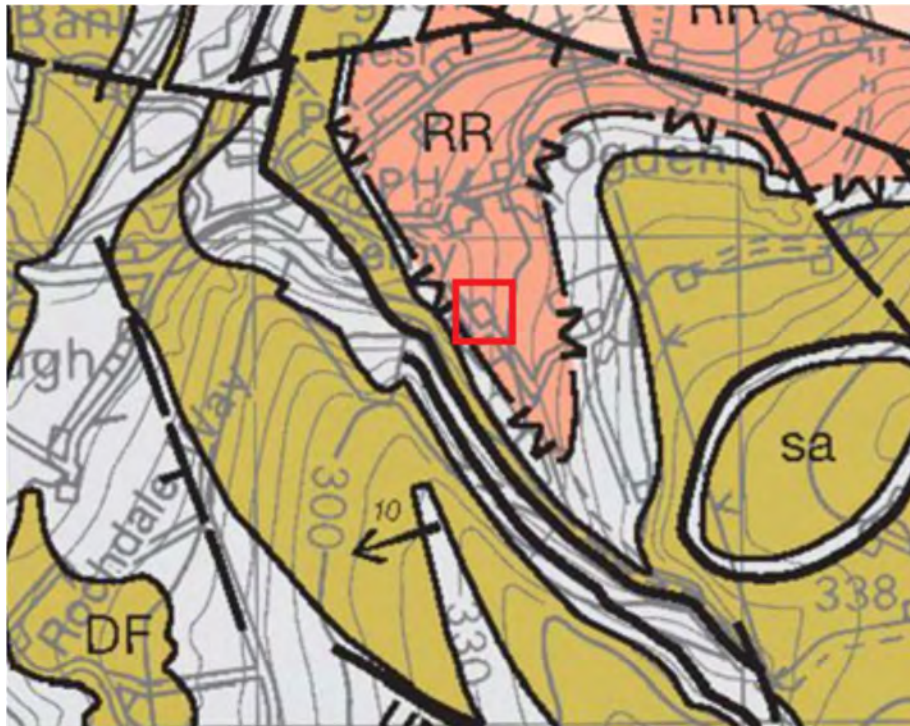
Figure 13: Extract showing the location of the outcropping coal seams (dark, dashed line) and a fossil horizon / marine band (light dashed line) and extract of the BGS 1:10,500 geological map (right) showing the unnamed Coal Seam cropping out near the south-western site boundary, in relation to the site location (red).

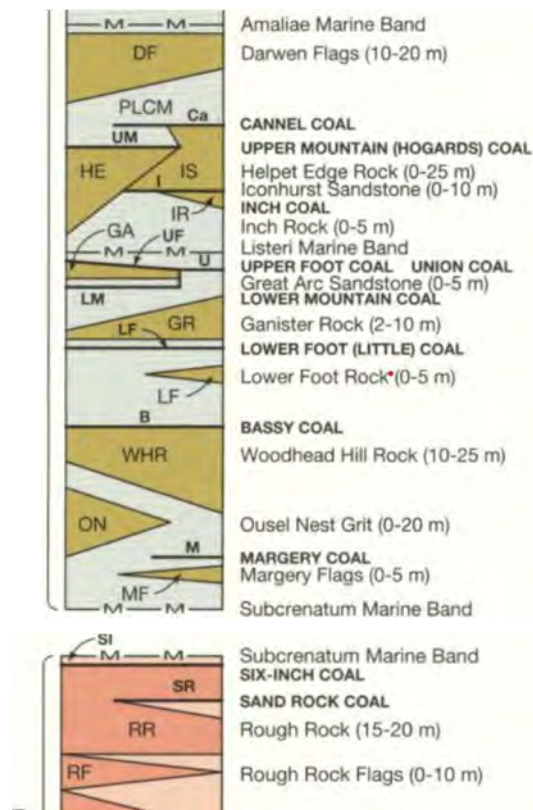
The bedrock found on-site comprises Rough Rock, which lies beneath the Pennine Lower Coal Measures in the geological sequence. The bedrock dips west at approx. 10°. Although the bedrock was recorded to dip westward, the Pennine Lower Coal Measures are not anticipated beneath the site due to the topography as well as the geological sequence and bedrock dip. The site is located at the bottom of a valley, with the Pennine Lower Coal Measures found on either side of the valley in the hillside. However, based on GVS, there are 2 No. coal seams potentially underlying the Rough Rock bedrock, which are the Six Inch Mine and the Sand Rock Mine seams, therefore, coal seams may be present at shallow depths beneath the site. An extract of the 1:50,000 BGS geological map generalised vertical section is included below for context:

Figure 14; Extract of the BGS generalised vertical section

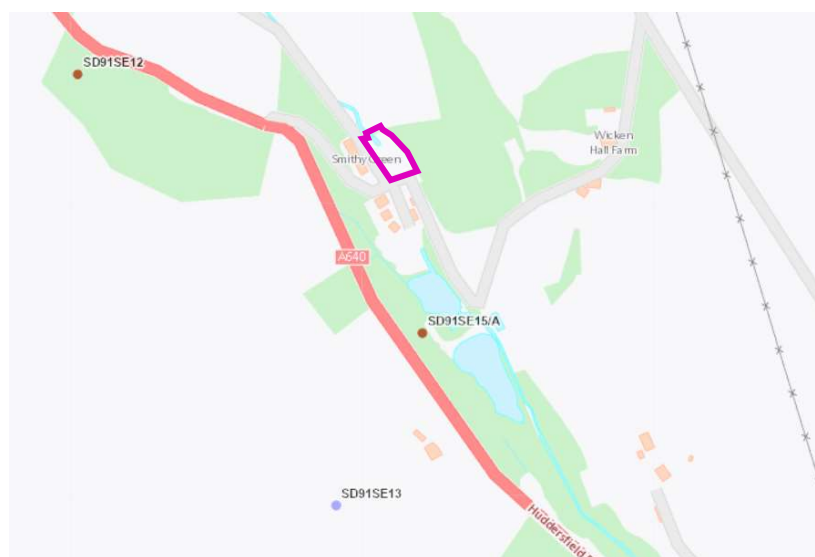
3 No. BGS boreholes are present in close proximity to the site (205m – 417m) the BGS boreholes do not contain information regarding the ground conditions beneath the site, however, do contain information regarding coal workings in the vicinity of the site, pertaining to Wicken Hall Colliery (205m SE), Ogden Colliery (400m NW), and South Wicken Hall Colliery (417m SW).

Figure 84: Extract showing the locations of the BGS Boreholes in relation to the approximate site boundary (pink).

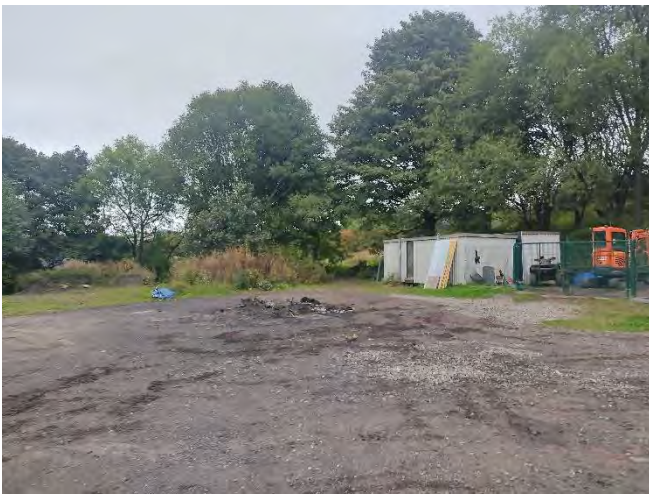
Figure 1 – The central and northern site sections, looking north.

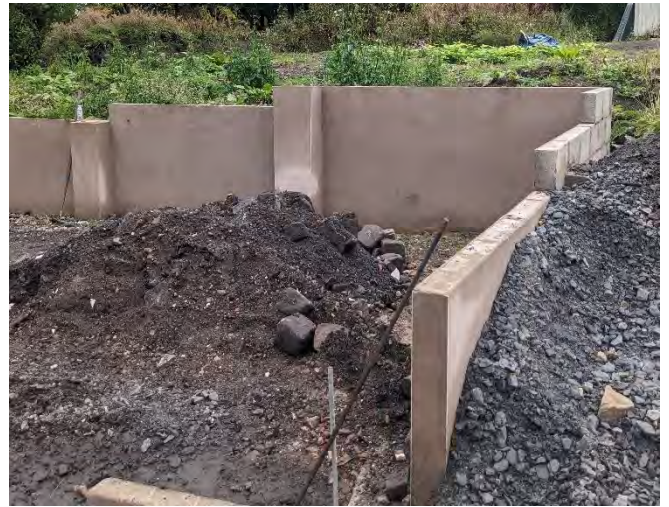
Figure 2 – A retaining wall along the western site boundary, looking east.

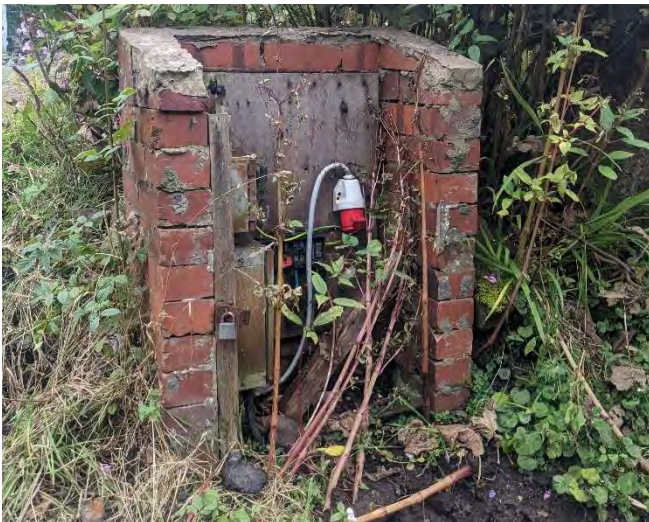
Figure 3 – An industrial electric outlet for buildings along the western site boundary, looking south-east.

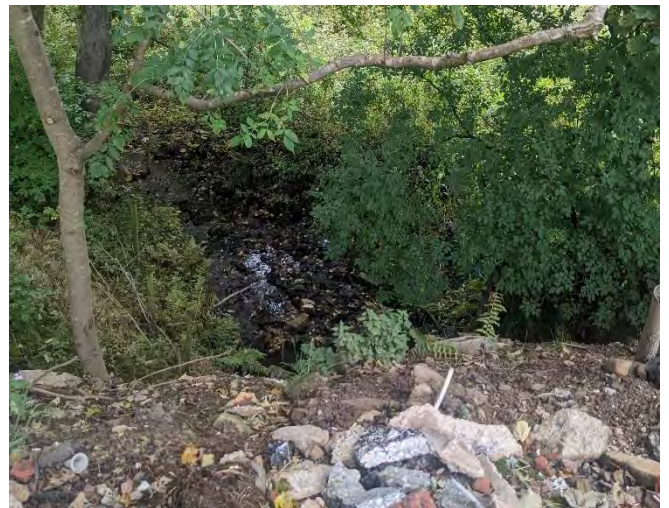
Figure 4 – The exit of the Wicken Hall Clough culvert near the northern site boundary, looking north.

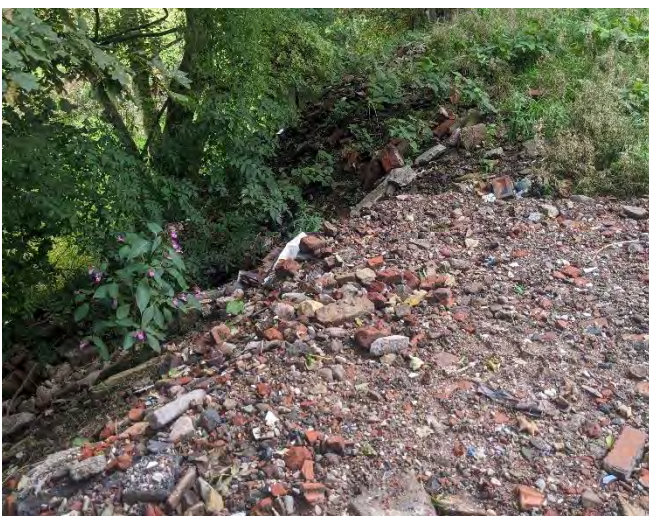
Figure 5 – Steep slopes in the northern site section, looking northeast.

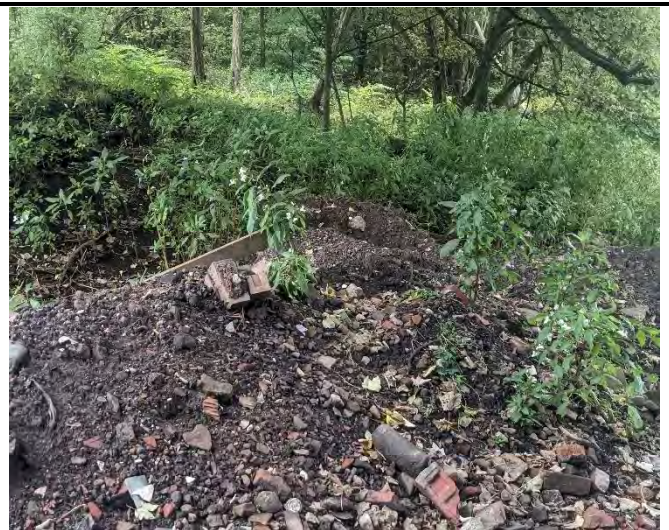
Figure 6 – On-site heaps with landslips visible in the distance, looking east.

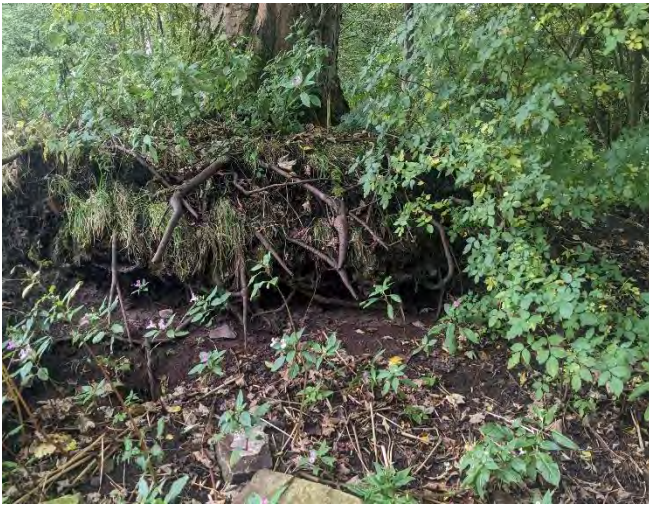
Figure 7 – Steep slopes with associated land slips and established trees in the northeastern site section, looking east.

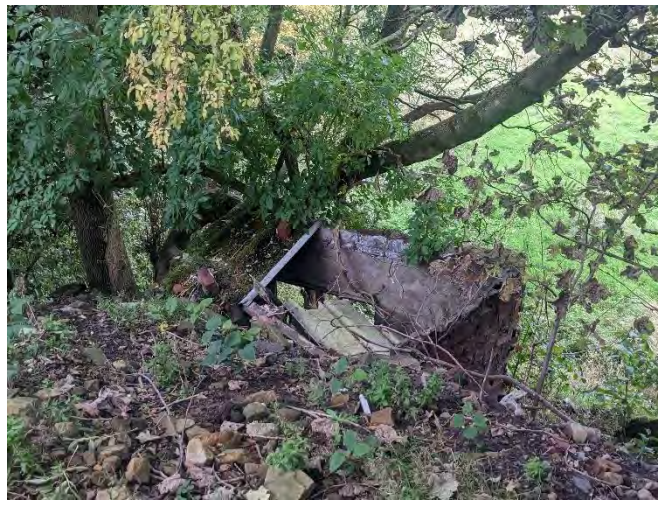
Figure 8 – Historical structures near the northern site boundary, looking north.

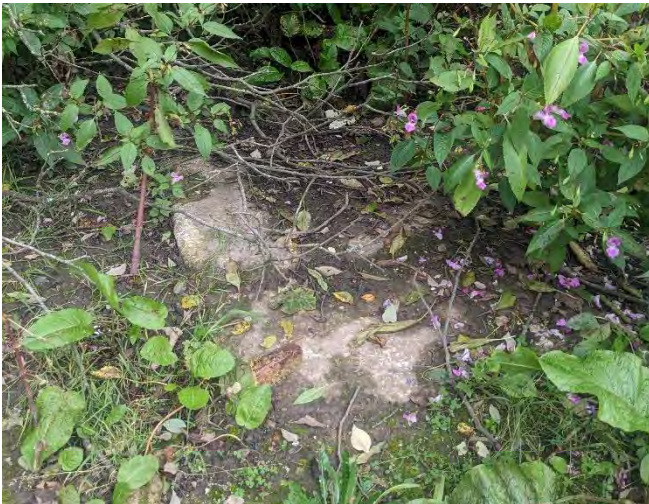
Figure 9 – Remnants of the historical industrial buildings in the top middle section of the site, looking southeast.

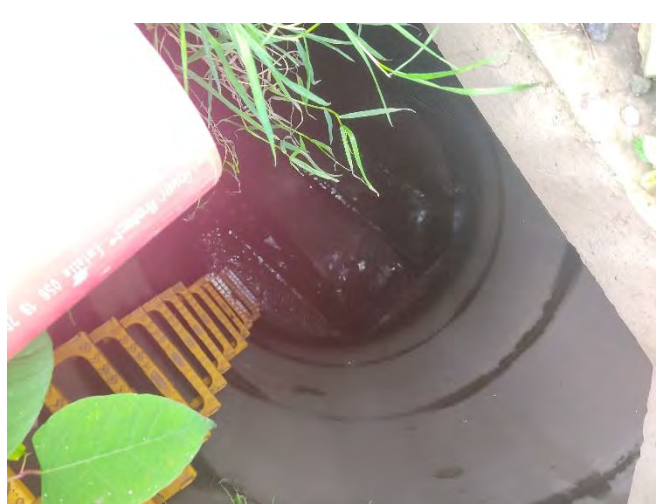
Figure 10 – The on-site culverted stream, at approx. 7.00m depth in the western site section.

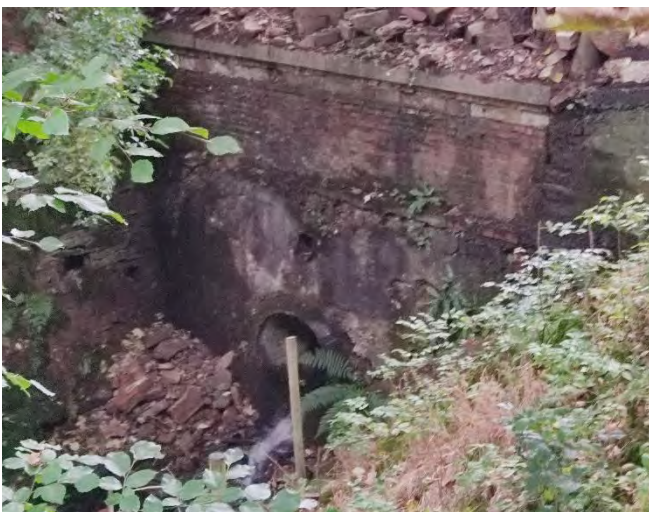
Figure 11 – Looking south, a retaining wall near the northern site boundary, looking south.

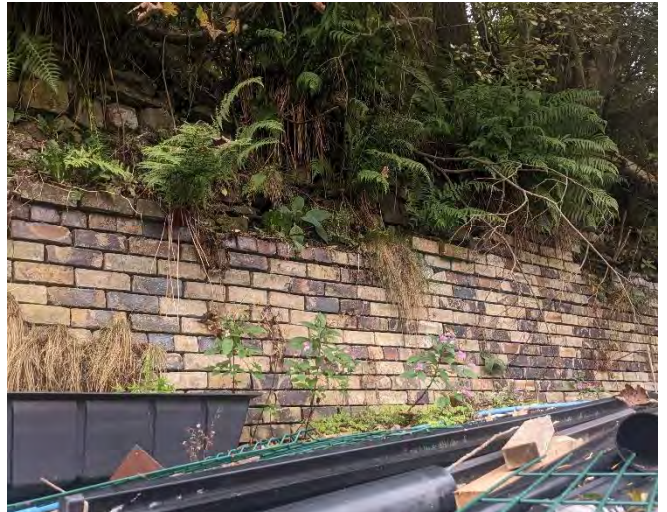
Figure 12 – Retaining walls off-site near the southeastern site boundary, looking east.

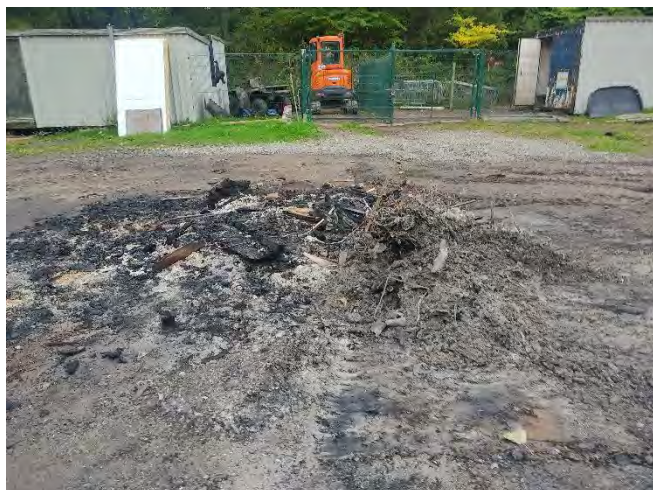
Figure 13 – Evidence for the burning of materials on site in the centre, looking east.

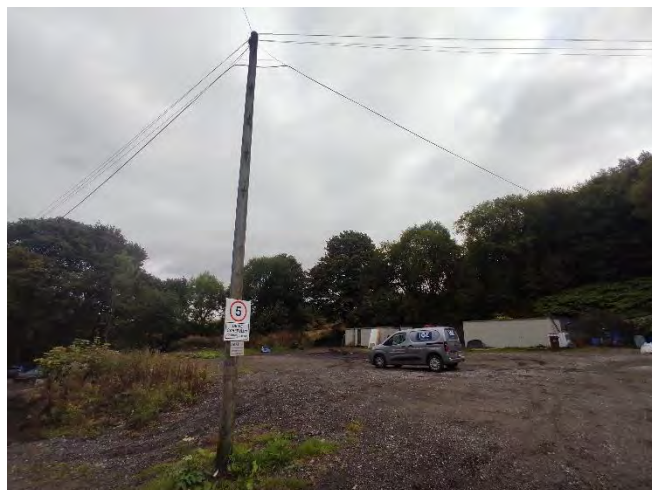
Figure 14 – Overhead power lines noted along the southern and western site boundaries, looking north-east.

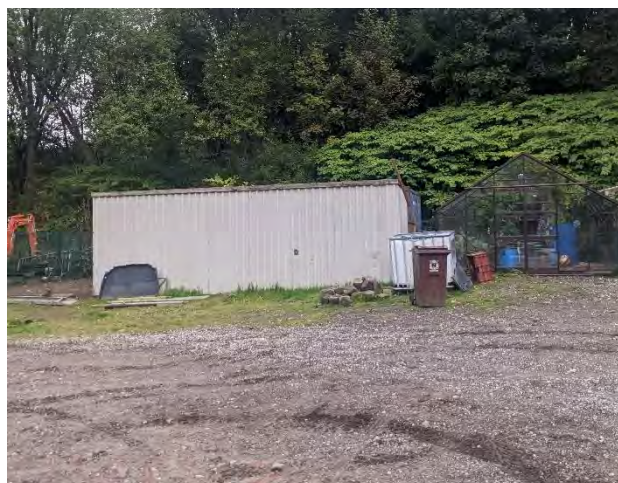
Figure 15 – Agricultural and industrial buildings along the eastern site boundary, looking east.
