## **Introduction**

This document is a Photographic Survey of Townhead House, a Grade II listed building, off Yorkshire Street, Rochdale. Rochdale Borough Council have issued a number of conditions pertaining to the proposed development of the property and this record fulfils Condition No. 13 for Listed Building Consent. In 2015 a gazetteer was produced for the property and included in a heritage statement. That gazetteer has been amended to document recent changes and includes cross-referencing to the plates forming this record. Photographic registers showing the location and direction of each photograph are included as Figures 1-5 below.

## **Photographic Survey: Townhead, Rochdale**

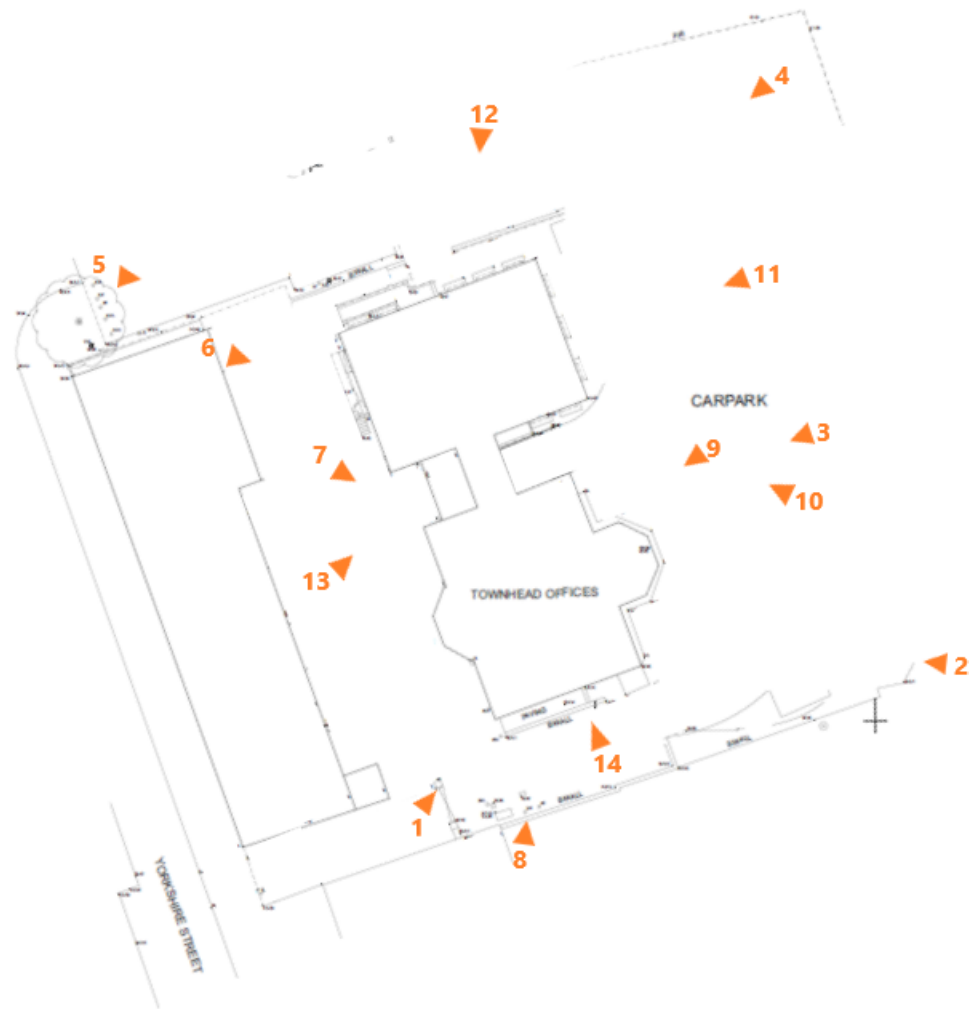
Figure 1: Photographic Register of the setting and exterior of Townhead House, Plates 1-14

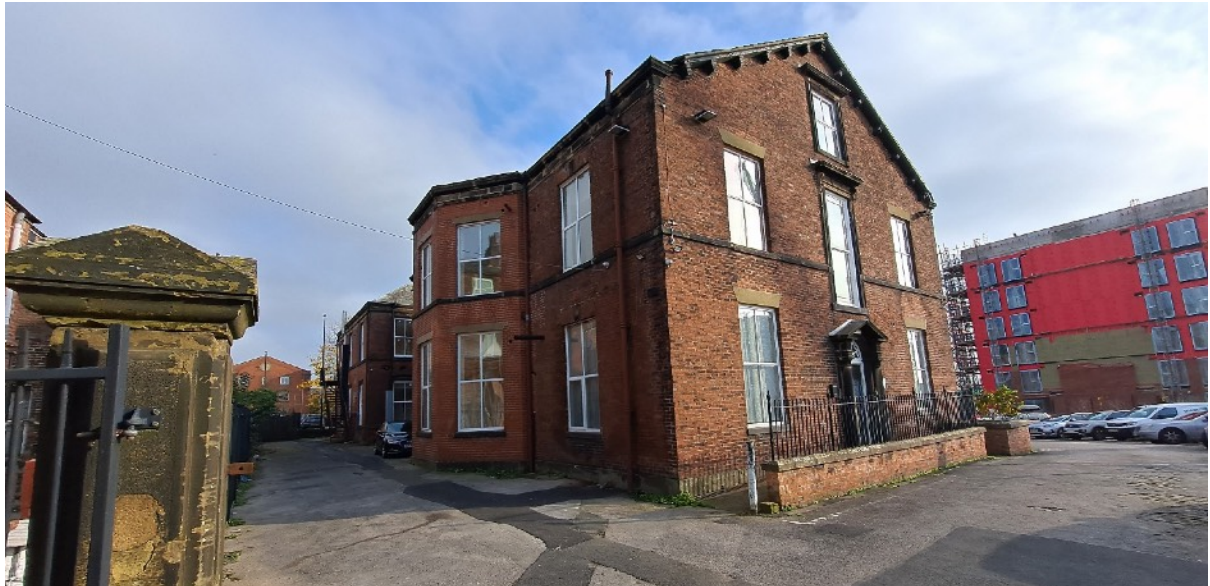
The southern block of the property is formed by a mannered, polite, classically-designed brick townhouse, with a porticoed entrance and bay windows, possibly dating to the early 1820s (Plates 1 and 2). It was built for the Entwistle family of Foxholes, who owned considerable property in the Townhead district of Rochdale. Built to lease, it is considered possible it was first occupied by John Elliot, a prominent local Attorney-at-Law. Later it became the home of Thomas Ainsworth Crook, a wealthy Liverpool wine merchant and Deputy Lieutenant of the County. His widow continued to occupy the property after his early death in 1856. After Mrs Crook died the house was left empty until Mr Entwistle suggested the Rochdale Board of Guardians take over the premises to replace their inadequate Boardroom and offices at Wardleworth Workhouse in 1878.

*Plate 1: The house from the south-west*

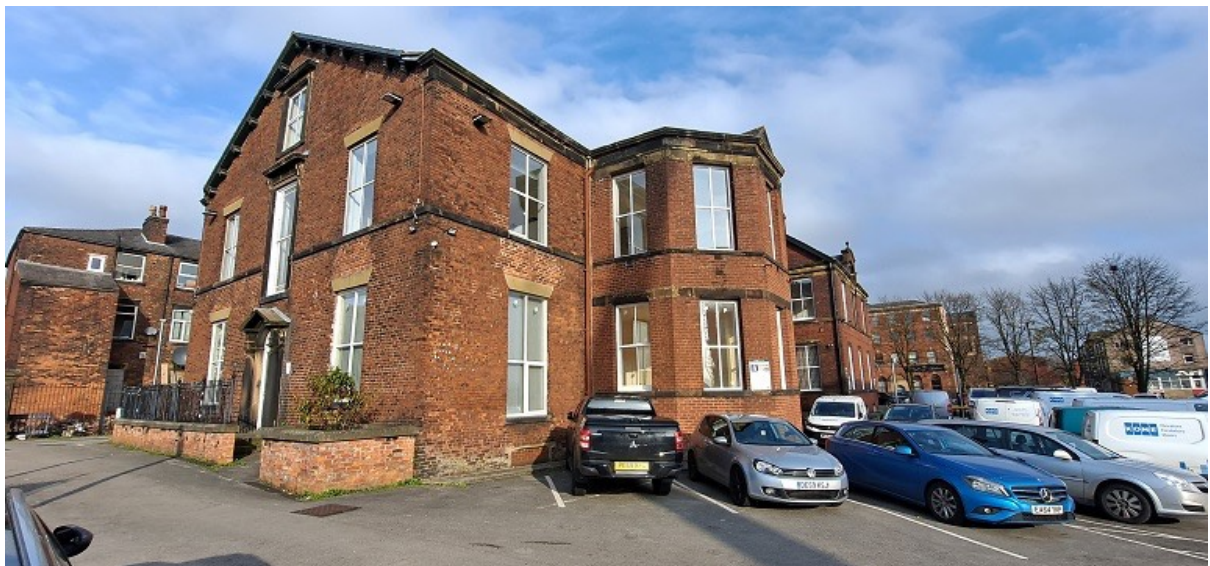
*Plate 2: The house looking west*

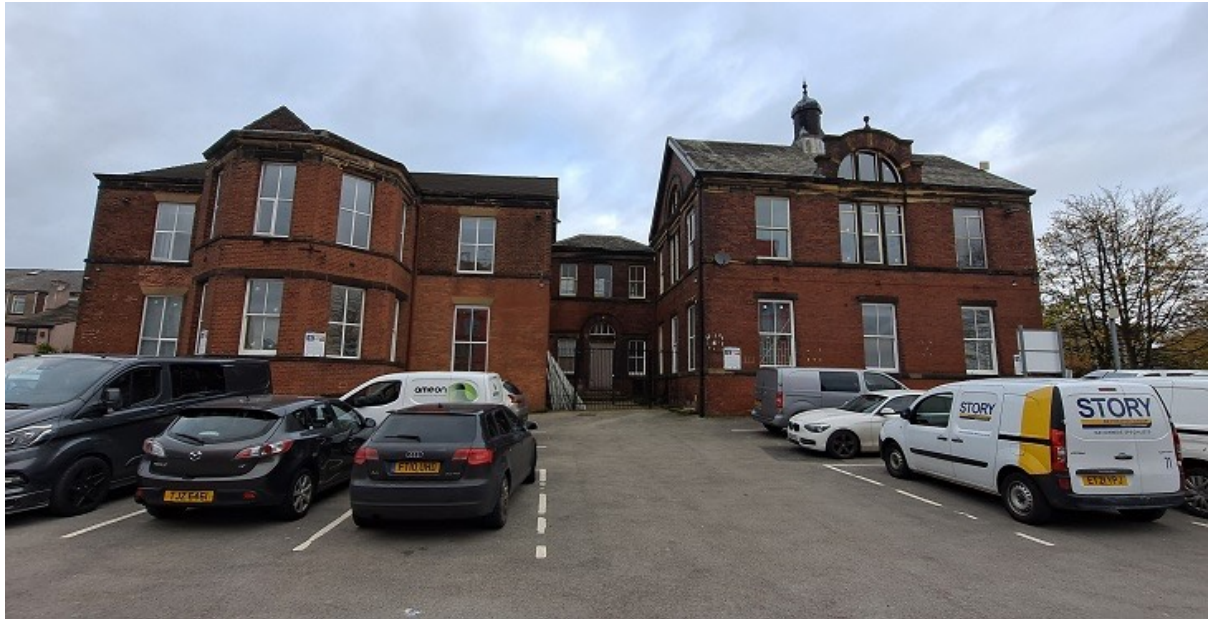
*Plate 3 : North-east elevation*

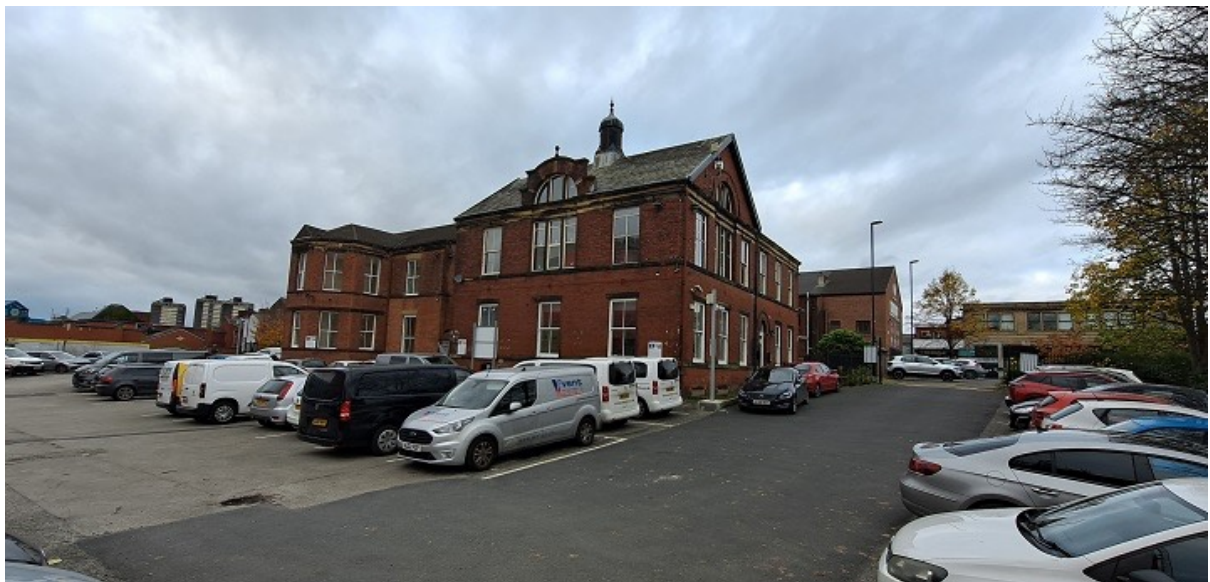
*Plate 4: Extension from north-east*

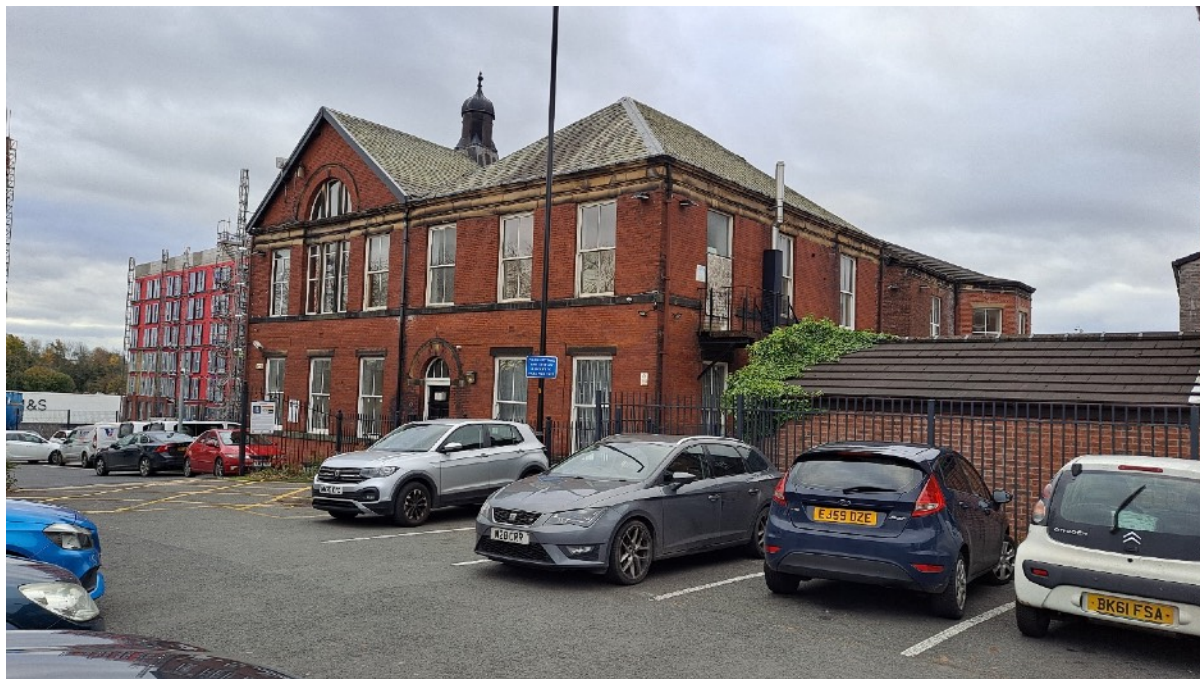
*Plate 5: Extension from north-west*

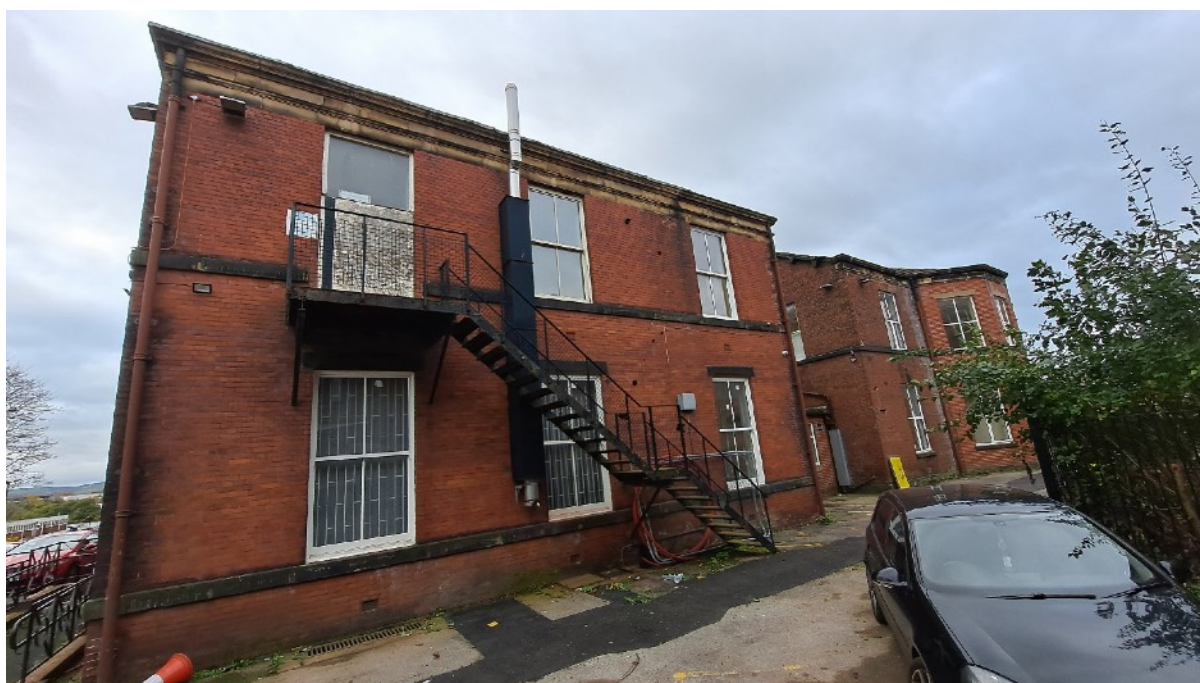
*Plate 6: The rear elevation of the extension looking south-east*

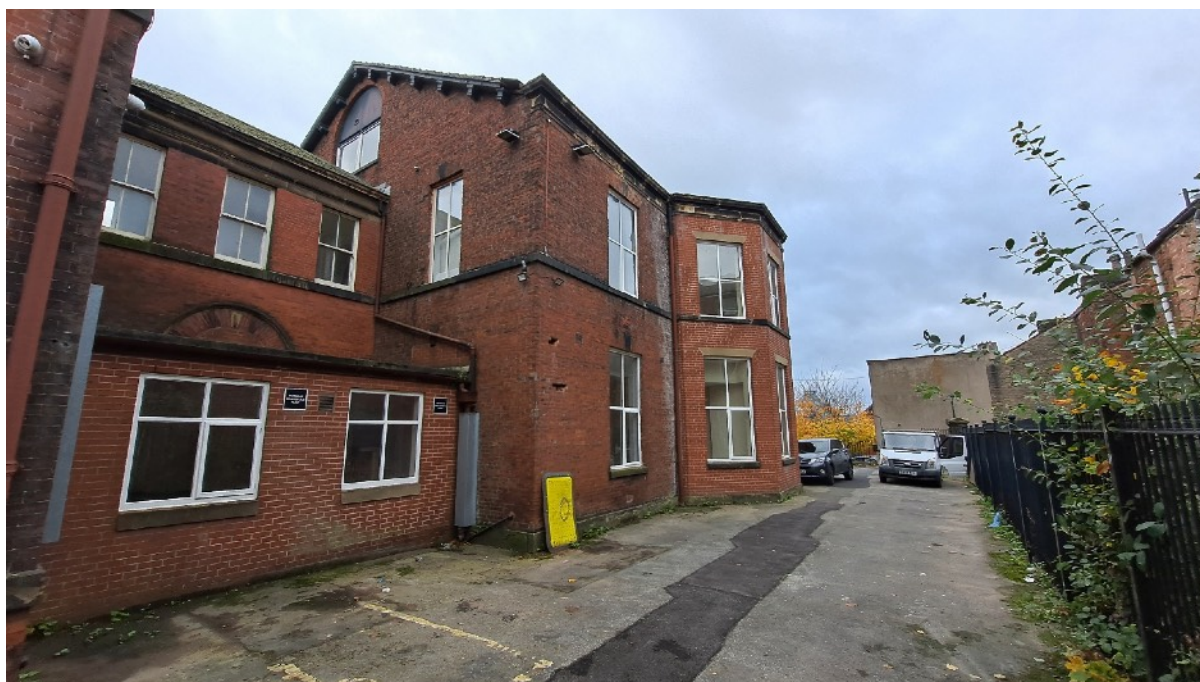
*Plate 7: The rear of house with link building to left looking south-east*

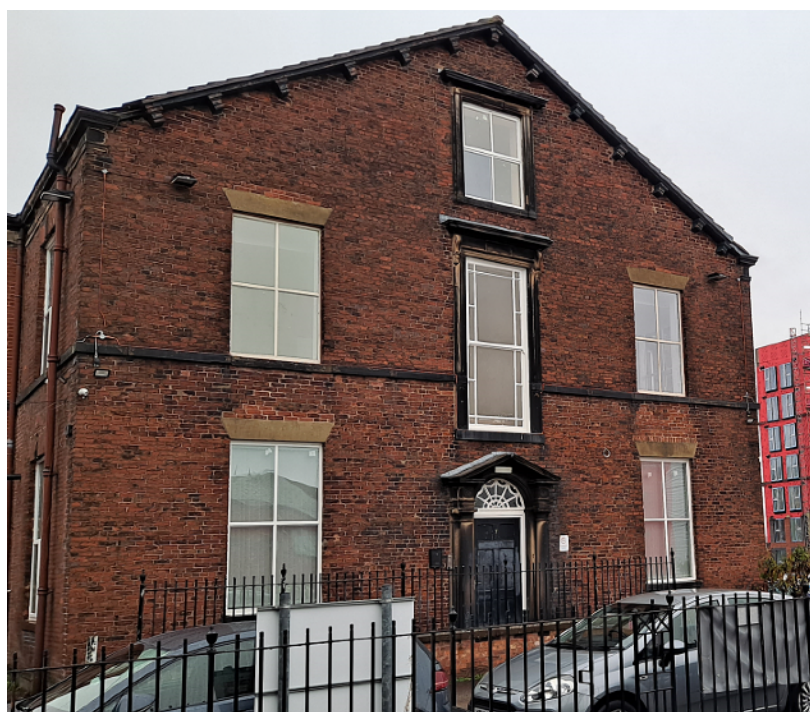
*Plate 8: Main elevation of house from south. A typical gabled front to a Late-Georgian townhouse*

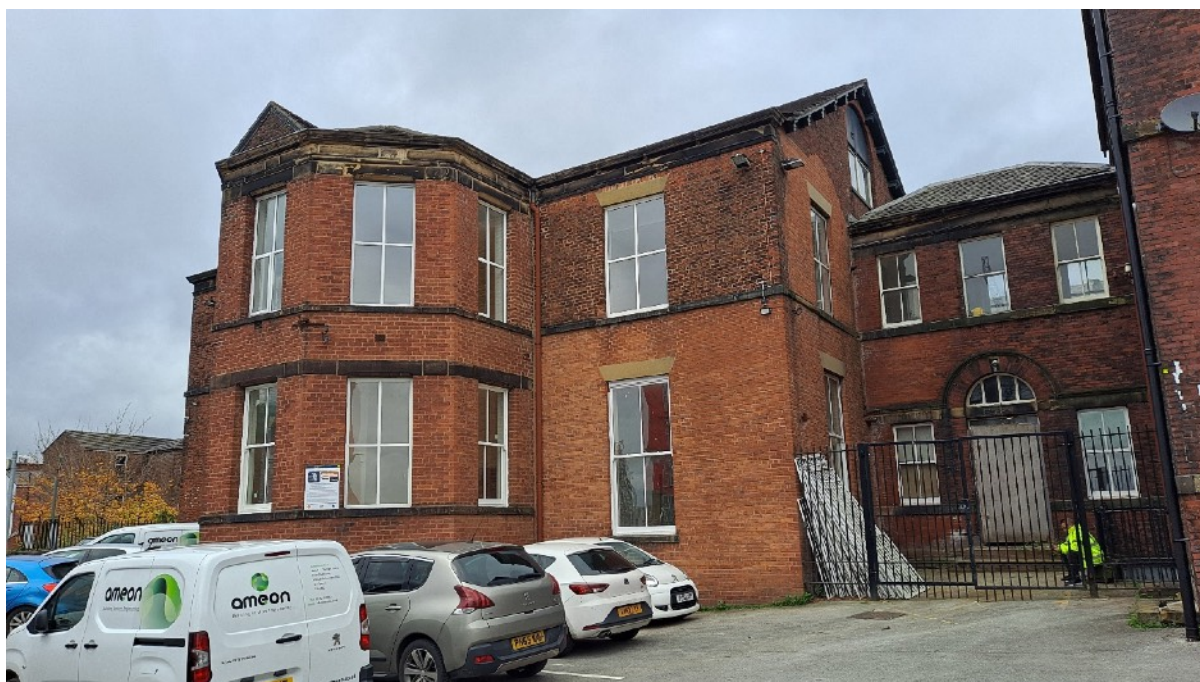
*Plate 9: The house from north-east with link building to right*

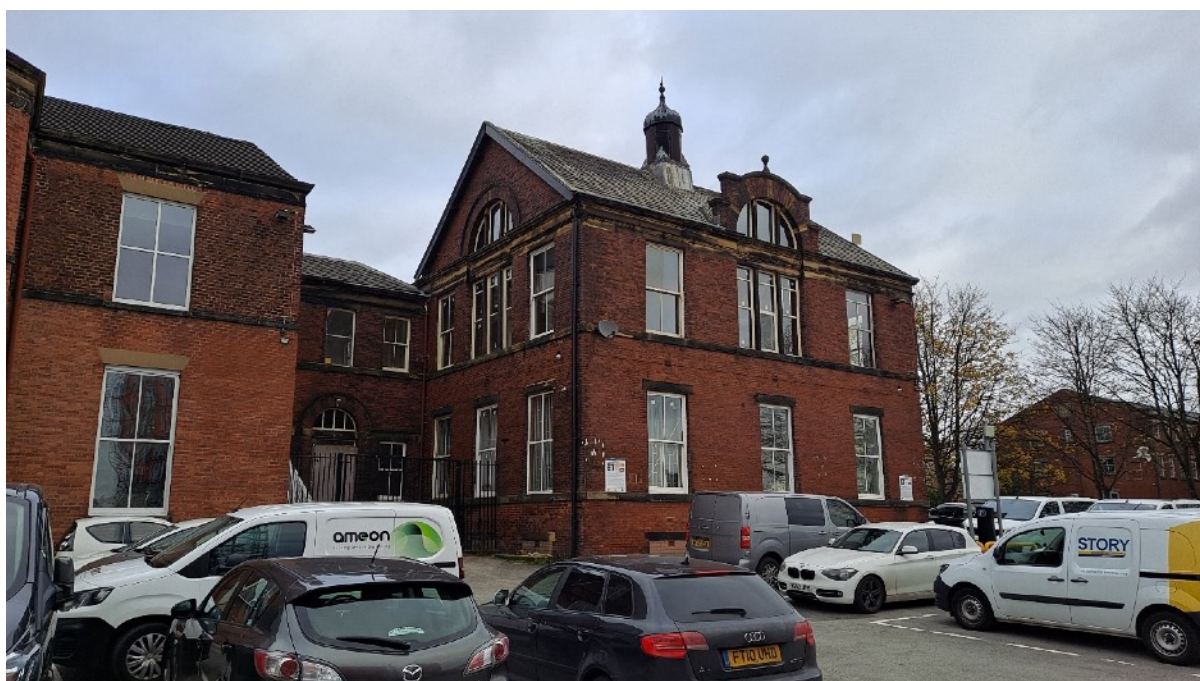
*Plate 10: The extension from south-east with house and link building to left*

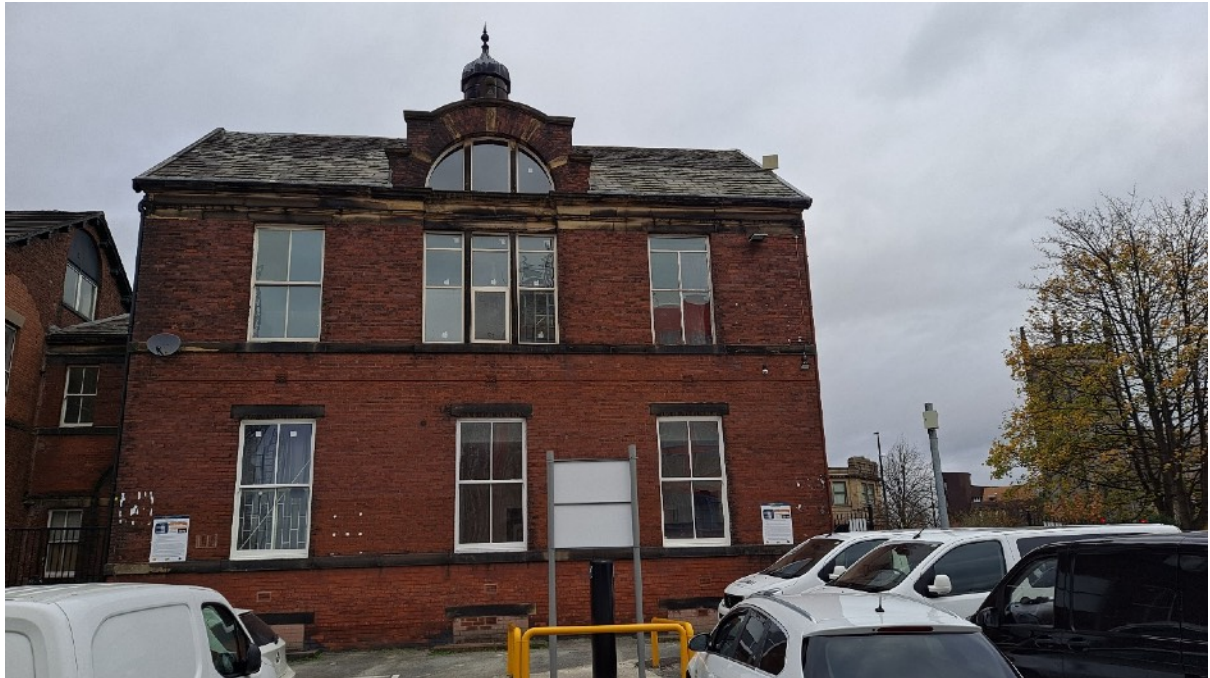
One of the most important features of the new extension was a first floor Boardroom with oak fittings, lit by large windows in each gable and one in a Dutch gable to the north-east elevation (Plate 11). To the rear was office space for the Assessment Committee. On the ground floor was a large waiting hall and offices for the relieving officers.

*Plate 11: The extension building looking west*

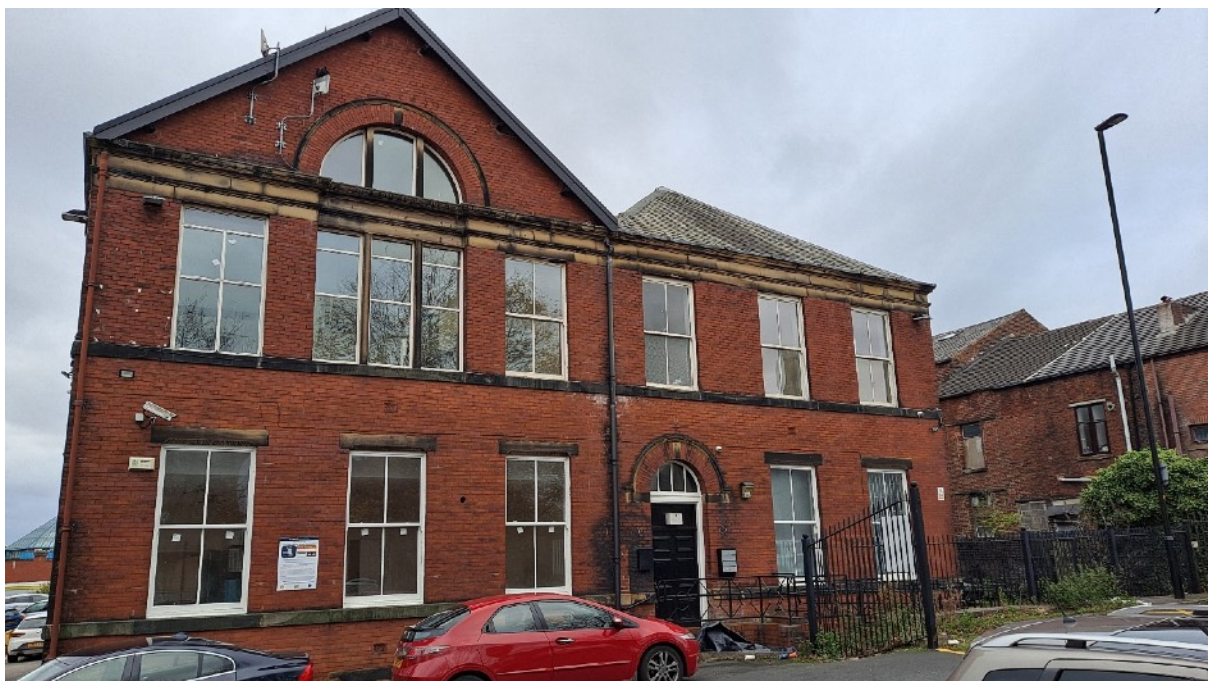
*Plate 12: The extension building from the north*

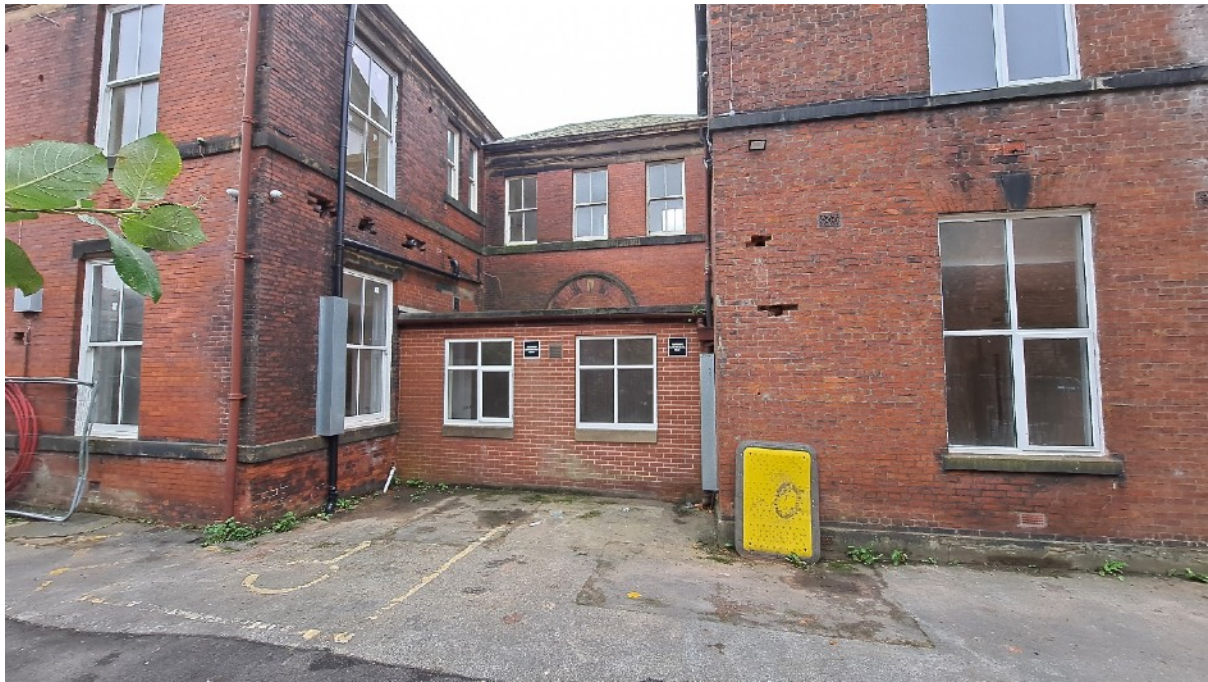
*Plate 13: The link building from west with extension to left and house to right*

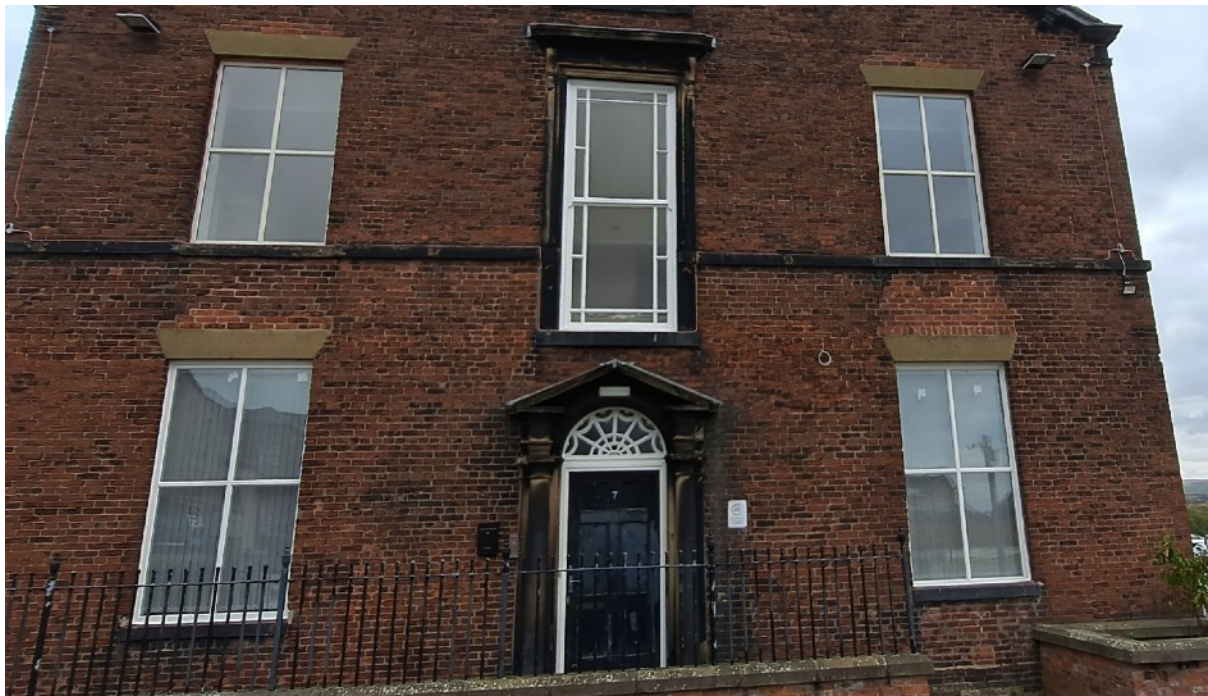
*Plate 14: The main entrance to the house with attached Doric columns, fanlight and open pediment. Above is a large window with stone architrave, consoles cornice and marginal glazing bars that would have lit the first floor central corridor.*

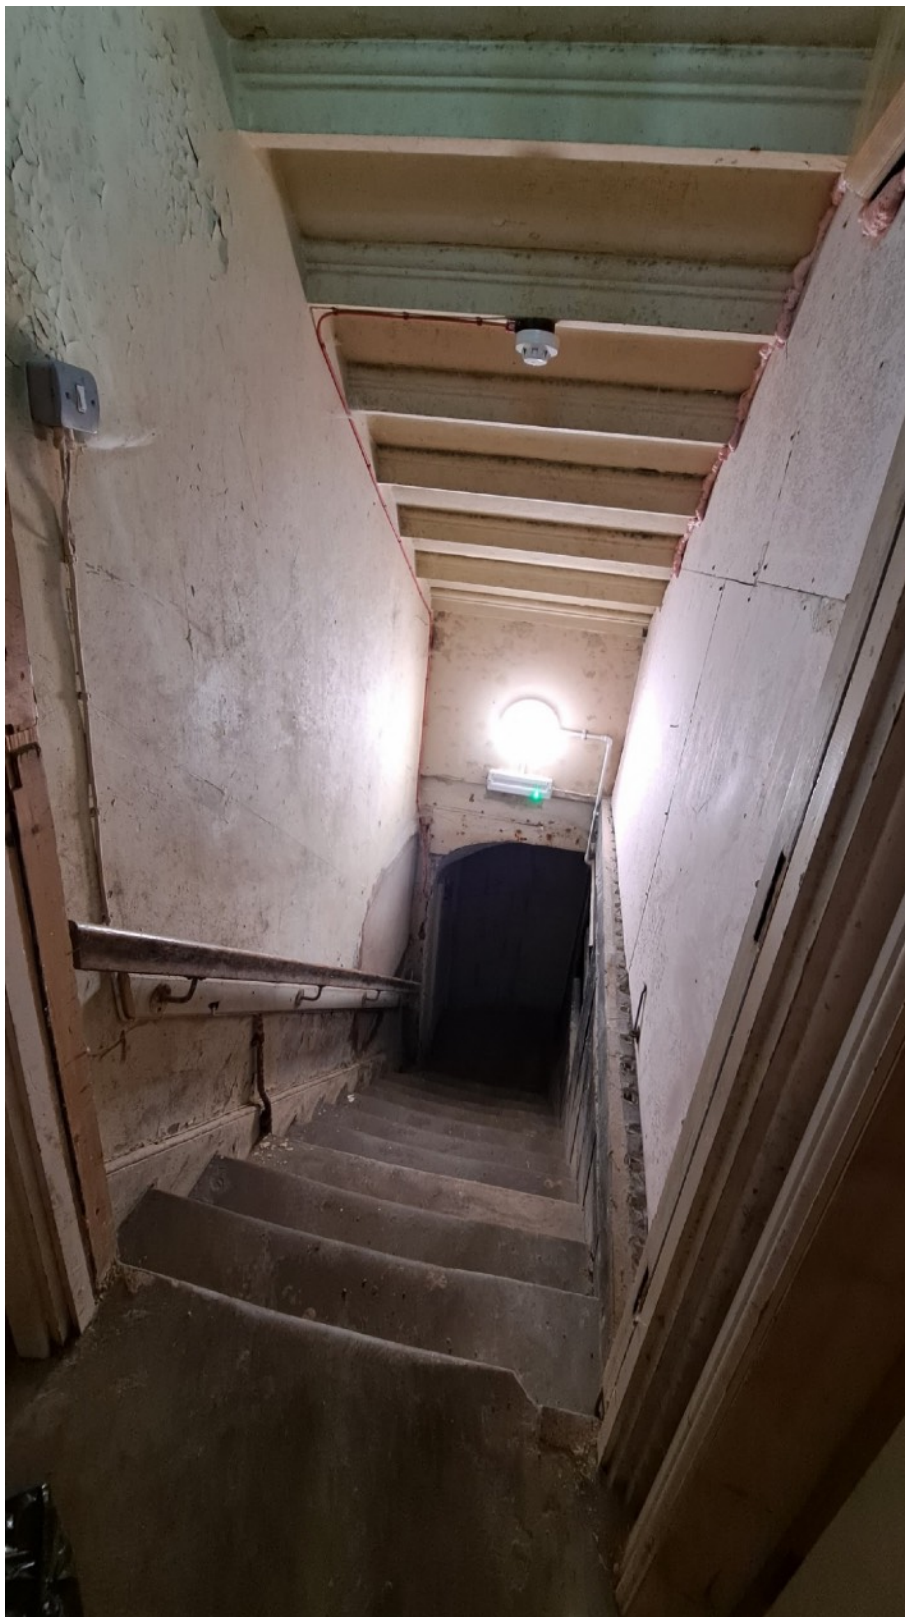
*Plate 15: To the rear of the original house the stairs from CG02 to CB02. They are brick with stone flag treads and an original board partition to the side.*

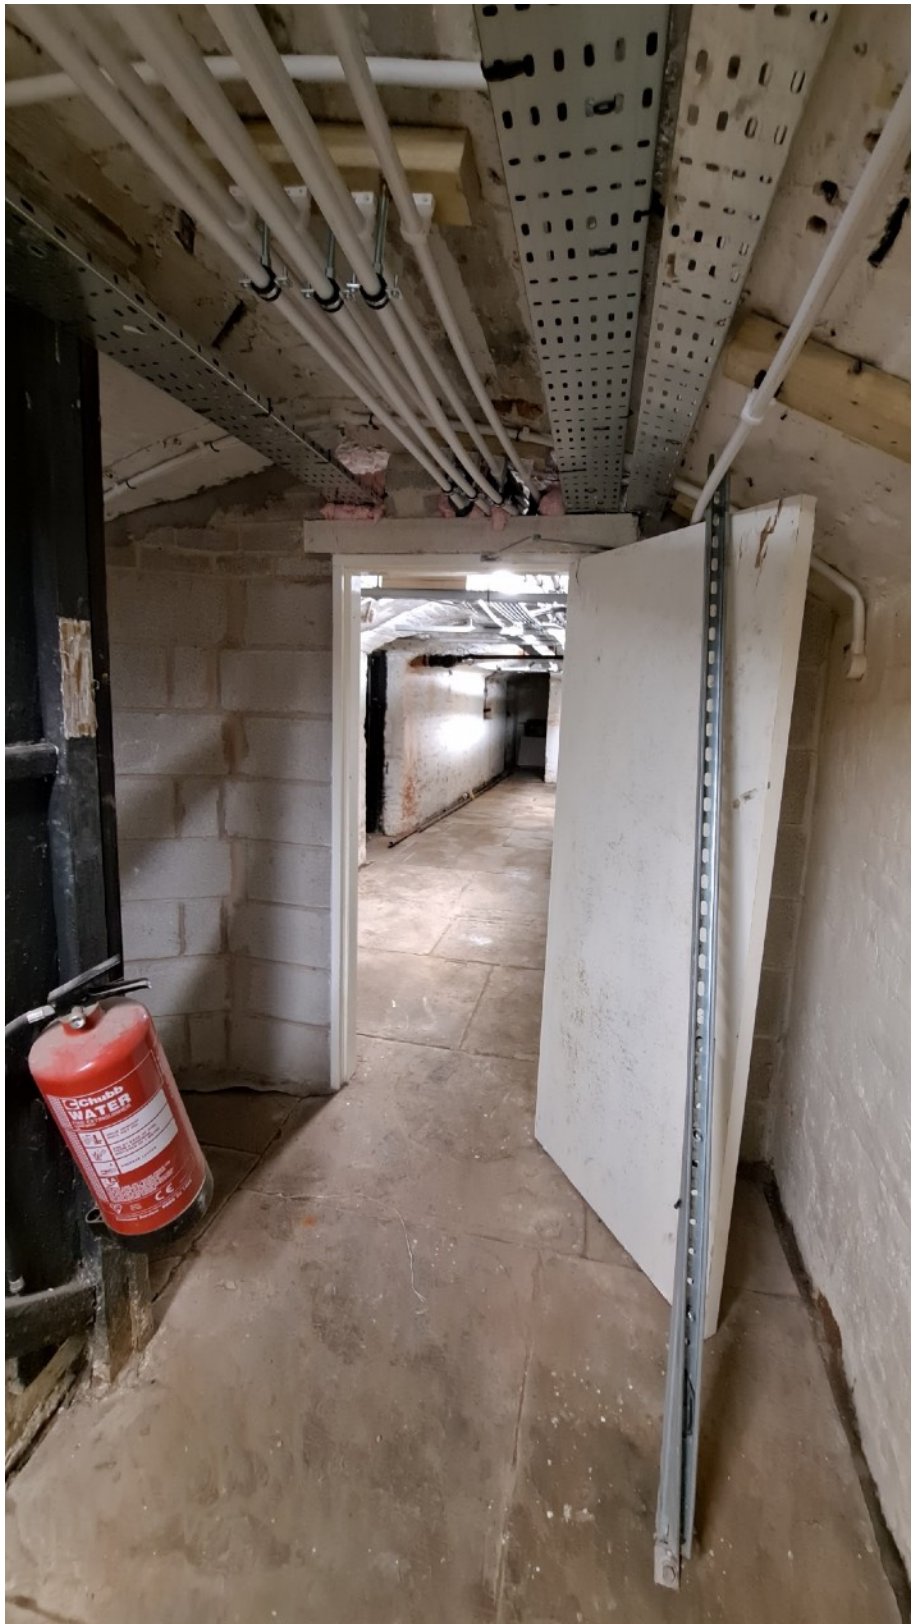
*Plate 16: At the bottom of the stairs an inserted wall now forms CB01 and CB02 from the original B10.*

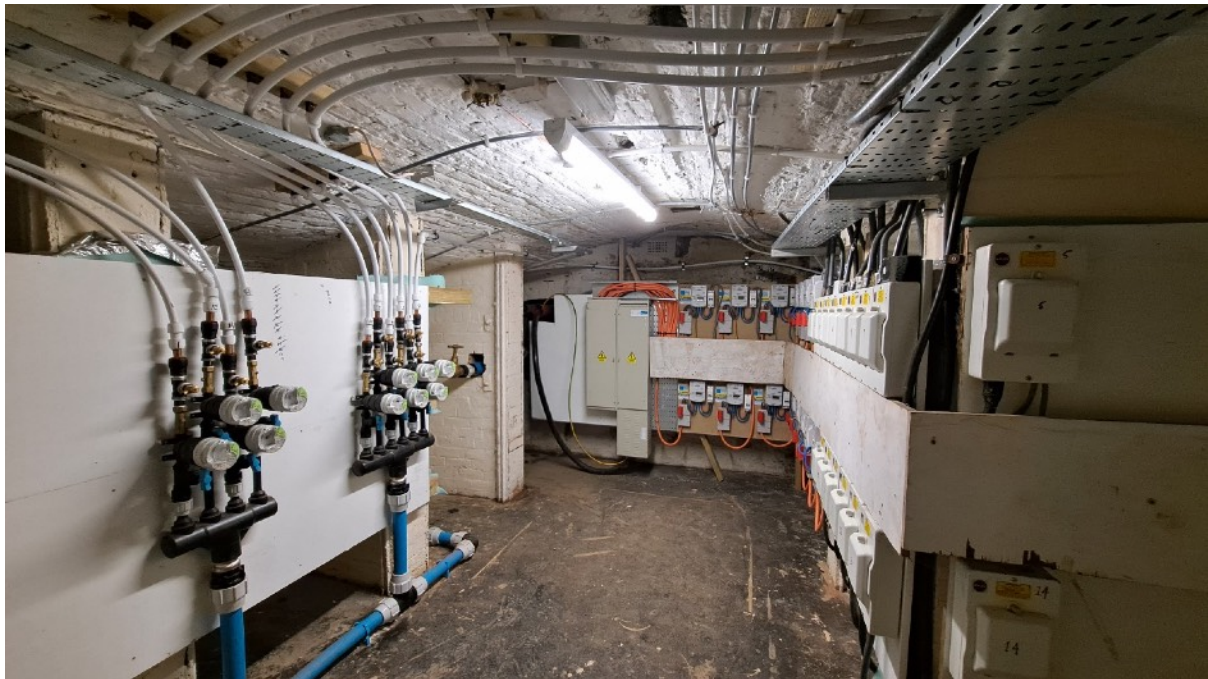
*Plate 17: In general, the basement rooms, storage and service rooms are unaltered. Although the former storage room B5 now contains electrical equipment it appears to have retained its earlier bins.*

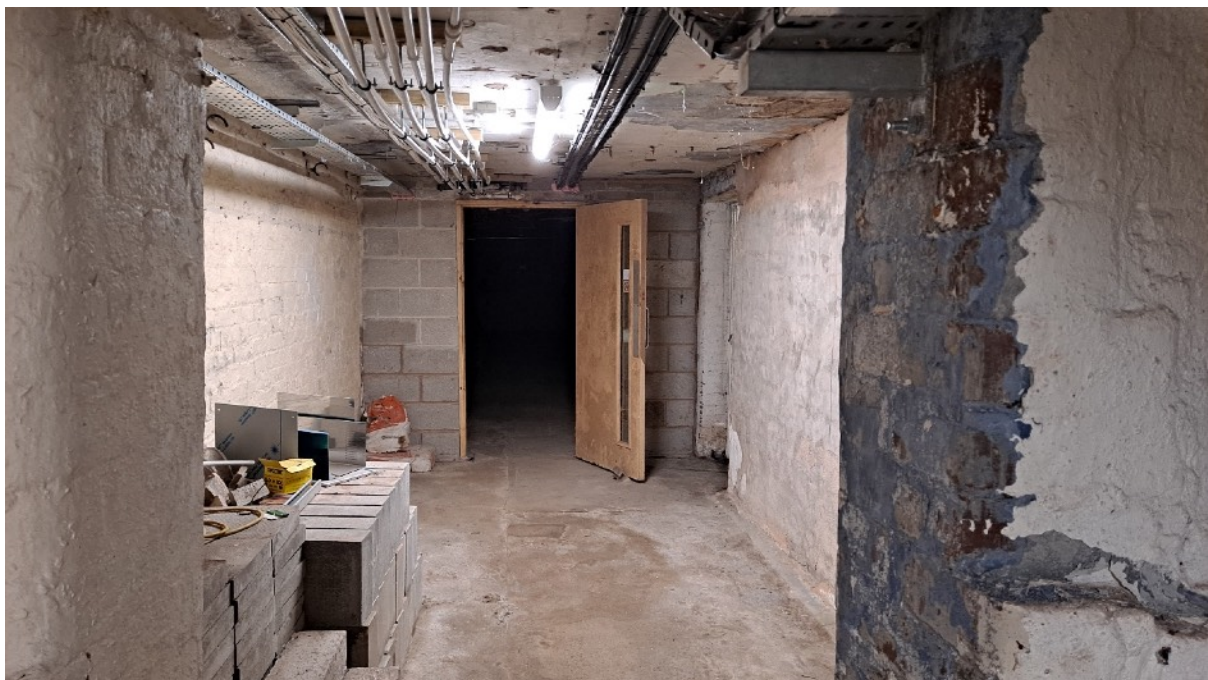
*Plate 18: With the building of the extension the central basement corridor was carried through to the rear with Room B11. Another inserted wall now forms CB01 and CB10.*

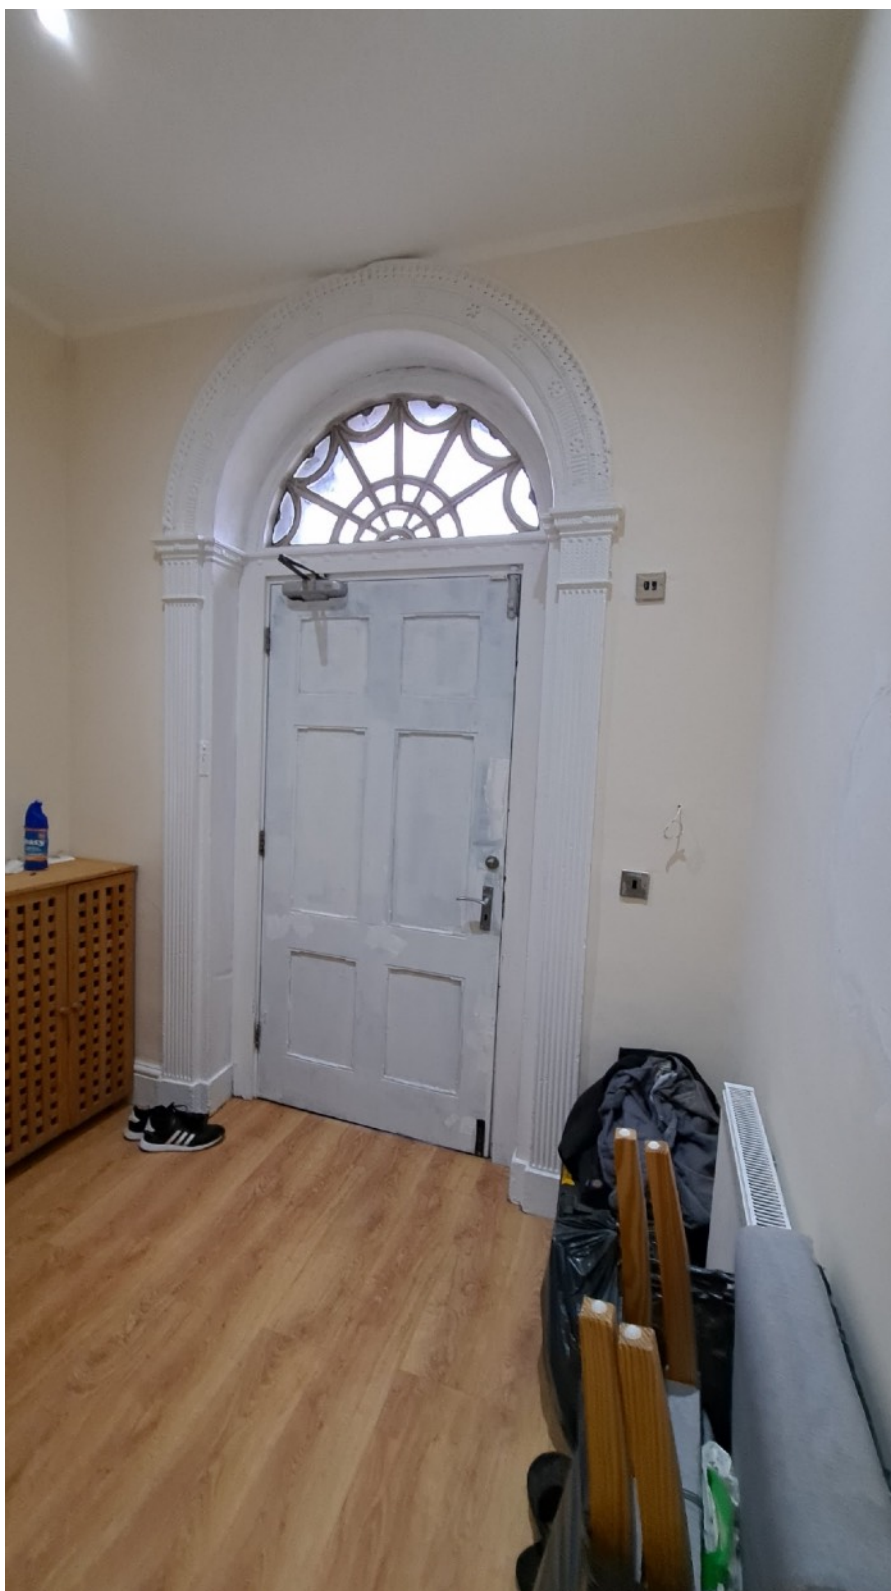
*Plate 19: The main entrance to the house with panelled door in decorated surround leading into a vestibule (G13), now altered to form the entrance, Room 1, of Apartment 7.*

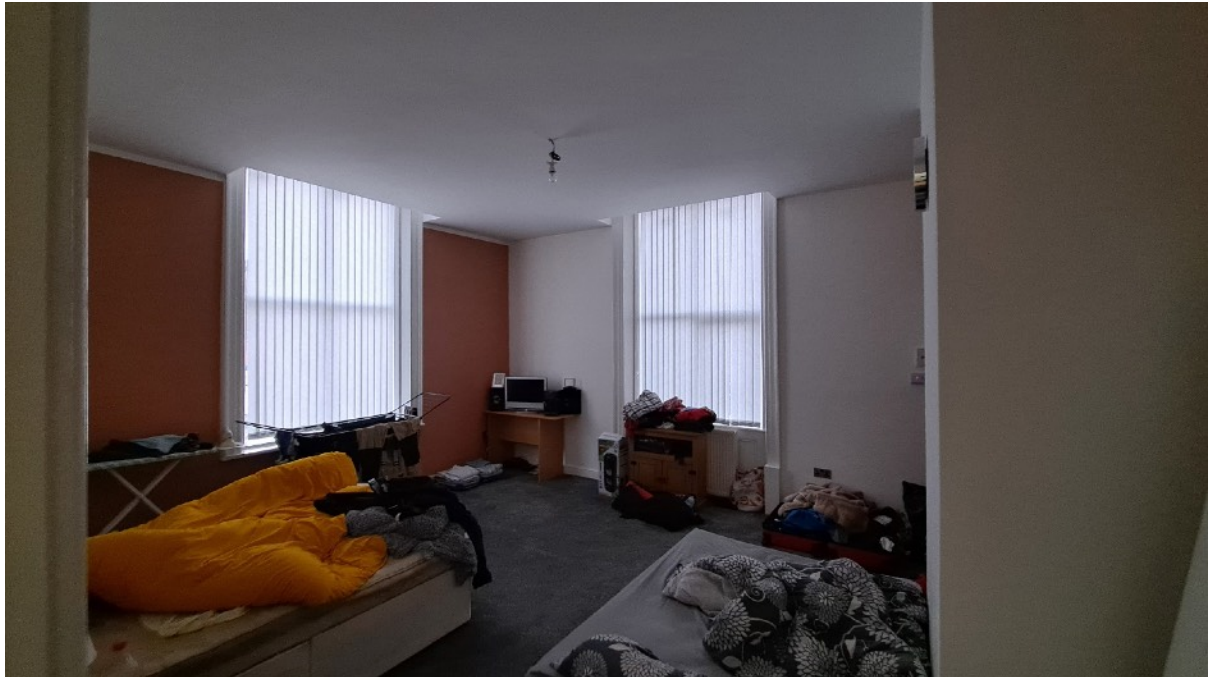
*Plate 20: G1, now Room 2 of Apartment 7. Originally a principal reception room, possibly Drawing Room, which has retained original window surrounds and panel.*

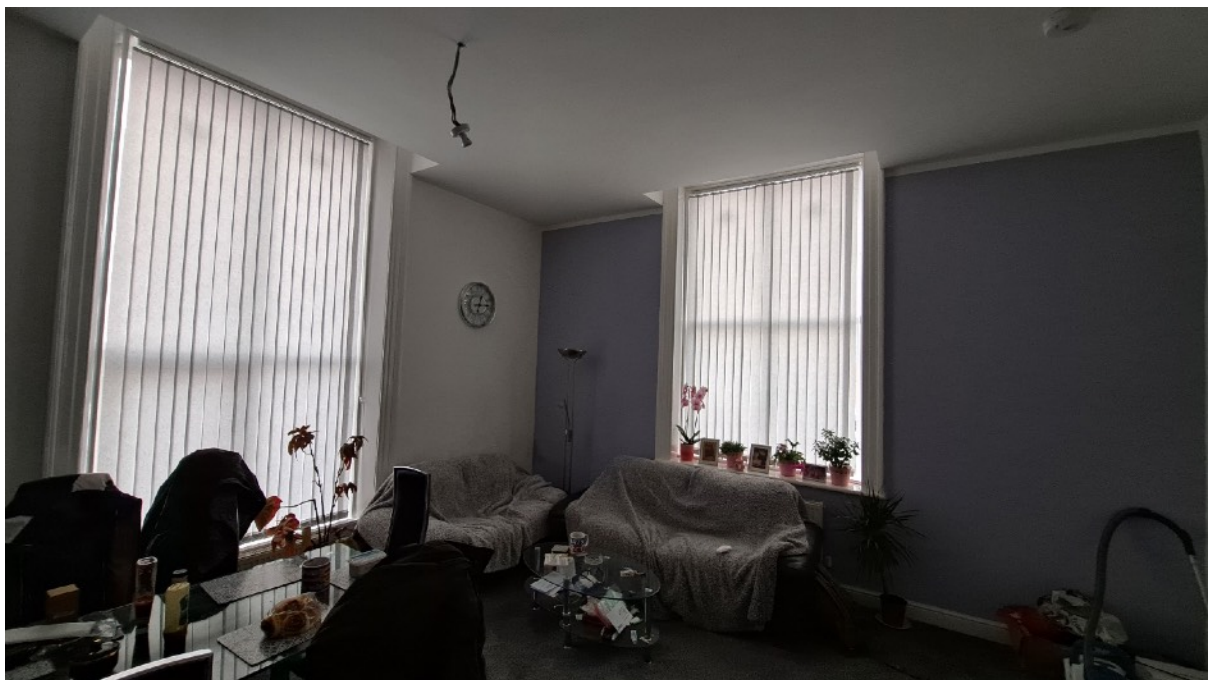
*Plate 21: A second principal reception room, possibly Morning Room (G11) to the original house with retained original window surrounds and panel. Now forms Room 5 of Apartment 7*

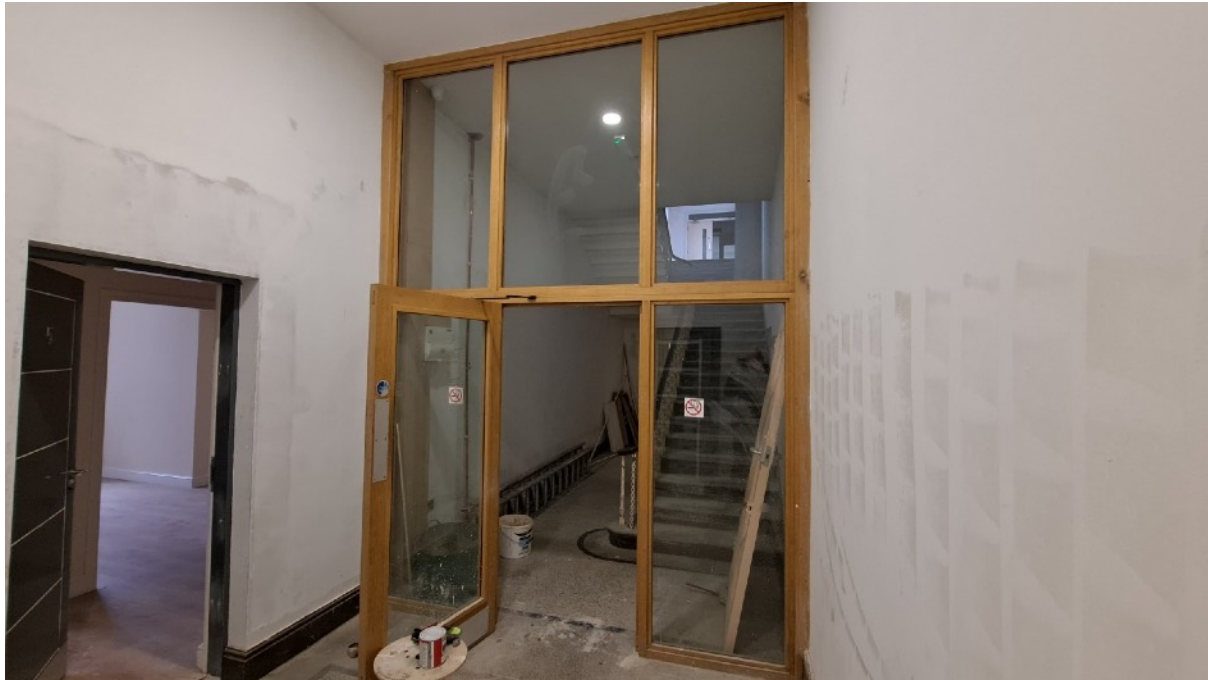
*Plate 22: The principal central corridor (G12) which would have formed a decorated circulation route to the main staircase with access to the principal ground floor rooms. Now forms CG01 and is no longer accessible from the front entrance.*

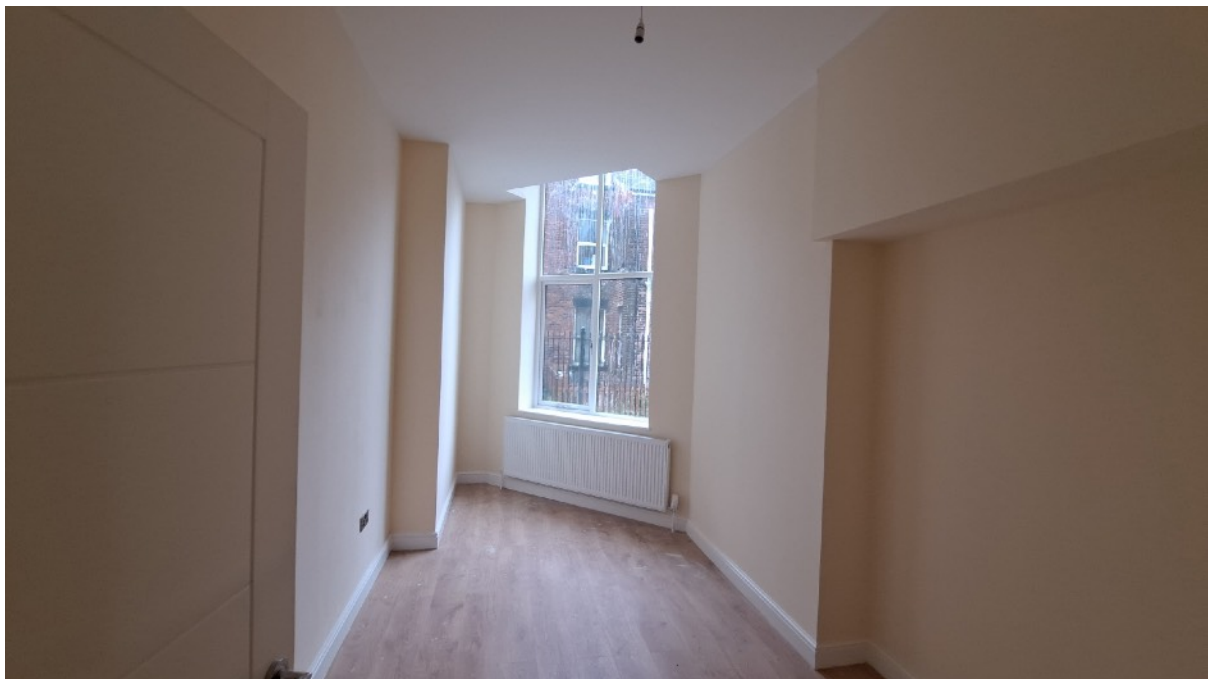
*Plate 23: The partitioned Room G2, formerly a decorated reception room, possibly Salon, now forming Rooms 1,2,3 and 4 of Apartment 5*

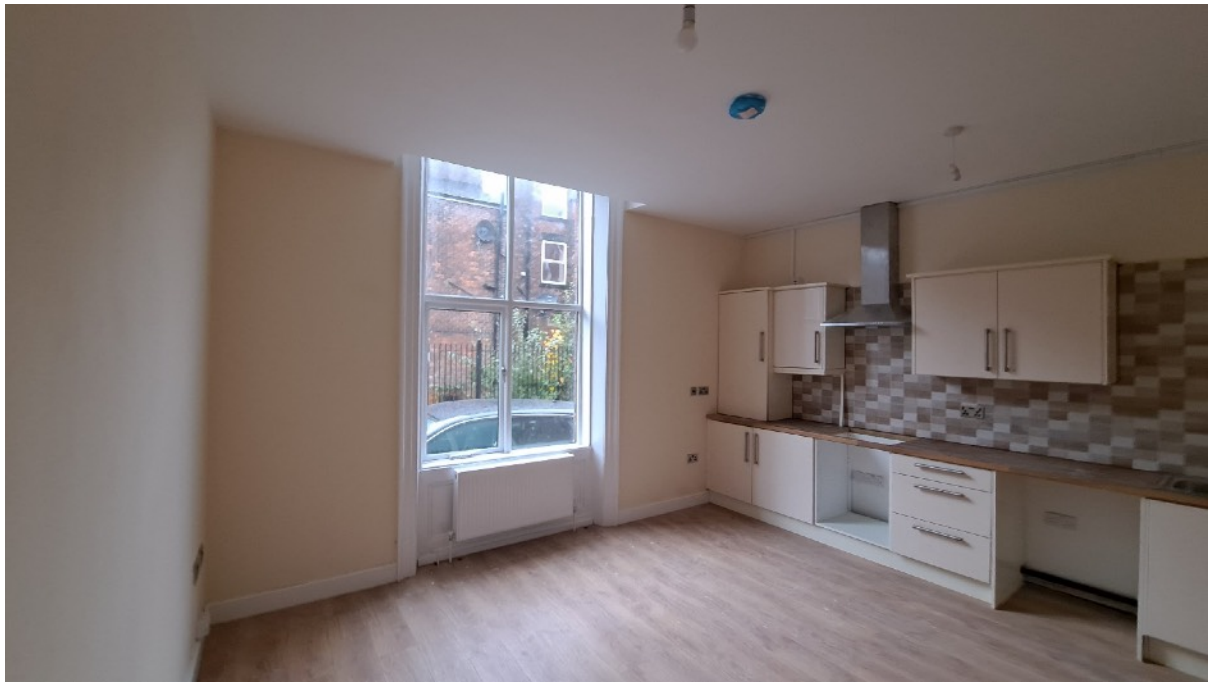
*Plate 24: A service room (G3) to the possible Salon, now Room 5 of Apartment 5 with retained original window surround, with bulkhead, and panel*
