## **Introduction**

This document is a Photographic Survey of Townhead House, a Grade II listed building, off Yorkshire Street, Rochdale. Rochdale Borough Council have issued a number of conditions pertaining to the proposed development of the property and this record fulfils Condition No. 13 for Listed Building Consent. In 2015 a gazetteer was produced for the property and included in a heritage statement. That gazetteer has been amended to document recent changes and includes cross-referencing to the plates forming this record. Photographic registers showing the location and direction of each photograph are included as Figures 1-5 below.

## **Photographic Survey: Townhead, Rochdale**

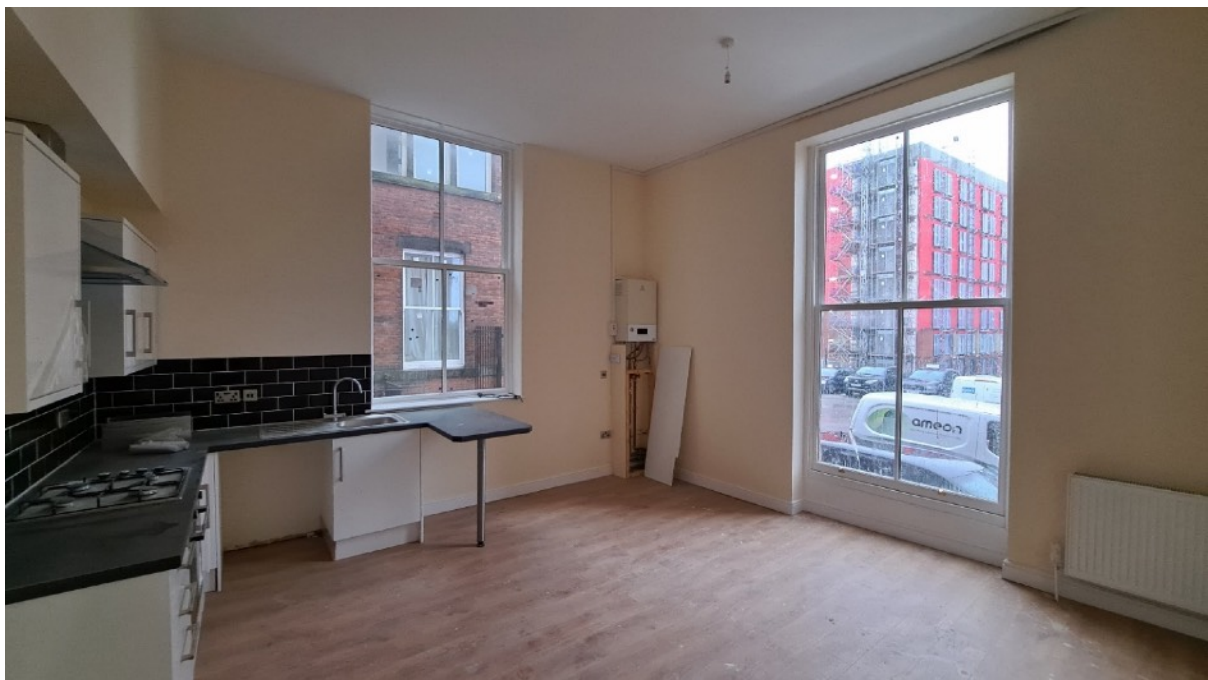
*Plate 25: Originally a service room (Rooms G5,6 and 7) to G8, this room has had later subdivisions removed and now forms Room 2 of Apartment 6. It retains an original sash window and is accessed by a reopened doorway*

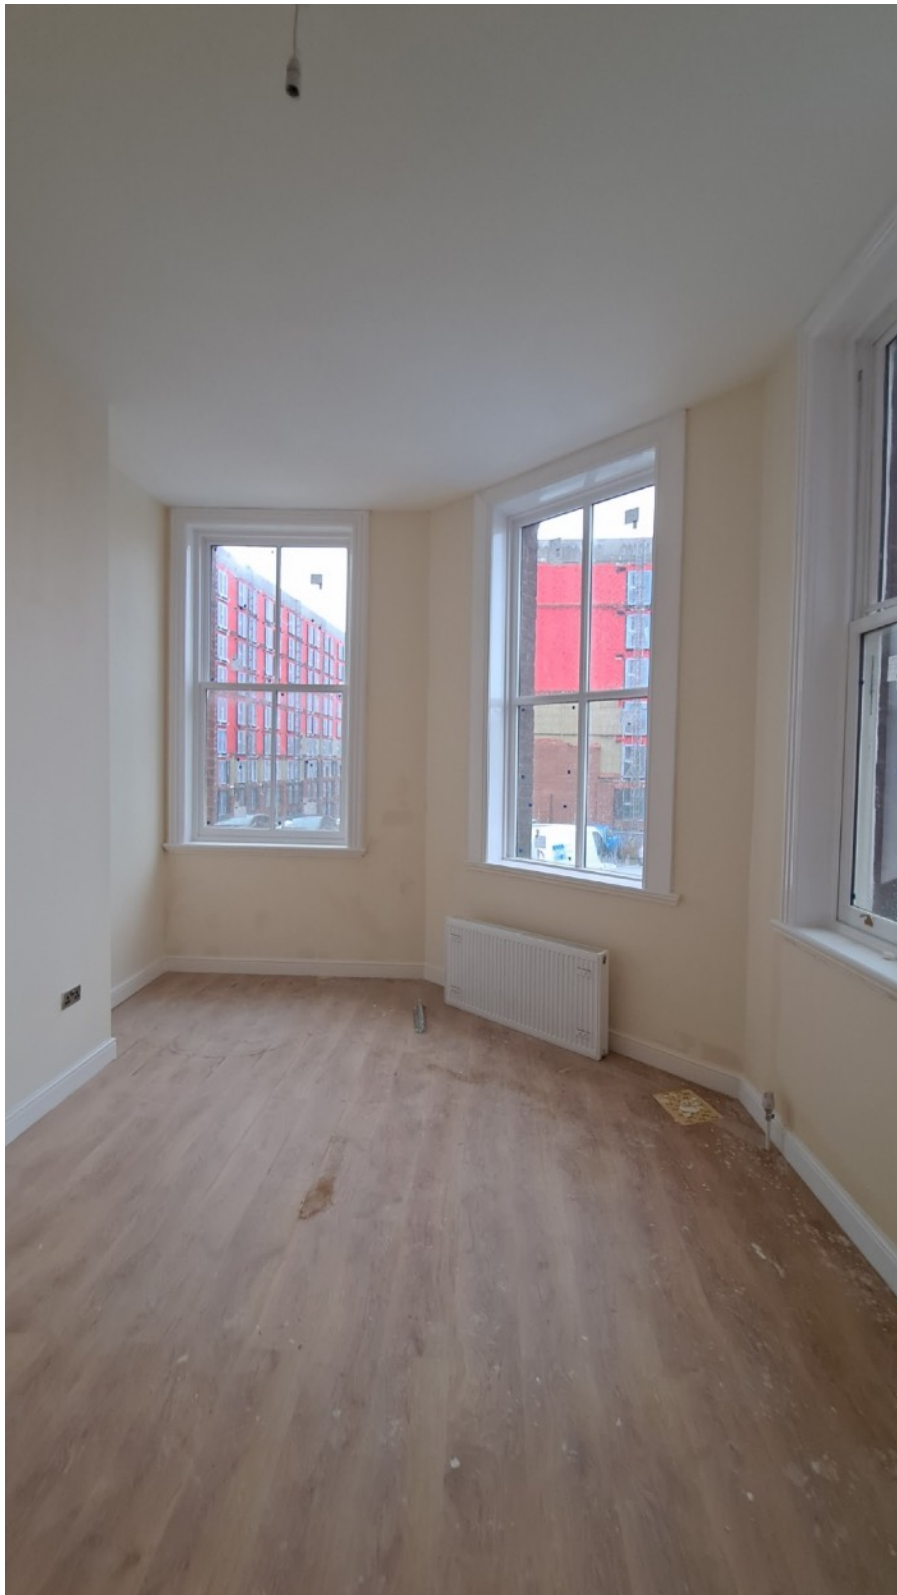
*Plate 26: Possible Dining Room (G8) in the extended bay to the east. Later sub-divided to form offices. Now re-configured to form Apartment 6 retaining original window surrounds and panels*

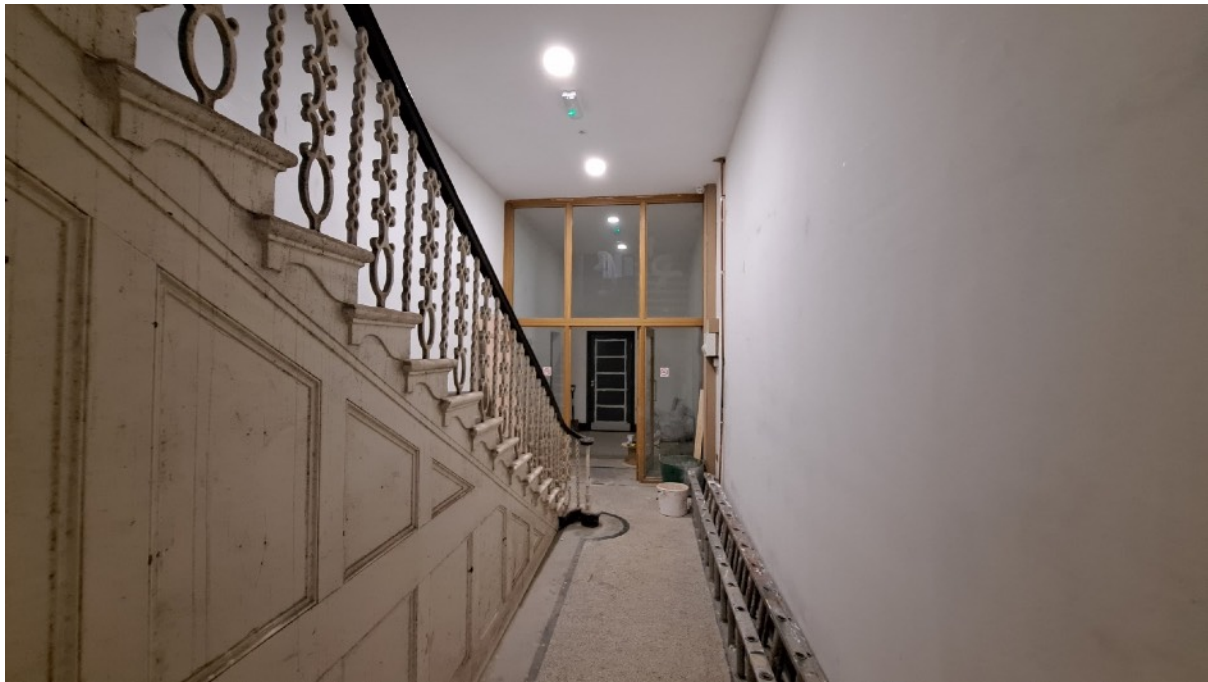
*Plate 27: Formerly Room G4, the stairwell looking back along what would have been the central corridor to the house. Inserted plaster ceiling conceals original detailing, but scagliola floor retained. Now CG02*

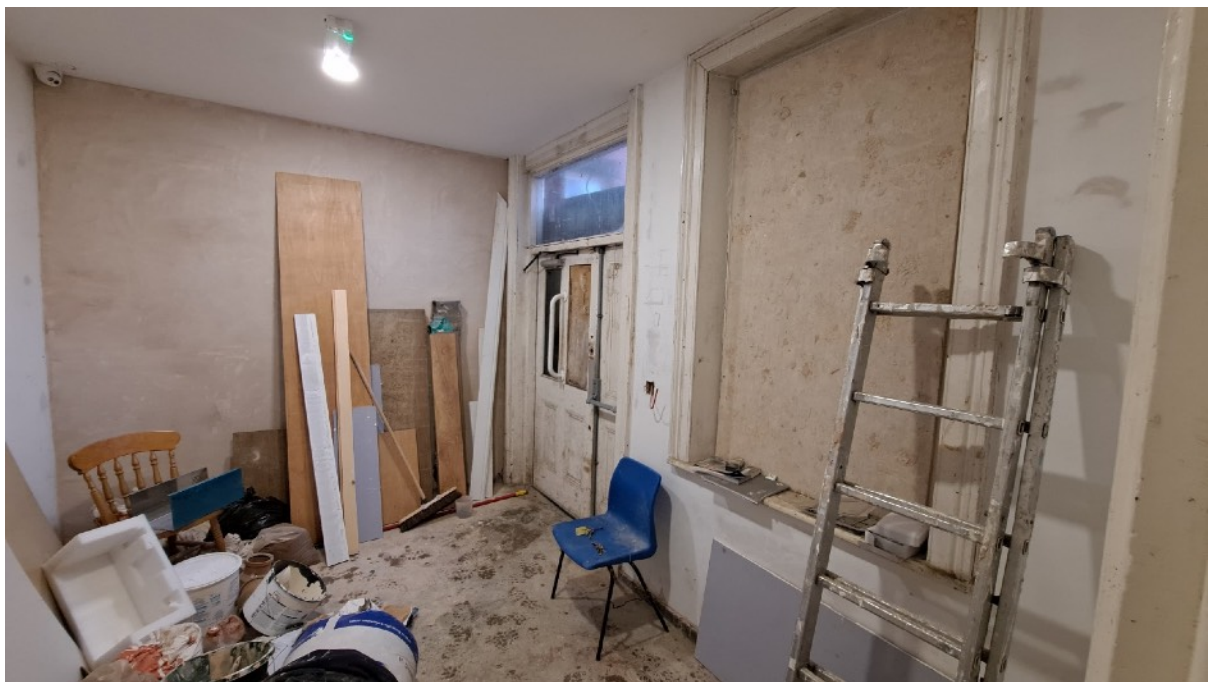
*Plate 28: Originally part of the continuation of the central corridor through the link (part of G14), now blocked to form CG01*

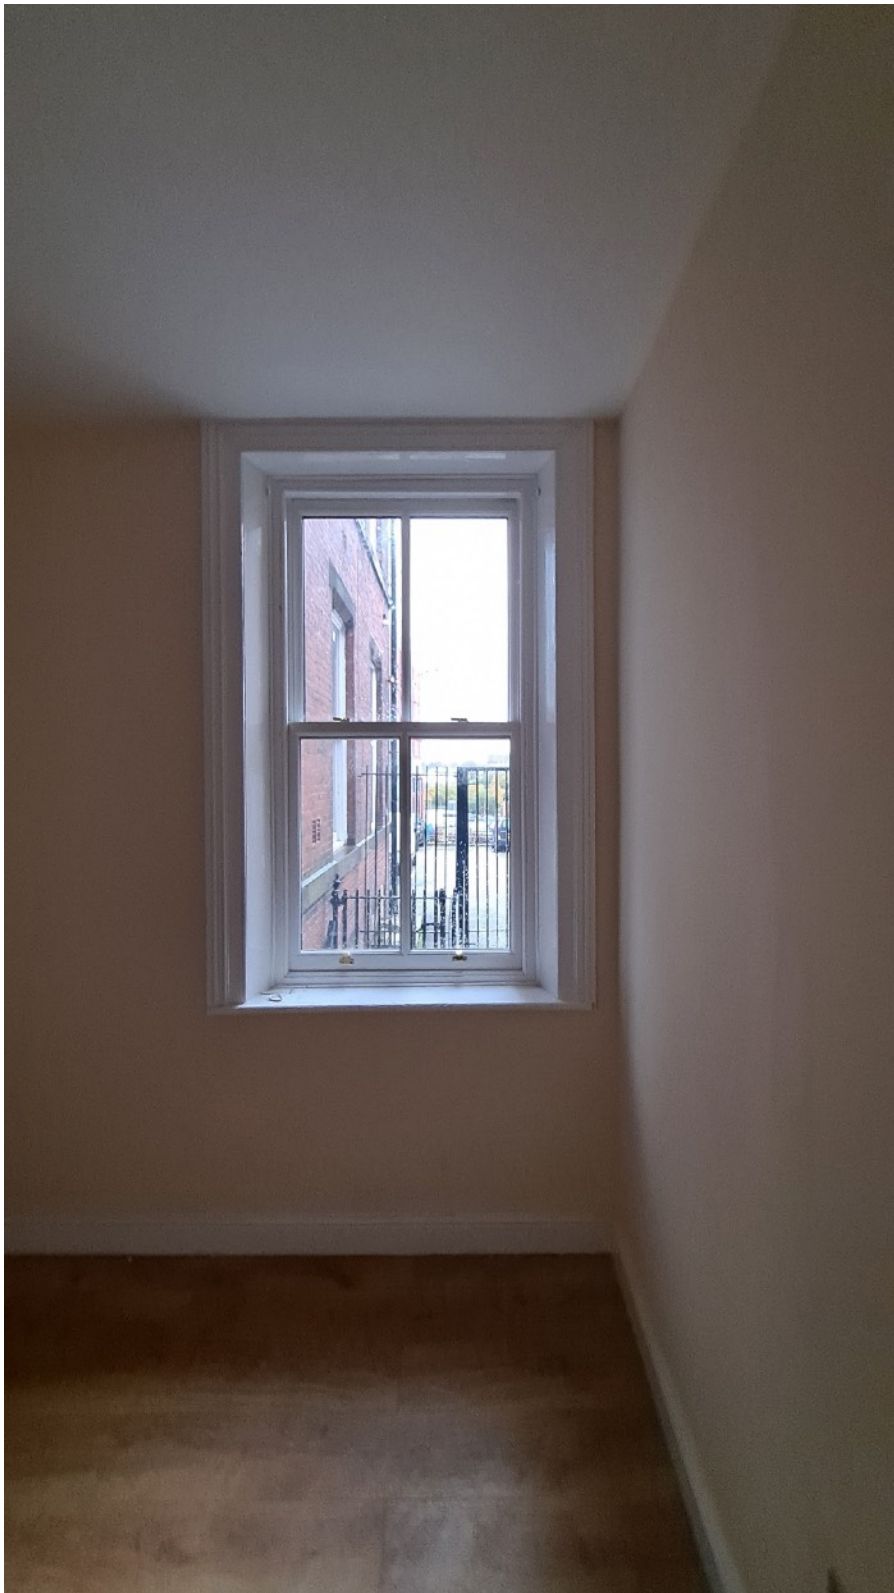
*Plate 29: Sash window in original surround in Room 4, Apartment 4 formed by inserting wall to right to block G14*

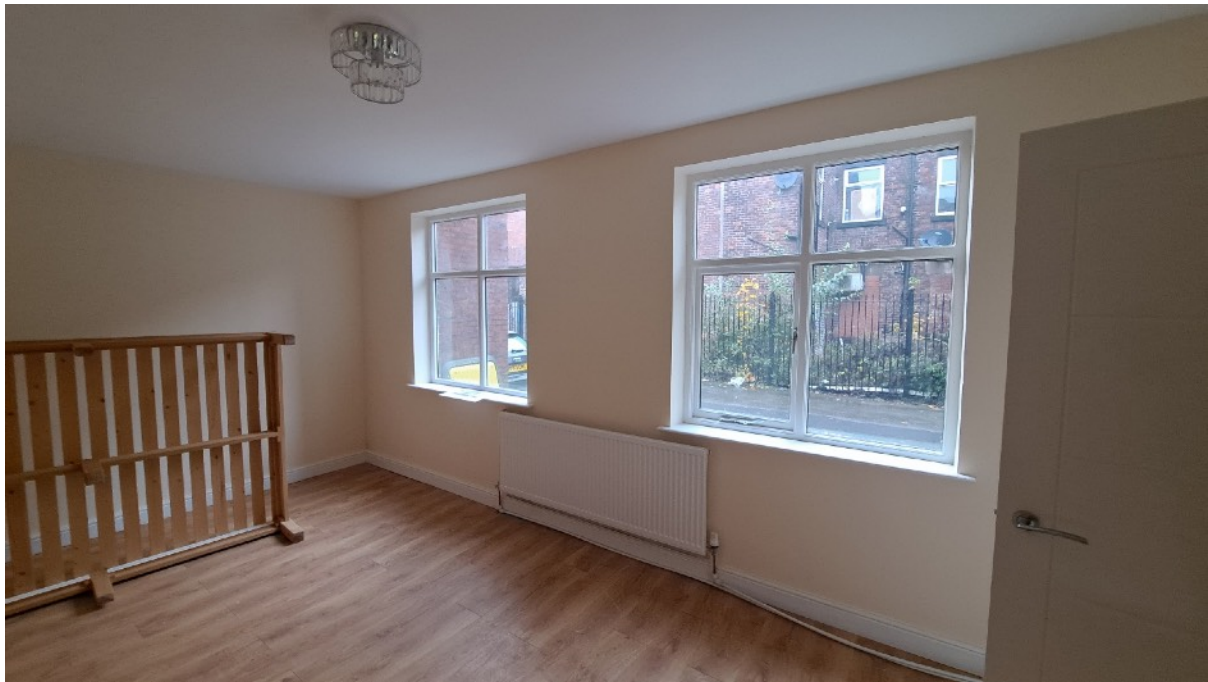
*Plate 30: A later single-storey office (G15) added to the rear of the link building now forming Room 5 of Apartment 4*

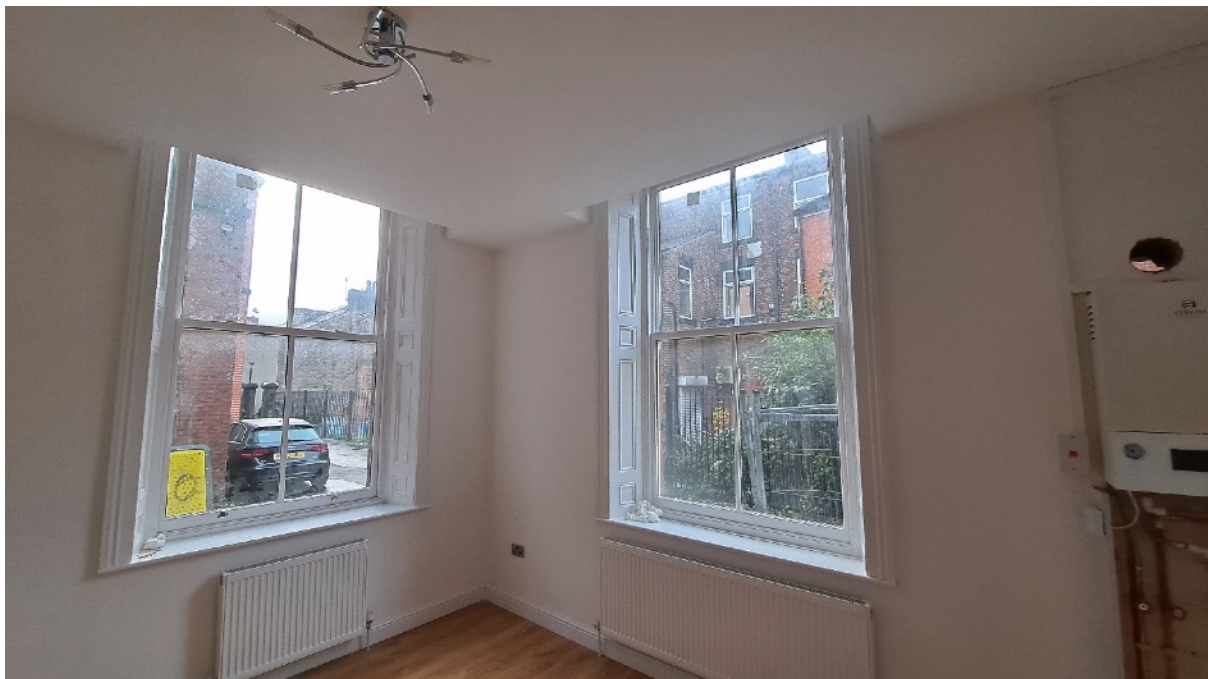
*Plate 31: Former office that was converted to form toilets (G16 and 17). Partitions removed to form Room 6 of Apartment 4. Retained window and surrounds with bulkheads, but apparently altered, and panels removed*

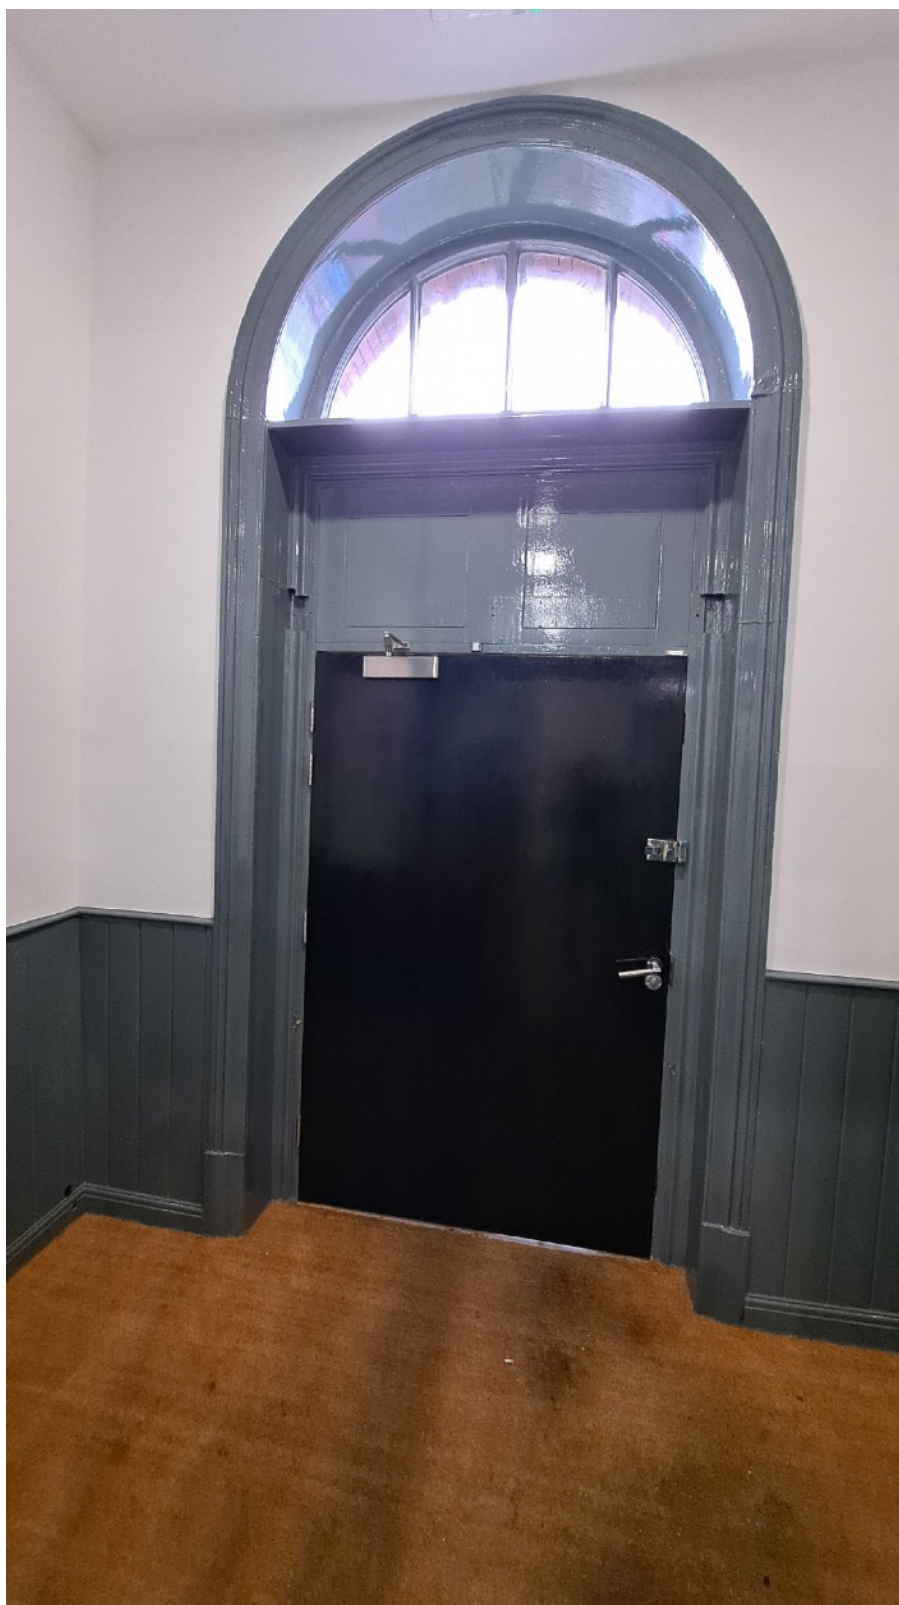
*Plate 32: Main entrance to extension with retained door surround and fanlight but replaced door. The vestibule retains its match boarding to dado. Formerly G23 now CG05*

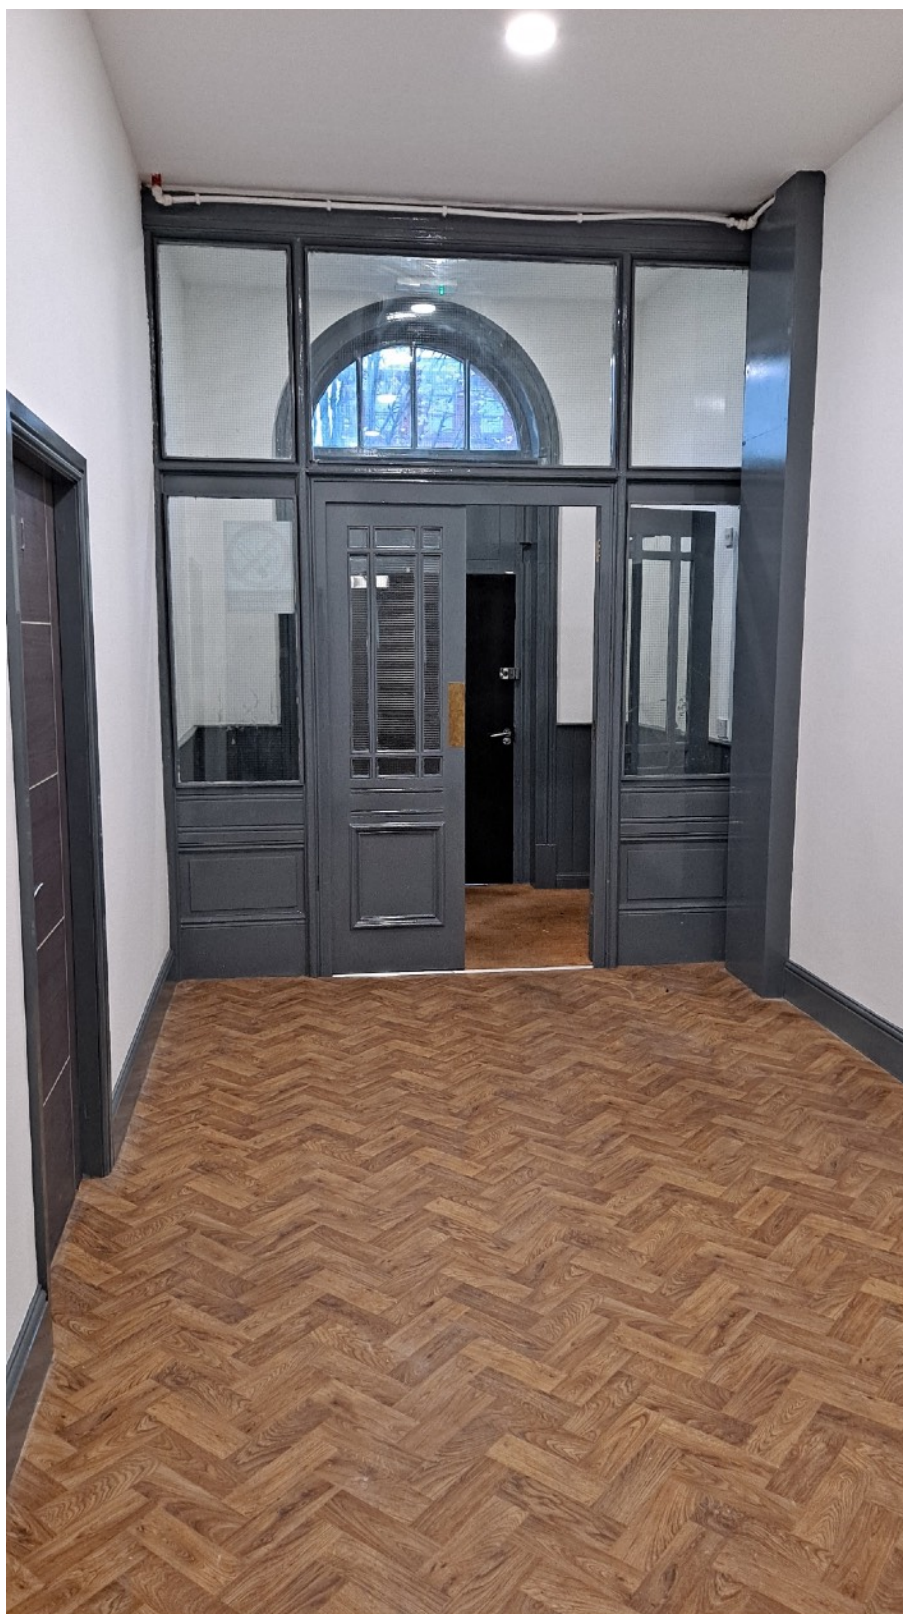
*Plate 33: The vestibule leads to a circulation area (G24) this was once a continuation of the central corridor. Now CG04*

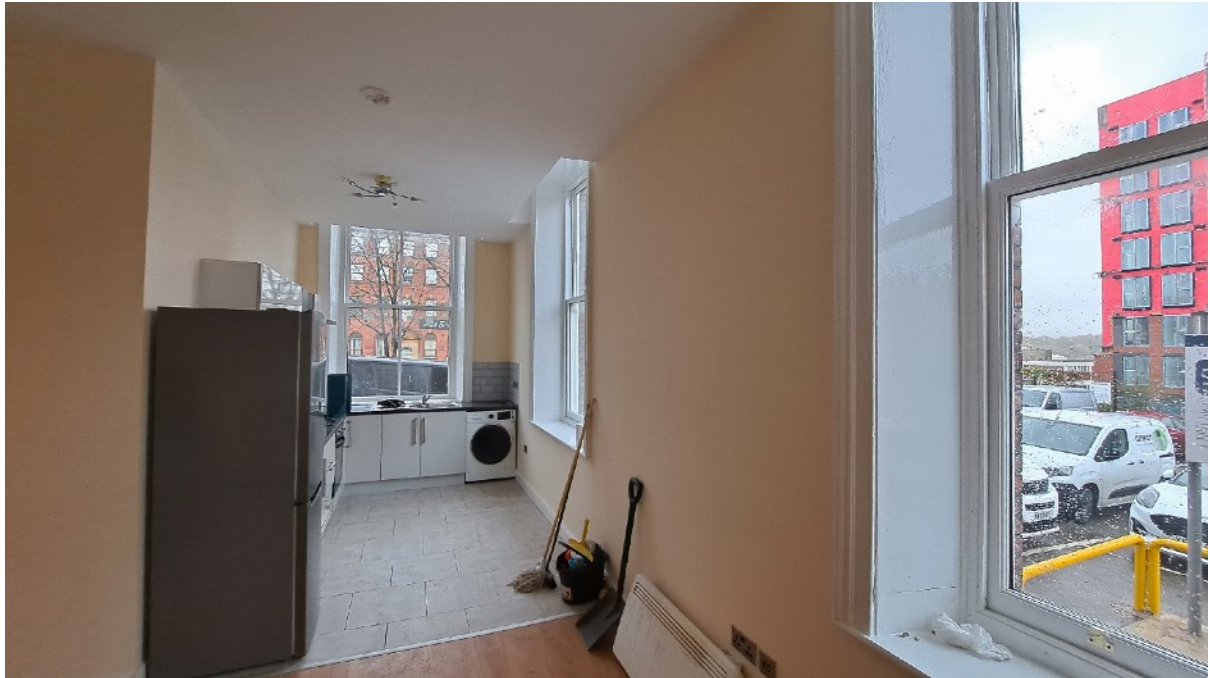
*Plate 34: Formerly a suite of rooms (G25 to 31) formed from the subdivision of the probable waiting hall, now reconfigured to form apartments 2 and 3. Room 4 of Apartment 2 shown above with retained window surrounds with bulkheads*

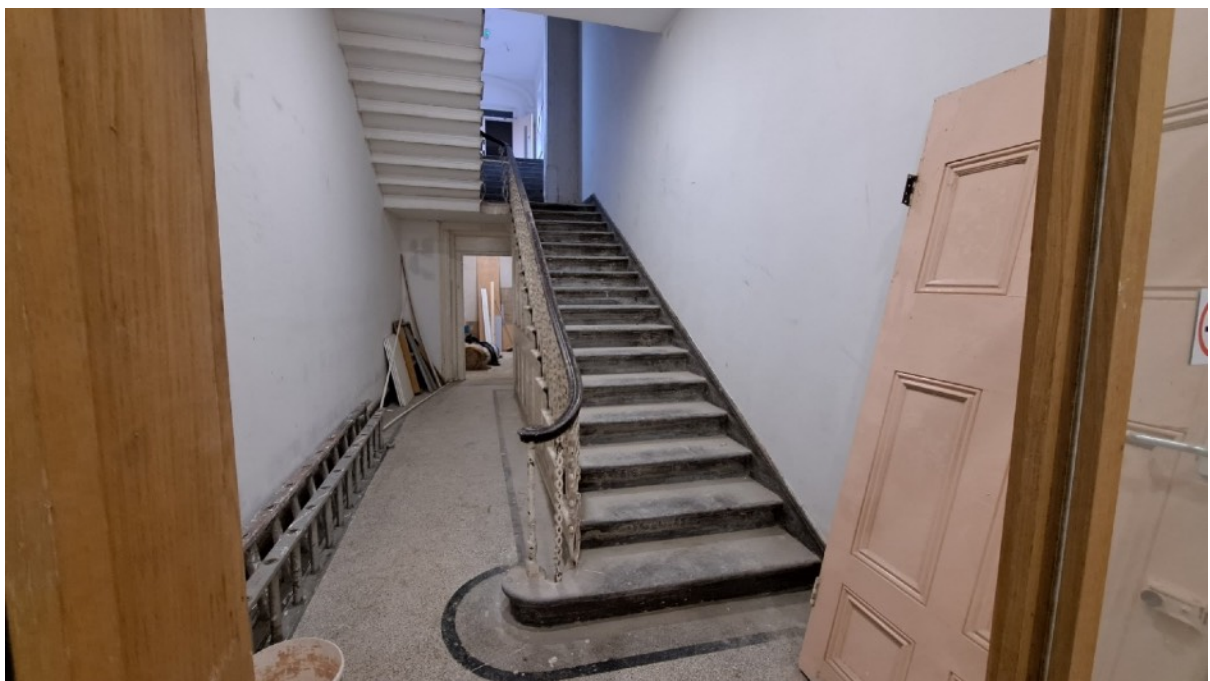
*Plate 35: Original cantilevered stone stair with flag landing, cast iron balustrade and mahogany handrail, now part of CG02*

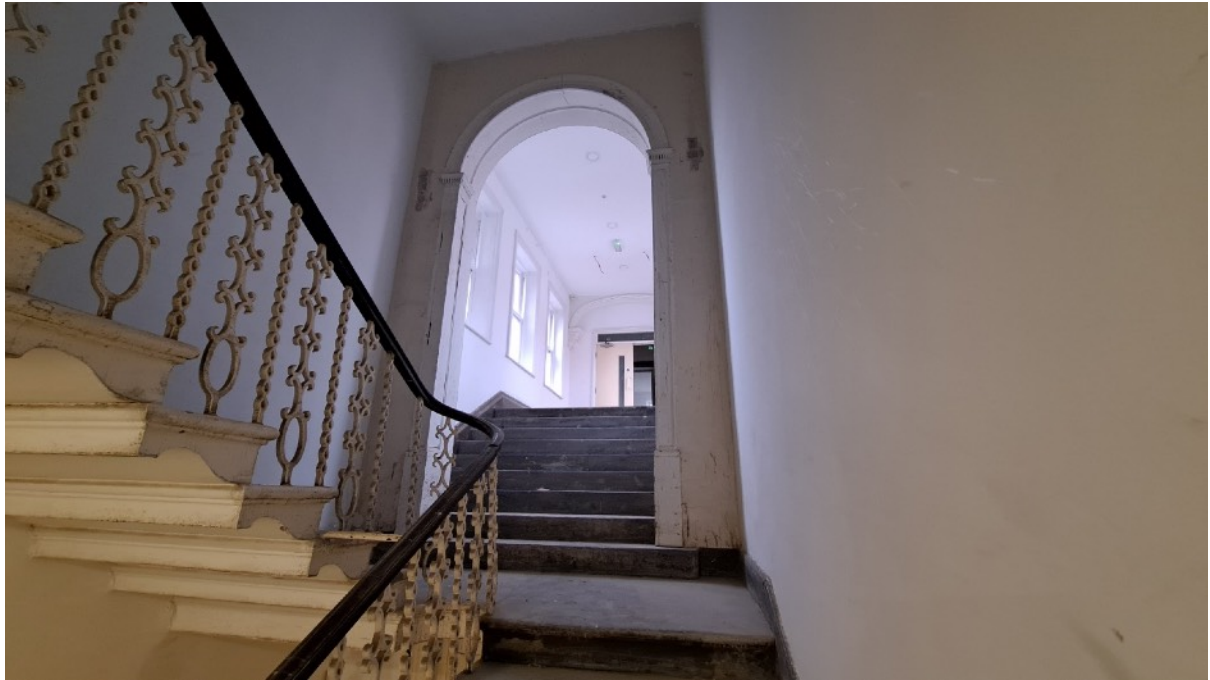
*Plate 36: The opening to the link building first floor corridor CF03, possibly formed from the original stairlight at the rear of the house*

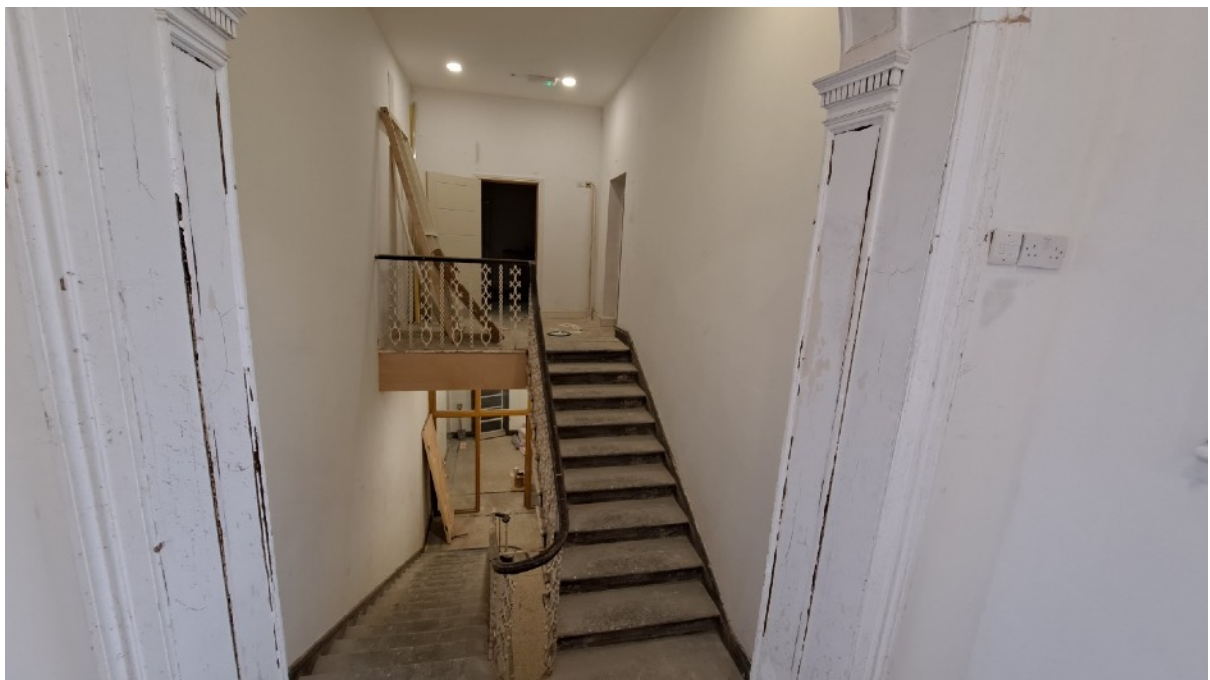
*Plate 37: Looking to the upper stairway and the landing (F6), now forming CF01*

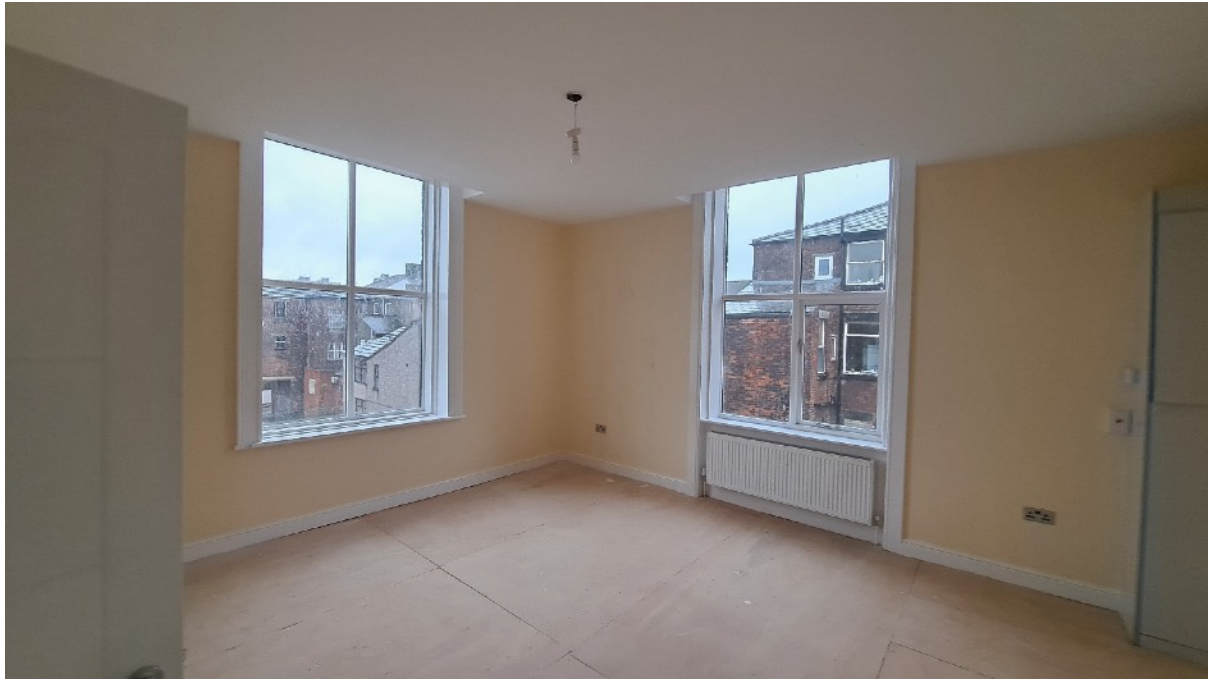
*Plate 38: A former principal bedroom (F1) with retained window surrounds and panel with bulkheads. Now Room 3 of Apartment 9*

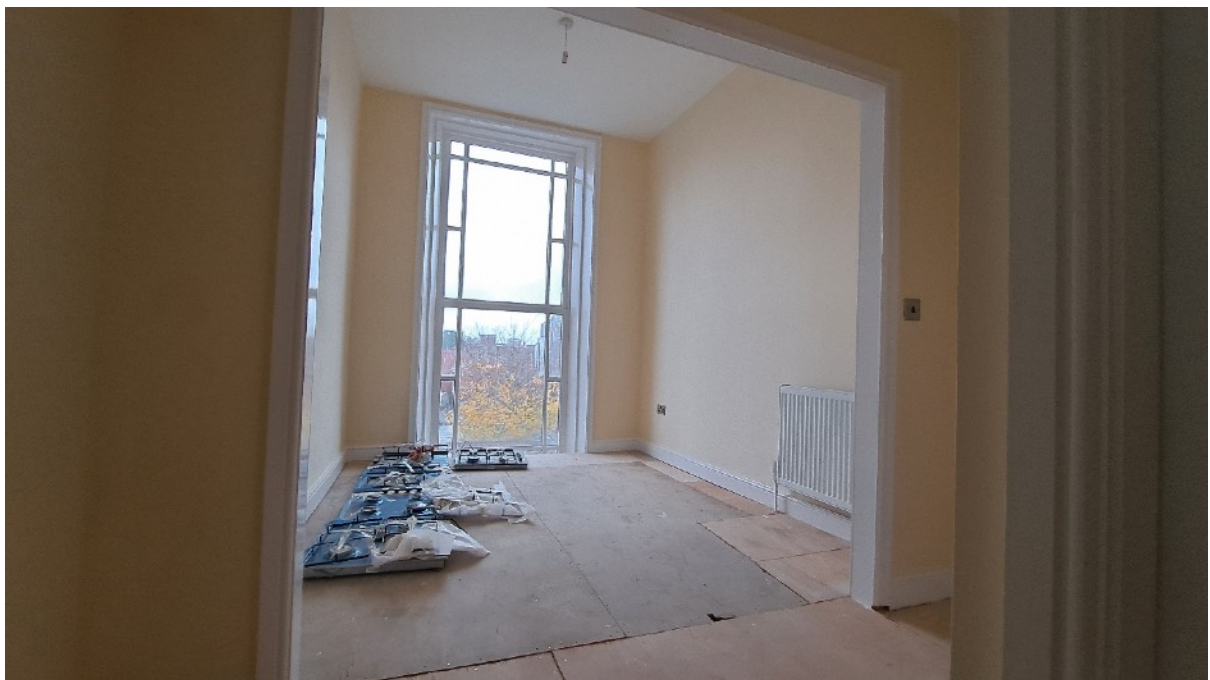
*Plate 39: Former F11, an inserted staircase to the front of the building, now altered to form Room 1 Apartment 9. The original window with marginal glazing bars has been retained in its original surround*

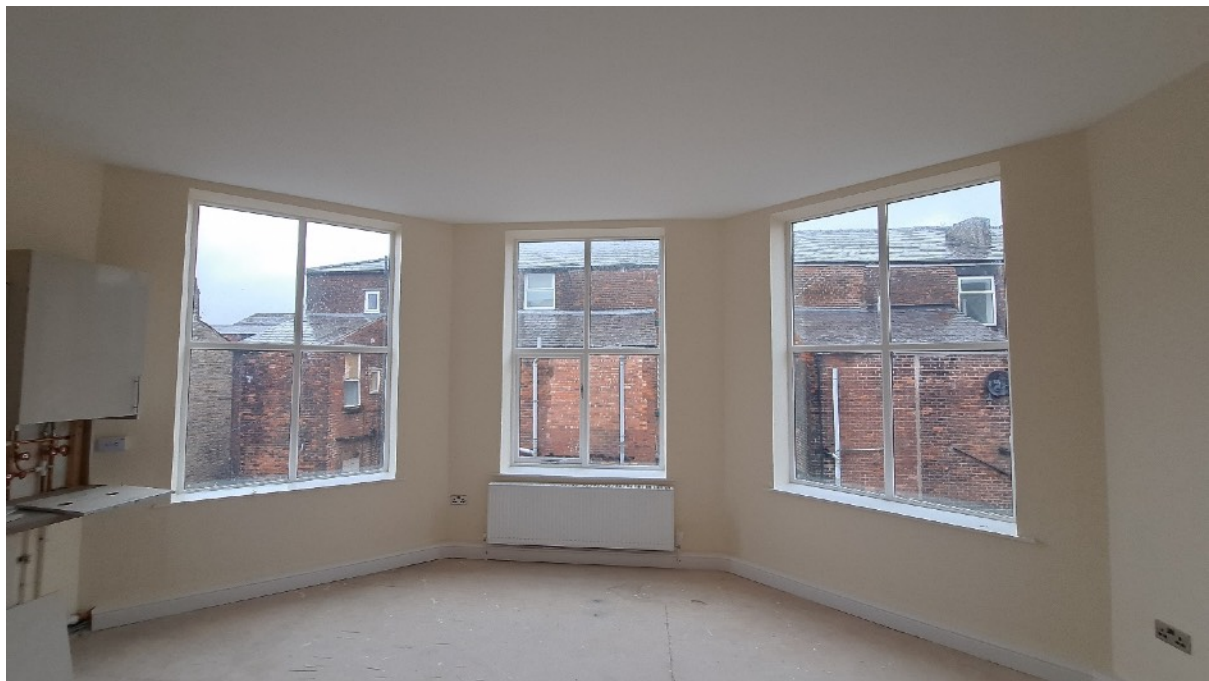
*Plate 40: Former principal bedroom (F2) now forming Room 3 of Apartment 8*

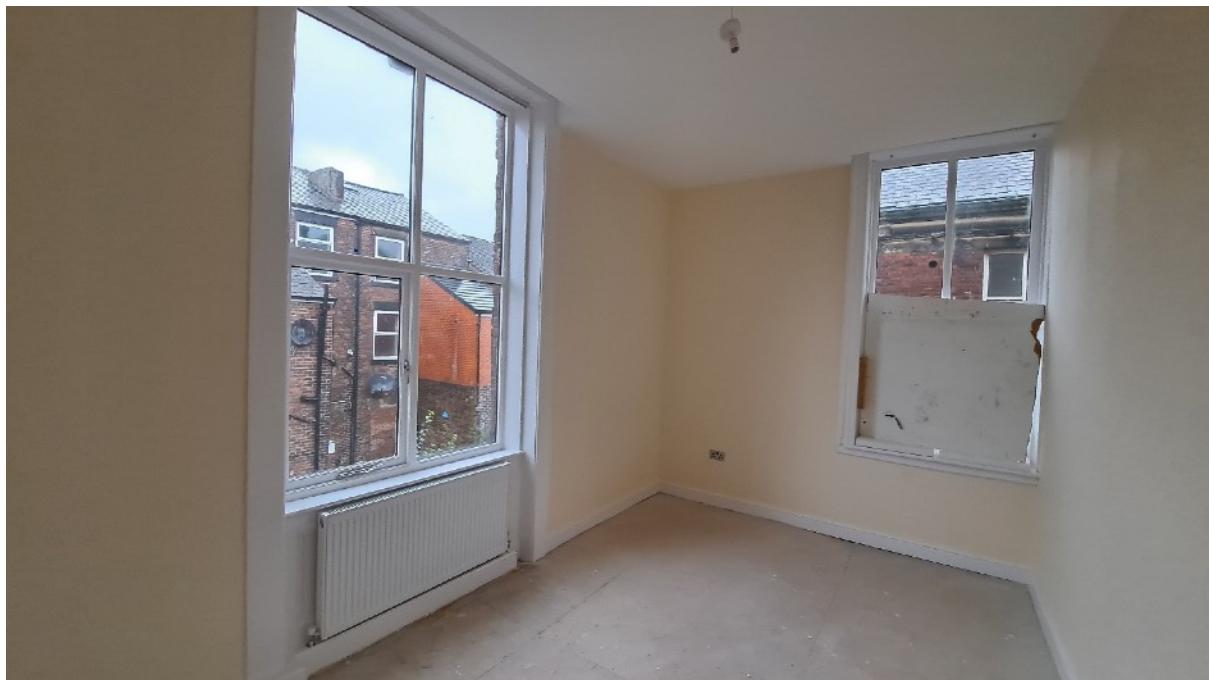
*Plate 41: Formerly F3, subdivided to form stair to attic, now Room 4 Apartment 8 accessed through reopened historic opening. Original window surrounds and panel with new frames*

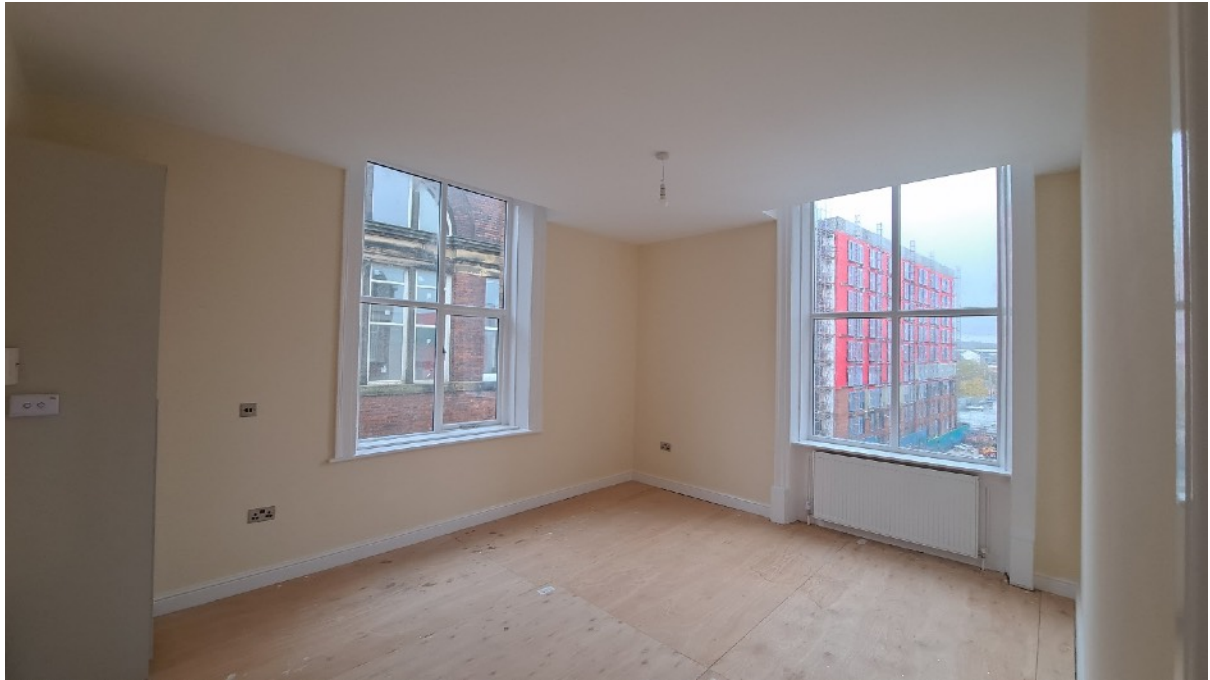
*Plate 42: Former bedroom (F7) now Room 2 Apartment 10 with partition to form corridor. Original window surrounds and panel with new frames and bulkheads*

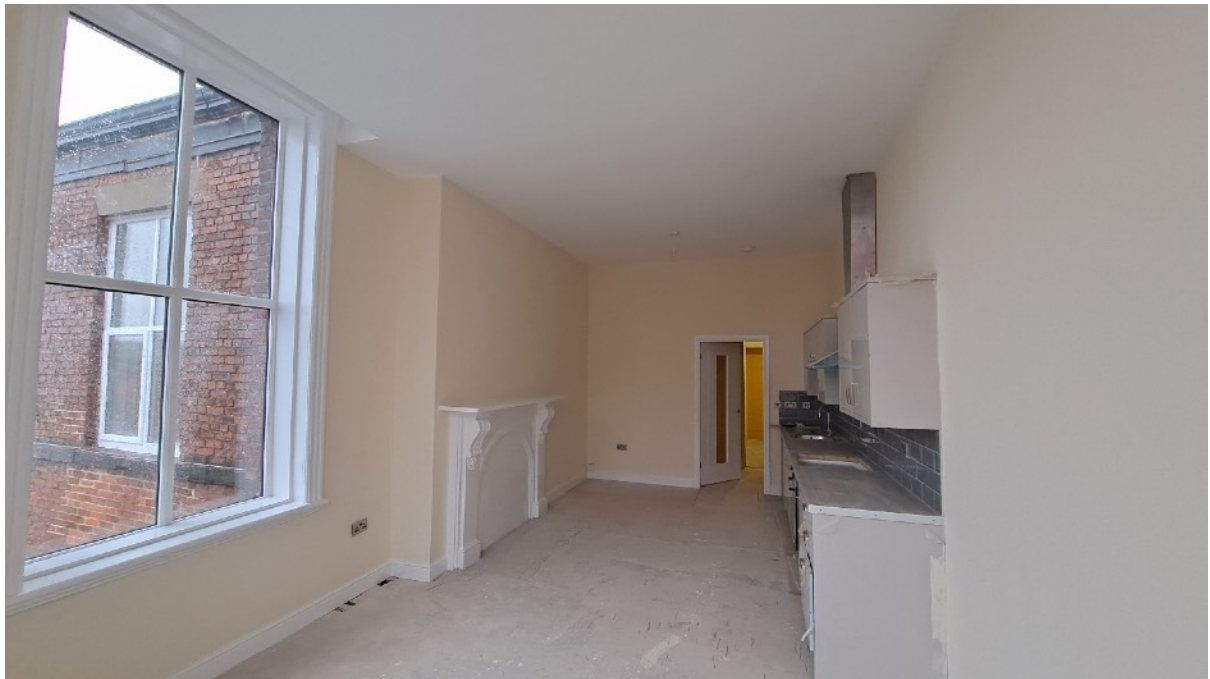
*Plate 43: Former bedroom (F8) now subdivided to form Apartment 10, Room 5 above retains a fireplace. Modern windows in original surrounds have bulkheads*

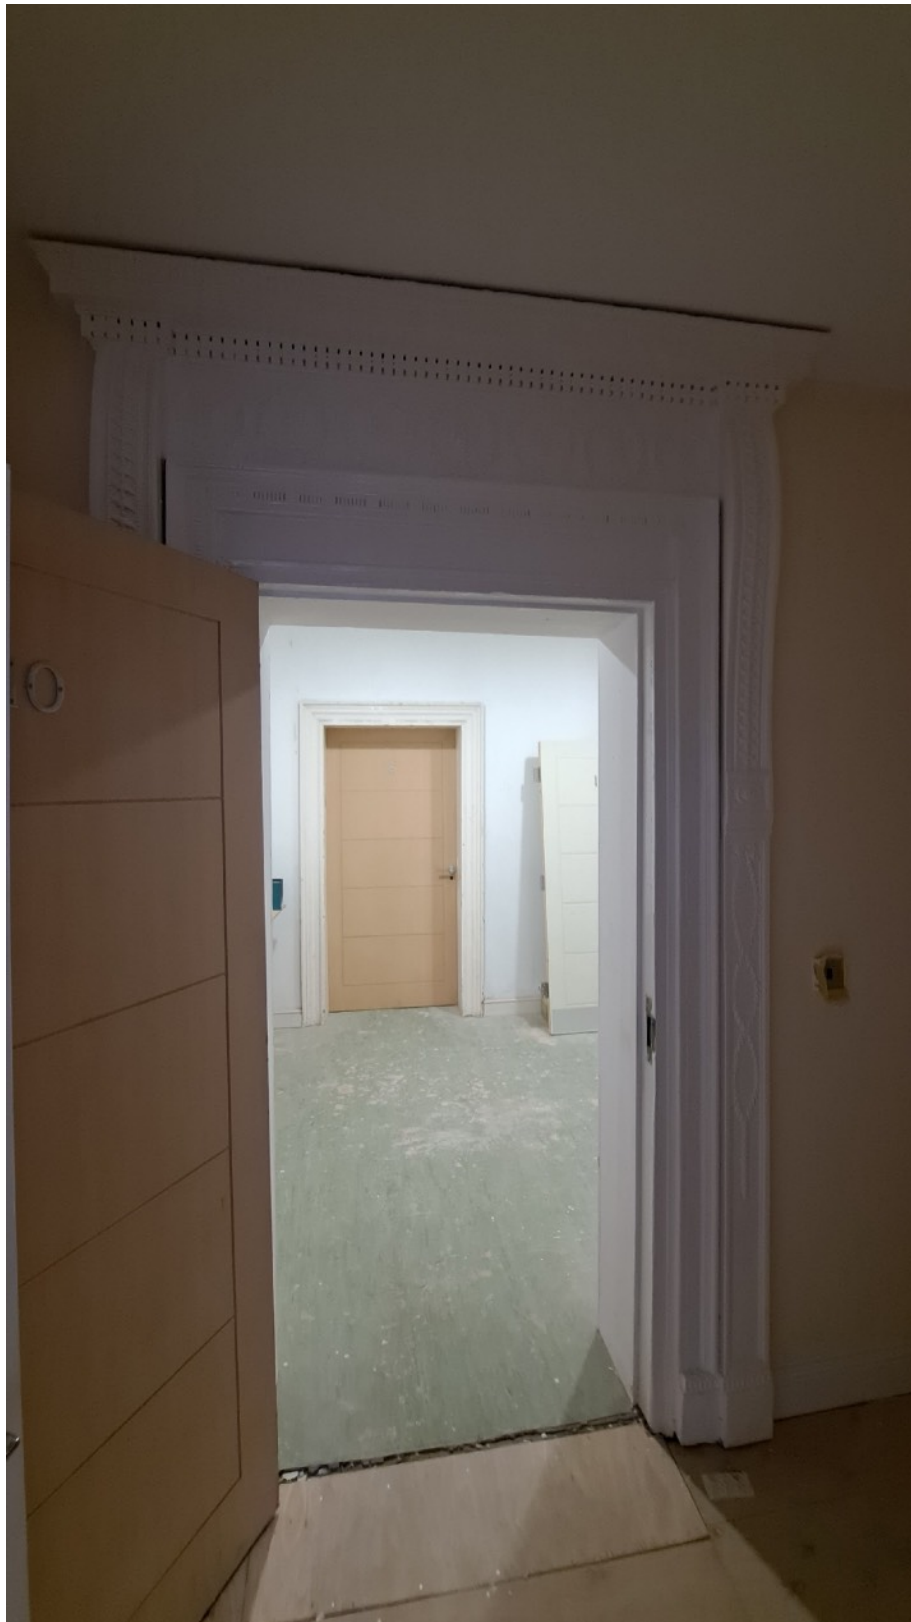
*Plate 44: The original doorway to Apartment 10 has been retained, however, the six-panel door is replaced with a modern fire door*

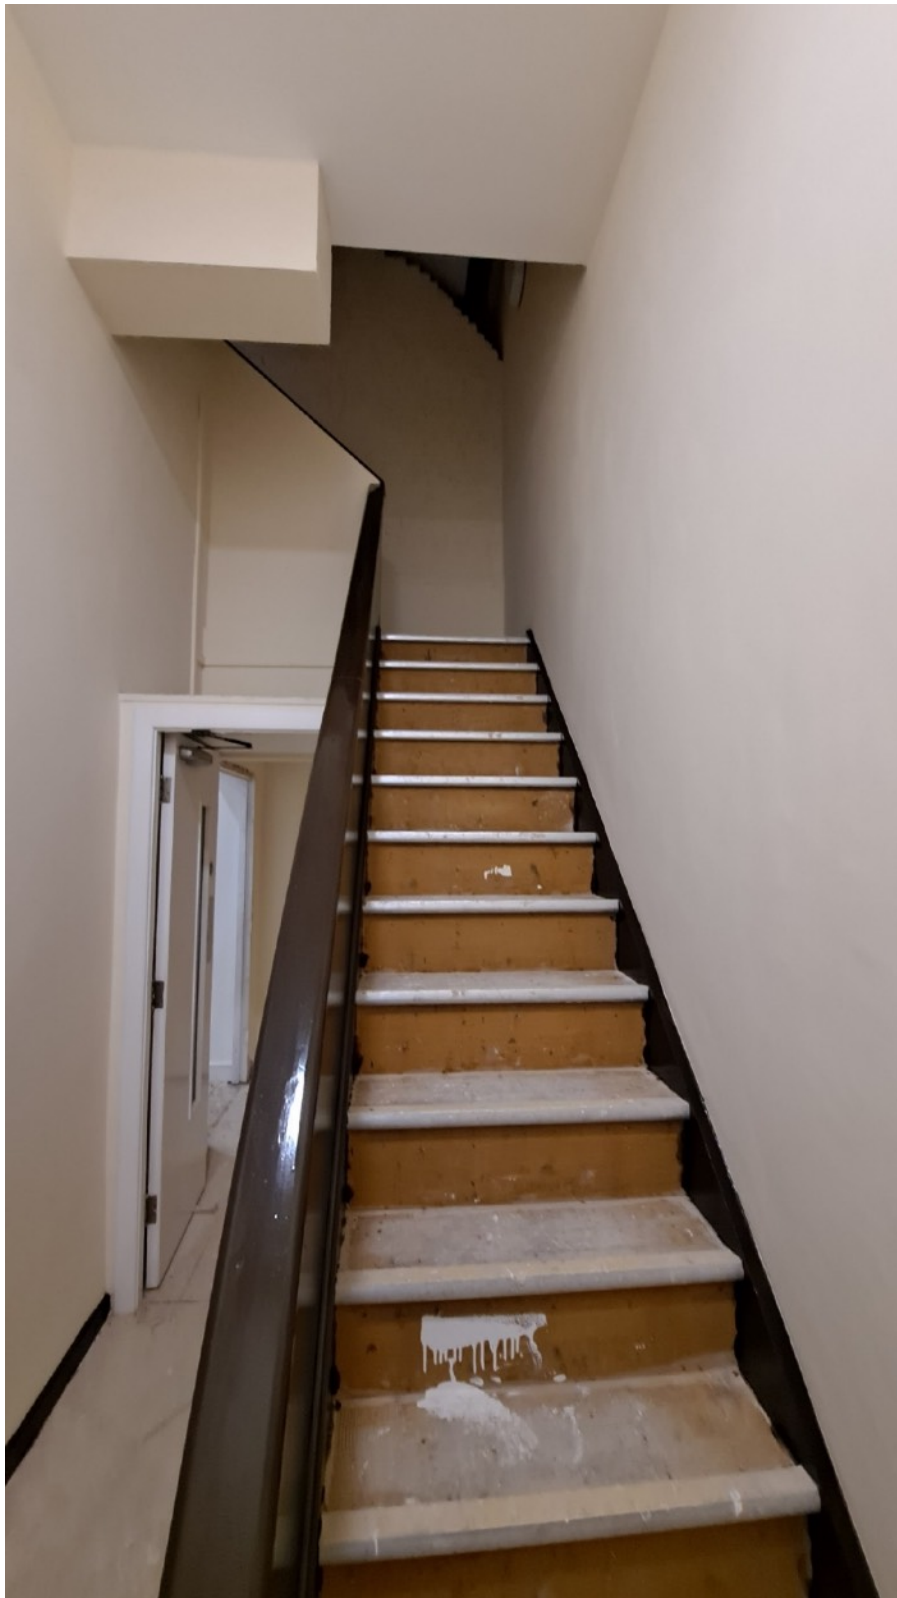
*Plate 45: Attic stair (F5) now Room 1 of Apartment 11*

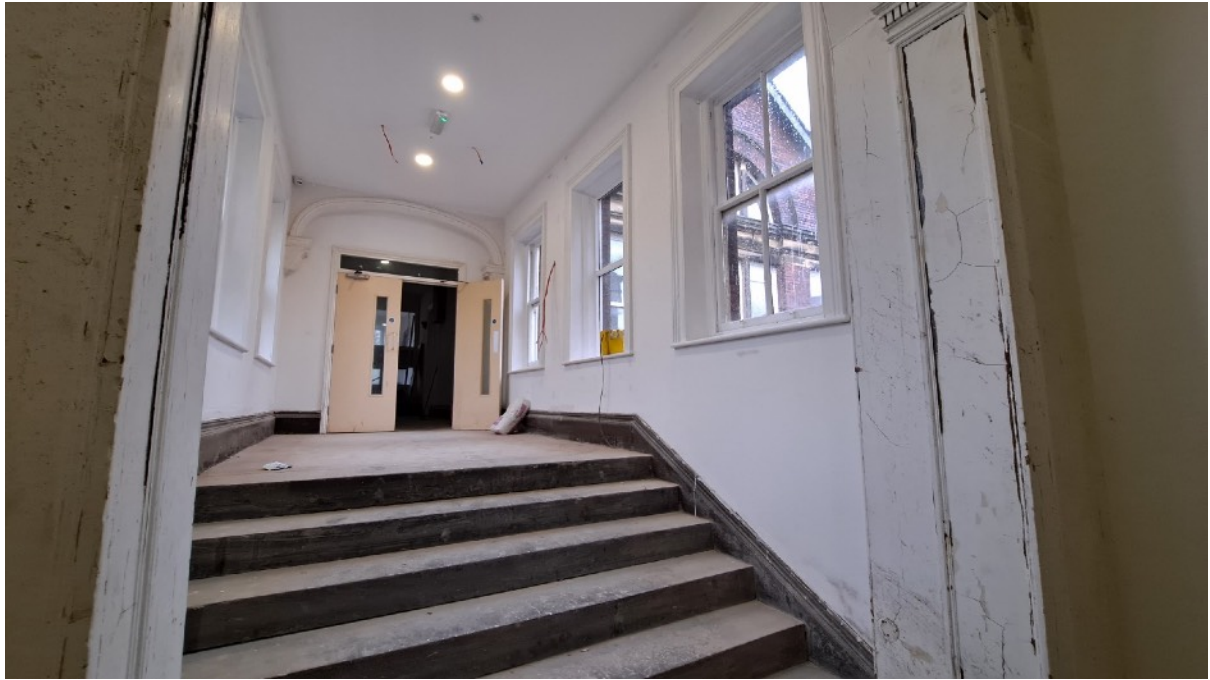
*Plate 46: The Link passage and stair (F12), now CF03, was the original access to the Board Room and retains original features, although the corbelled arch has a modern inserted partition and door. Modern windows in original surrounds*
