## **Introduction**

This document is a Photographic Survey of Townhead House, a Grade II listed building, off Yorkshire Street, Rochdale. Rochdale Borough Council have issued a number of conditions pertaining to the proposed development of the property and this record fulfils Condition No. 13 for Listed Building Consent. In 2015 a gazetteer was produced for the property and included in a heritage statement. That gazetteer has been amended to document recent changes and includes cross-referencing to the plates forming this record. Photographic registers showing the location and direction of each photograph are included as Figures 1-5 below.

## **Photographic Survey: Townhead, Rochdale**

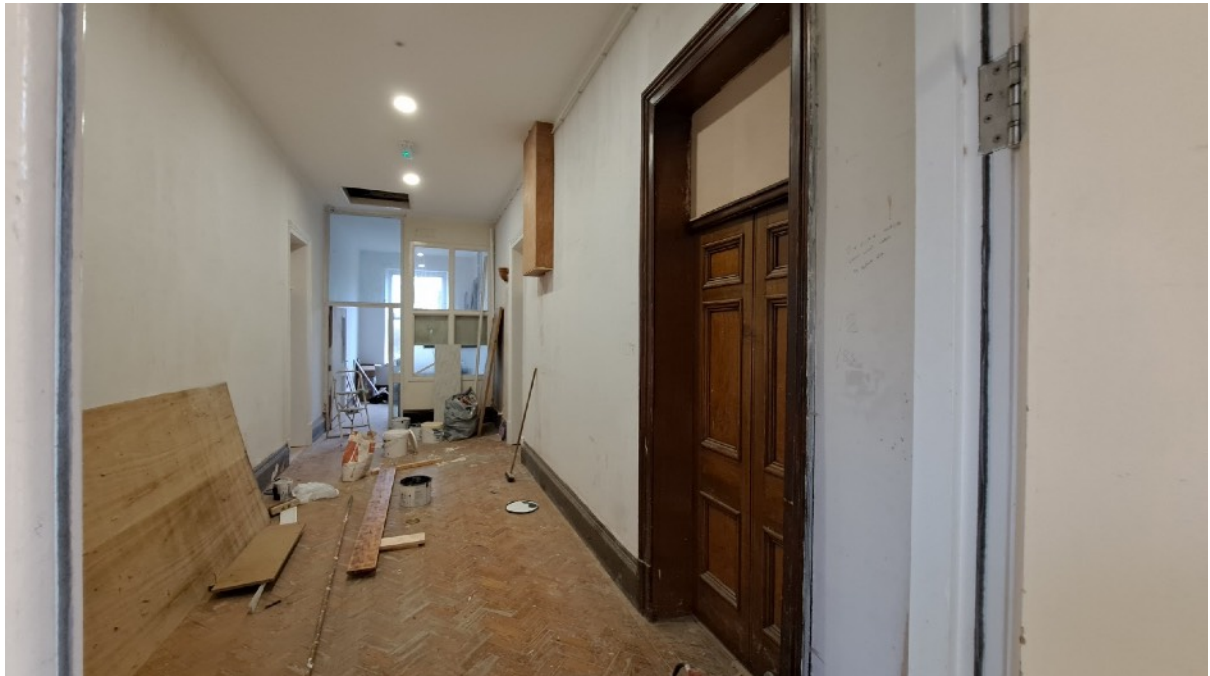
*Plate 47: The corbelled arch leads to the access corridor to the Board Room (F13), now CF04. High quality finishes including skirting and door surrounds have been retained with original Board Room door*

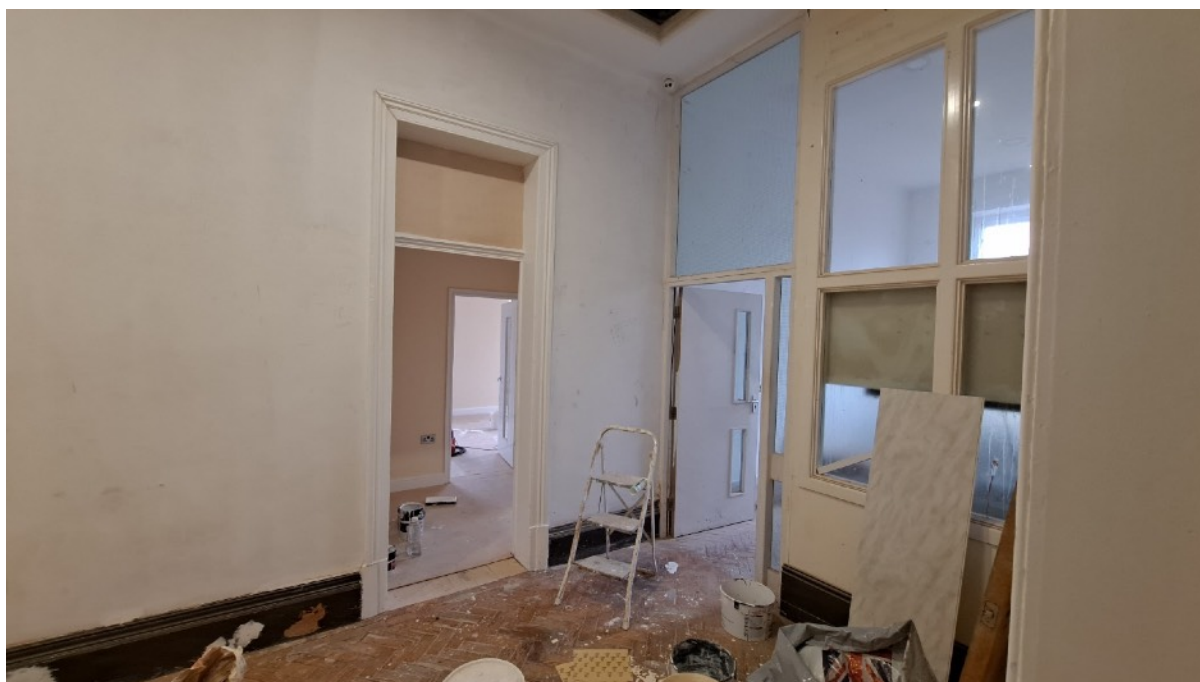
*Plate 48: To the right the Manager's Office, with the original door surround retained for the entrance to Apartment 14 to centre*

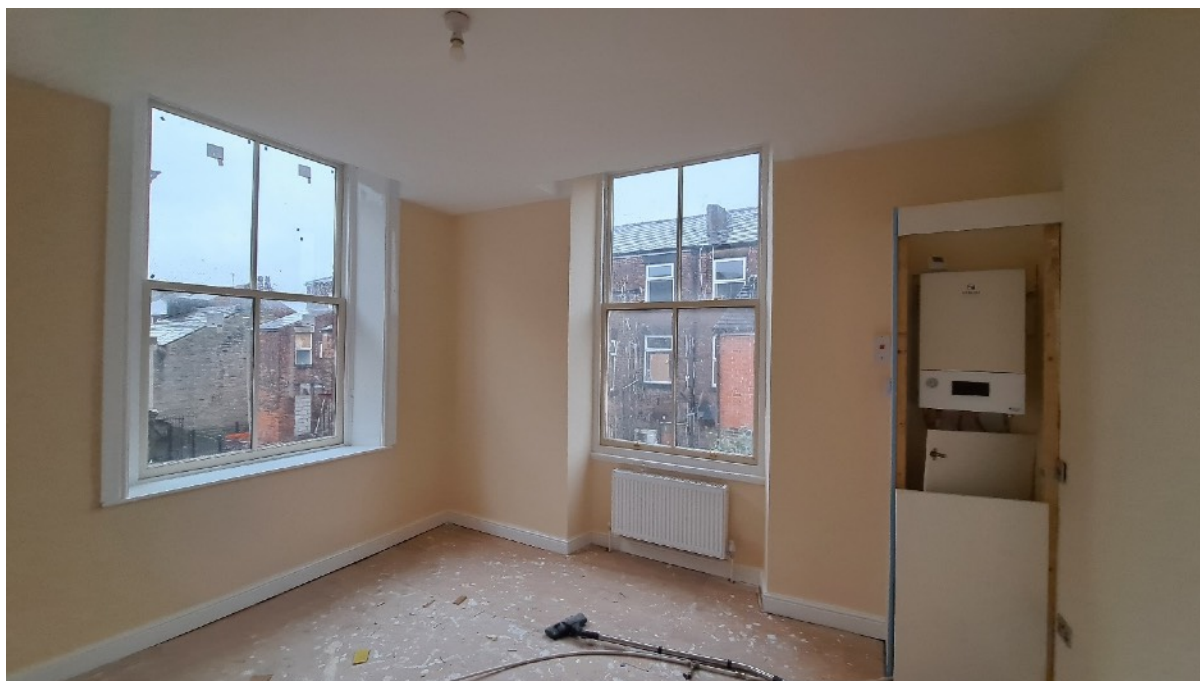
*Plate 49: Former toilets (F14 and 15) with partitions removed to form Room 3 of Apartment 14. Window surrounds retained with modern windows*

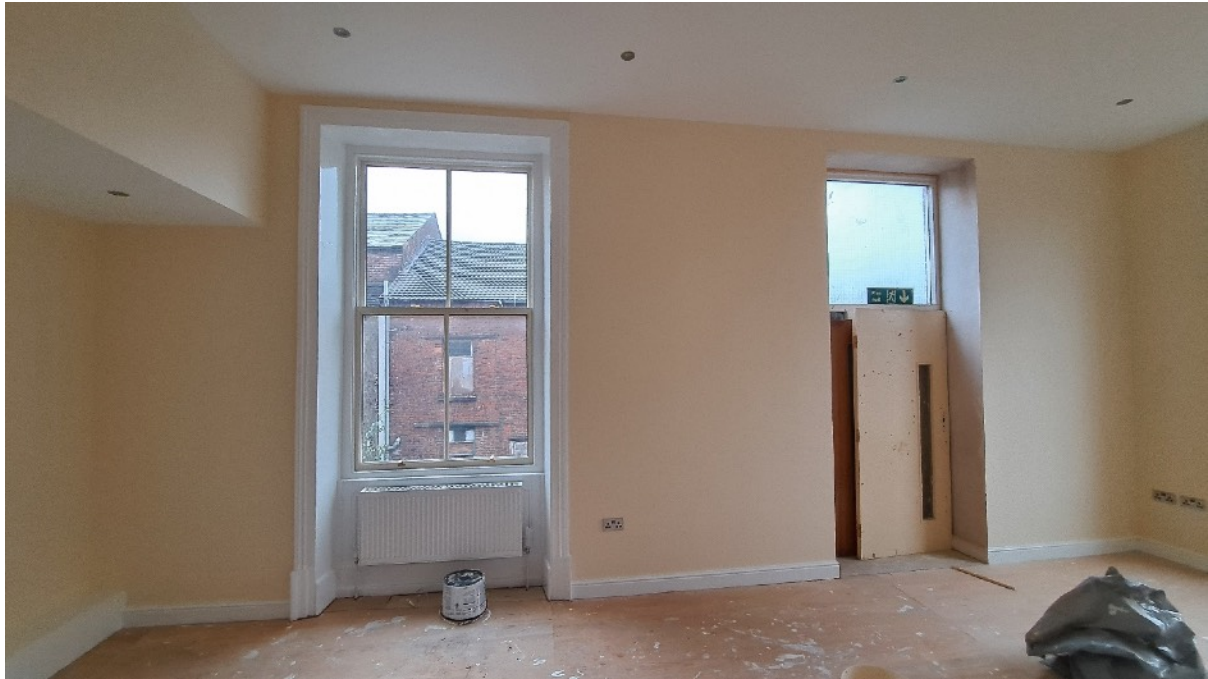
*Plate 50: Former offices F16, 17 and 18 have had partitions removed to form Room 4 of Apartment 14, but the space has been subdivided to form Rooms 1 and 5*

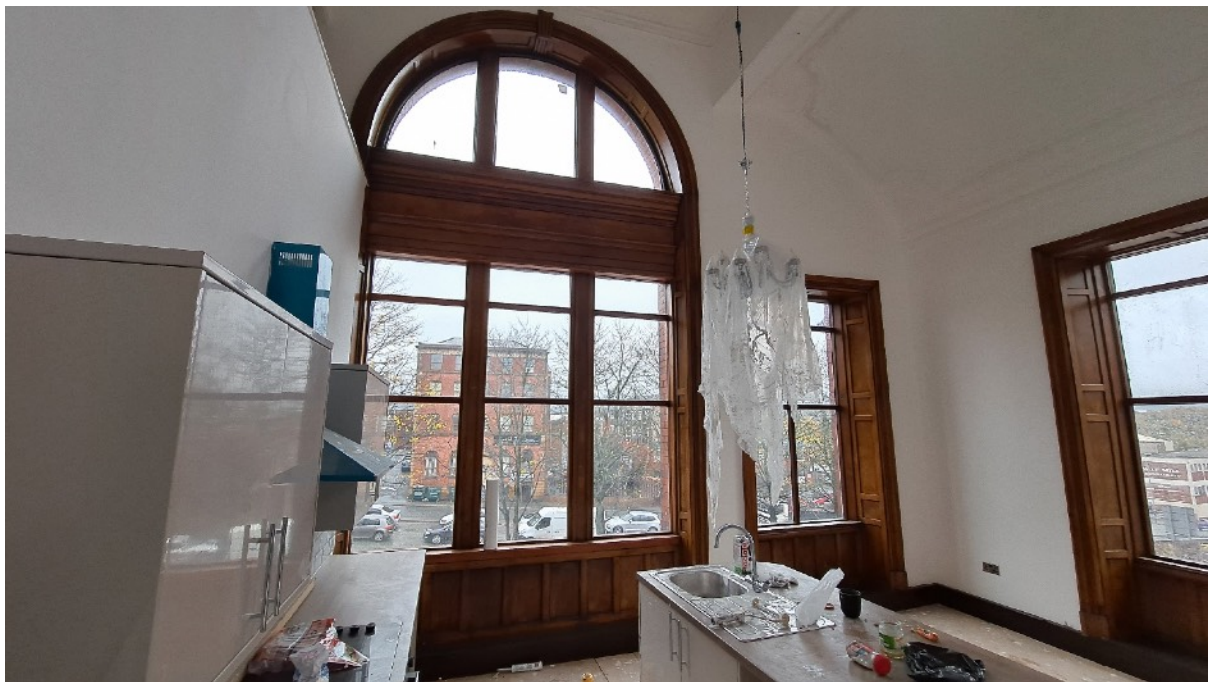
*Plate 51: The high status Board Room is lit by Venetian windows on three sides. Former subdivisions to form F20 and 21 have been altered and the northern end of the space is now Apartment 13. Much of the decoration of the Board Room has been retained including window surrounds but some windows have been replaced*

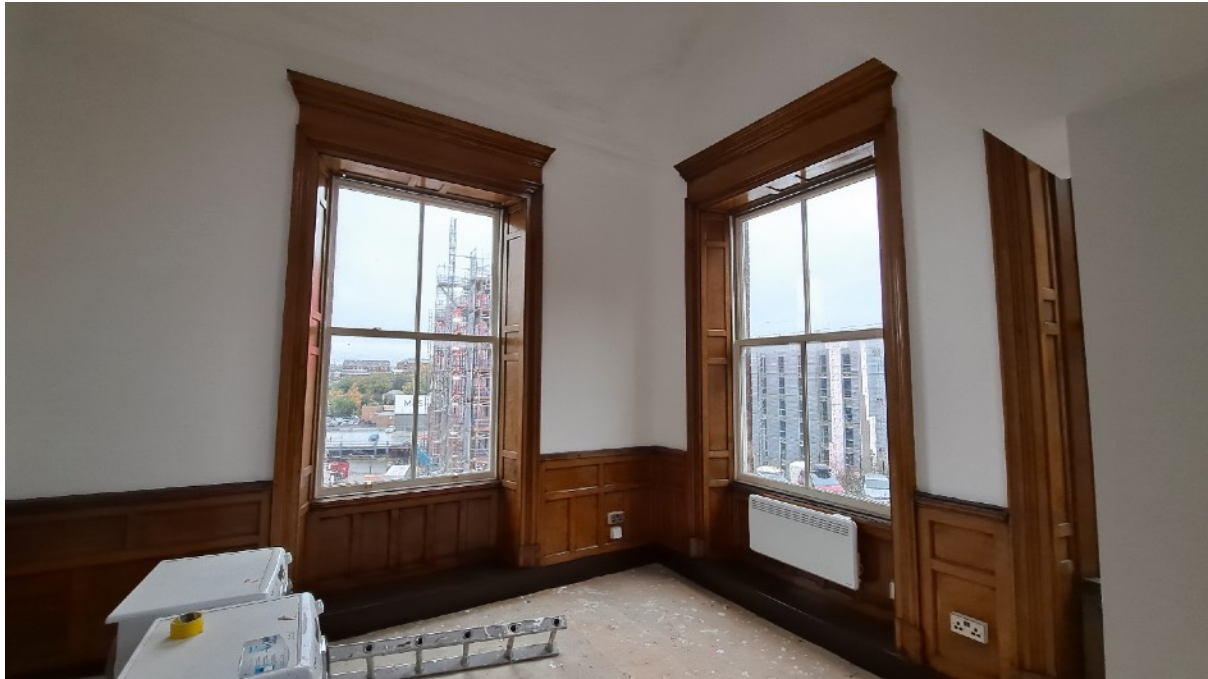
*Plate 52: As with Apartment 13 original features have been retained in Apartment 12 but some windows have been replaced*

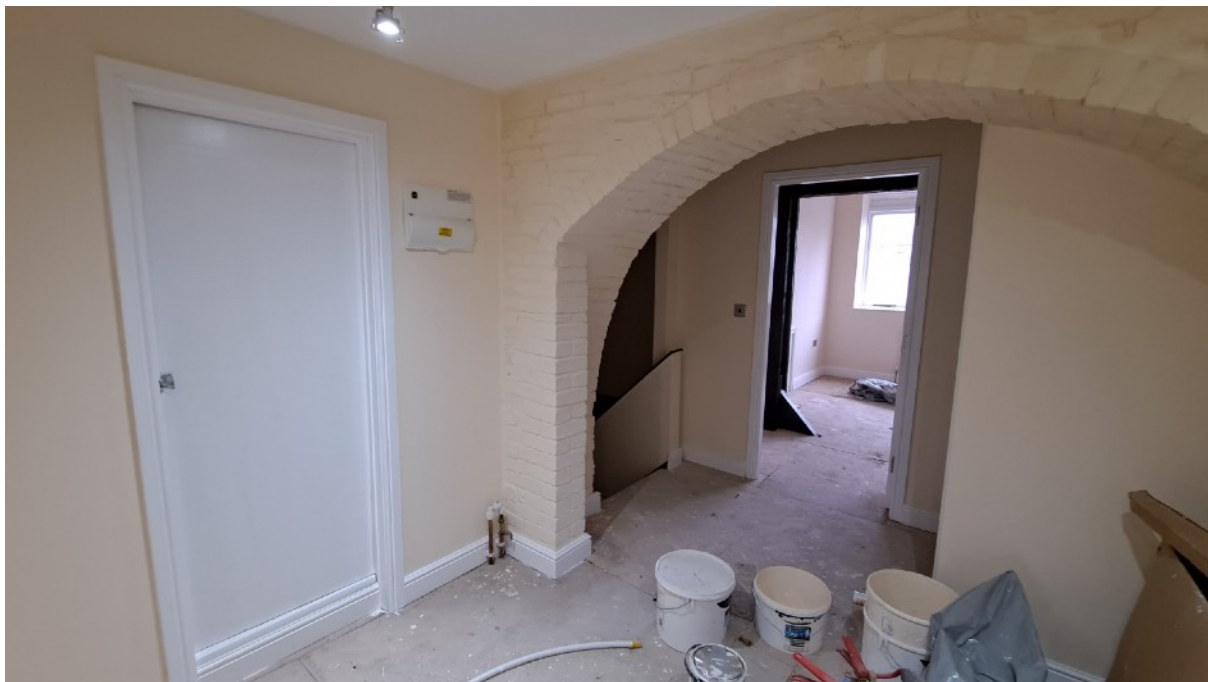
*Plate 53: The attic stair, centre, leads into what is now Apartment 11, formed in the attic space*

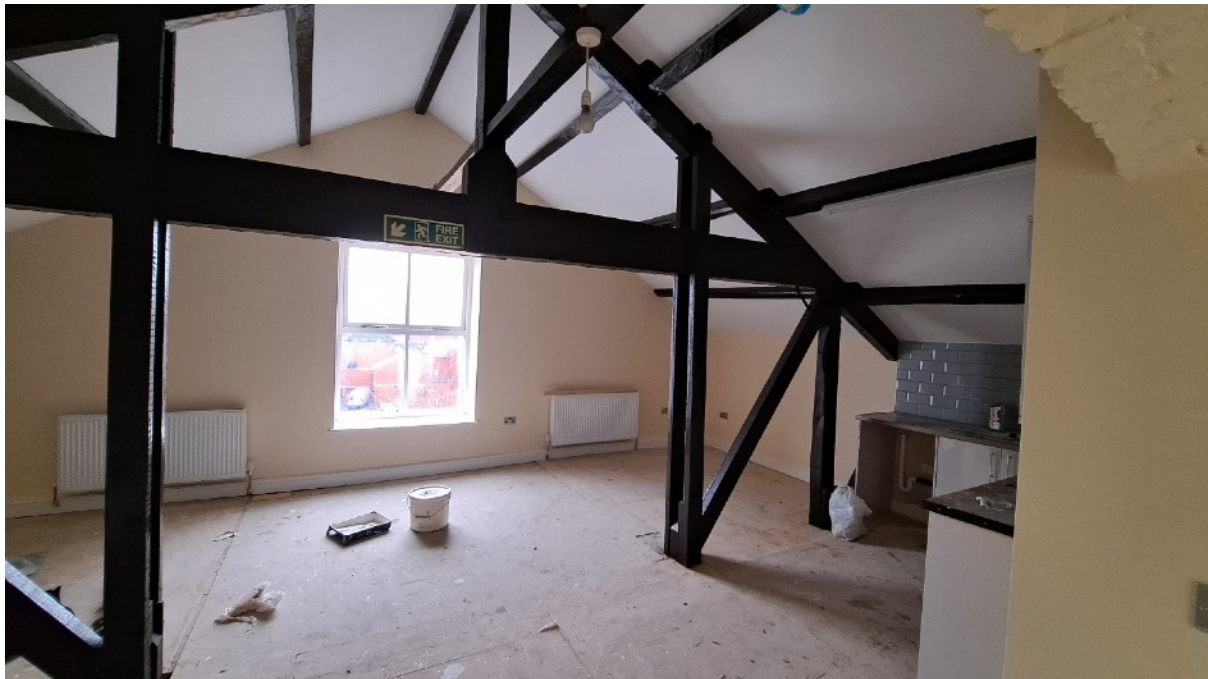
*Plate 54: Room 4 of Apartment 11 is lit by the window in the front gable of the house*

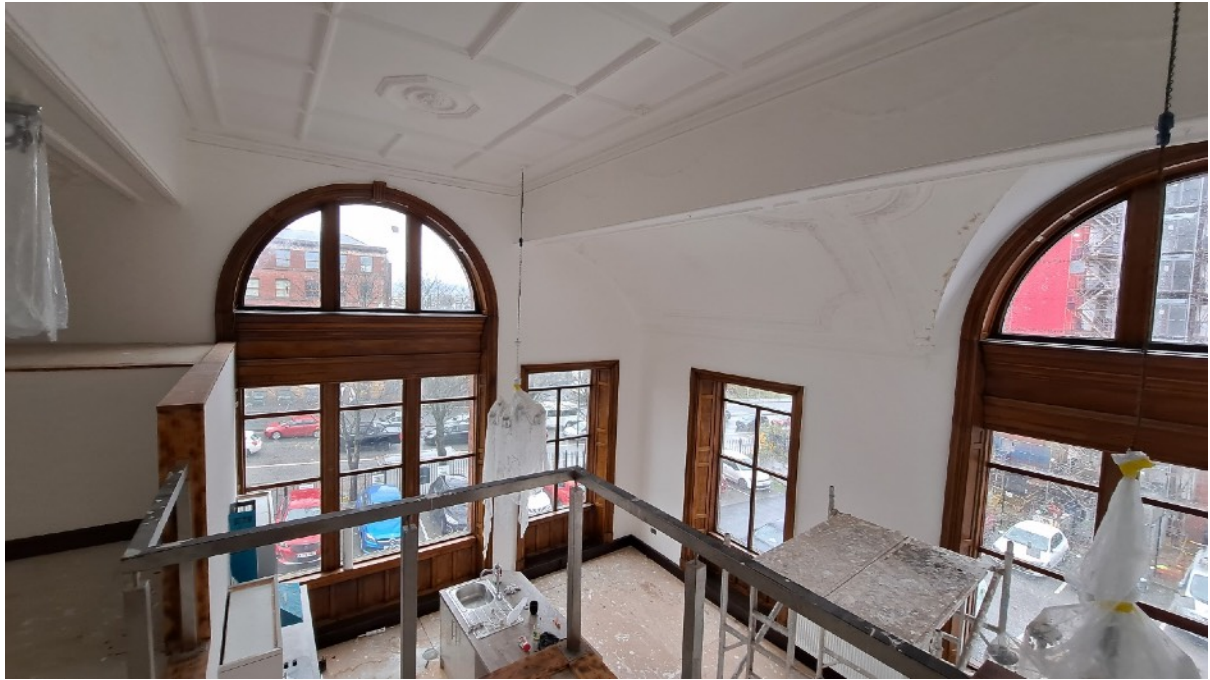
*Plate 56: The full height of the Board Room has been used in Apartment 13 with the introduction of a mezzanine floor*

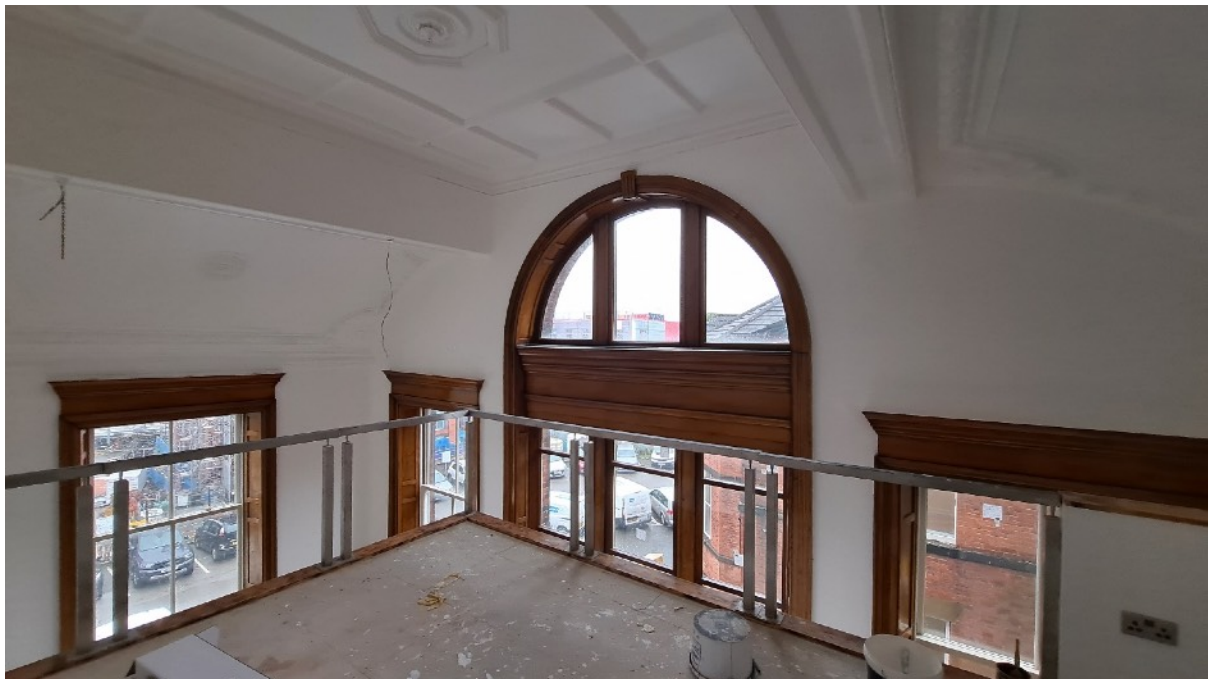
*Plate 57: At the southern end of the Board Room (F22) a similar approach to Apartment 13 has been used to form Apartment 12*
