# **Preliminary Bat Roost Assessment Report**

**Petrol Filling Station,  
Yorkshire Street,  
Rochdale,  
OL16 2DR**

**02.02.2023**

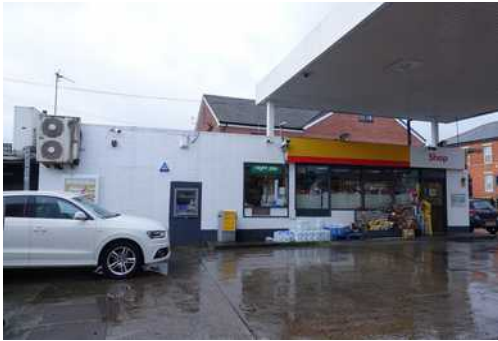
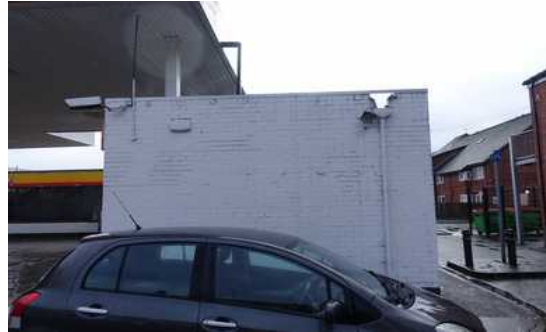
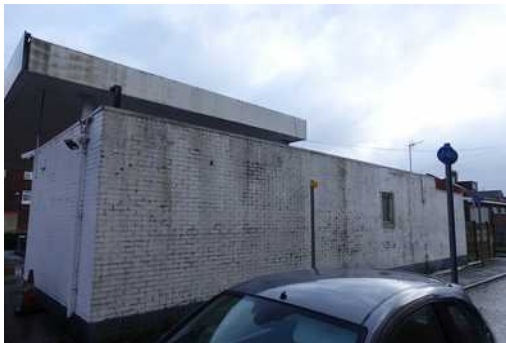
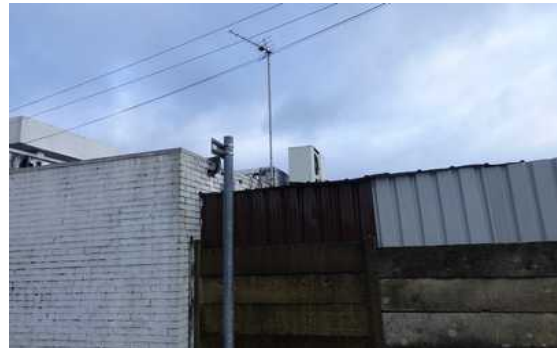
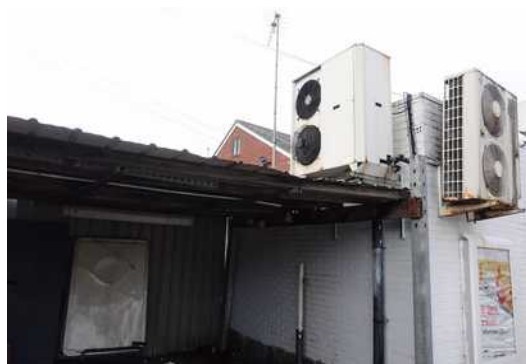
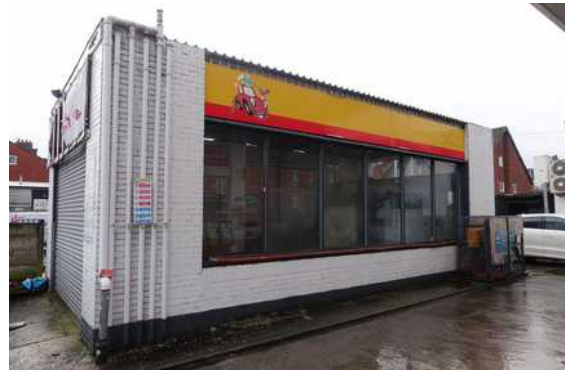
The property consists of a detached brick built single storey building with a flat roof. A single storey lean-to with corrugated metal roof is present on the southern gable. A detached car wash building with single skin corrugated metal roof present to the east of the filling station building. External walls are generally well pointed and painted with no cracks, crevices or cavities present.

The roof is in good condition with no cracks, crevices or cavities present.

The property can be considered to offer negligible bat potential.

The building is well sealed with no cracks, gaps, cavities or crevices suitable for roosting bats and was assessed as offering negligible roosting potential.

No evidence (in the form of scattered droppings, urine splashing, feeding remains or grease marking) to suggest use by bats was recorded.
