Sartex, Norwich Mill – Rochdale.

# STRUCTURAL ENGINEERS REPORT

23220/PMH/KLH  
26<sup>th</sup> April 2023

**Sartex, Norwich Mill – Rochdale.**

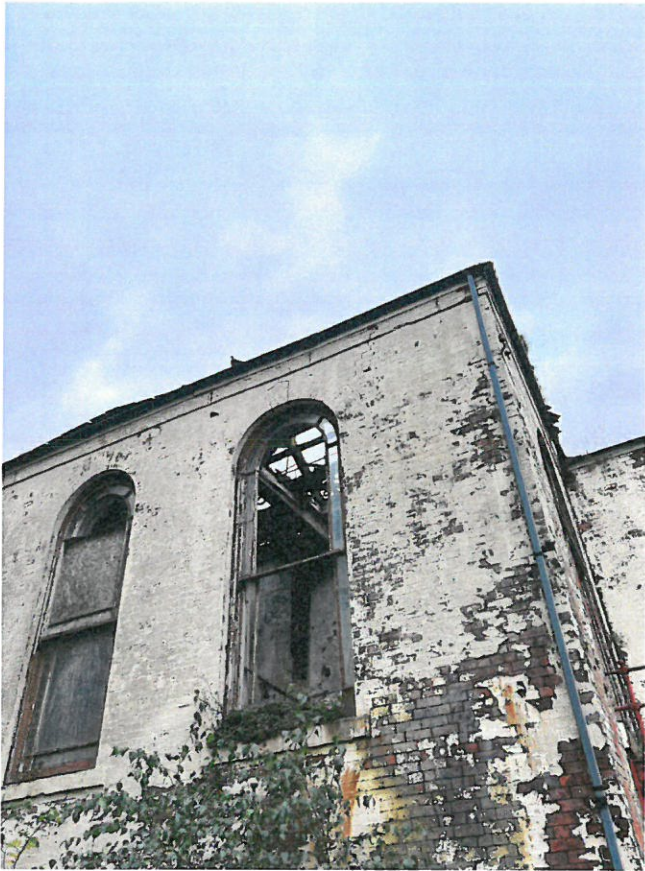
Photograph 1

- The roof structure to the Engine House should be removed remotely.
- The large timber beams (bottom boom of truss) spanning the Engine House will remain to aid the stability in the temporary condition.
- The Engine House walls can remain, but the failed brick arch over the side windows should be stitch repaired prior to the removal. See data sheet MA01 attached, and photographs 1 & 2.
- Following the above the first floor can be cleared of debris by remote means.
