# NOCTURNAL BAT SURVEY REPORT & EcOW SUMMARY

Hopwood Hall College,  
Rochdale Road,  
Middleton,  
Manchester,  
M24 6XH

1697B-NBR-V1-C

Seven Architecture

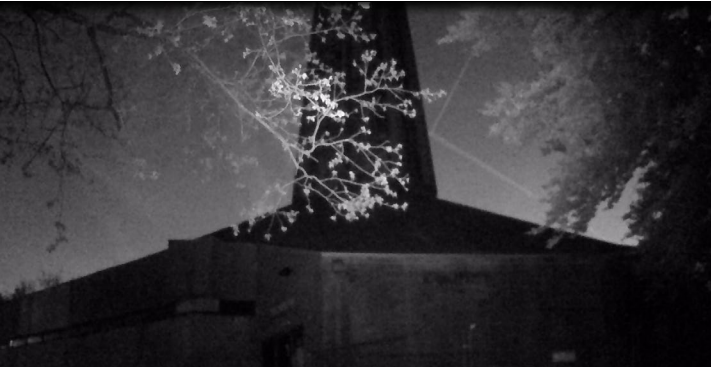
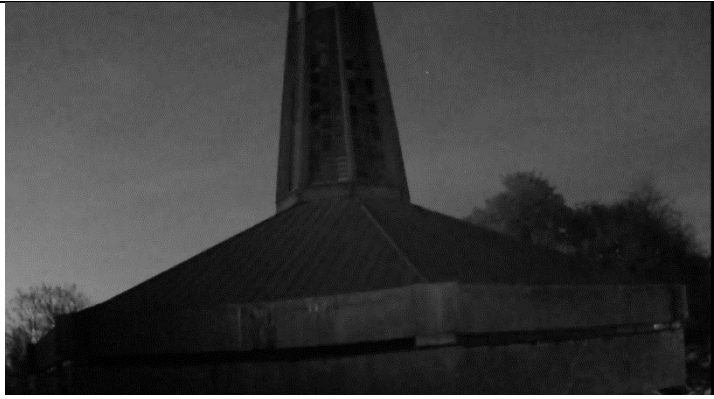
**Table 2** – Camera Screenshots

- 3.1.4. There were no roost locations identified by VP2, VP4 and VP6 during the survey.
- 3.1.5. A review of the IRC camera footage did not identify any bats emerging/ re-entering from the building from the points of view at VP1, VP3 and VP5.
- 3.1.6. **No roost locations were recorded during the dusk survey.**

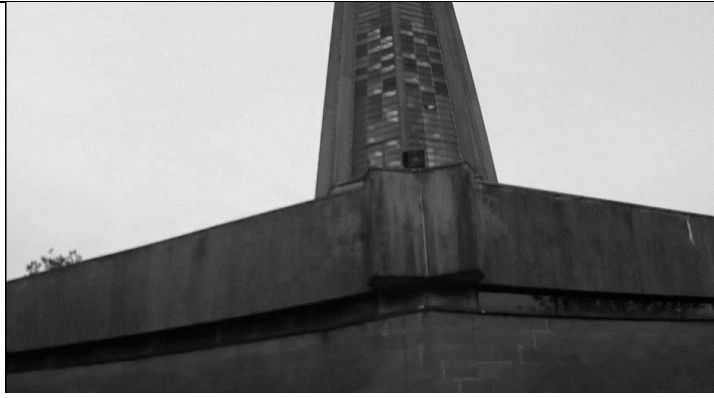
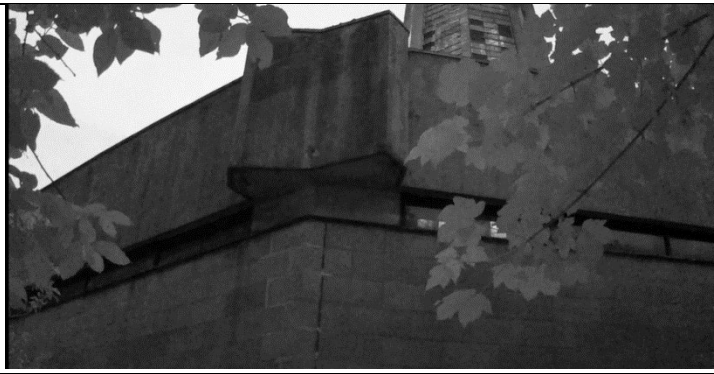
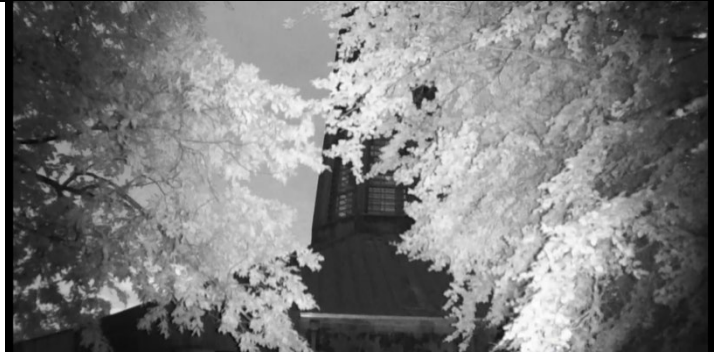
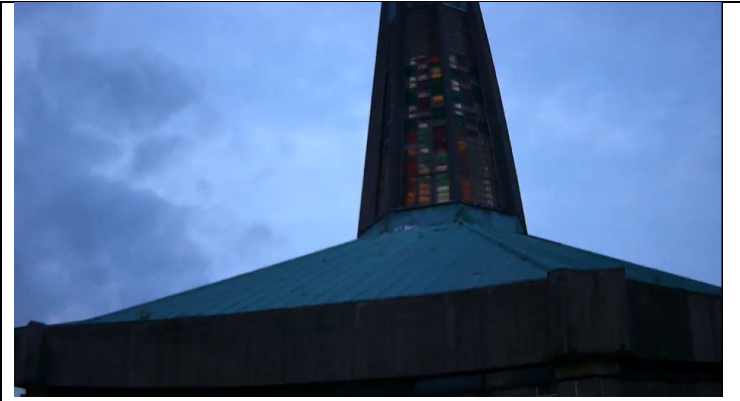
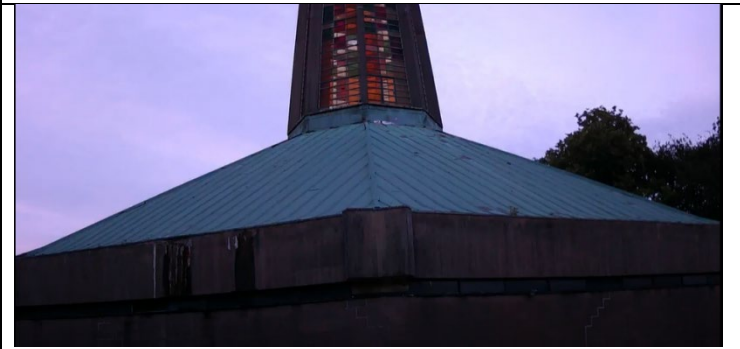
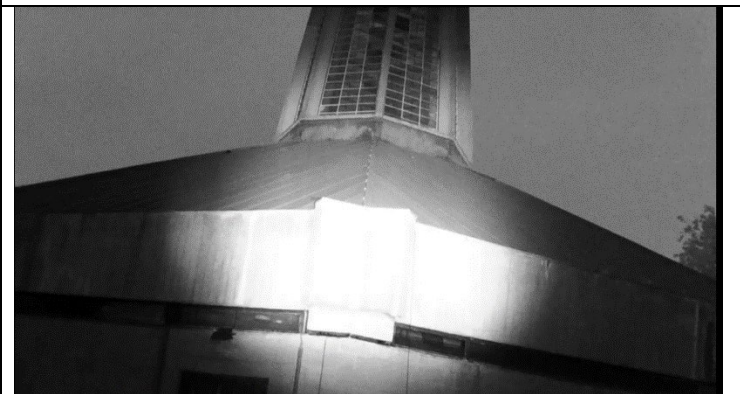
- 3.1.7. Bat activity was recorded during the survey, there were less bats identified during the survey. The first bat was recorded at 21:49 and was identified as a common pipistrelle nearby VP5 and VP6 and it was identified from the adjacent woodland and foraging over the grassland. Bats were identified commuting around the building and into the open habitats and woodland for foraging purposes from throughout the survey from 21:30 – 22:20pm.
- 3.1.8. A review of the IRC camera footage (VP3) did not find any bats emerging from the building on all vantage points.
- 3.1.9. **No roost locations were recorded during the dusk survey.**
