# Heywood Stores, Heywood

Coal Mining Risk Assessment

Report no. 322834-R02 (00)

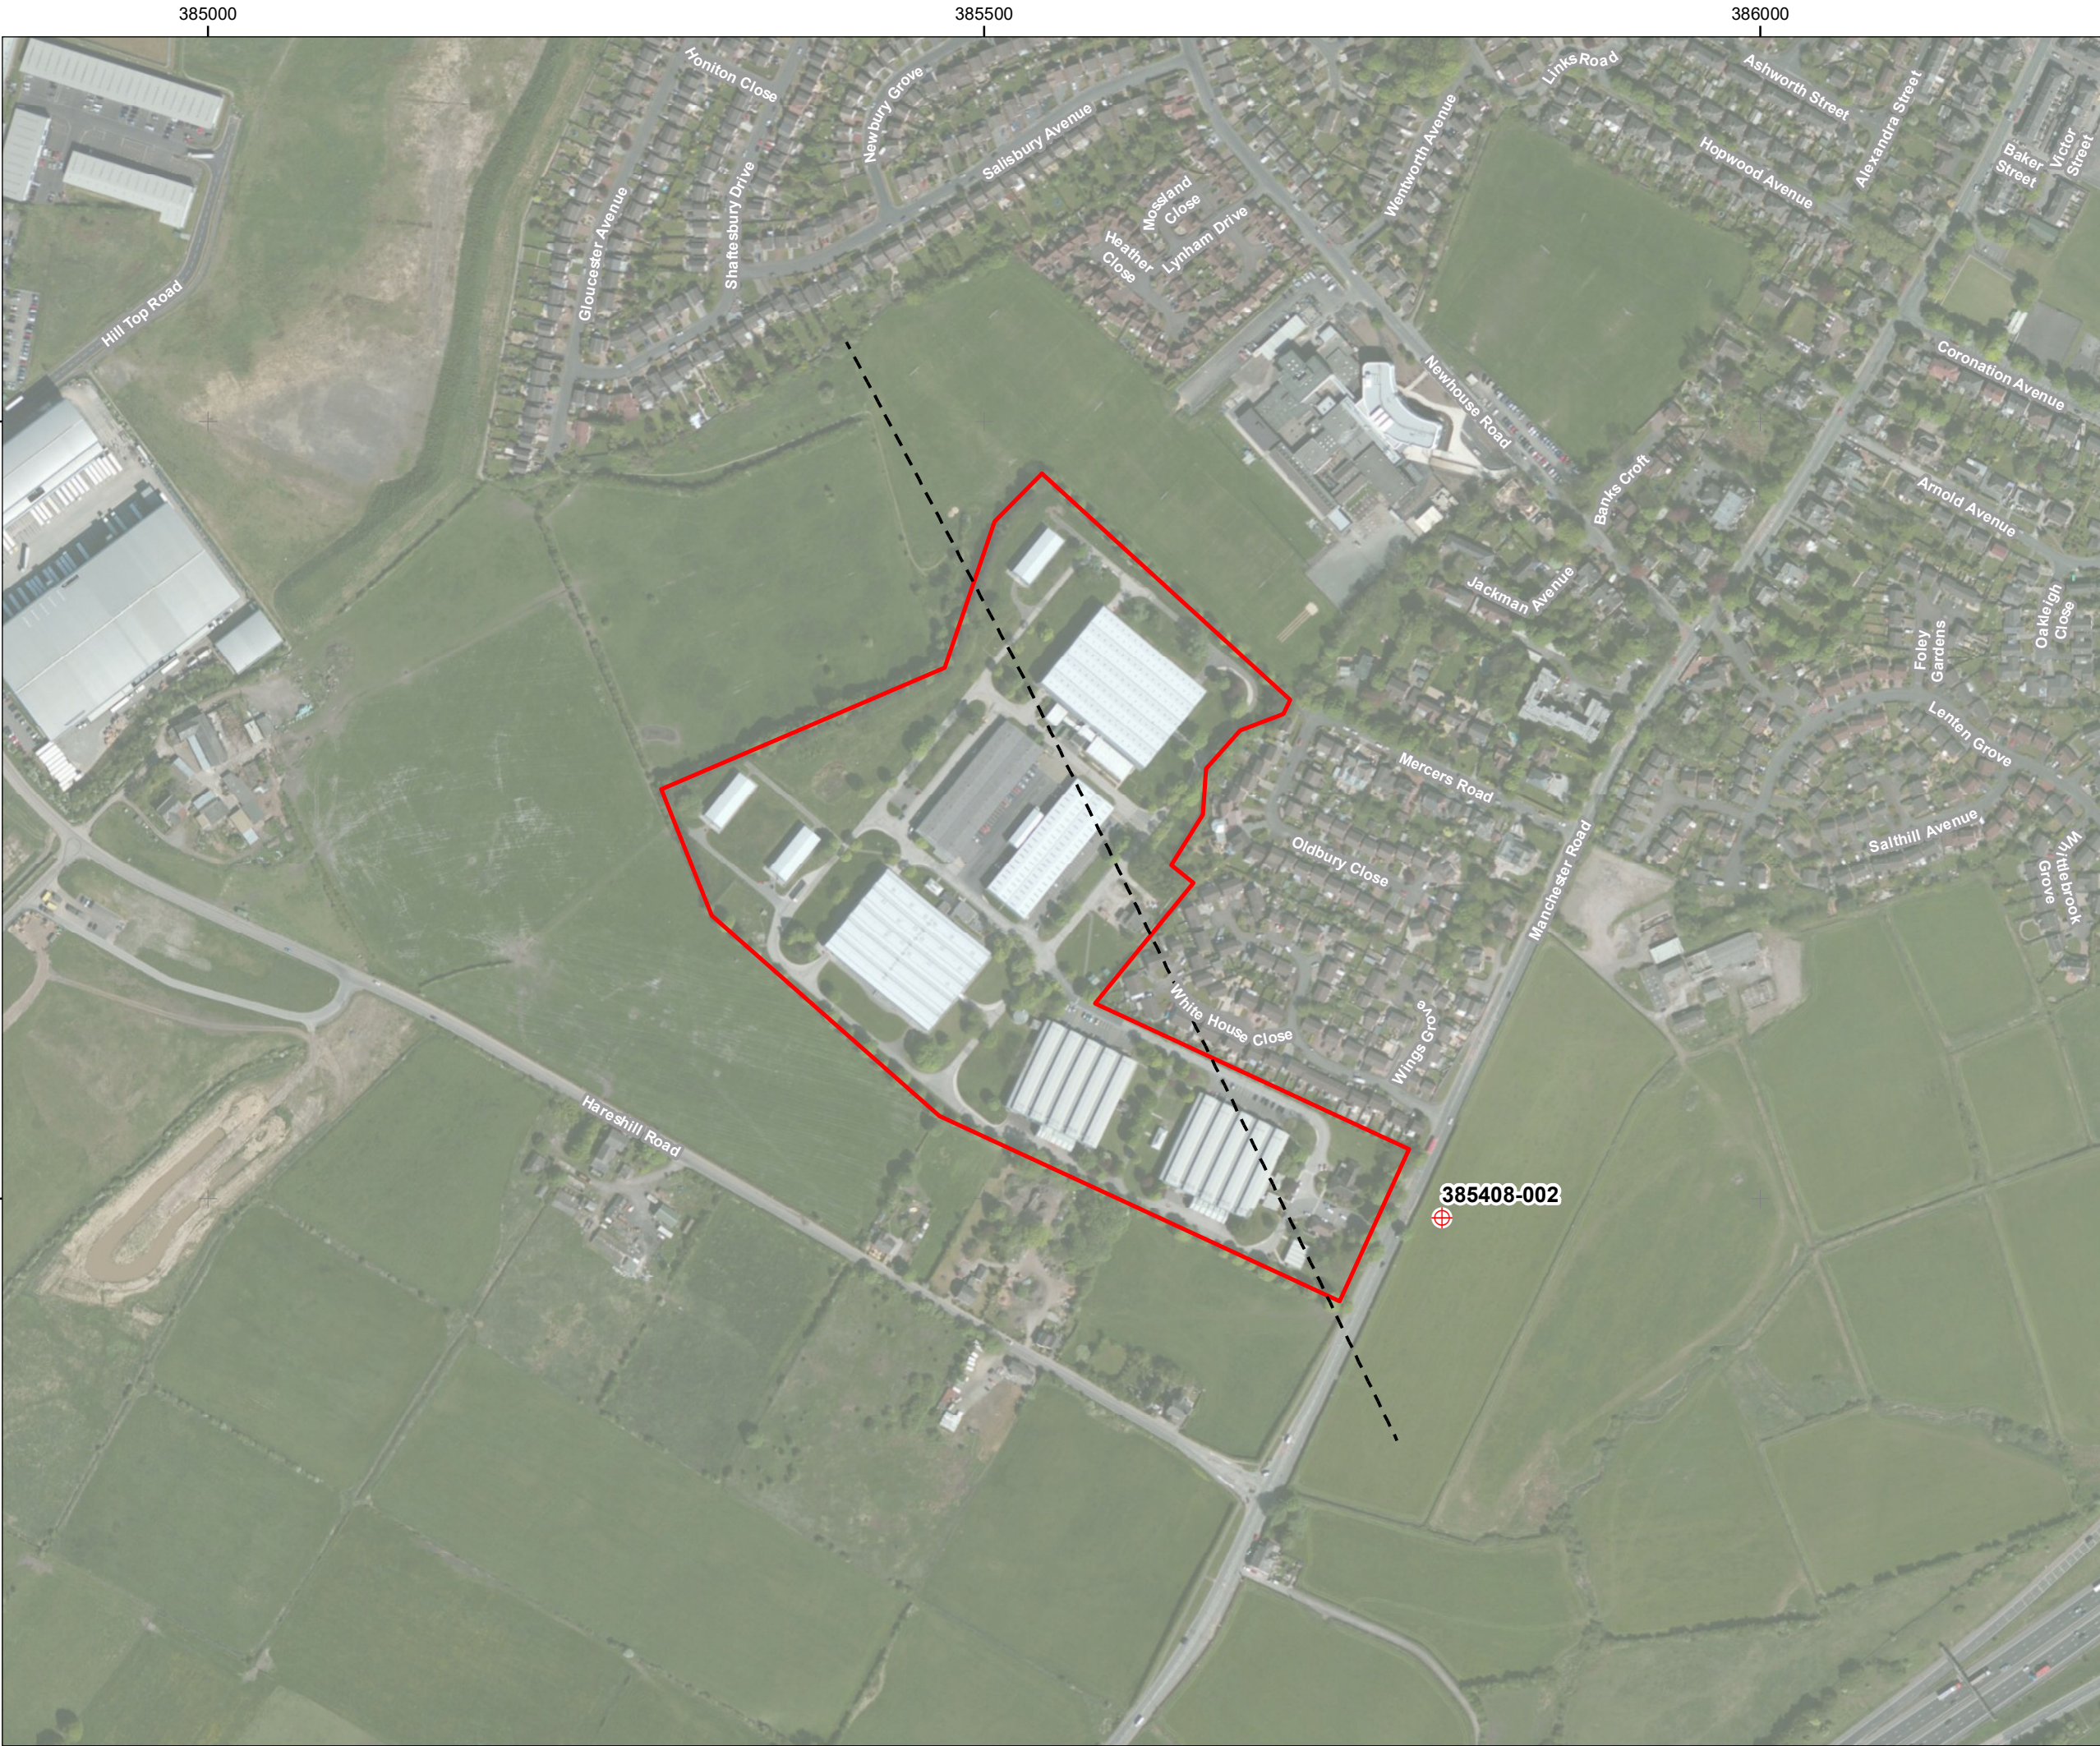
- Site Boundary
- Disused Mine Shaft
- Geological Fault

There are no known mine entries located within the site boundary. The nearest mine entry being recorded located at approximately 50m to the east of the site. The departure for this shaft is 10m and therefore not considered to cause ground stability issues on the site itself.
