# Northern Gateway

## Geo-environmental and Geotechnical Desk Study and Coal Mining Risk Assessment Report

| <b>Project:</b> | Northern Gateway |
| <b>Document Number</b> | TTE-B048805-SD-DS-002 |

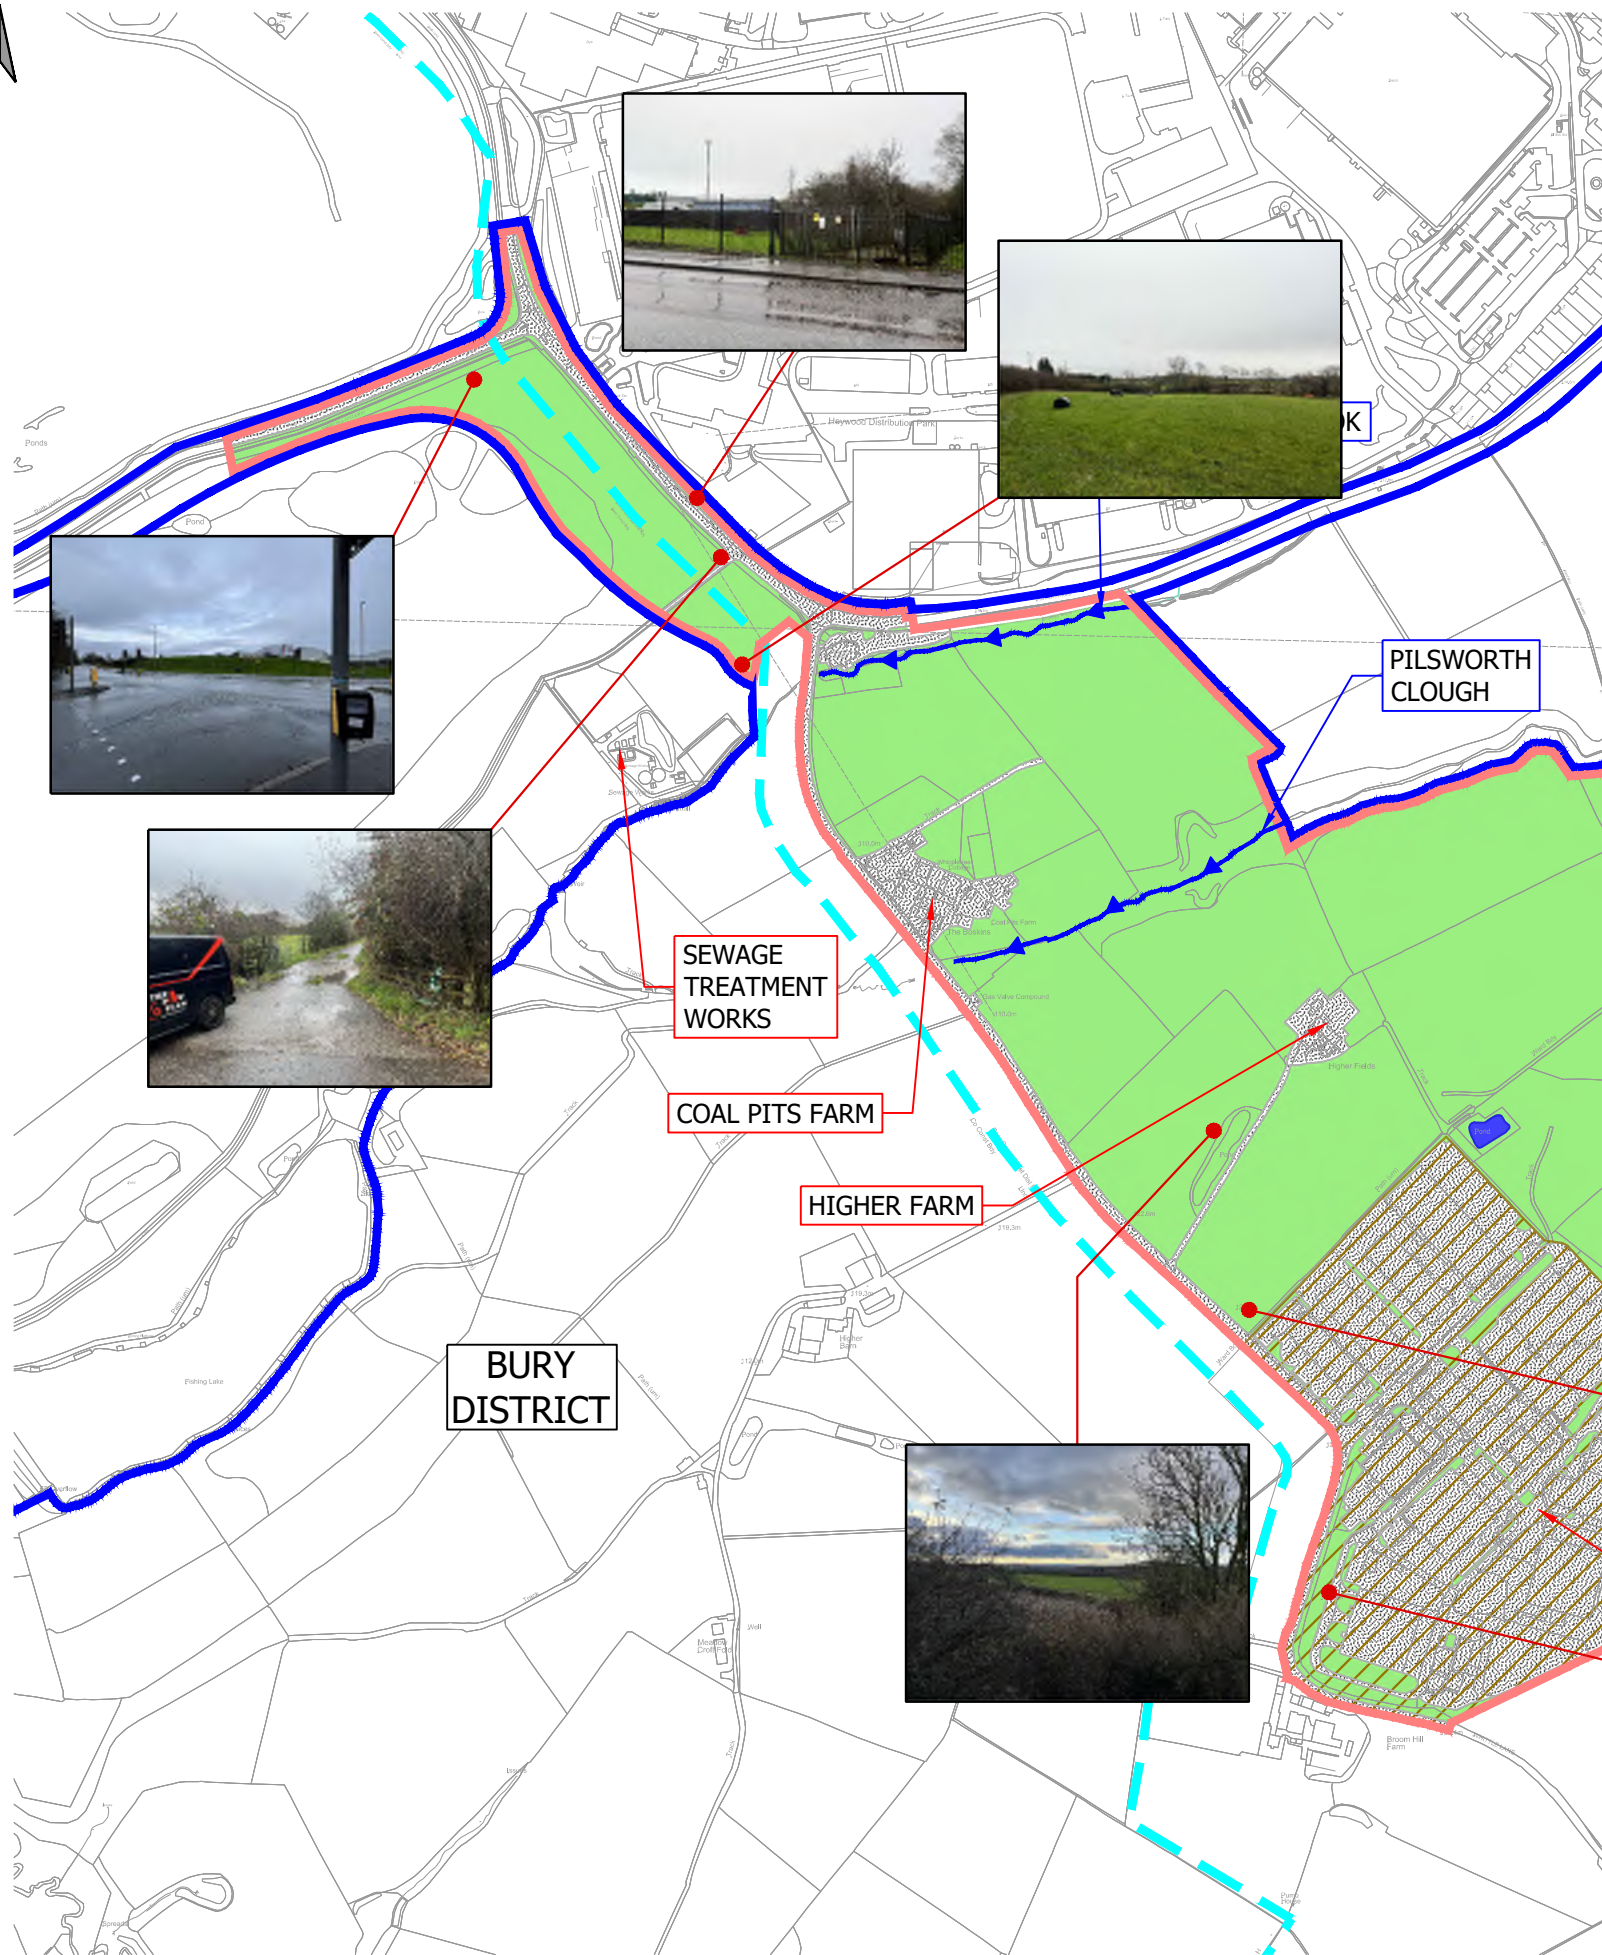
- KEY**
- SITE BOUNDARY
  - GROUNDSURE SECTION A
  - FIELDS / GRASS / VEGETATION
  - HARDSTANDING / ROADS / TRACKS / FARMS / INDUSTRIAL
  - PONDS / WATERCOURSES
  - APPROXIMATE LOCATION OF FORMER RAF HEYWOOD - POTENTIAL FOR UXO
  - DISTRICT BOUNDARY

- NOTES:**
1. WALKOVER UNDERTAKEN IN NOVEMBER 2023.
  2. FIELDS & FIELD ACCESSES WERE NOTED AS BEING VERY WET & BOGGY.
  3. ANECDOTAL UXO INFORMATION WAS PROVIDED BY DAVID HILLARY AT UNSWORTH MOSS FARM & HAS BEEN CORROBORATED BY THE ZETICA PSDA IN APPENDIX F.

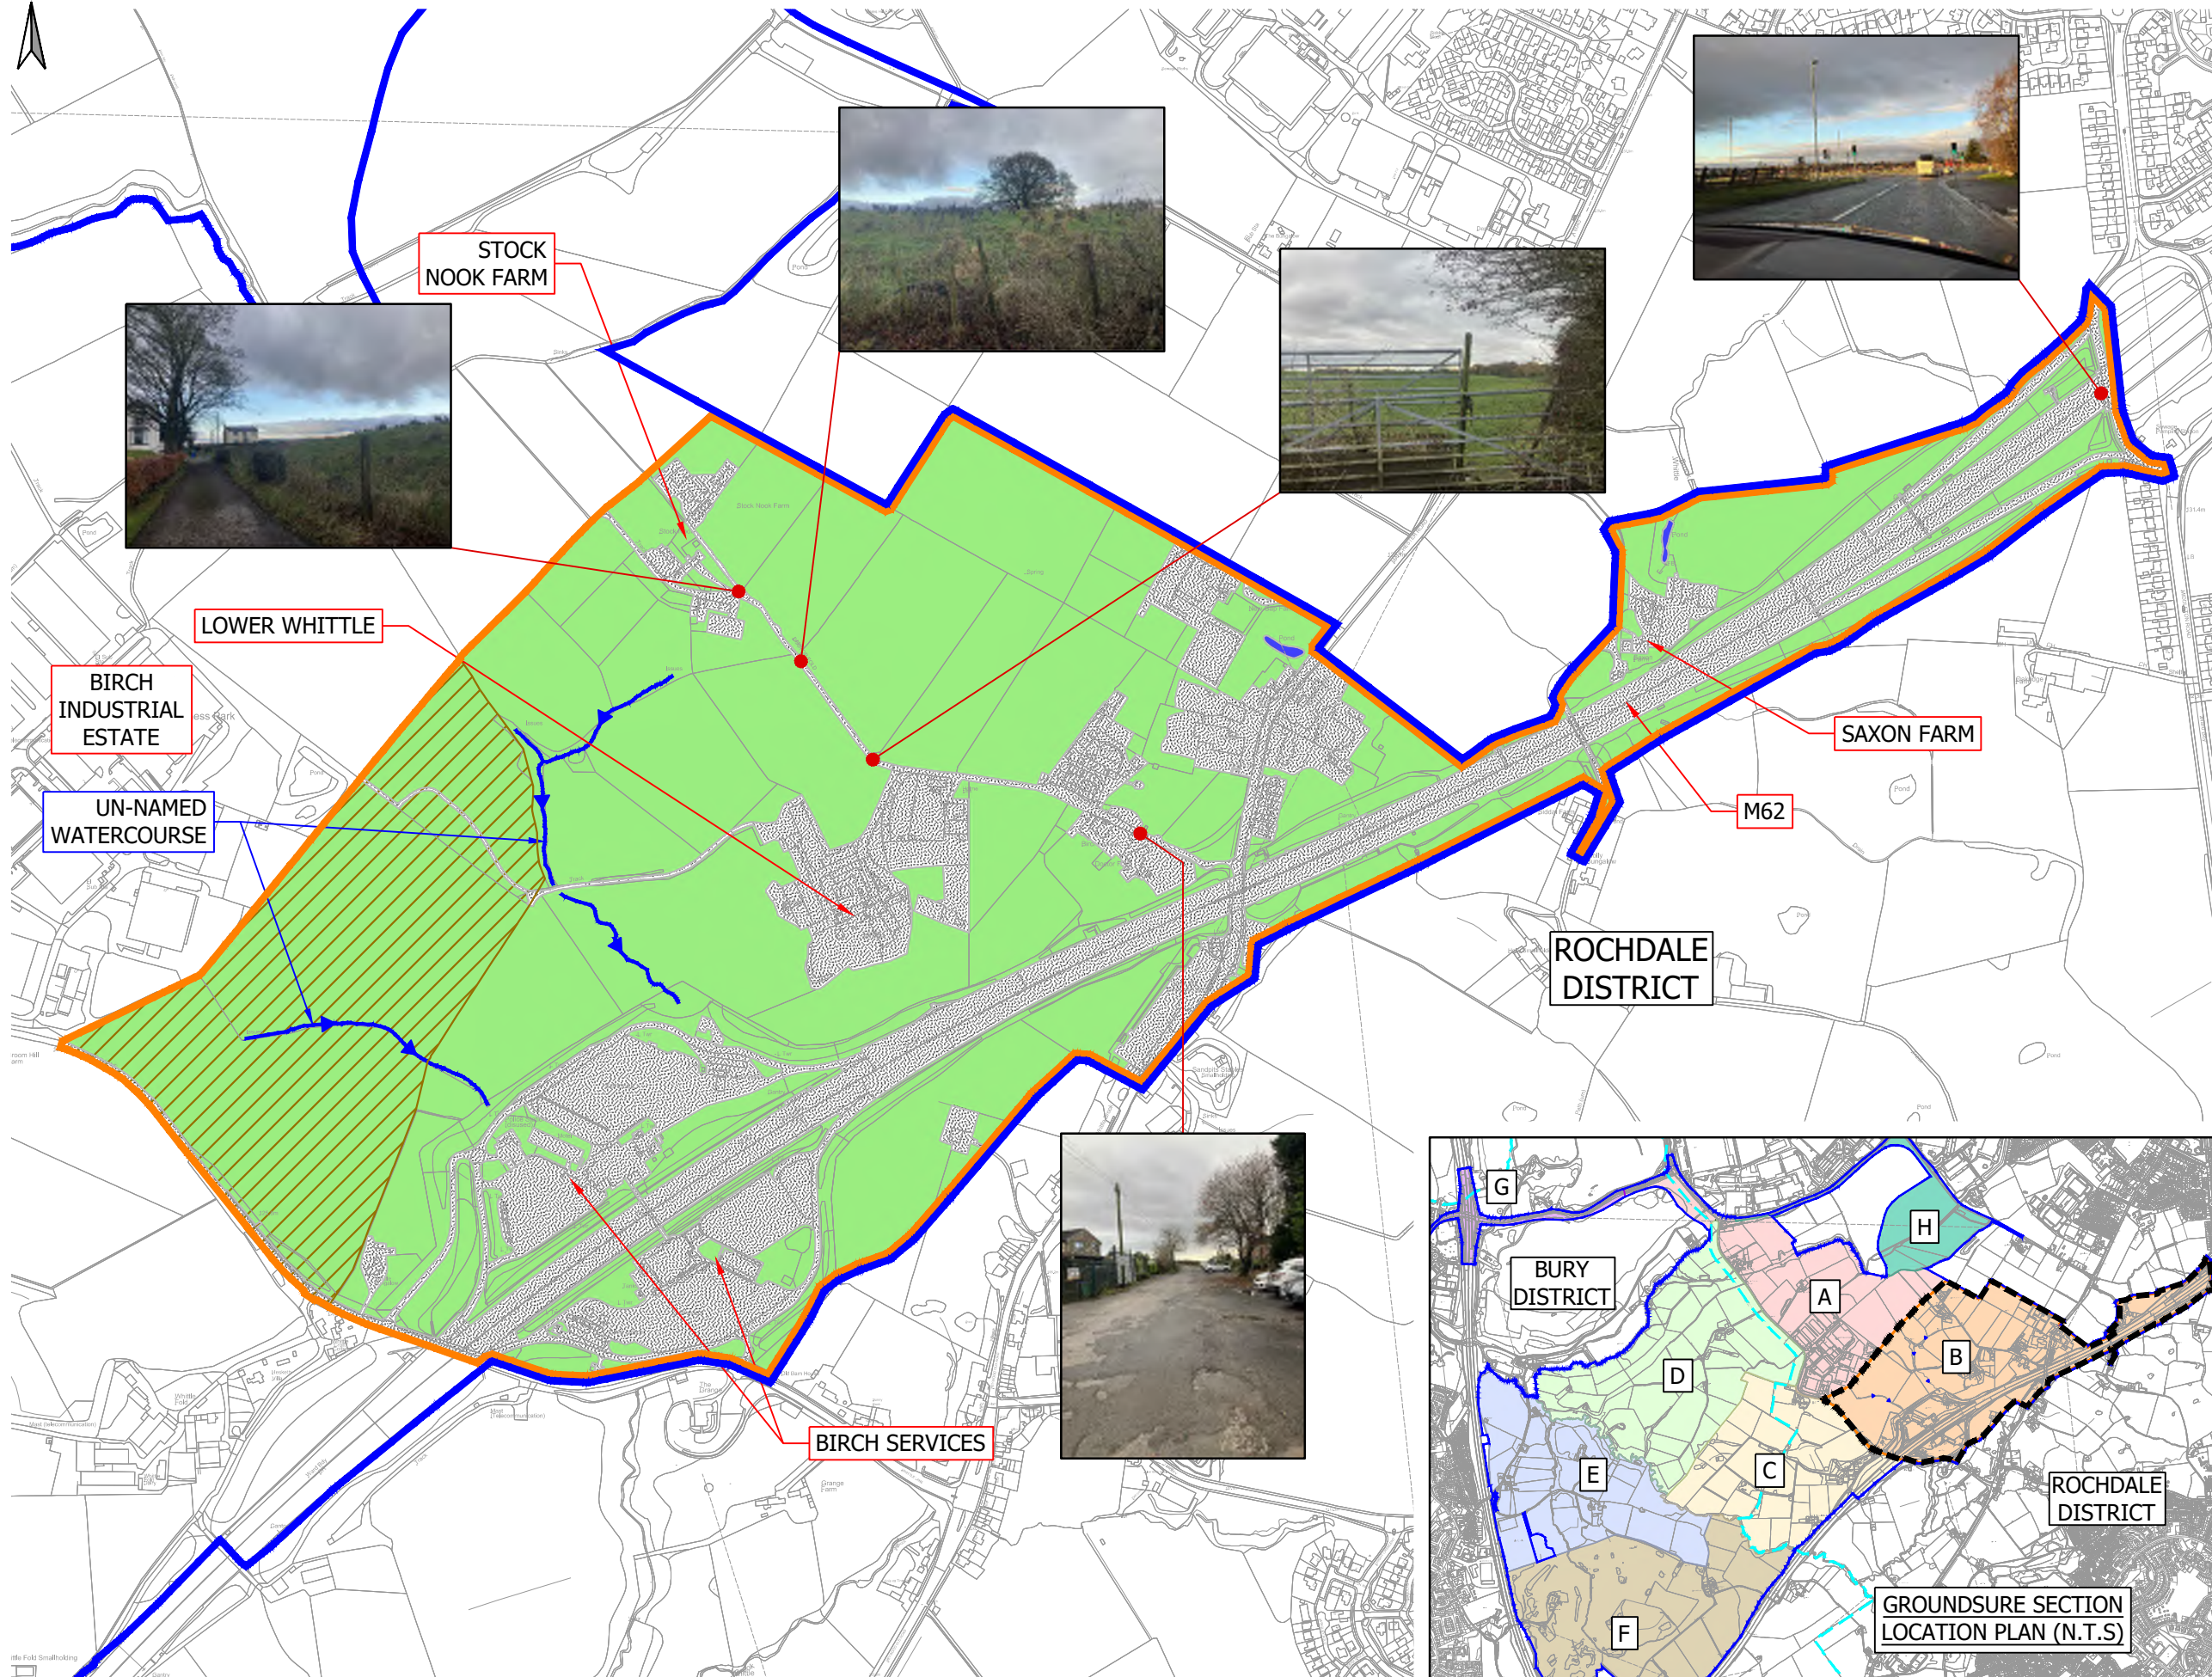
- SITE BOUNDARY
- GROUNDSURE SECTION B
- FIELDS / GRASS / VEGETATION
- HARDSTANDING / ROADS / TRACKS / FARMS / RESIDENTIAL / INDUSTRIAL / SERVICES
- PONDS / WATERCOURSES
- POTENTIAL FOR UXO FROM ASSOCIATED FORMER RAF HEYWOOD
- DISTRICT BOUNDARY

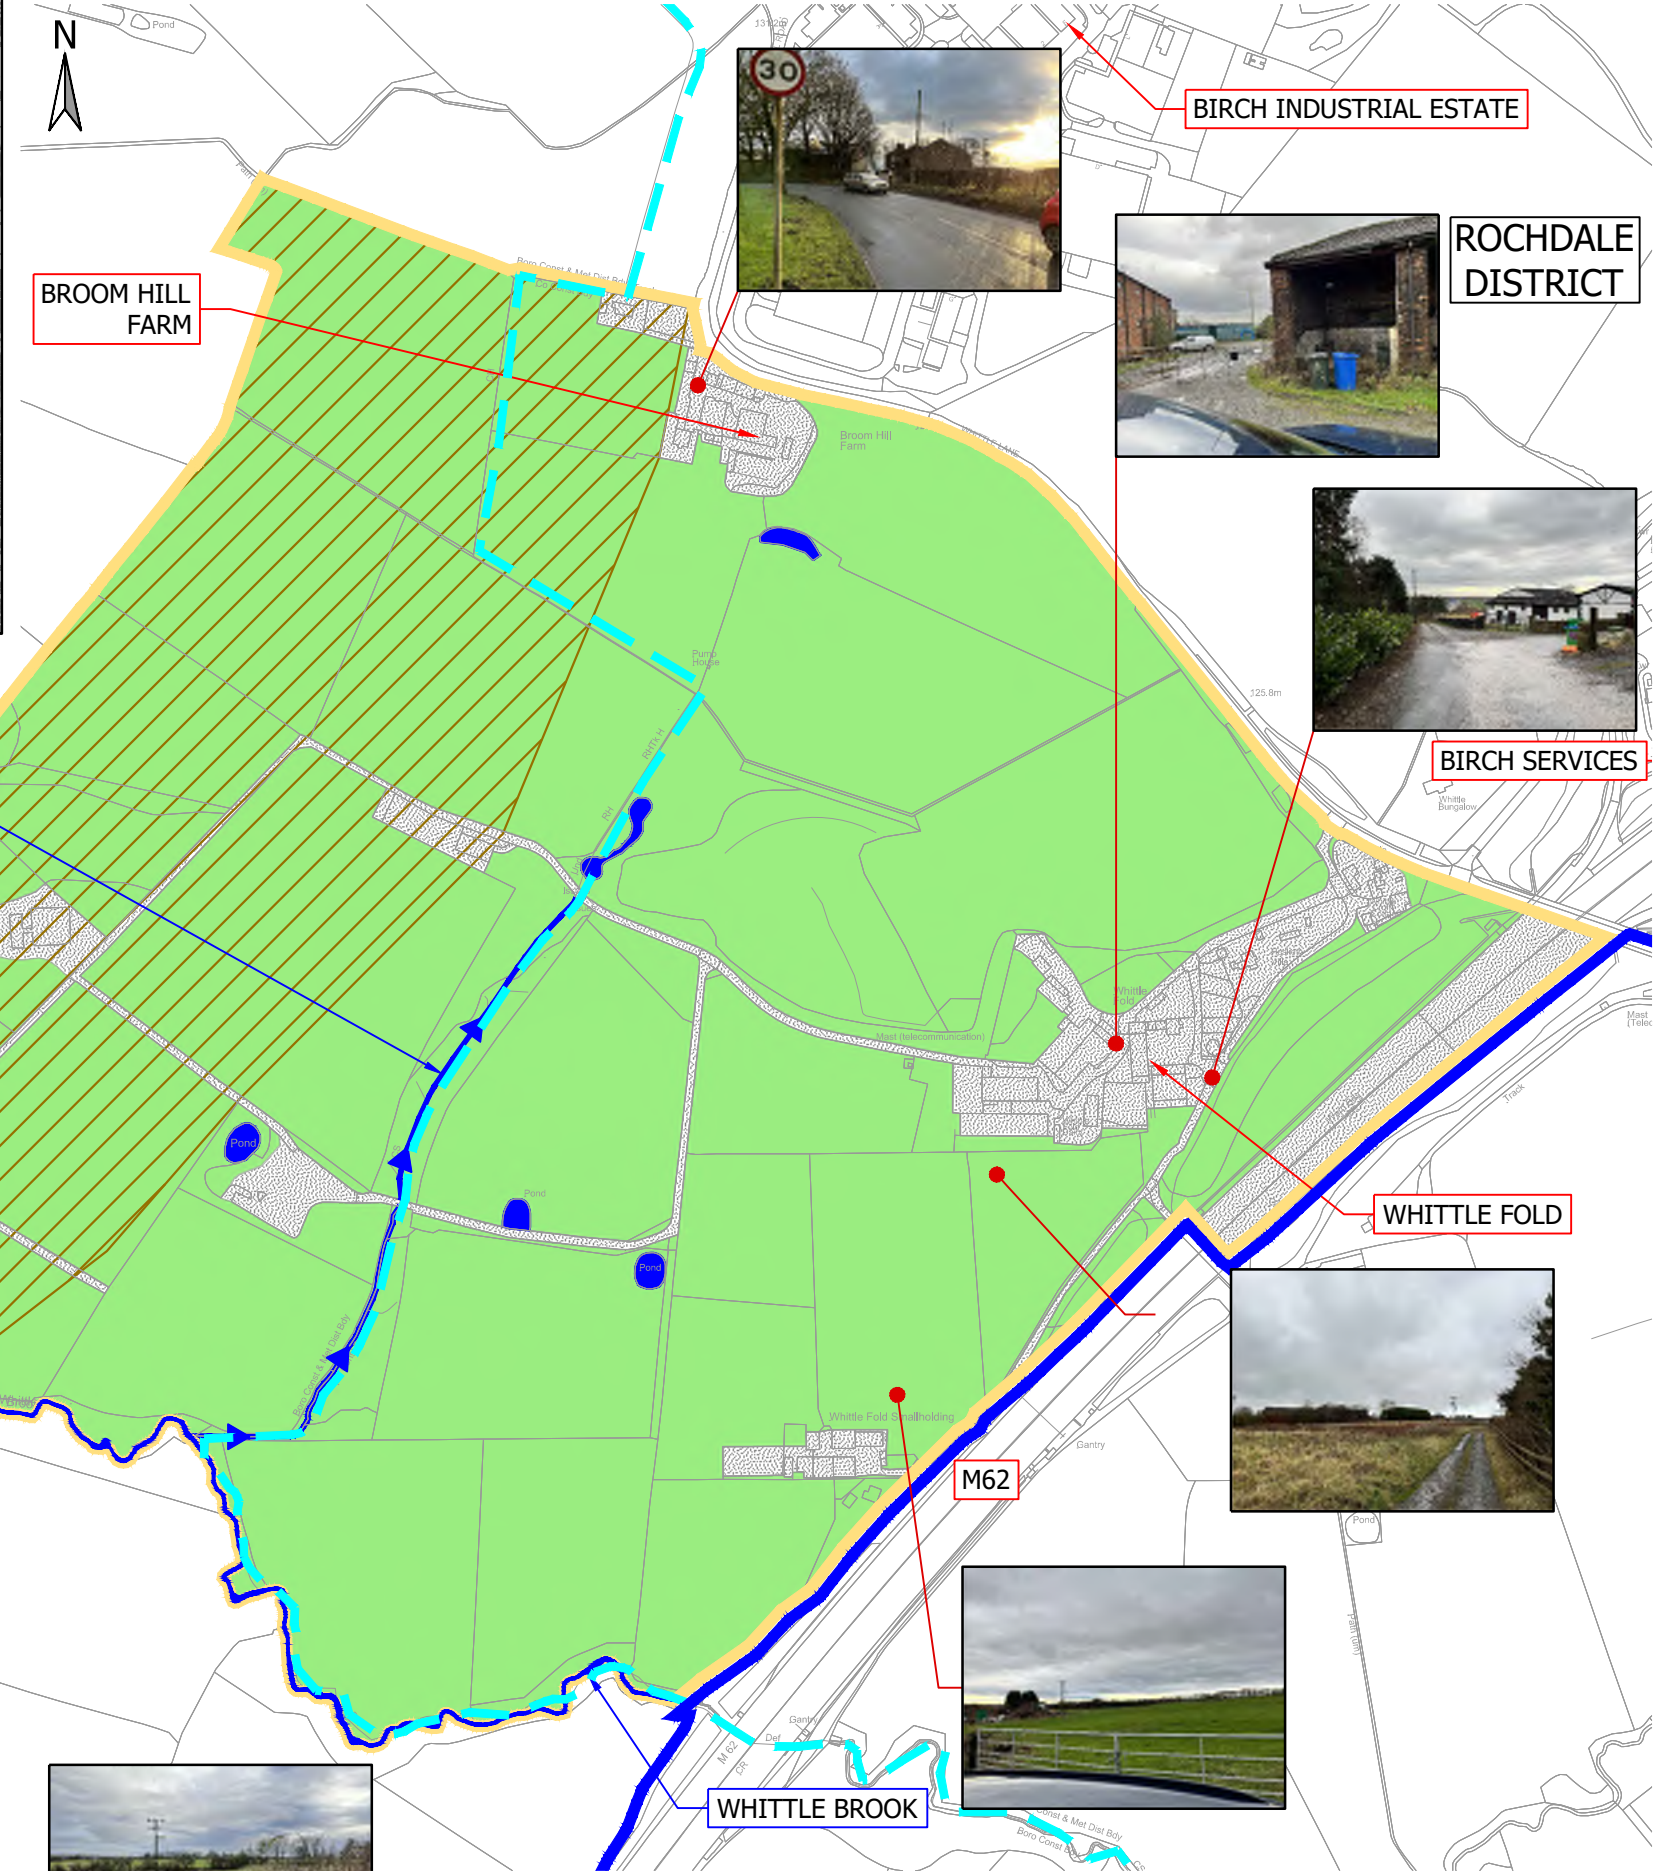
| TTE Project Number | Drawn By | Date | Checked By | Date | Approved By | Date | Scale @ A3 | Status |
|---|---|---|---|---|---|---|---|---|
| B048805 | - TTE - | 00 | - XX - | DR | - U - | 0004C | 02 | |

- ASSESSMENT BOUNDARY
- GROUNDSURE SECTION C
- FIELDS / GRASS / VEGETATION
- HARDSTANDING / ROADS / TRACKS / RESIDENTIAL / FARMS / INDUSTRIAL
- PONDS / WATERCOURSES
- POTENTIAL FOR UXO FROM ASSOCIATED FORMER RAF HEYWOOD
- DISTRICT BOUNDARY

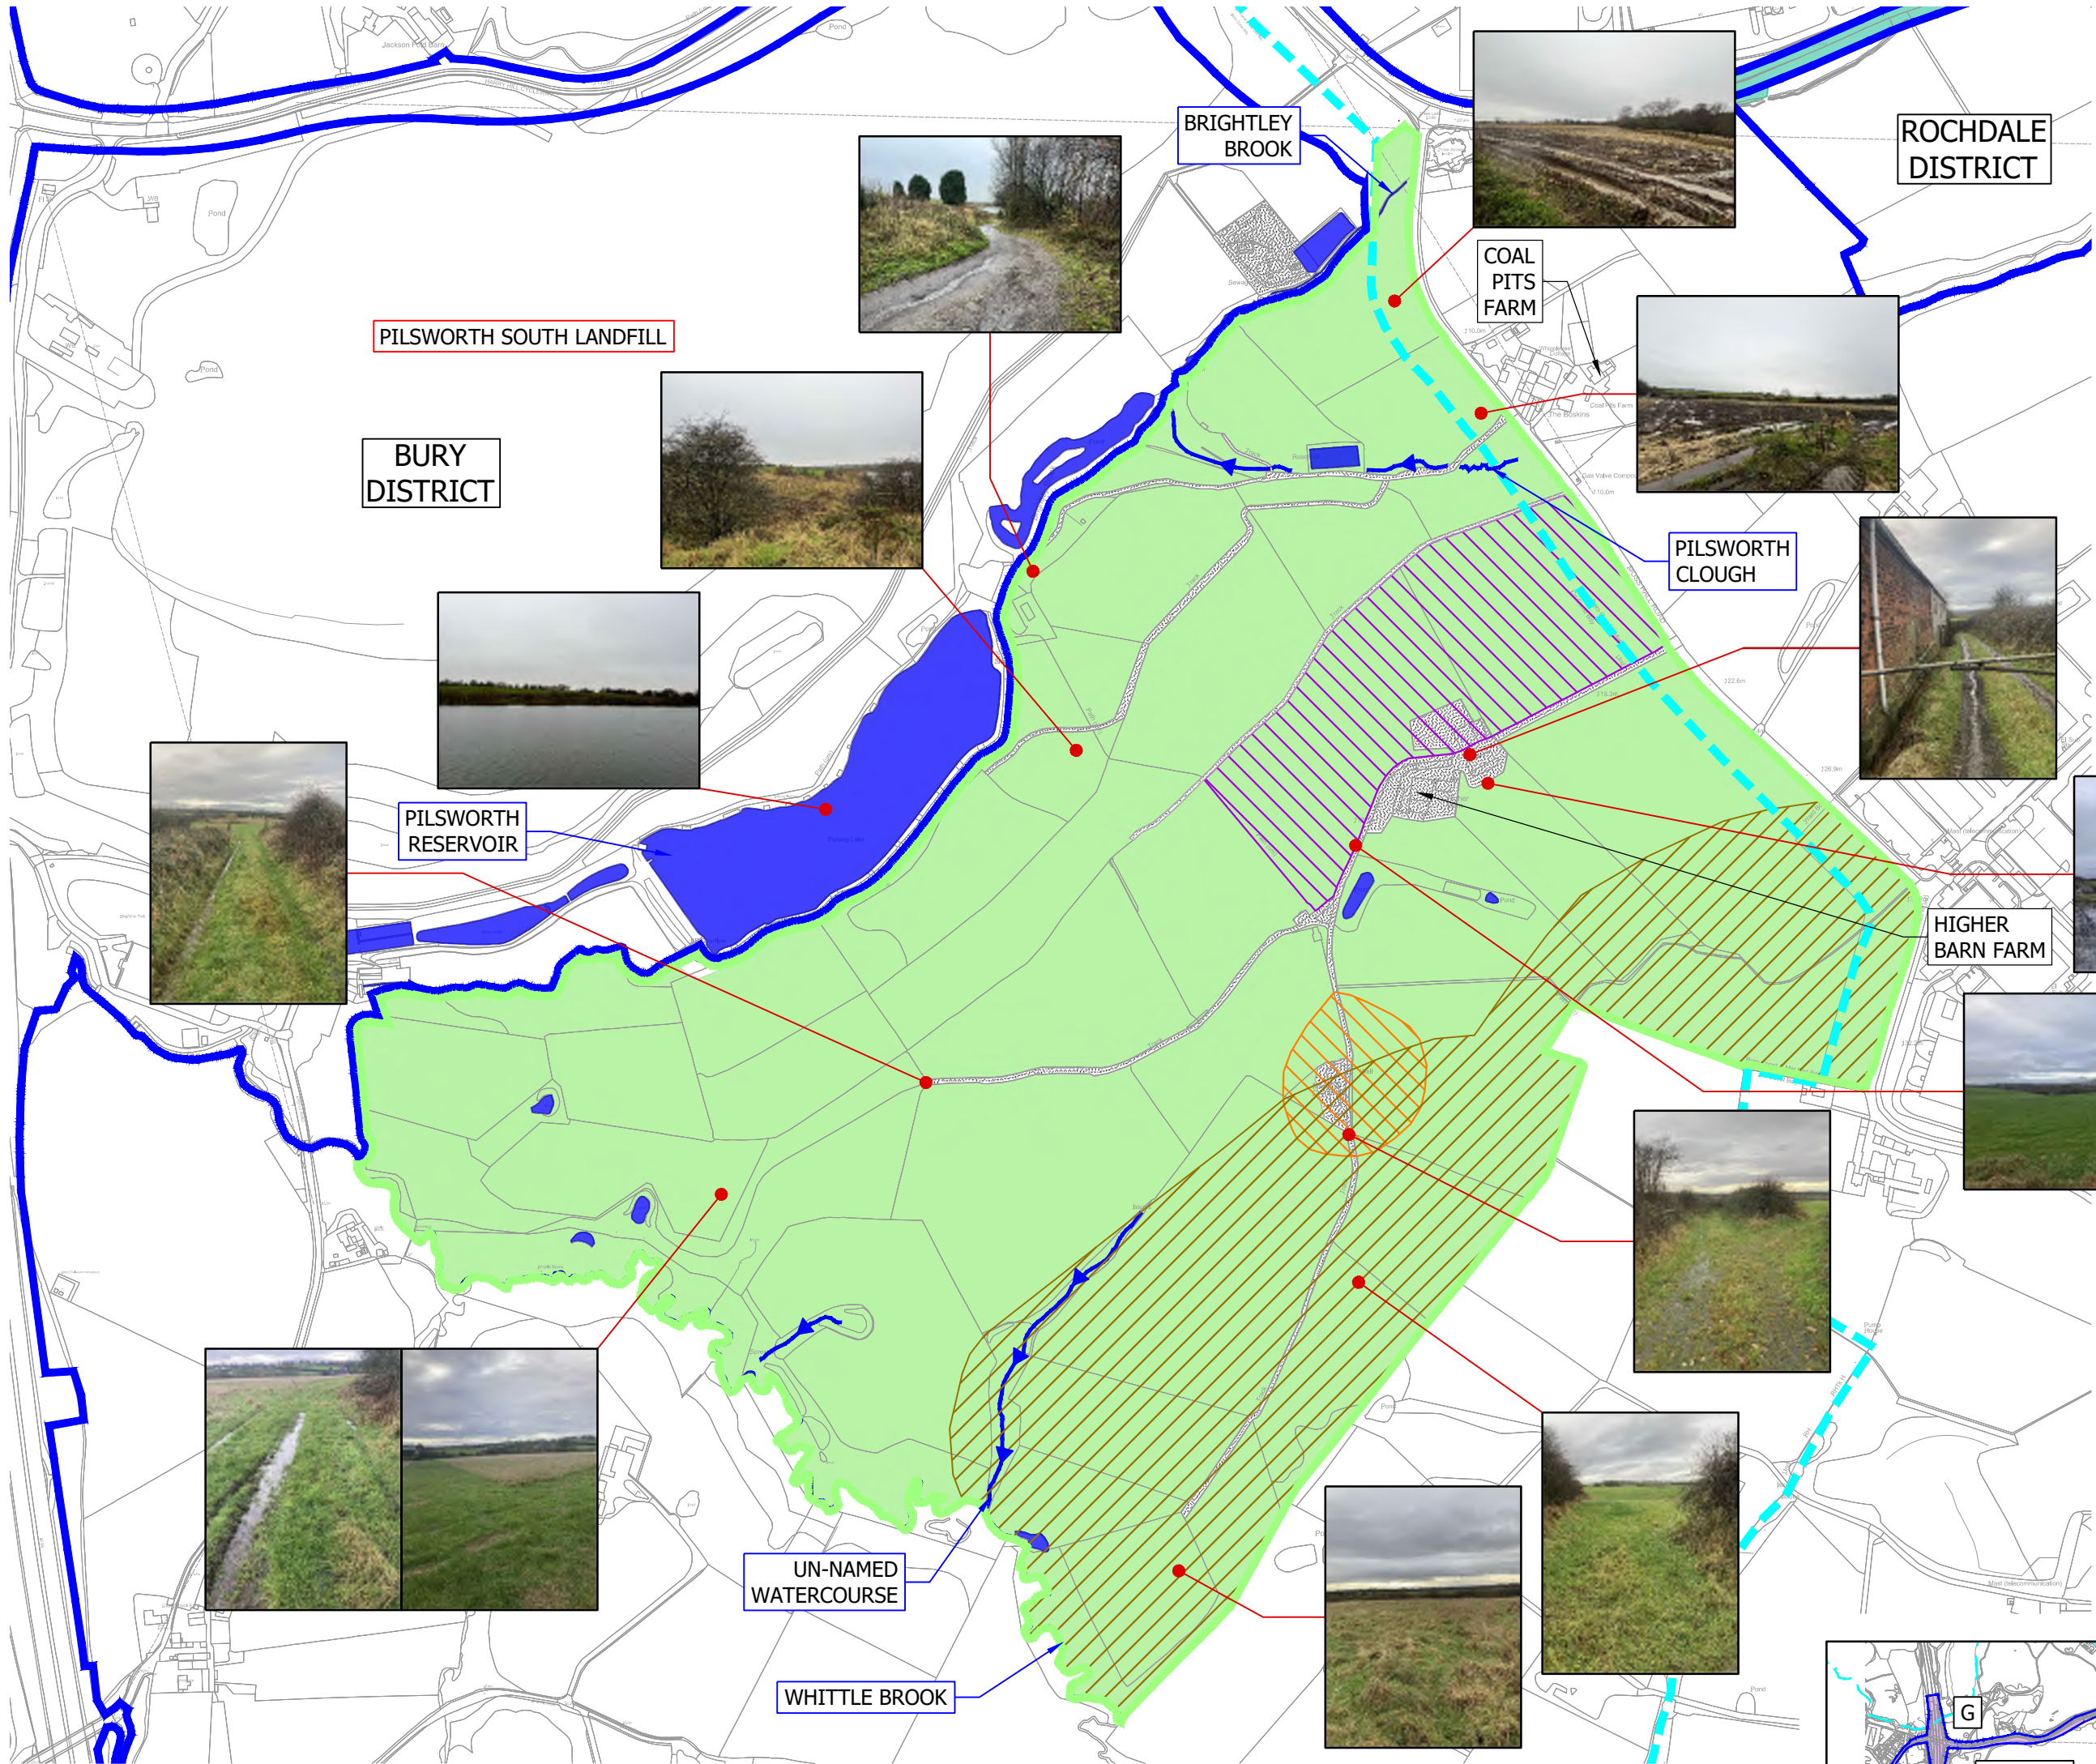
| Model Reference | | | | | | | | | |
|---|---|---|---|---|---|---|---|---|--|
| B048805 | - TTE - | 00 | - ZZ - | DR | - U - | 0004D | 03 | | |

- ASSESSMENT BOUNDARY
- GROUNDSURE SECTION D
- FIELDS / GRASS / VEGETATION
- HARDSTANDING / ROADS / TRACKS / RESIDENTIAL / FARMS / INDUSTRIAL
- POND / RESERVOIR / WATERCOURSE
- POTENTIAL FOR UXO FROM ASSOCIATED FORMER RAF HEYWOOD
- ANECDOTAL POTENTIAL FOR ADDITIONAL MINE SHAFTS
- ANECDOTAL POTENTIAL MINING VILLAGE PRE 1848

The tenant farmer's family indicated they had farmed the land for the last 100 years and before that recorded that there was a mining village located around Meadowcroft Fold in the 1800s with mining having been undertaken across site with shafts sunk onsite as well in the Pilsworth Fishing Lakes Car Park to the north. In the 1980s they said the site had been investigated by the National Coal Board (NCB) now (Mining Remediation Authority) to investigate the potential for Opencast mining. They noted that boreholes found workings with some boreholes collapsing leaving significant voids which were stoned and grouted up.

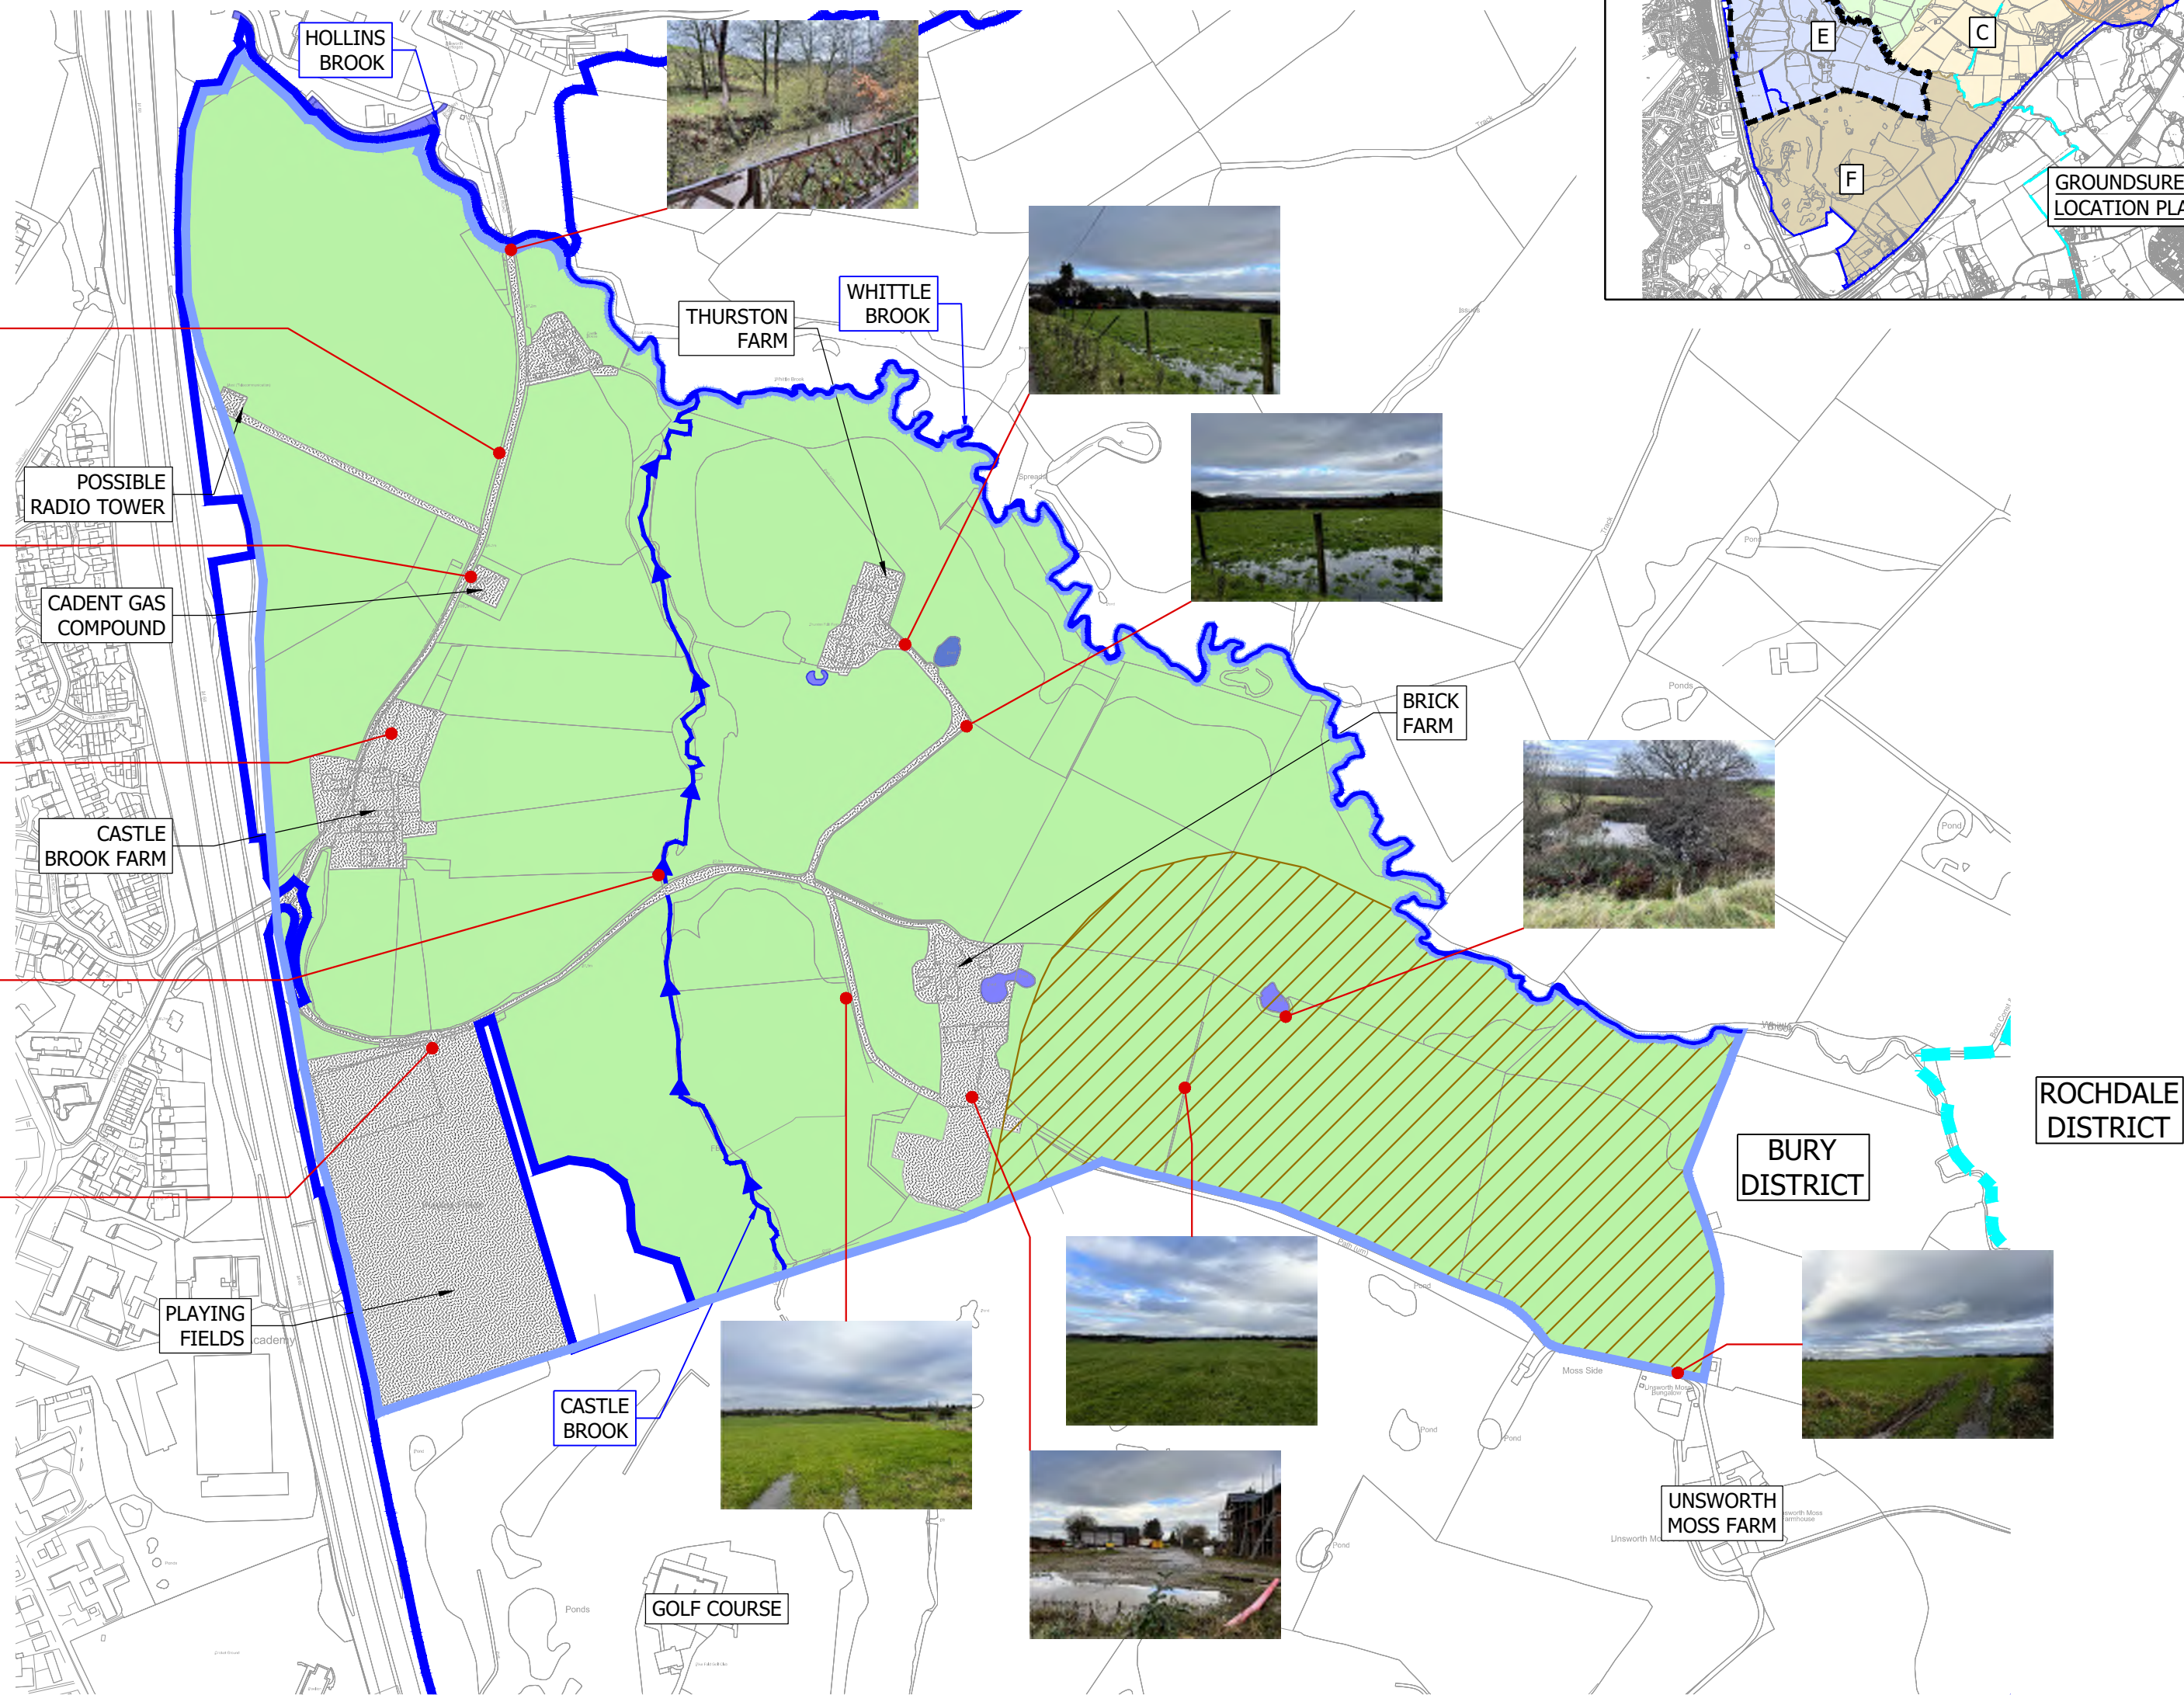
- KEY**
- ASSESSMENT BOUNDARY
  - GROUNDSURE SECTION E
  - FIELDS / GRASS / VEGETATION
  - HARDSTANDING / ROADS / TRACKS / RESIDENTIAL / FARMS / INDUSTRIAL
  - POND / WATERCOURSE
  - POTENTIAL FOR UXO FROM ASSOCIATED FORMER RAF HEYWOOD
  - DISTRICT BOUNDARY

- NOTES:**
- WALKOVER UNDERTAKEN IN NOVEMBER 2023.
  - FIELDS & FIELD ACCESSES WERE NOTED AS BEING VERY WET & BOGGY.
  - ANECDOTAL UXO INFORMATION WAS PROVIDED BY DAVID HILLARY AT UNSWORTH MOSS FARM & HAS BEEN CORROBORATED BY THE ZETICA PDSA IN APPENDIX F.

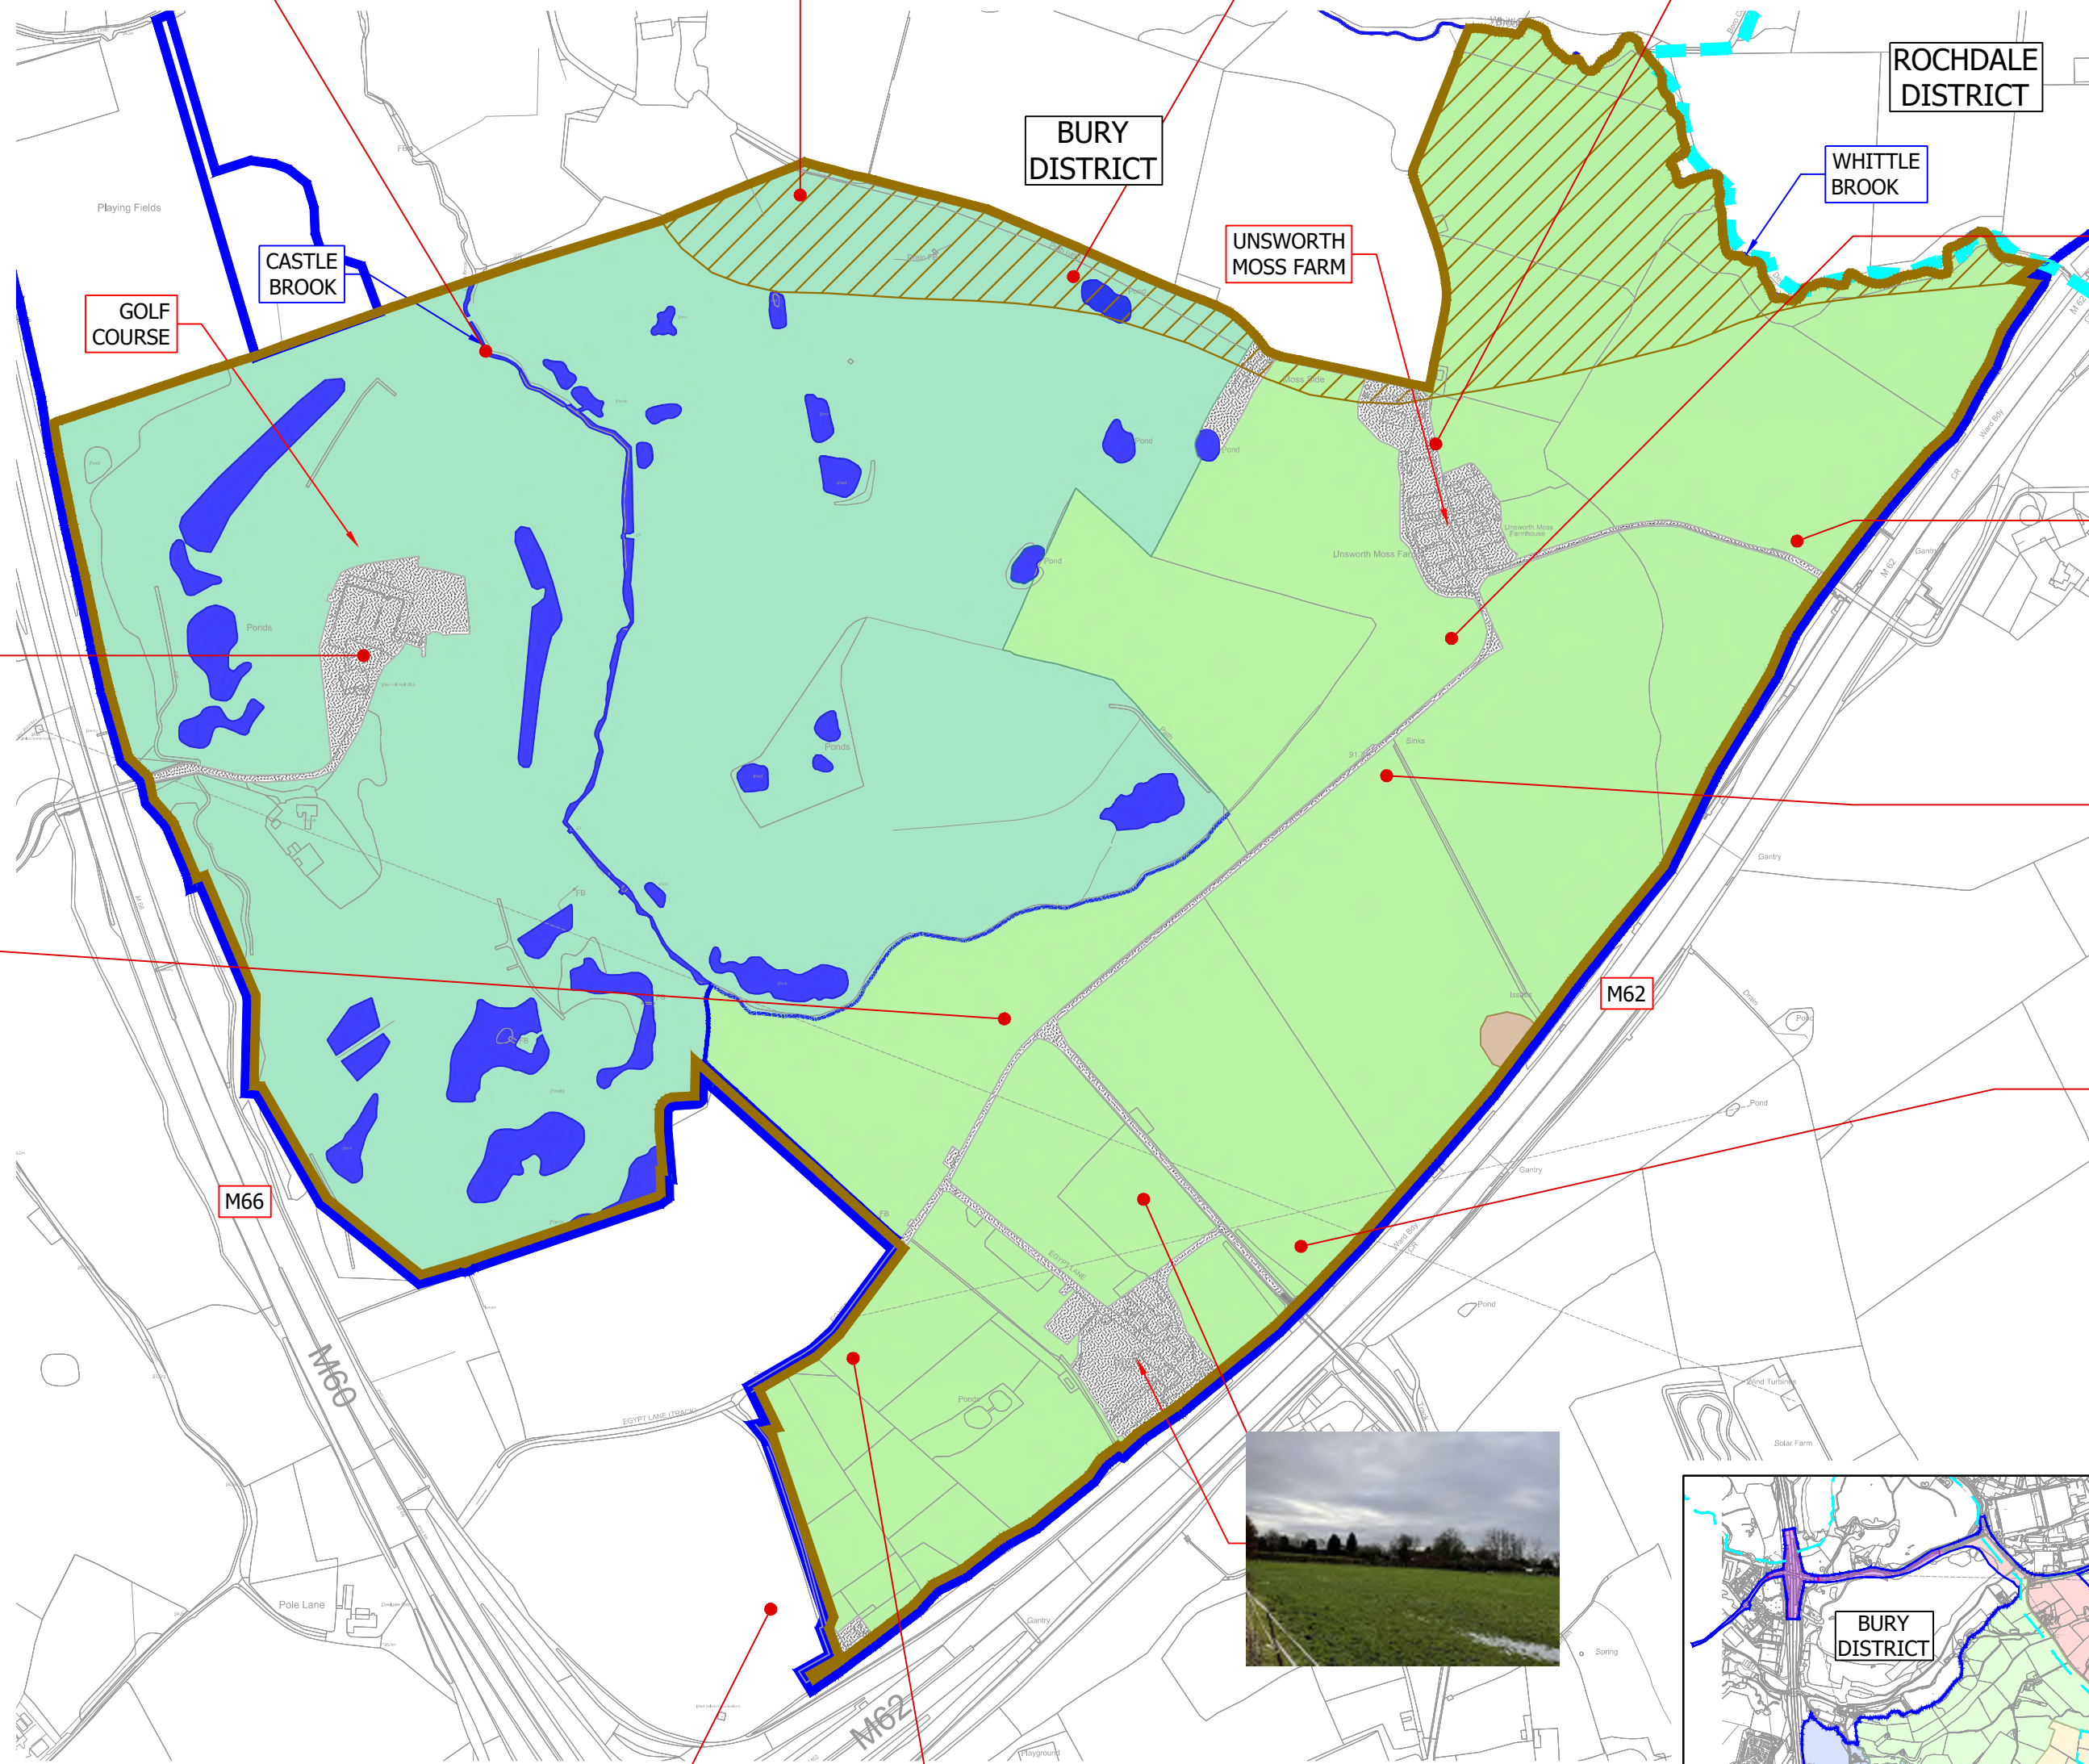
- KEY**
- ASSESSMENT BOUNDARY
  - GROUNDSURE SECTION F
  - FIELDS / GRASS / VEGETATION
  - PIKE FOLD GOLF COURSE
  - HARDSTANDING / ROADS / TRACKS / RESIDENTIAL / FARMS / INDUSTRIAL
  - POND / WATERCOURSE
  - ANECDOTAL POTENTIAL SPOIL MOUND
  - POTENTIAL FOR UXO FROM ASSOCIATED FORMER RAF HEYWOOD
  - DISTRICT BOUNDARY

- NOTES:**
- WALKOVER UNDERTAKEN IN NOVEMBER 2023.
  - FIELDS & FIELD ACCESSES WERE NOTED AS BEING VERY WET & BOGGY.
  - ANECDOTAL UXO INFORMATION WAS PROVIDED BY DAVID HILLARY AT UNSWORTH MOSS FARM & HAS BEEN CORROBORATED BY THE ZETICA PDSA IN APPENDIX F.

No areas of obvious contamination were observed during the site walkover. Evidence of fill/ made ground was observed associated with the golf course. Two potential spoil mounds were observed, a small pile of potential plainings was noted on the southern boundary within the agricultural fields, though could not be confirmed due to access. Further, a large spoil mound appears to be present in the southwest with possible boreholes, (small, fenced areas typically used for protecting boreholes), used for gas monitoring. Anticipated to be natural spoil tipped following motorway development.
