# Northern Gateway

## Geo-environmental and Geotechnical Desk Study and Coal Mining Risk Assessment Report

| <b>Project:</b> | Northern Gateway |
| <b>Document Number</b> | TTE-B048805-SD-DS-002 |

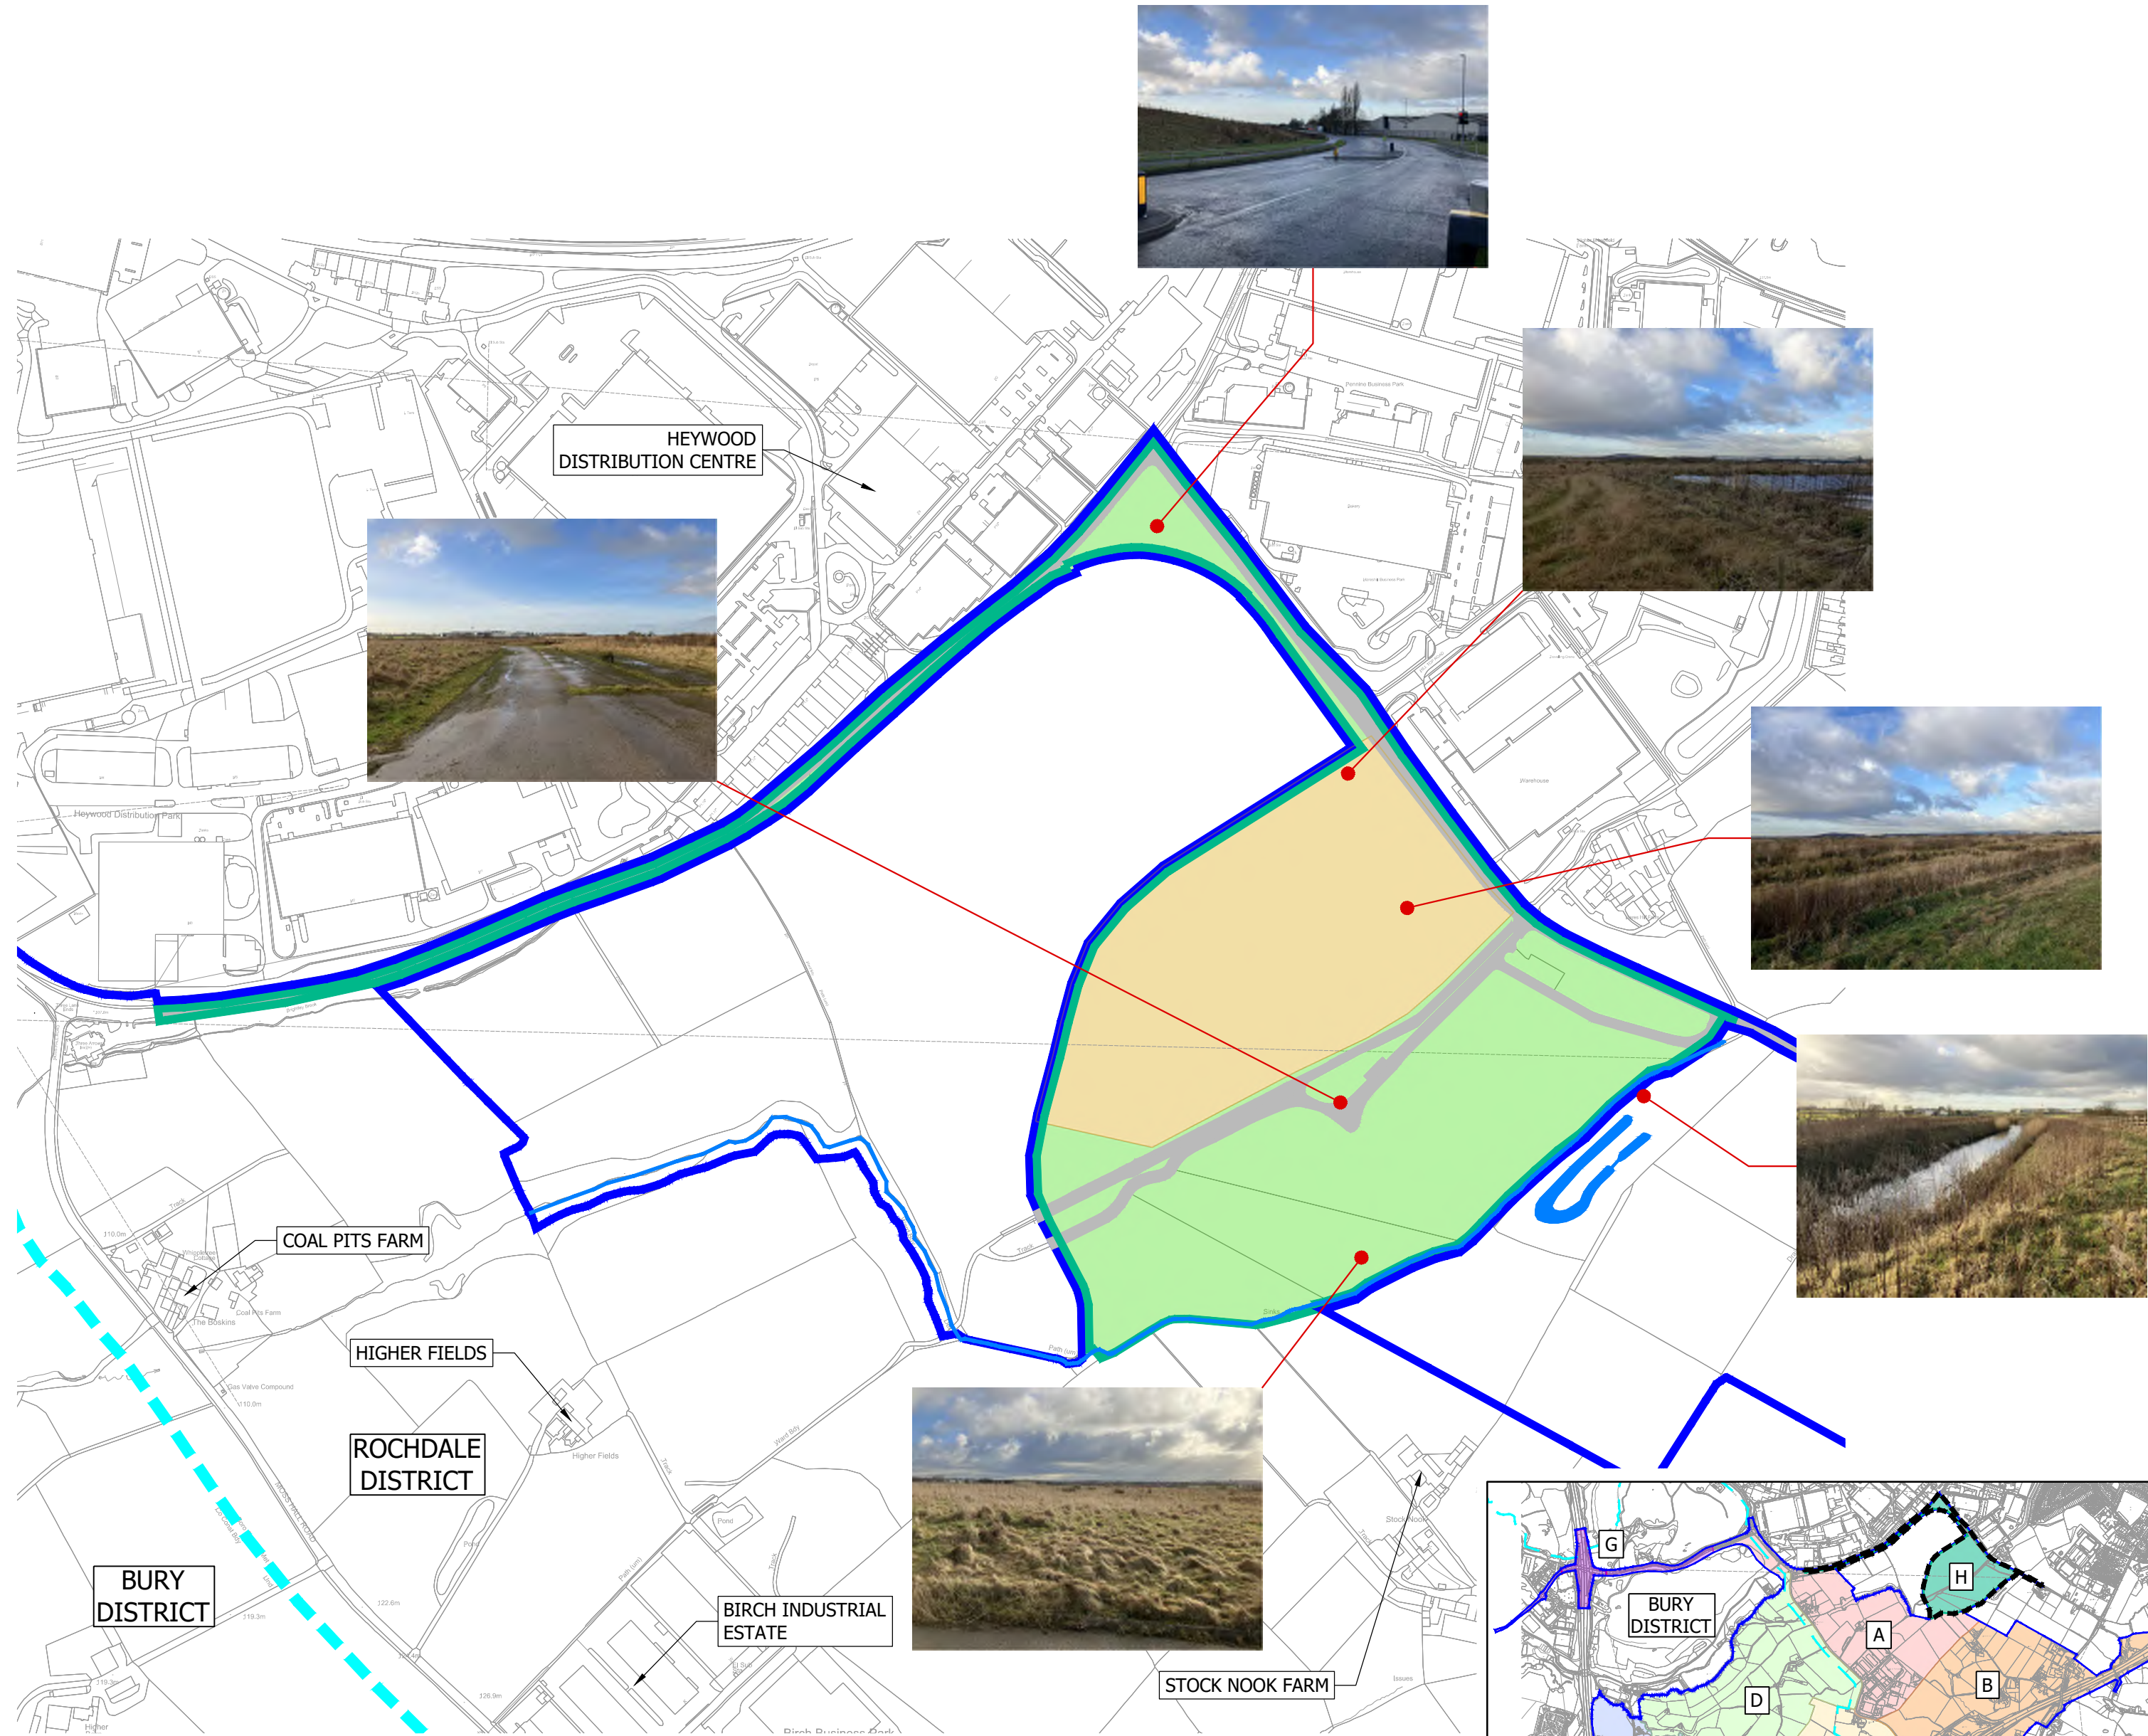
- KEY**
- ASSESSMENT BOUNDARY
  - GROUNDSURE SECTION H
  - FIELDS / GRASS / VEGETATION
  - LANDFILL PERMITTED AREA
  - HARDSTANDING / ROADS / TRACKS / RESIDENTIAL / FARMS / INDUSTRIAL
  - POND / WATERCOURSE
  - DISTRICT BOUNDARY

**NOTES:**  
WALKOVER UNDERTAKEN IN FEBRUARY 2025.  
FIELDS WERE NOTED AS BEING VERY BOGGY.

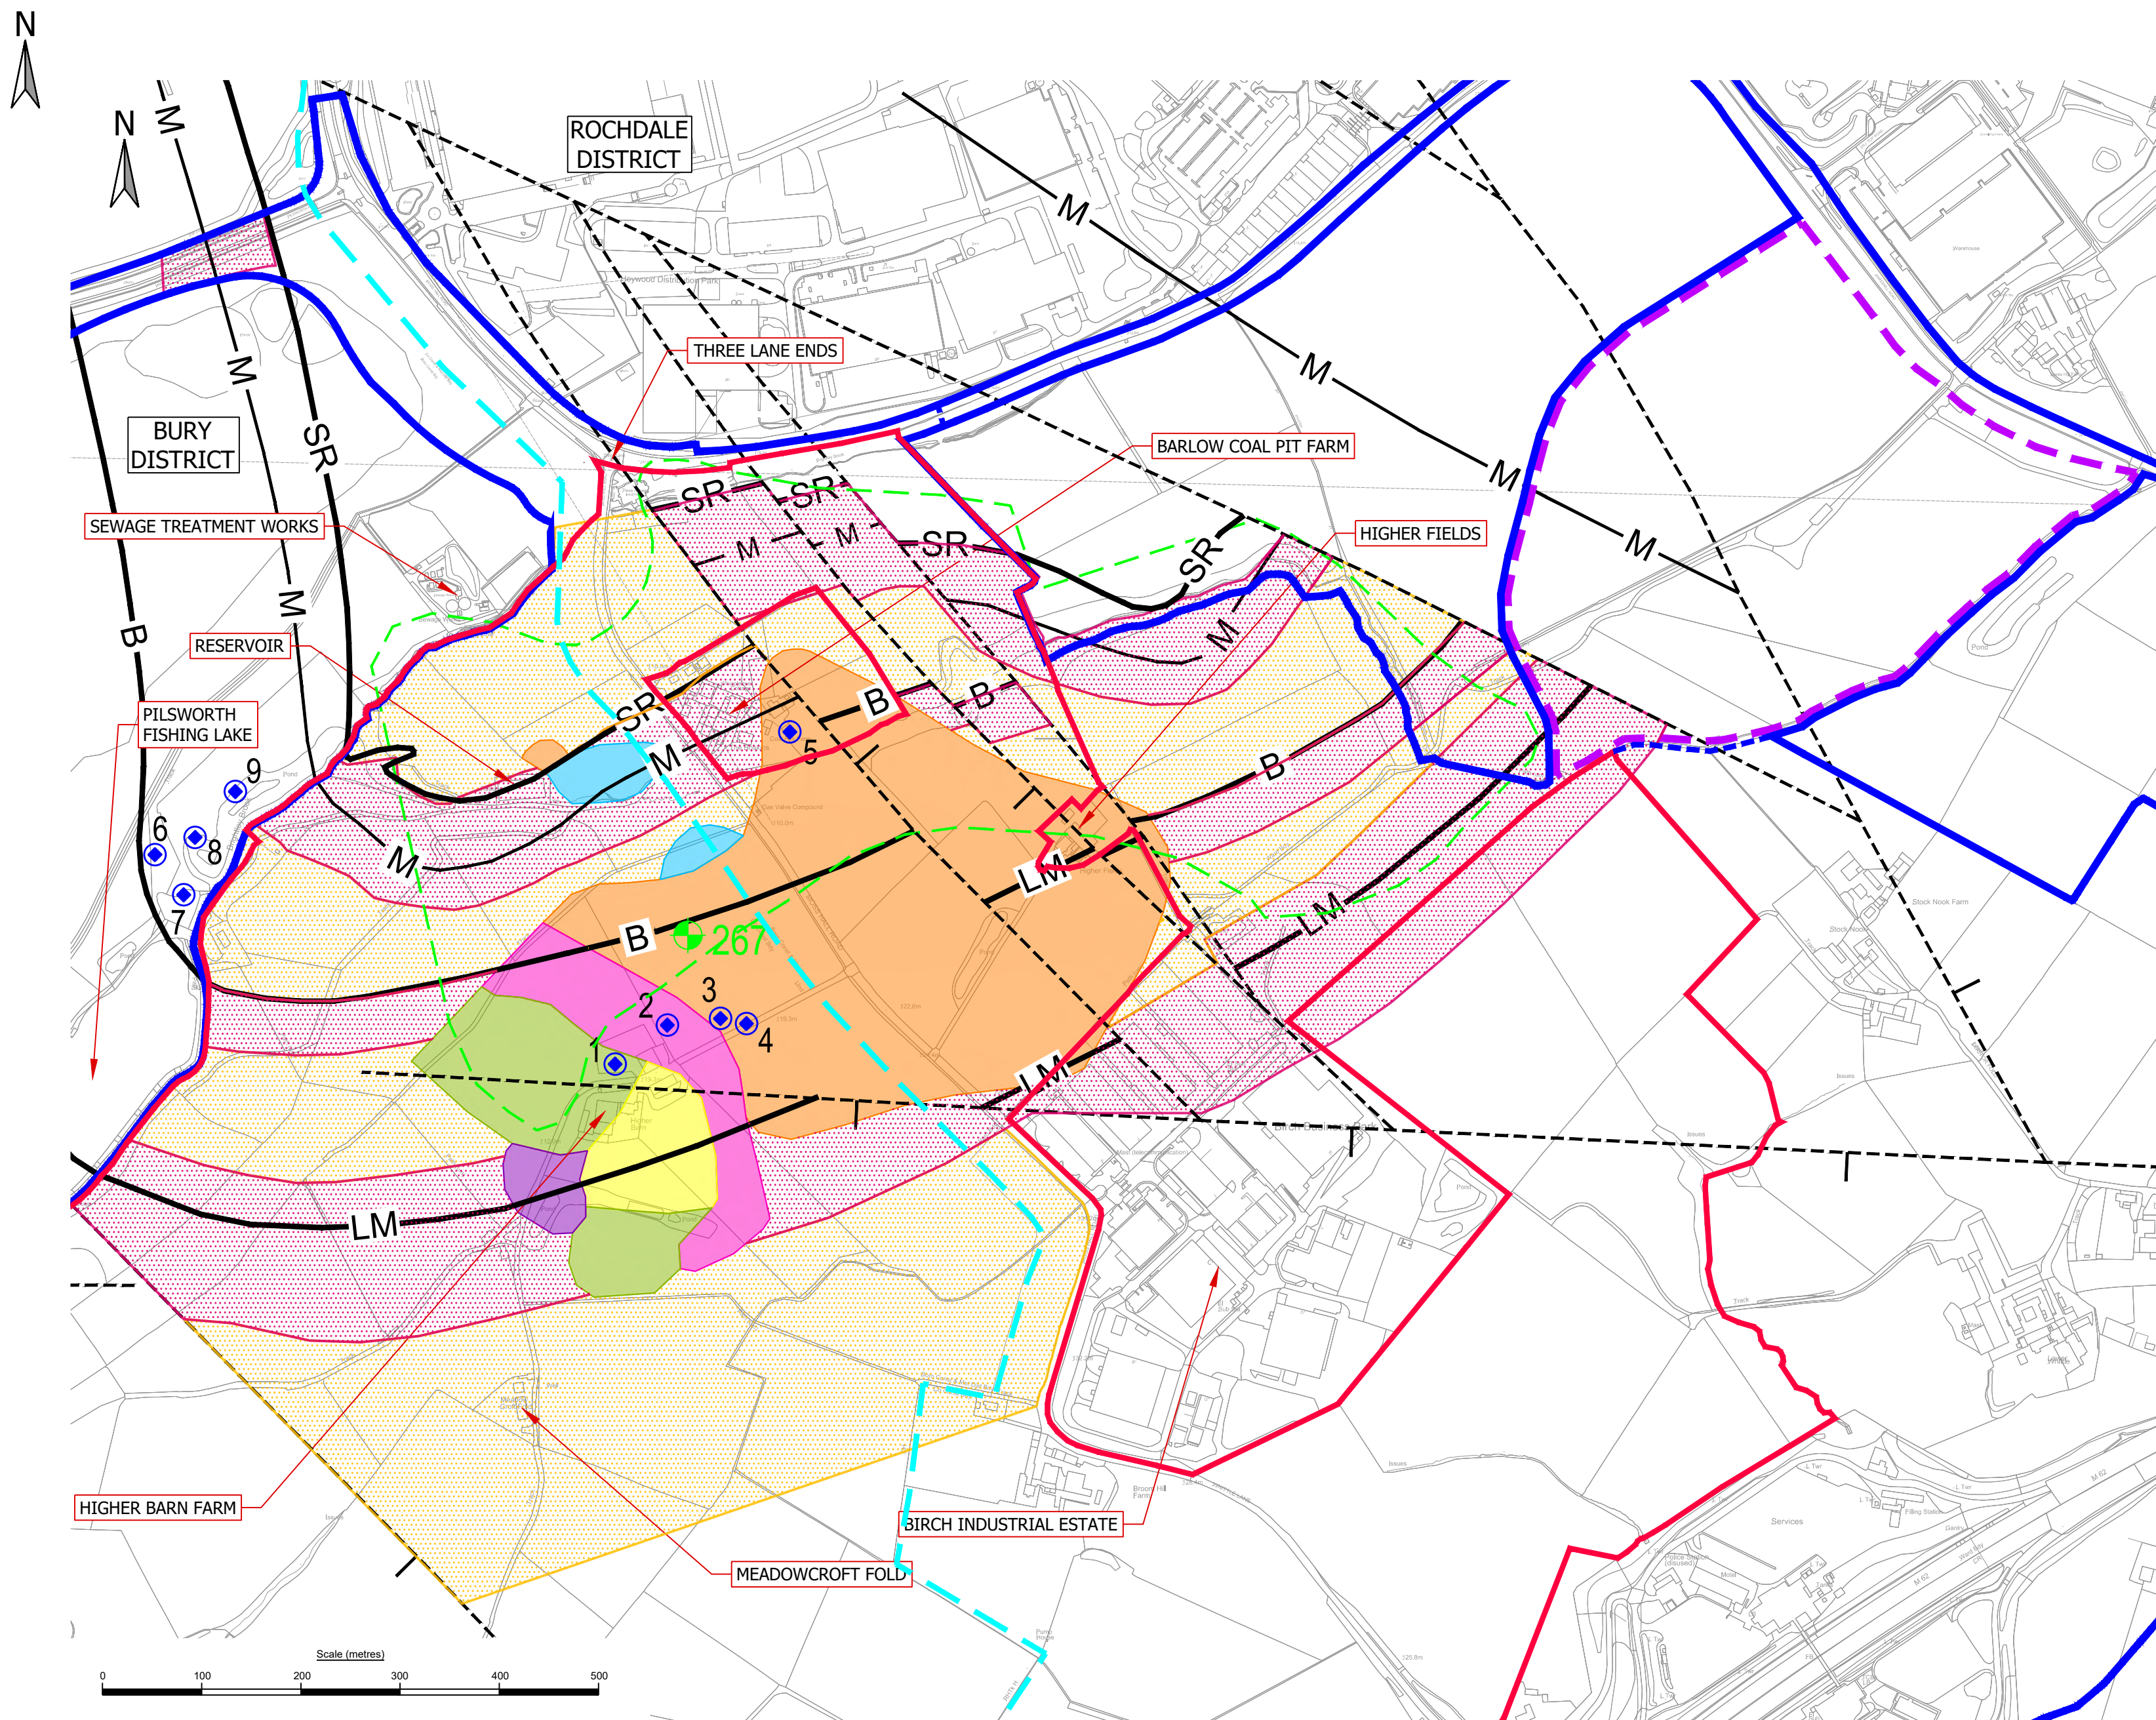
- KEY**
- ASSESSMENT BOUNDARY
  - APPLICATION BOUNDARY
  - DISTRICT BOUNDARY
  - SOUTH HEYWOOD AREA
- COAL SEAMS**
- LM LOWER MOUNTAIN COAL SEAM
  - B BASSEY COAL SEAM
  - SR SAND ROCK COAL SEAM
  - A ARLEY COAL SEAM
  - M SUBCRENATUM MARINE BAND (6")
- STRUCTURAL GEOLOGY**
- FAULT LINES
- CONSTRAINTS**
- CONSIDERATION TO BE GIVEN TO CUT LEVELS WHICH COULD ENCOUNTER SHALLOW BEDROCK IF GREATER THAN 5m
- COAL MINING**
- COAL MINING REPORTING AREA (HIGH RISK FOR DEVELOPMENT)
  - REVISED DEVELOPMENT HIGH RISK AREA BASED ON BGS PLANS
- RECORDED WORKINGS DEPTHS AS PART OF SAND ROCK MINE**
- 0-10m
  - 10-20m
  - 20-30m
  - 30-40m
  - 40-50m
  - 50m+
- NATIONAL COAL BOARD BOREHOLE: POTENTIAL UNRECORDED SHAFT LOCATION
  - COAL AUTHORITY INDICATED MINESHAFT - EXACT LOCATION / BACKFILL UNKNOWN

**CONSTRAINTS IDENTIFICATION**  
COAL MINING POSSES A POTENTIAL ISSUE AS MINE SHAFTS AND SHALLOW WORKINGS CAN COLLAPSE. THE COLLAPSE CAN BE MIGRATORY FROM DEPTH TO THE SURFACE MEANING THAT IN ORDER TO BUILD THEY NEED TO BE STABILISED.

SURFACE EXTRACTION MEANS THAT A COMMODITY HAS BEEN REMOVED FROM SURFACE TO BELOW GROUND LEVEL. THE RESULTANT EXCAVATION MAY OR MAY NOT HAVE BEEN BACKFILLED. IF THE EXCAVATION HAS BEEN BACKFILLED IT IS LIKELY TO HAVE BEEN IN AN UNCONTROLLED MANNER AND MAY BE WITH MATERIALS THAT POSE AN UNACCEPTABLE RISK TO CONTROLLED WATERS & HUMAN HEALTH. UNCONTROLLED FILLING MAY LEAD TO GROUND COLLAPSE, UNACCEPTABLE SETTLEMENTS AND THE FAILURE OF FOUNDATIONS.

- NOTES:**
- WHOLE SITE FALLS WITHIN A COAL MINING REPORTING AREA
  - FOR OTHER MINERAL EXTRACTION INFORMATION REFER TO DRAWING B048805-TTE-00-XX-DR-U-0005.2-01.
  - RECORDED WORKINGS IDENTIFIED FROM BGS RECORDS ASSOCIATED WITH SAND ROCK COAL SEAM.
